<p>California Public Utilities Commission <i>Mitigation Monitoring, Compliance, and Reporting Program</i></p>
	<p>Cleveland National Forest Power Line Replacement Projects</p> <p>Compliance Status Report: 037</p> <p>February 18, 2018</p>

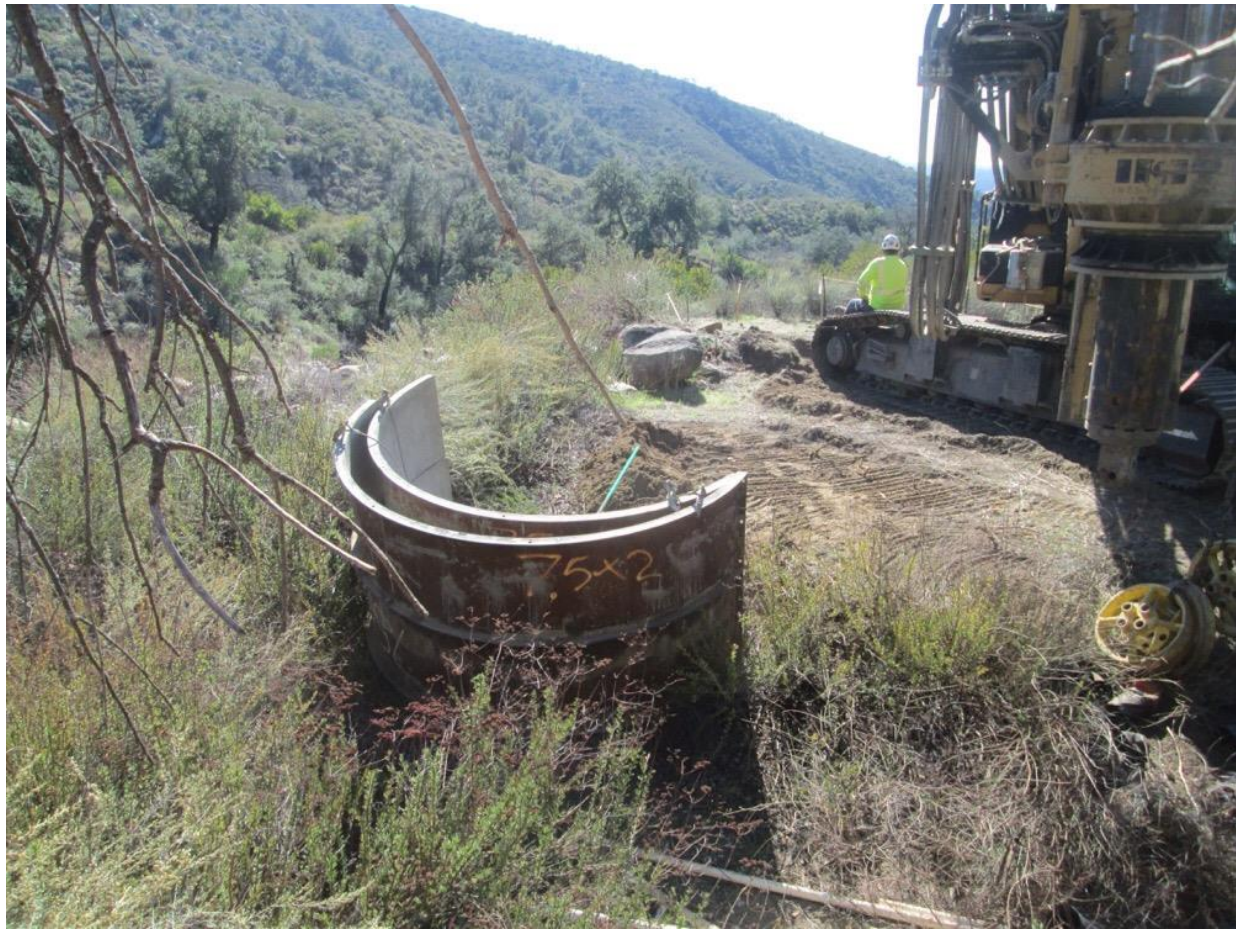
During construction activities, crews were observed adhering to delineated work limits and working within existing access roads in accordance with MM BIO-1. On February 6, a third party ECM observed that a foundation form had been set approximately three feet outside of the work limits at Z118018 (TL 682) where a crew was setting up for pole hole drilling (See Photo 1 – Attachment A). The Lead Environmental Inspector (LEI) notified the crew foreman to move the form into the delineated work area. No impacts to sensitive resources were observed.

Photo 1: During drill site set up at Z118018 (TL 682), a foundation form was observed being staged approximately three feet outside of the delineated workspace. The LEI was notified, who contacted the crew foreman and had the form brought back inside the approved workspace (MM-BIO-1).

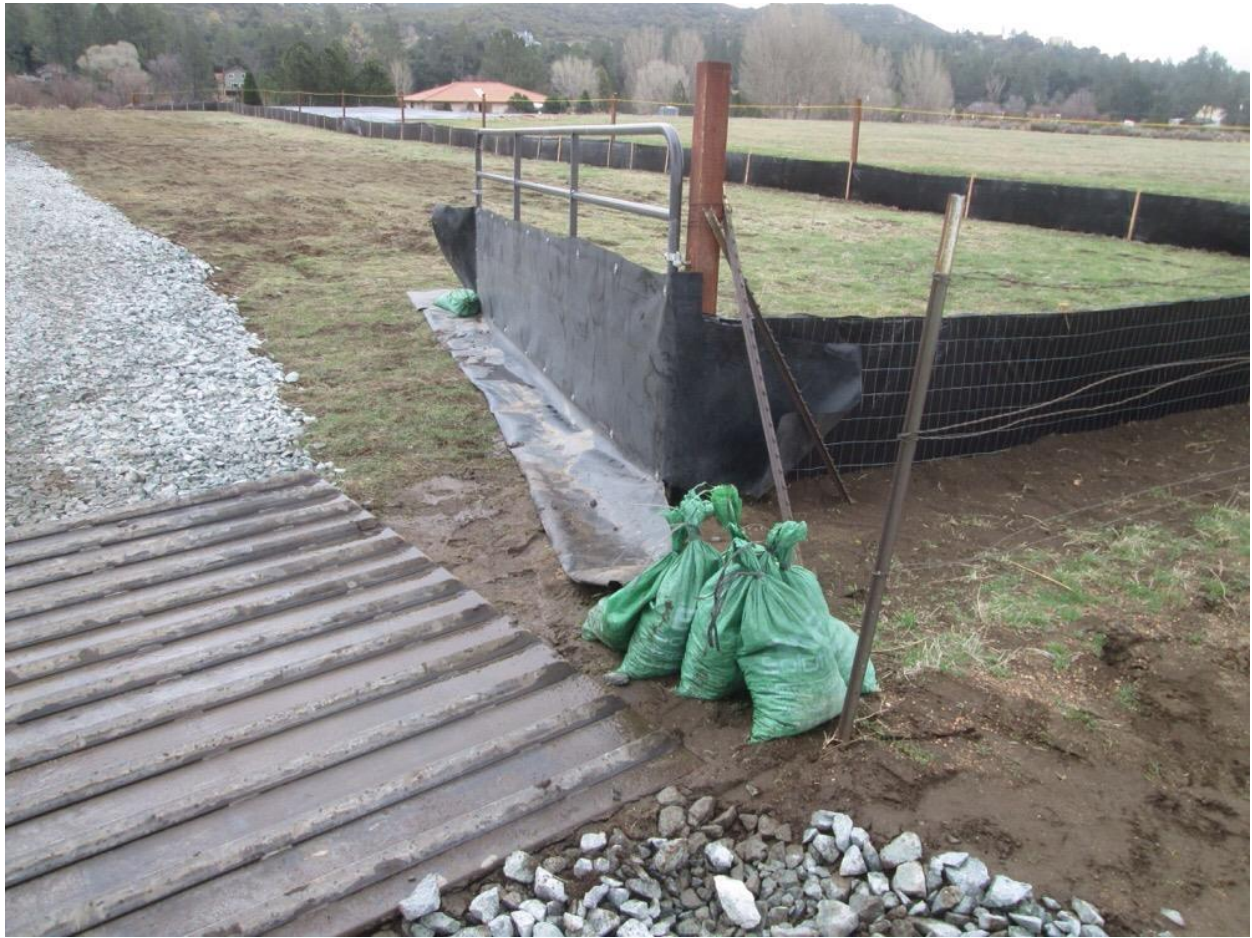
On February 12, the Lead Biological Monitor (BM) informed the third party ECM that silt fencing had been installed as exclusionary fencing surrounding the Creekside Staging Yard at the recommendation of the authorized arroyo toad biologist (See Photo 2 – Attachment A).

Photo 2: At the recommendation of the authorized biologist, arroyo toad protective measures for exclusionary purposes, such as the use of silt fencing around the yard and a rubber flap and gravel bags at the yard entrance, were observed being implemented at Creekside Staging Yard (Section 2.11 - Streambed Alteration Agreement).

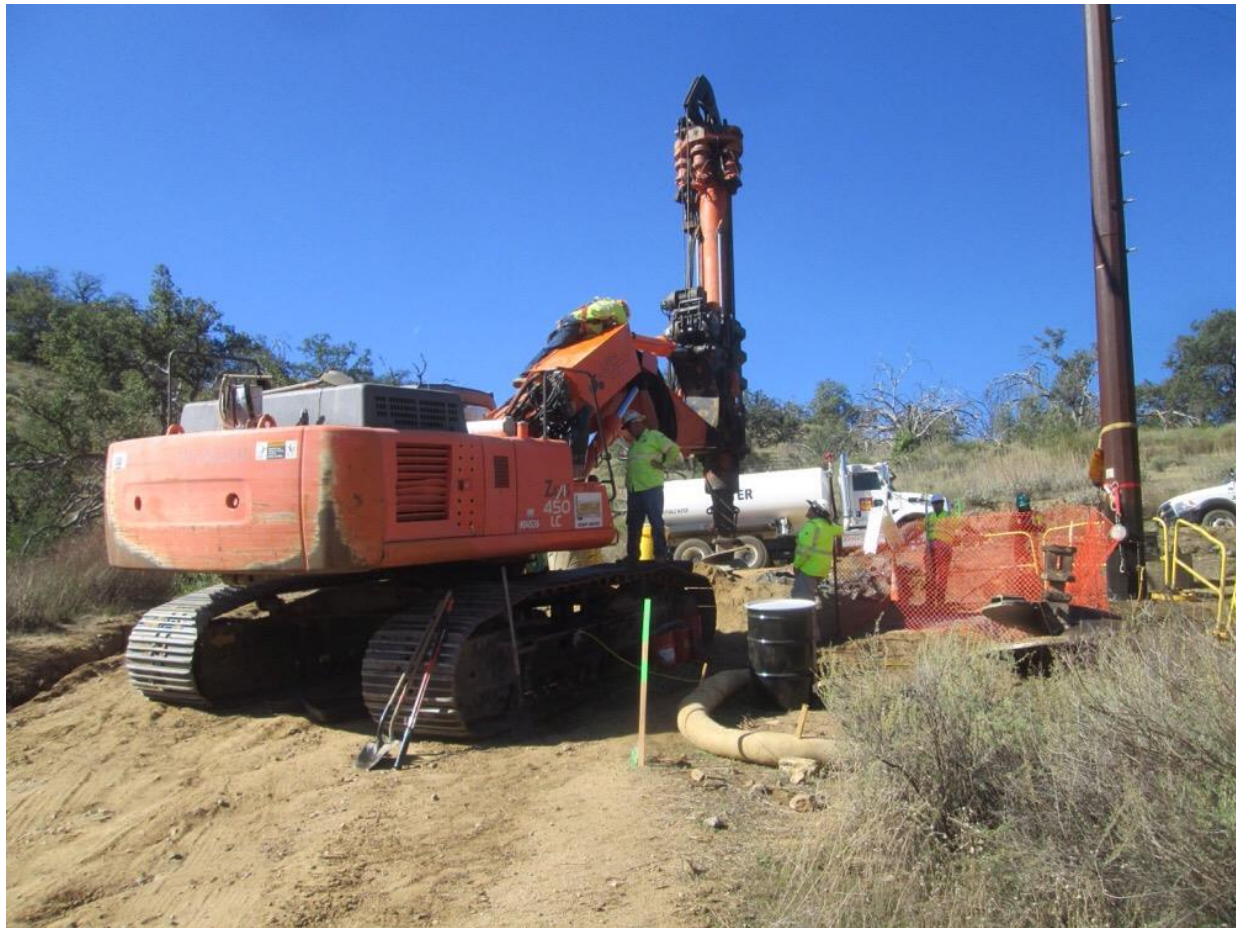
To prevent leaks and spills from being discharged into the soil in accordance with the Spill Response and Notification Plan (MM PHS-2), crews were observed implementing spill prevention BMPs, which included the use of secondary containment beneath hazardous materials and fuel tanks, double walled fuel tanks, drip pans beneath staged equipment and sanitary facilities, and spill kits. On February 8, a crew was observed repairing a leak on a drilling rig and conducting cleanup of stained soil (See Photo 3 – Attachment A). Absorbent pads and drip pans were observed being used, and stained soil was placed in a drum for disposal in accordance with the Spill Response and Notification Plan and MM-PHS-2.

Photo 3: A drilling crew was observed repairing a hydraulic fluid leak on a drill rig and conducting stained soil cleanup. Absorbent pads and drip pans were observed being utilized, and stained soils were placed in a drum for disposal in accordance with the Spill Response and Notification Plan and MM-PHS-2.

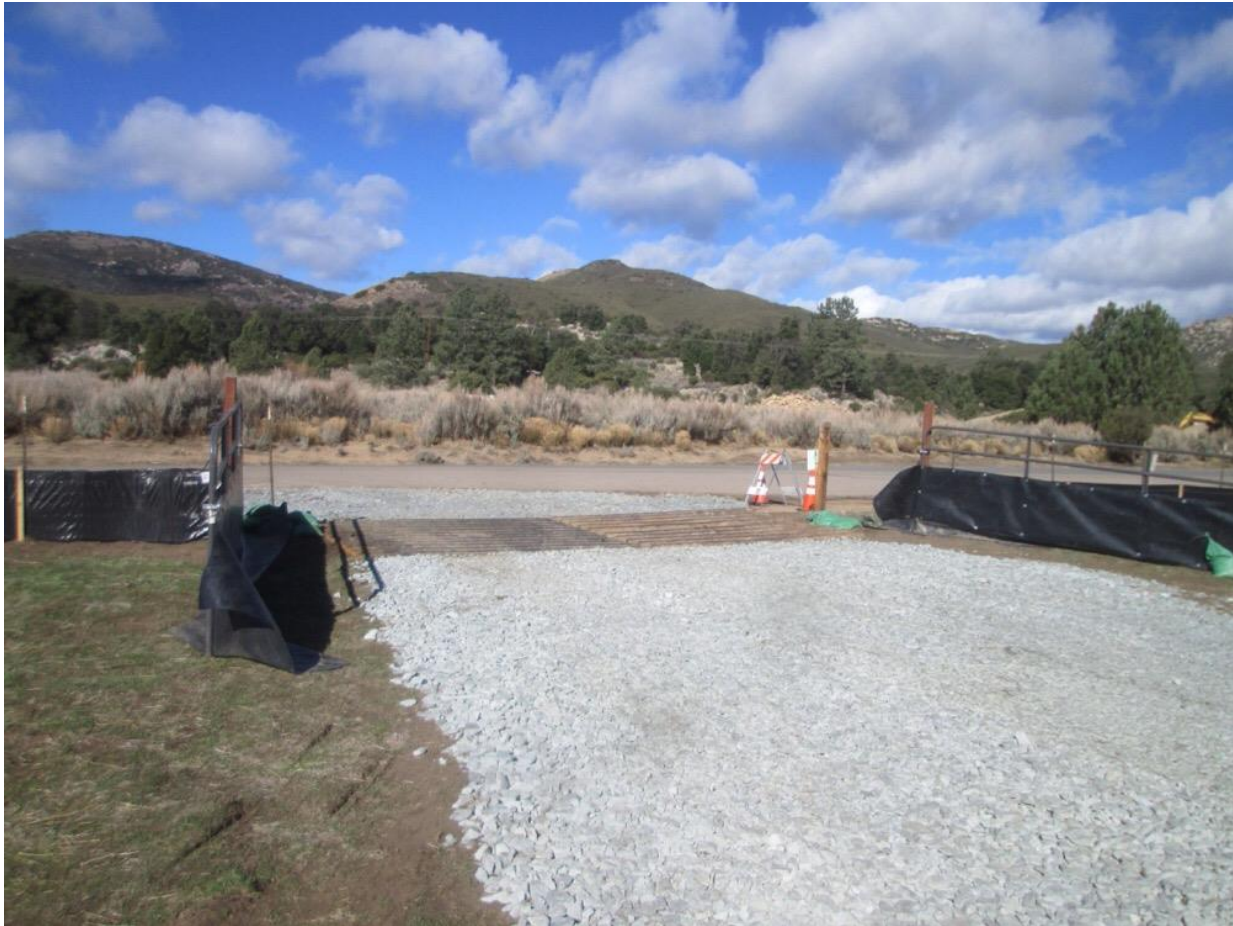
Photo 4: Track-out control BMPs, such as rattle plates and a rock apron were observed at the ingress and egress of Creekside Staging Yard in accordance with the SWPPP, Erosion Control Plan, MM-HYD-1, MM-BIO-7, and APM-HYD-09.

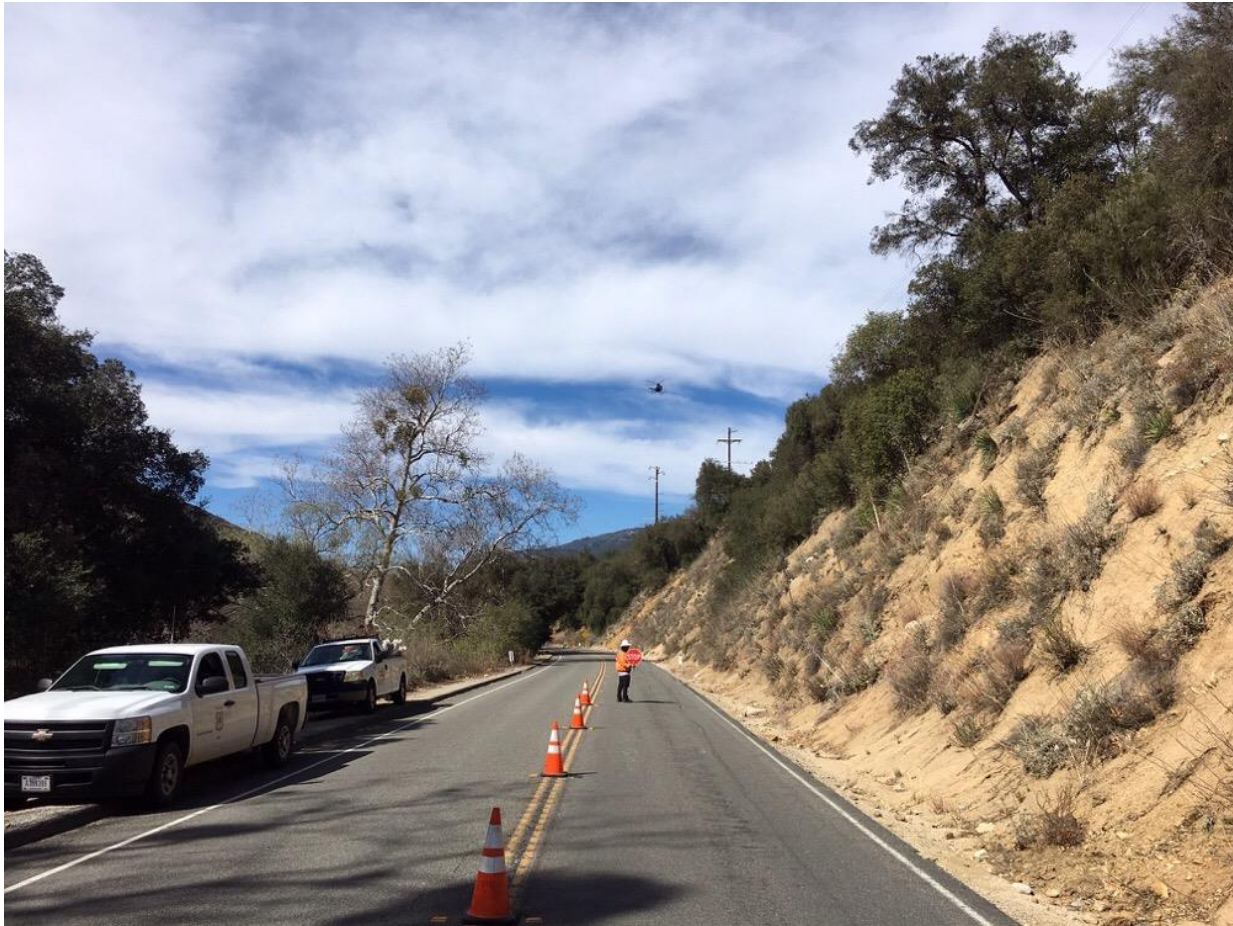
In accordance with APM TRANS-02, traffic control measures were implemented during this reporting period. Traffic control measures, such as the placement of signage and cones as well as the use of flag persons were observed along Pine Creek Road and Highway 76 (See Photo 5 – Attachment A).

Photo 5: During steel pole installation with helicopter assistance, traffic control was setup in multiple locations along Highway 76 to temporarily stop traffic when work occurred adjacent to the highway in accordance with MM-TRANS-2.
