California Public Utilities Commission <i>Mitigation Monitoring, Compliance, and Reporting Program</i>
	Cleveland National Forest Power Line Replacement Projects Compliance Status Report: 038 March 5, 2018

This compliance status report covers construction activities from February 19, 2018 through March 4, 2018.

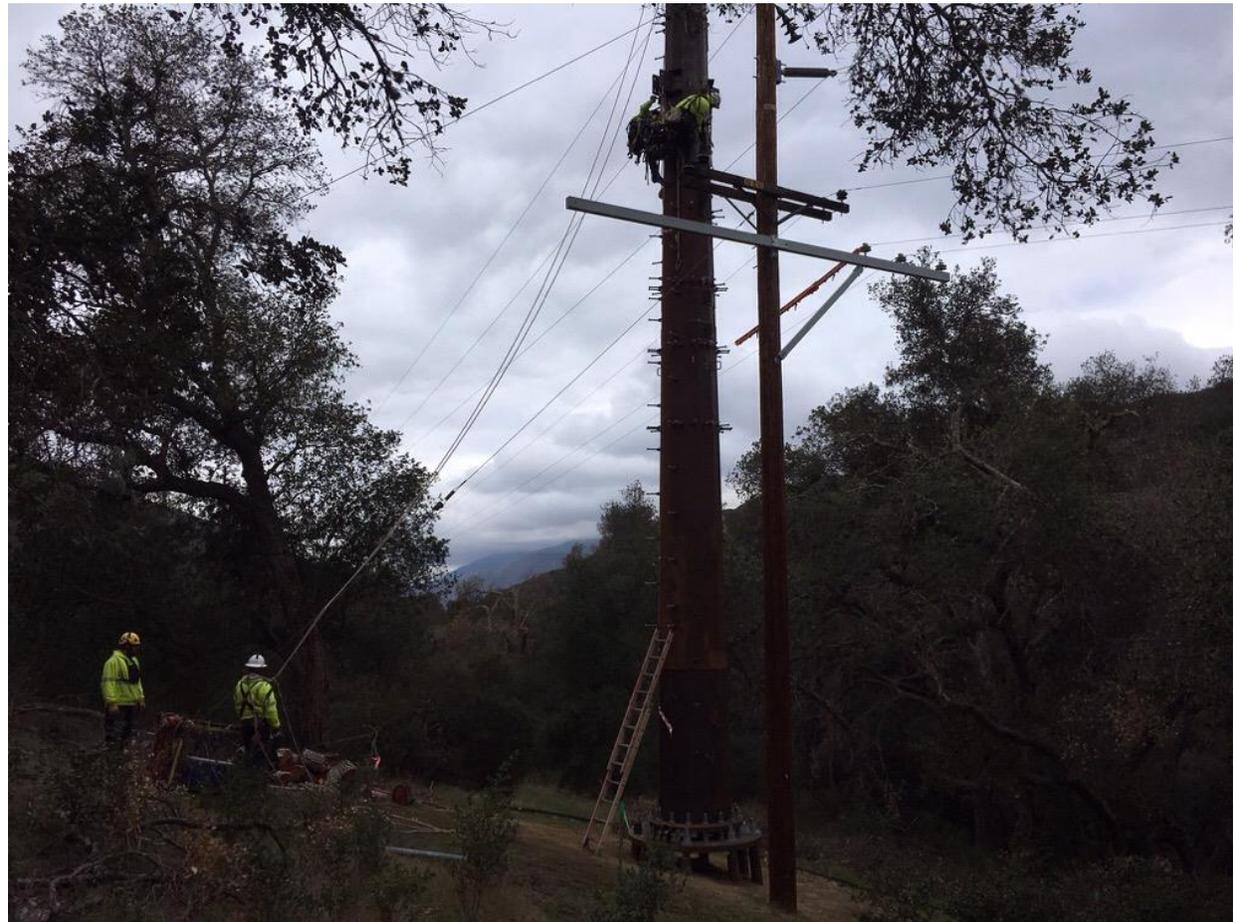
During construction activities, crews were observed adhering to delineated work limits and working within existing access roads in accordance with MM BIO-1 (See Photo 1 – Attachment A).

Photo 1: A construction crew is observed installing a pole top at Z118150 (TL 682). All work was observed being conducted within the designated workspace in accordance with MM-BIO-1.

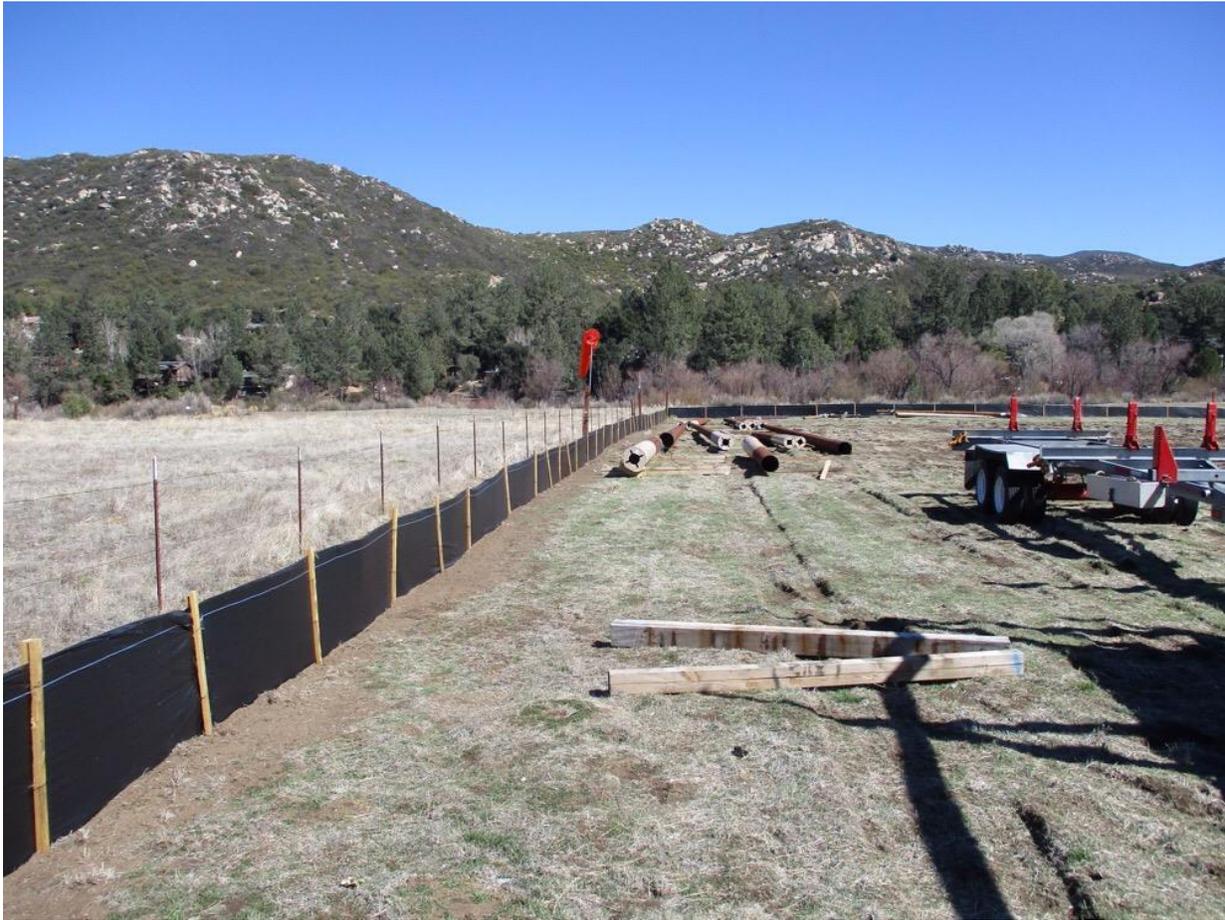
In accordance with MM BIO-3 and MM BIO-22, Biological Monitors were observed conducting full time monitoring of initial ground-disturbing activities as well as vegetation clearing. In accordance with the Avian Protection Plan/Nesting Bird Management Plan and MM BIO-28, avian biologists were observed surveying for nesting raptors ahead of scheduled work activities along C 442 and TL 682. No-disturbance buffers were established around active nests and nest sites were monitored while work occurred within the vicinity. Arroyo toad exclusionary fencing surrounding the Creekside Staging Yard, in place at the recommendation of the authorized biologist, remained in place in accordance with the Streambed Alteration Agreement (See Photo 2 – Attachment A).

Photo 2: Arroyo toad exclusionary fence surrounding the Creekside Staging Yard remains in place at the recommendation of the authorized biologist in accordance with the Streambed Alteration Agreement.

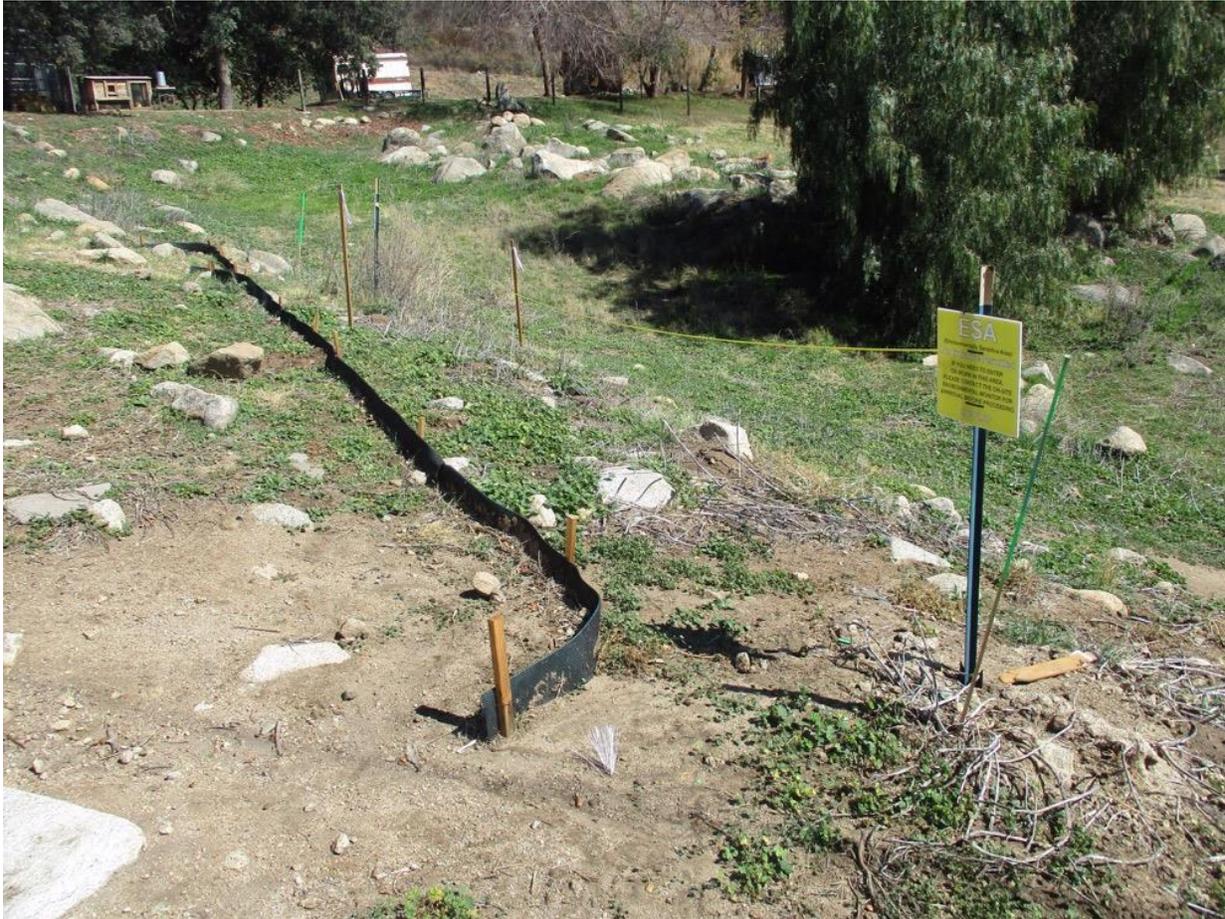
Cultural resource monitors, including Archaeological and Native American Monitors, were observed monitoring ground disturbing activities, such as vegetation clearing, BMP installation, and pole hole drilling. Cultural resources monitors inspected excavated soils for potential sensitive cultural resources in accordance with the Historic Properties Management Plan (HPMP), MM CUL-1, MM CUL-3, and APM CUL-04. In addition, cultural resources environmental sensitive areas (ESAs) were fenced to prevent unauthorized access into areas with previously recorded cultural resources (See Photo 3 – Attachment A).

Photo 3: During crane setup/mobilization for drilling at along TL 682, an ESA was observed along the eastern perimeter of the site in accordance with the Historic Properties Management Plan.

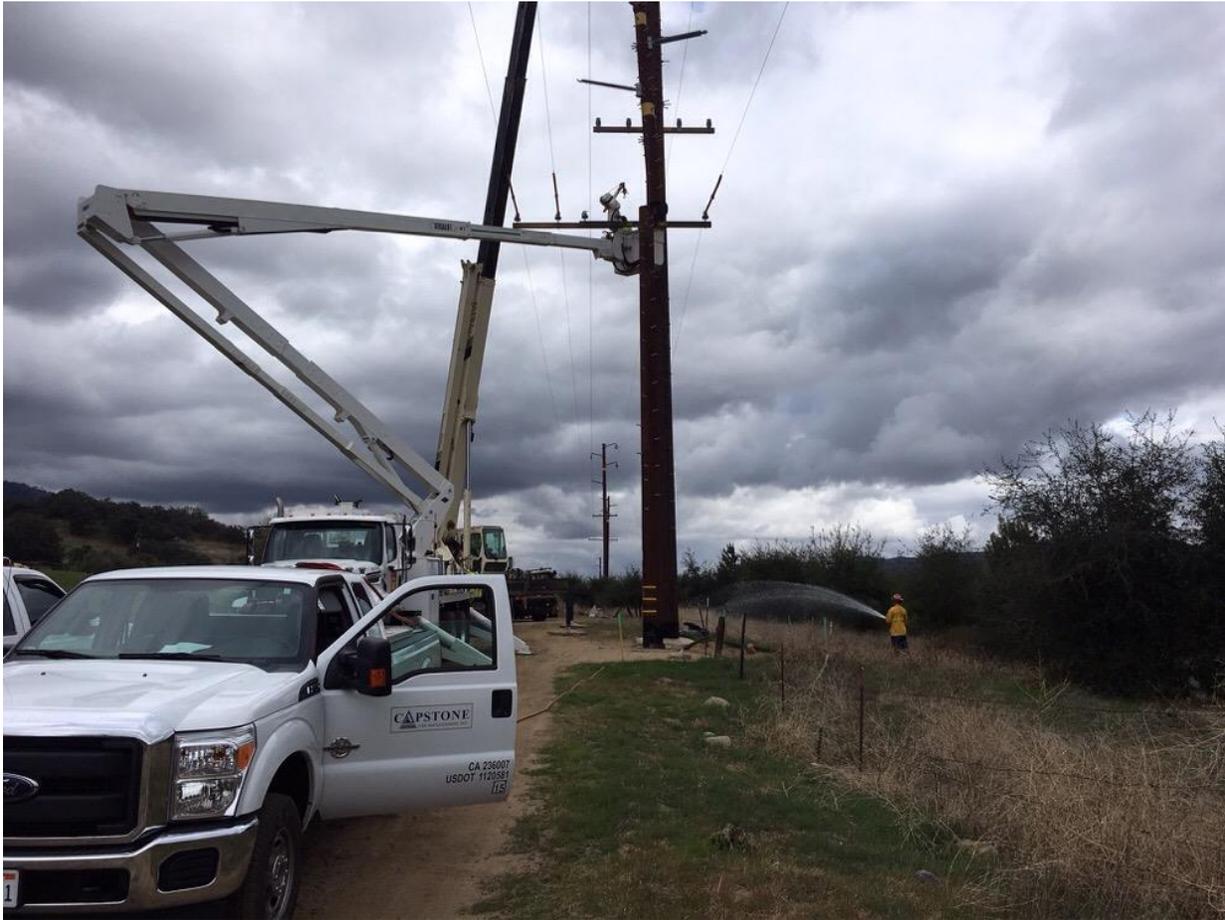
During construction activities, construction fire patrols were observed inspecting sites for compliance with the Construction Fire Prevention/Protection Plan (CFPPP) and MM FF-1 (See Photo 4 – Attachment A). Construction crews were observed staging the required fire tools and equipment based on the Project Activity Level (on CNF land)/Fire Potential Index (off CNF land) and the construction activity being performed as allowed in the CFPPP Fire Prevention Matrices. A set of fire tools (5-gallon backpack pump, round point shovel, Pulaski, and 2A10BC fire extinguisher) was observed at active construction sites in accordance with APM HAZ-01 and APM HAZ-04.

Photo 4: During cutting of the existing steel distribution pole at Z118048 (TL 682), a fire patrol was observed monitoring the hot work and wetting down the surrounding area in accordance with the CFPPP.

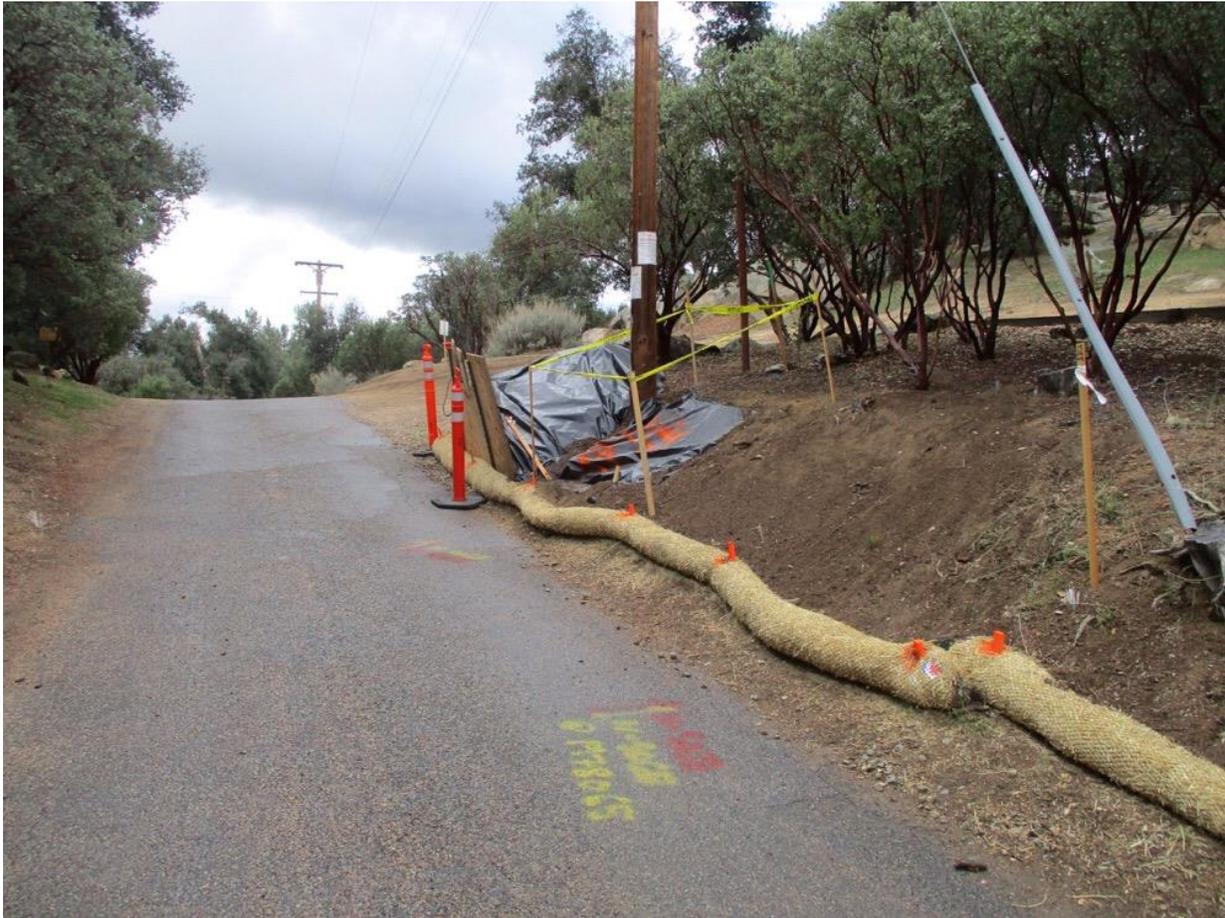
Site-specific erosion and sediment control BMPs continued to be observed along the project rights-of-way in accordance with the project Storm Water Pollution Prevention Plan (SWPPP), MM HYD-1, MM BIO-7, and APM HYD-09. Sediment control BMPs included fiber rolls, silt fencing, and pro-wattle were observed to be in good condition at pole replacement sites and staging yards (See Photo 5 – Attachment A).

Photo 5: At P178056 (C 442), dirt spoil was covered and fiber rolls were in place to prevent erosion in accordance with the Erosion Control Plan and SWPPP. The pole hole was securely covered for safety and to prevent wildlife entrapment in accordance with MM-BIO-23.
