<p>California Public Utilities Commission <i>Mitigation Monitoring, Compliance, and Reporting Program</i></p>
	<p>Cleveland National Forest Power Line Replacement Projects</p> <p>Compliance Status Report: 044</p> <p>May 27, 2018</p>

This compliance status report covers construction activities from May 14, 2018 through May 27, 2018.

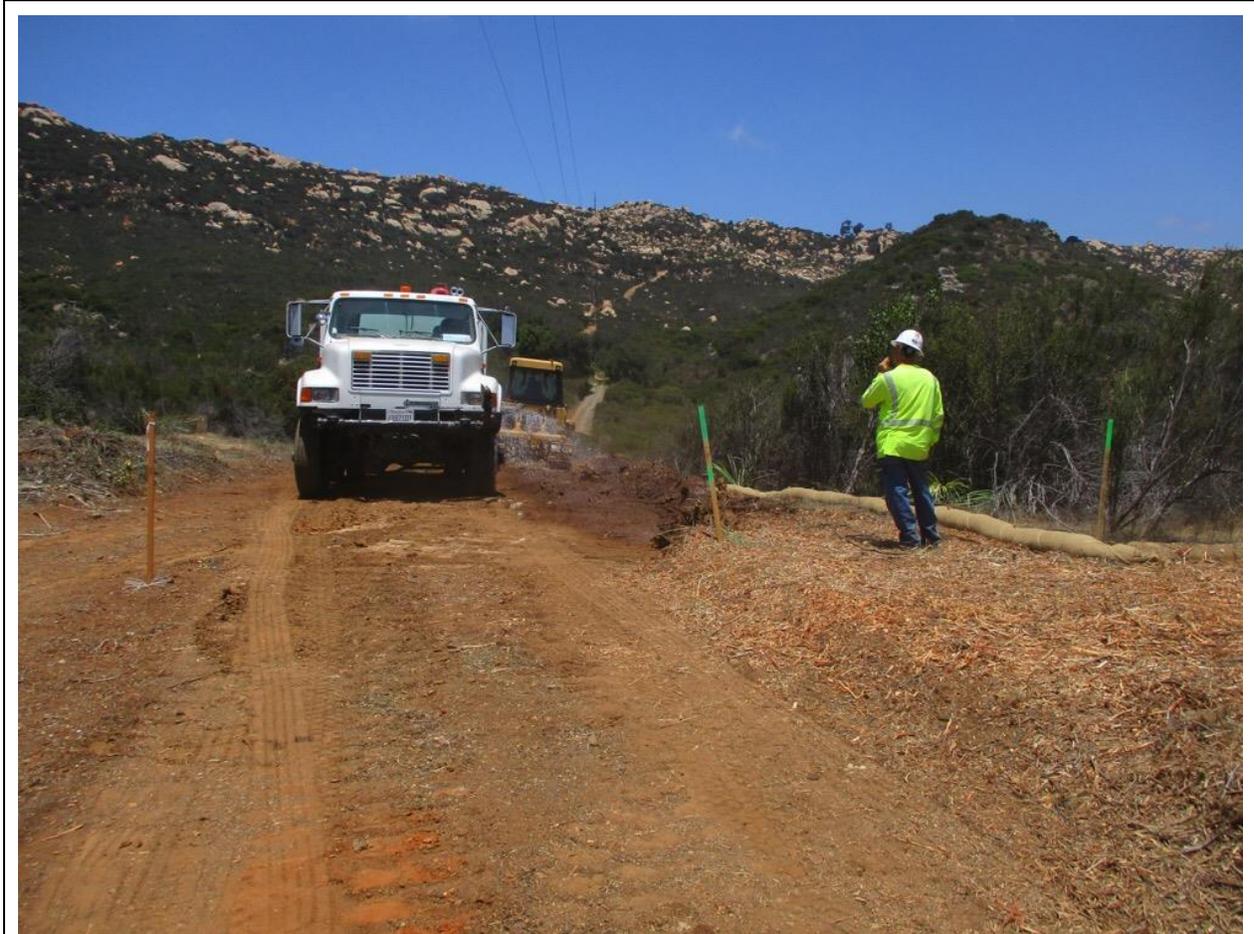
During this reporting period, CPUC ECMs observed implementation of dust control measures including the application of water on access roads and in work areas in accordance with APM AIR-02 (See Photo 1—Attachment A). Project personnel were observed maintaining posted speeds of 15 miles per hour on unpaved roads in accordance with APM AIR-03 and MM BIO-24. Track-out was not observed along paved access roads in accordance with APM AIR-05.

Photo 1: During grading of stringing site 6 (TL6957), a water tender was used to follow behind the movement of steel-tracked equipment, to wet down the work area for fire risk during grading in accordance with the CFPPP fire prevention matrix (on CNF land - PAL B), and to prevent dust emissions in accordance with APM AIR-2. In addition, the required fire tools were staged on-site, and observed on/in all equipment and vehicles on the ROW in accordance with the CFPPP, MM FF-1, MM BIO-7, and APM HAZ-04.

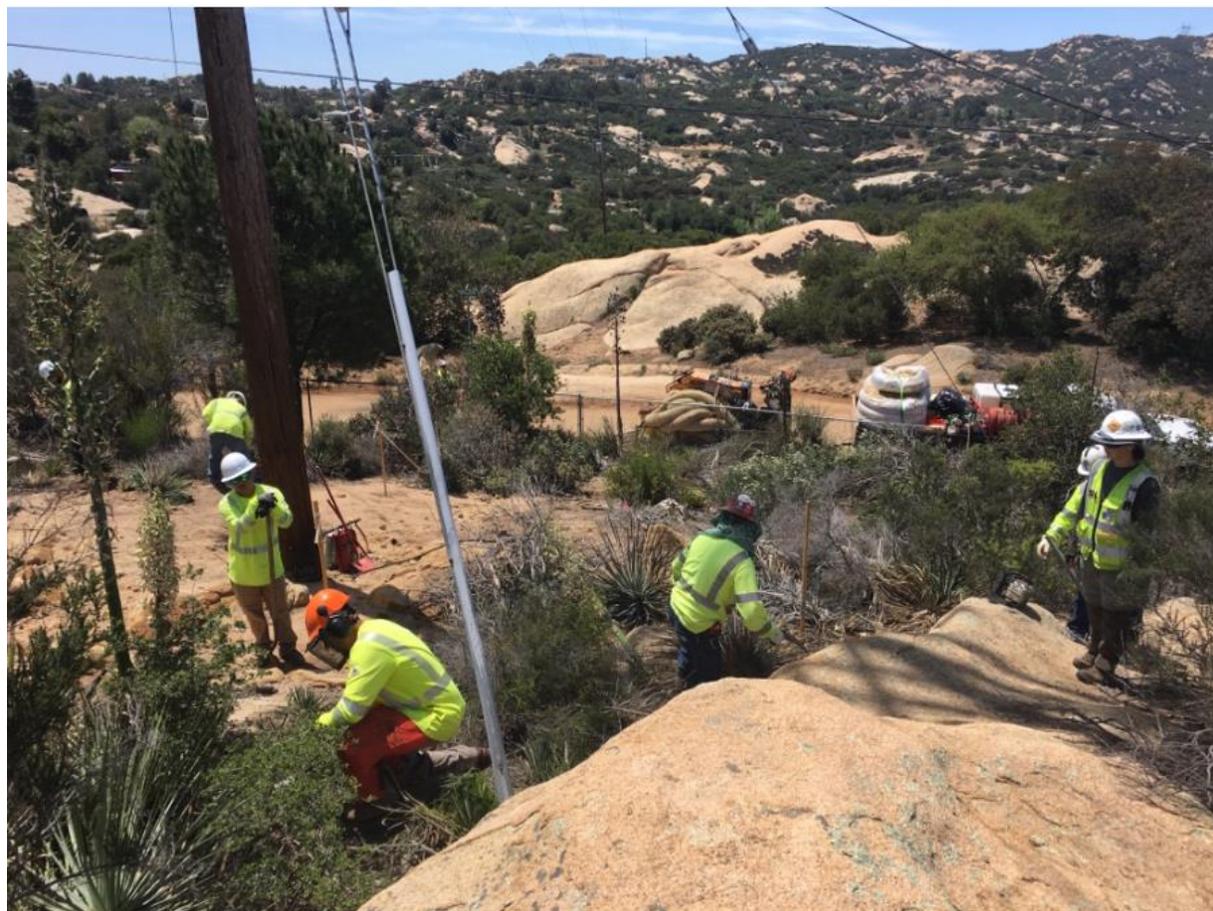
Photo 2: Prior to SWPPP BMP installation, a biological monitor observes vegetation clearing activities/initial ground-disturbing activities at Pole Z571417 (TL6957) in accordance with MM BIO-22. Fire equipment was observed on site in accordance with the Construction Fire Protection /Prevention Plan (CFPPP) (MM FF-1).

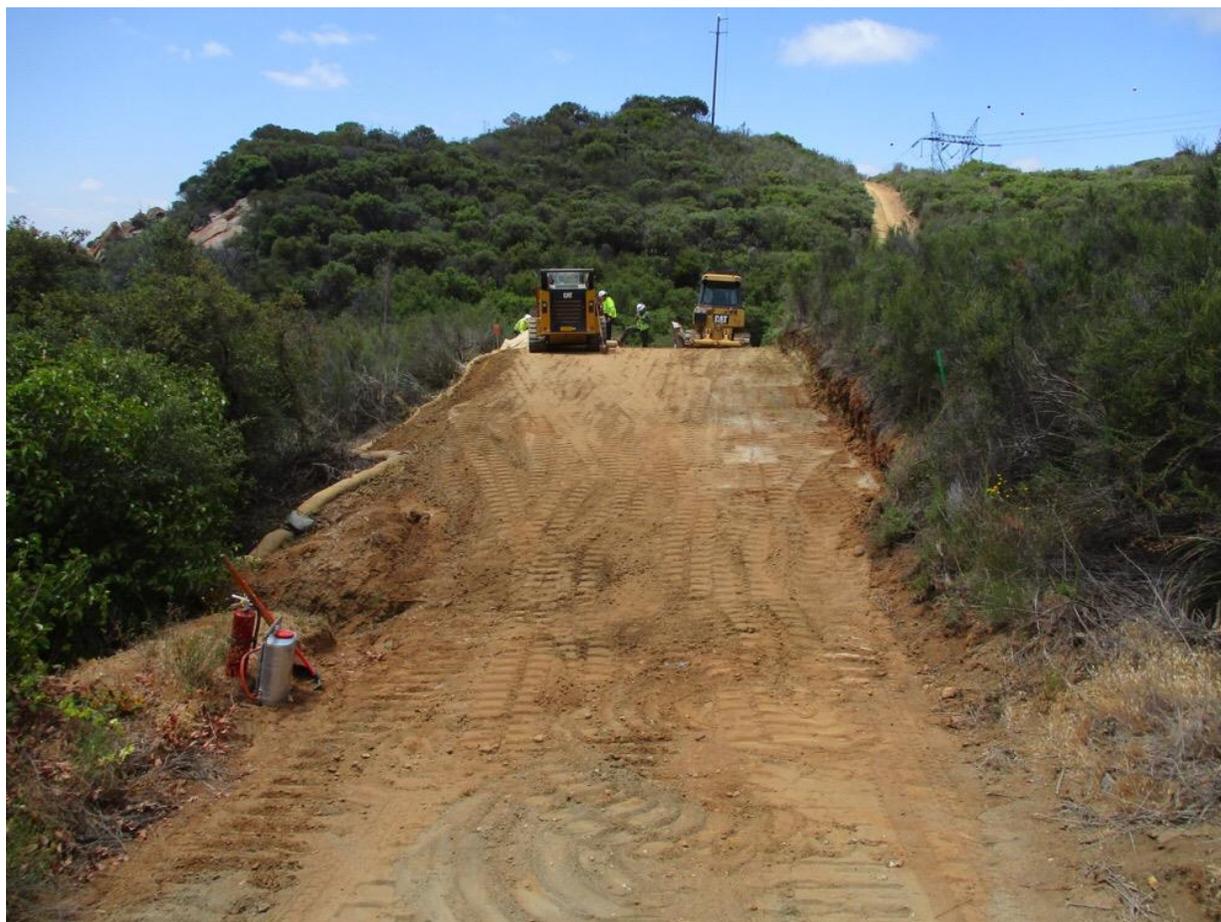
Photo 3: During grading of stringing site 5 (TL 6957), topsoil was salvaged and stockpiled for later use in restoration, in accordance with the Habitat Restoration Plan (MM BIO-4). Fiber rolls along the downslope perimeter of the work limits were effective in retaining sediment within the work limits and stockpiled topsoil was covered with jute mesh in accordance with the Erosion Control Plan and SWPPP (MM HYD-1).

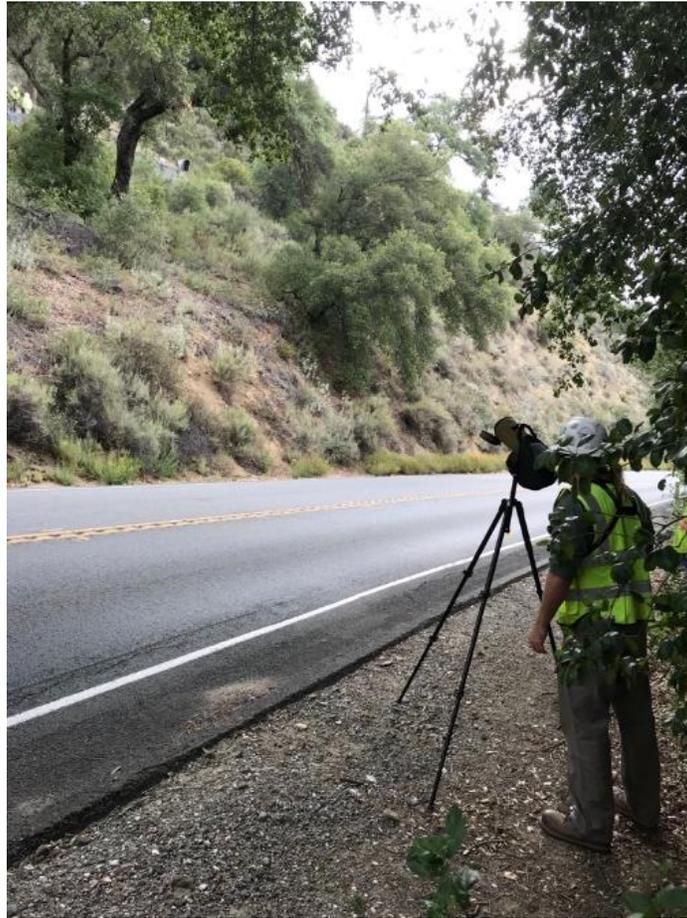
Photo 4: In accordance with the APP, NBMP, and MM BIO-28, an Avian Biologist was observed monitoring an active nest near Pole Z118096 (TL 682) to ensure no impacts were occurring as a result of nearby vegetation removal.

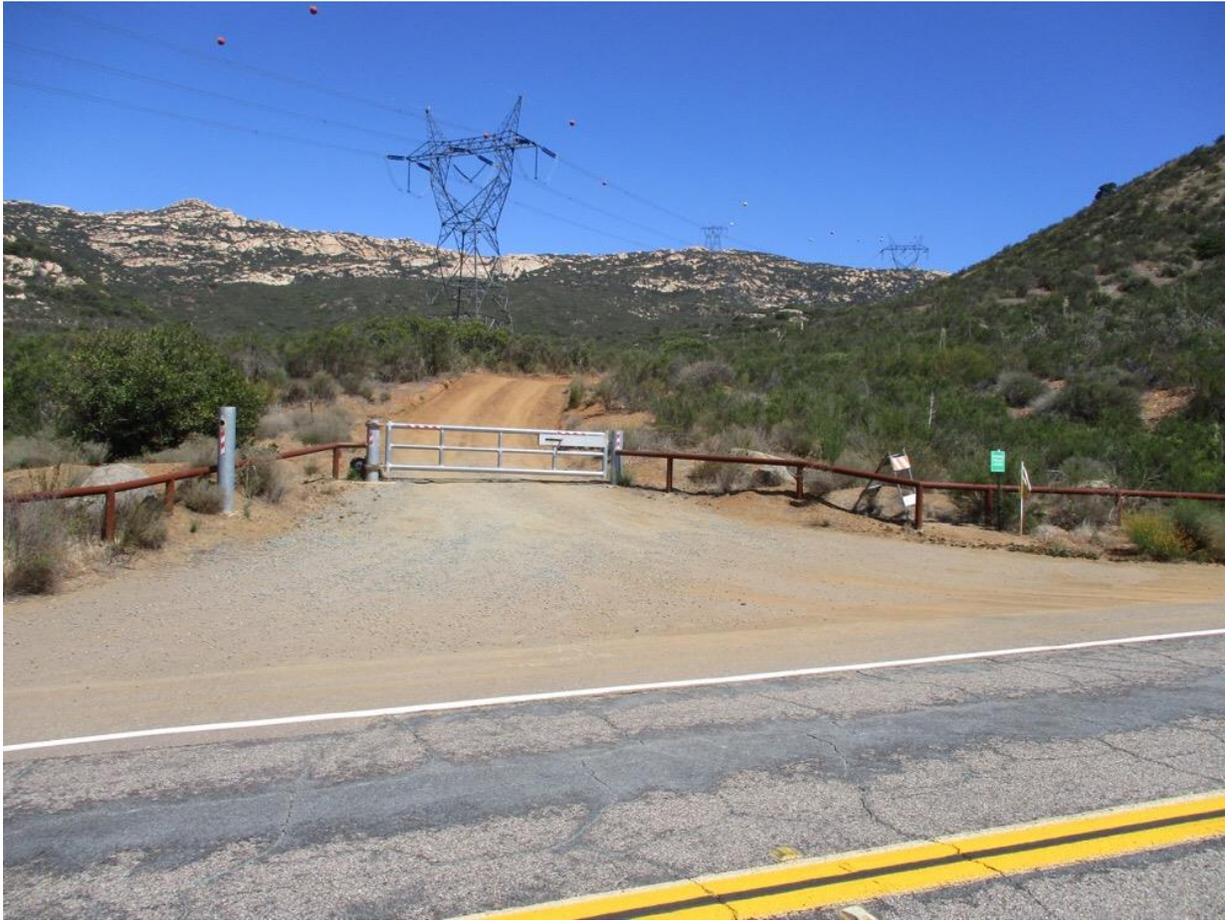
In accordance with MM REC-2, proper gate protocol was observed being implemented (See Photo 5 – Attachment A).

Photo 5: Construction crews were observed implementing proper gate protocol for forest service lands by locking gates immediately after ingress and egress in accordance with MM REC-2 (picture of gate used to access Z571436 and Z571435 (TL6957)), where vegetation clearing was observed.

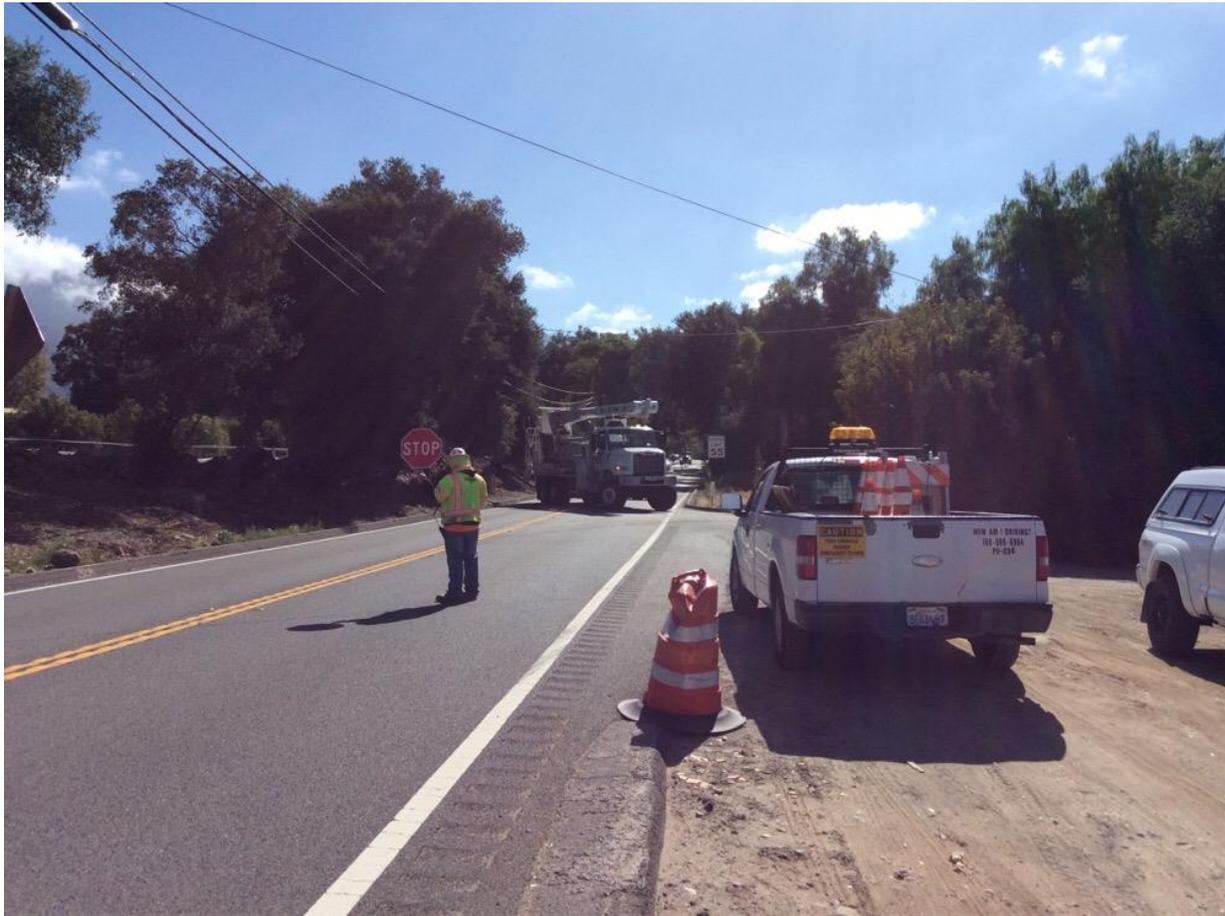
In accordance with APM TRANS-02, traffic control measures were implemented. Traffic control measures, including the placement of signage and cones as well as the use of flag persons were observed along Highway 76 (See Photo 6 – Attachment A).

Photo 6: In accordance with APM TRANS-02, flaggers were present to maintain a safe travel corridor along Highway 76 during pole and equipment ingress to Pole Z115712 (TL682).
