<b>California Public Utilities Commission</b> <b><i>Mitigation Monitoring, Compliance, and Reporting</i></b> <b><i>Program</i></b>
	<b>Cleveland National Forest Power Line Replacement</b> <b>Projects</b>
	<b>Compliance Status Report: 046</b>  <b>June 24, 2018</b>

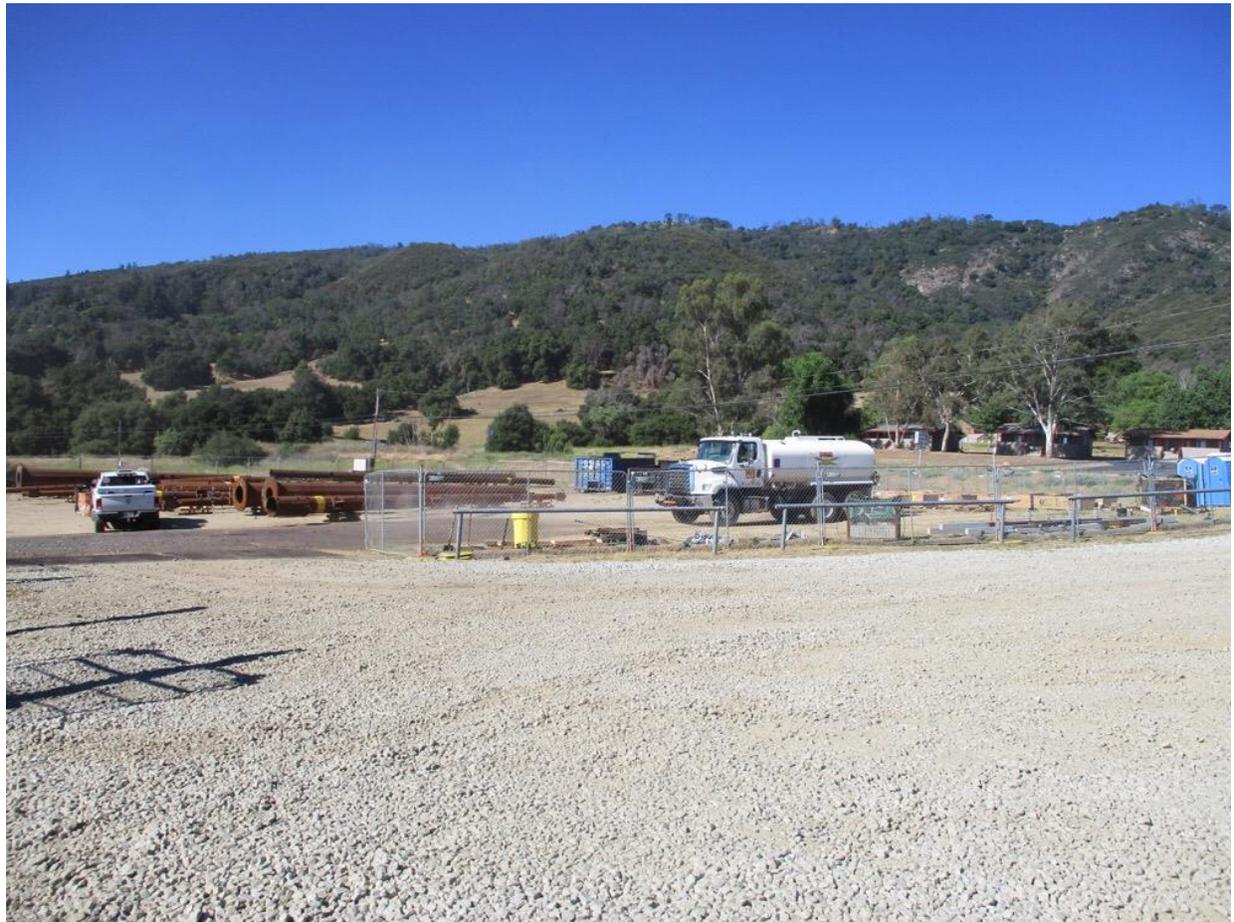
During this reporting period, CPUC ECMs observed implementation of dust control measures including the application of water on access roads and in work areas in accordance with APM AIR-02 (See Photo 1 – Attachment A). Project personnel were observed maintaining posted speeds of 15 miles per hour on unpaved roads in accordance with APM AIR-03 and MM BIO-24. Track-out was not observed along paved access roads in accordance with APM AIR-05.

**Photo 1:** In preparation for helicopter external load operations out of Lake Henshaw Yard associated with fiber optic stringing between Z118153 and Z118179 (TL 682), water was applied for dust control in accordance with the Aviation Safety Plan (MM PHS-5) and APM AIR-02.

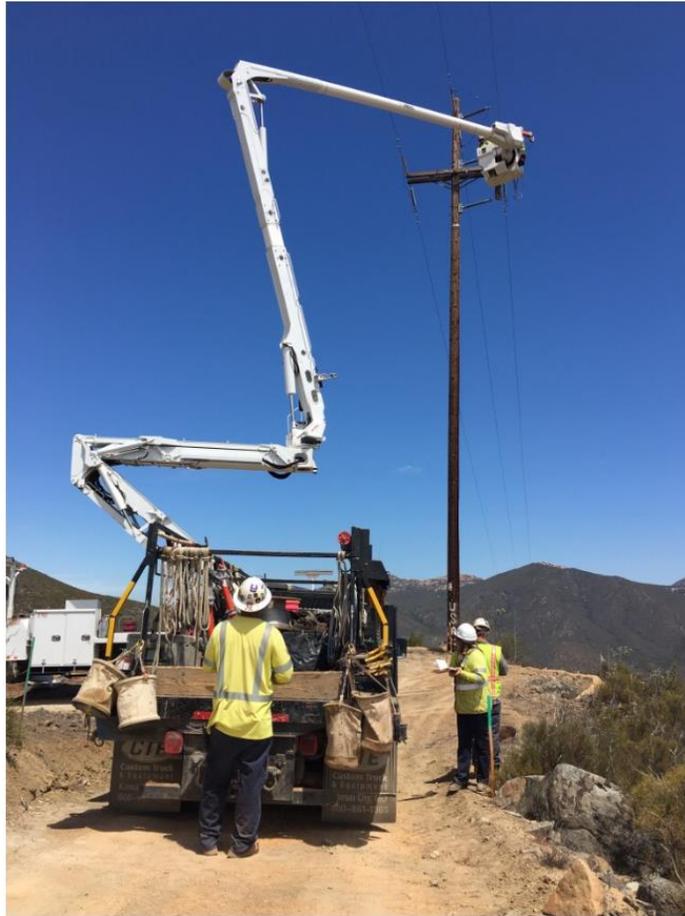
**Photo 2:** Biological monitors were observed monitoring crews during wire spreading activities per MM BIO-22. Insulator brackets were observed being tapped off under the supervision of biological monitors in order to dissuade birds from nesting on the pole and attachments at location Z571462 (TL 6957).

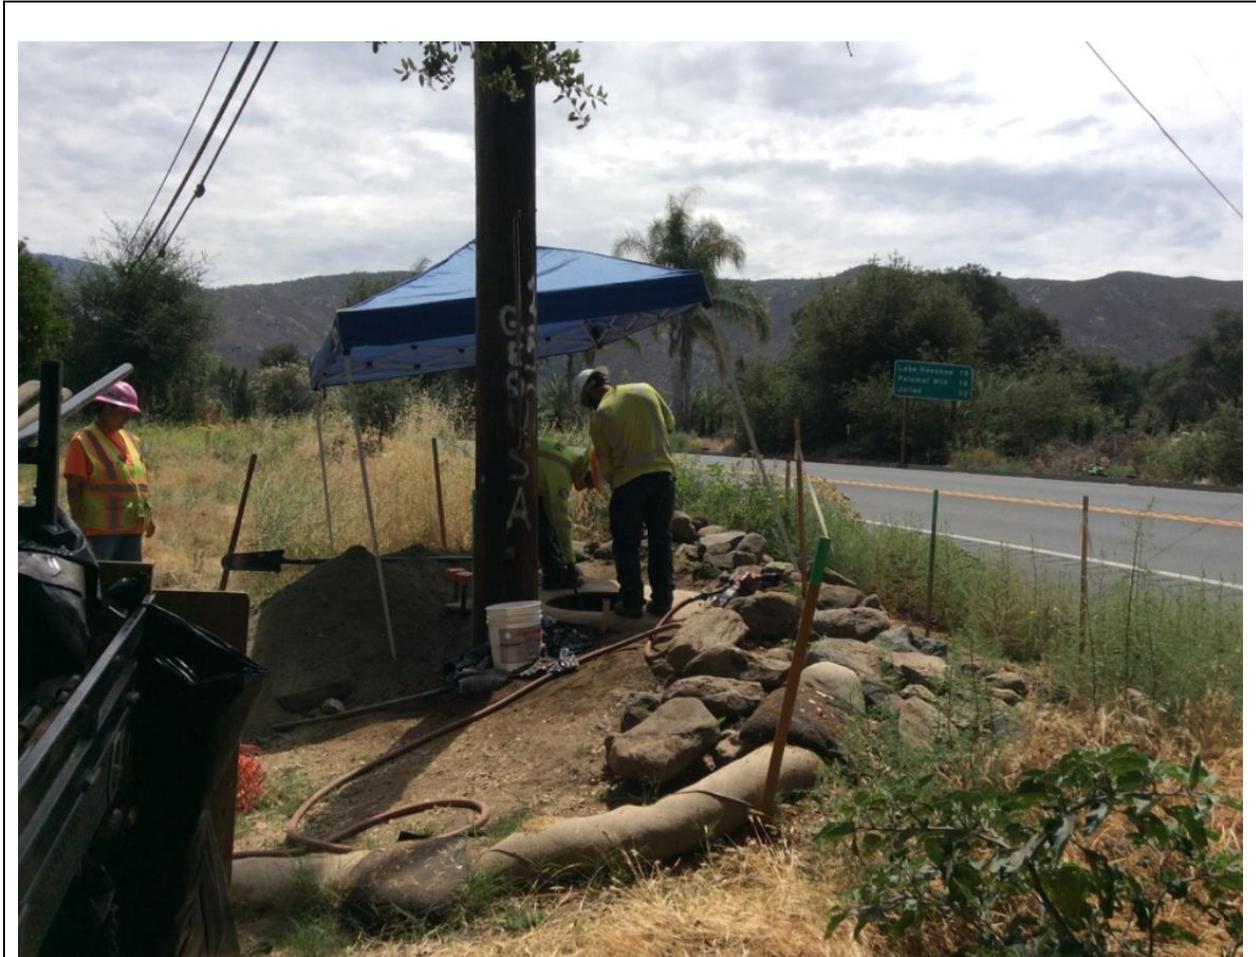
Cultural resource monitors, including Archaeological and Native American Monitors, were observed monitoring ground disturbing activities in accordance with the Historic Properties Management Plan (HPMP), MM CUL-1, MM CUL-3, and APM CUL-04 (See Photo 3—Attachment A). In addition, cultural resources ESAs were fenced and signed to prevent unauthorized access into areas with previously recorded cultural resources.

**Photo 3:** A Cultural Resources Monitor was present to monitor pole hole excavation at Pole P312751 (TL 682) in accordance with APM CUL-04 and MM CUL-1e.

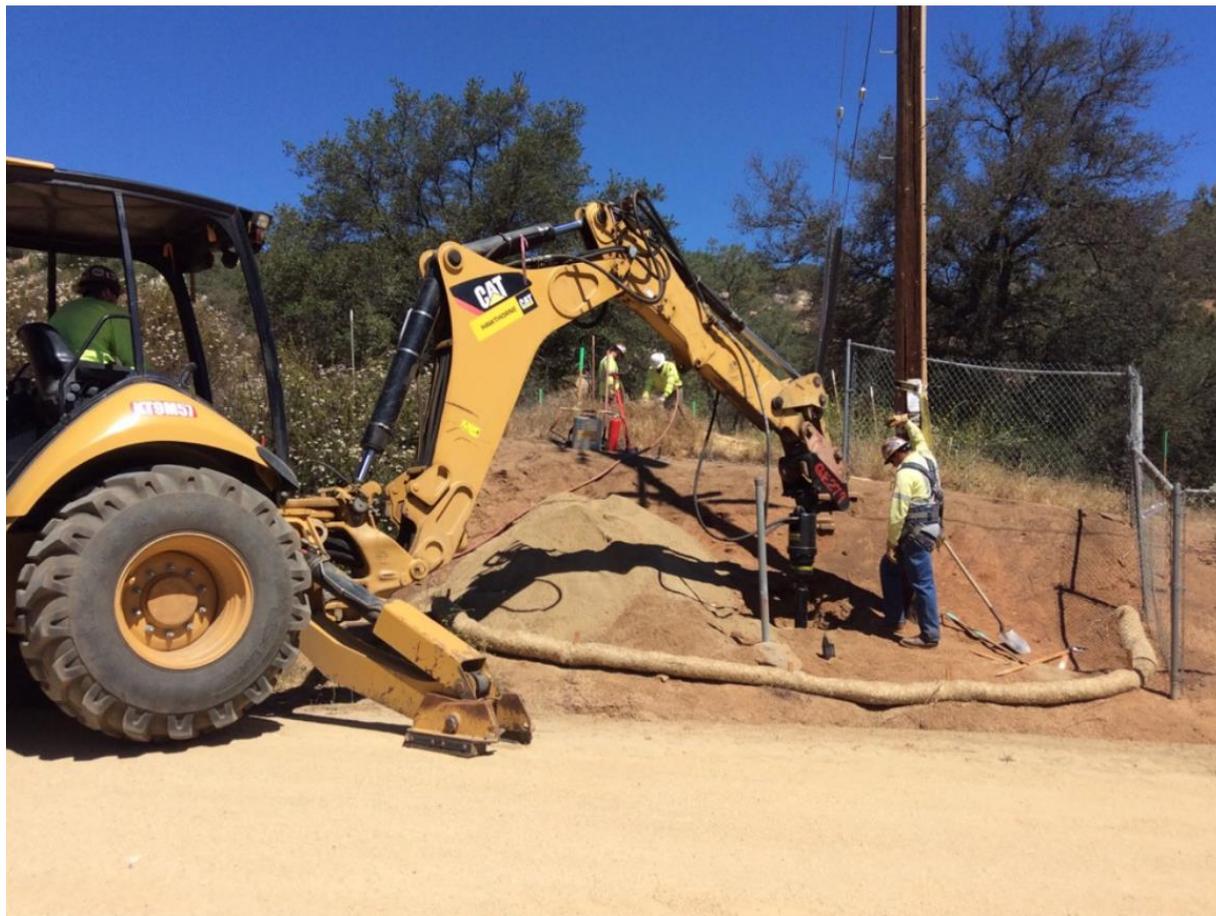
During construction activities, construction fire patrols were observed inspecting sites for compliance with the Construction Fire Prevention/Protection Plan (CFPPP) and MM FF-1. Construction crews were observed staging the required fire tools and equipment based on the Project Activity Level (on CNF land)/Fire Potential Index (off CNF land) and the construction activity being performed as allowed in the CFPPP Fire Prevention Matrices. A set of fire tools (5-gallon backpack pump, round point shovel, Pulaski, and 2A10BC fire extinguisher) was observed at active construction sites in accordance with APM HAZ-01, APM HAZ-04 and MM FF-1 (See Photo 4 – Attachment A).

**Photo 4:** During pole and anchor excavation at Pole P870072 (TL6957), all required fire tools (5-gallon backpack pump, round point shovel, Pulaski, and 2A10BC fire extinguisher) were staged on site in accordance with the CFPPP.

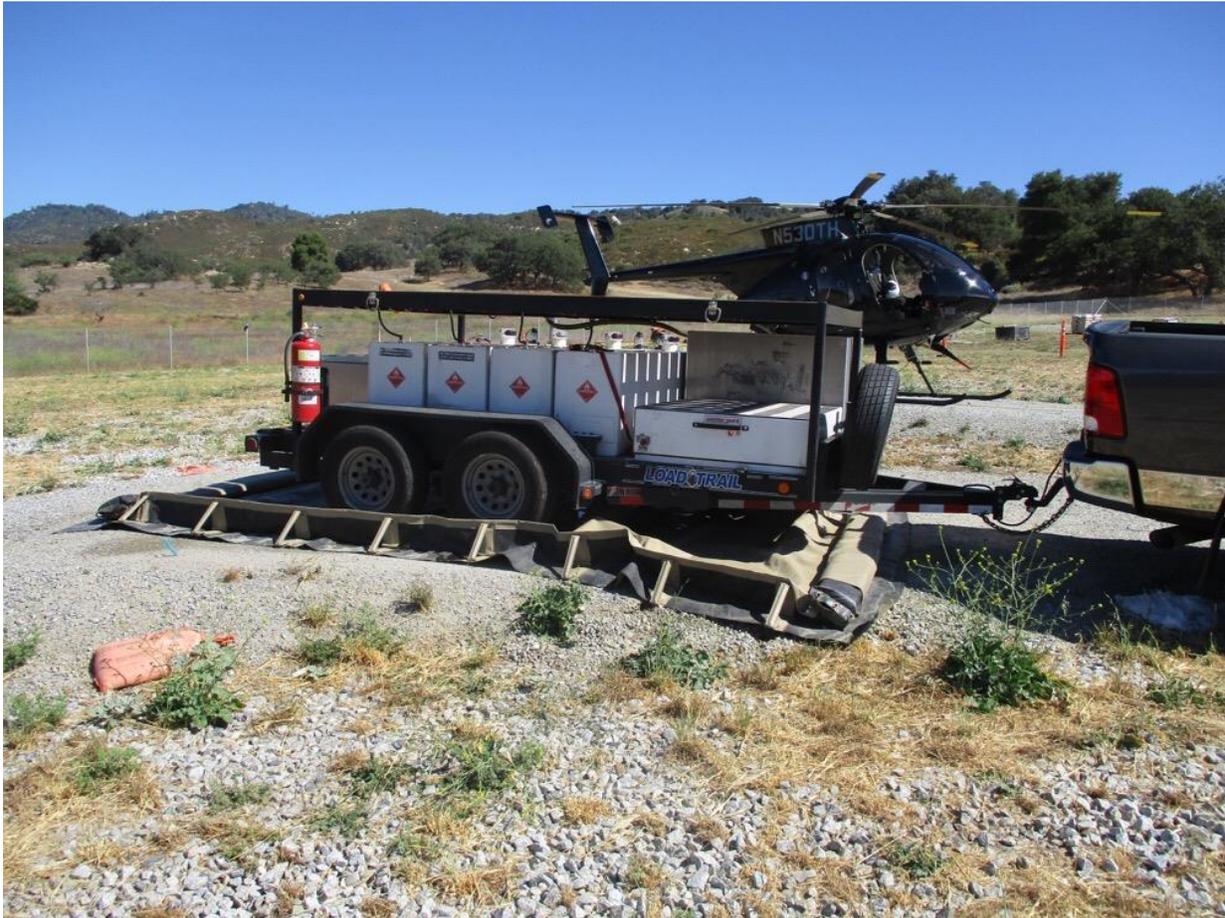
**Photo 5:** To prevent leaks/spills from being discharged into the soil, pop-up secondary containment was observed beneath a fuel tank at Love Valley Yard in accordance with the Spill Response and Notification Plan and MM PHS-2.

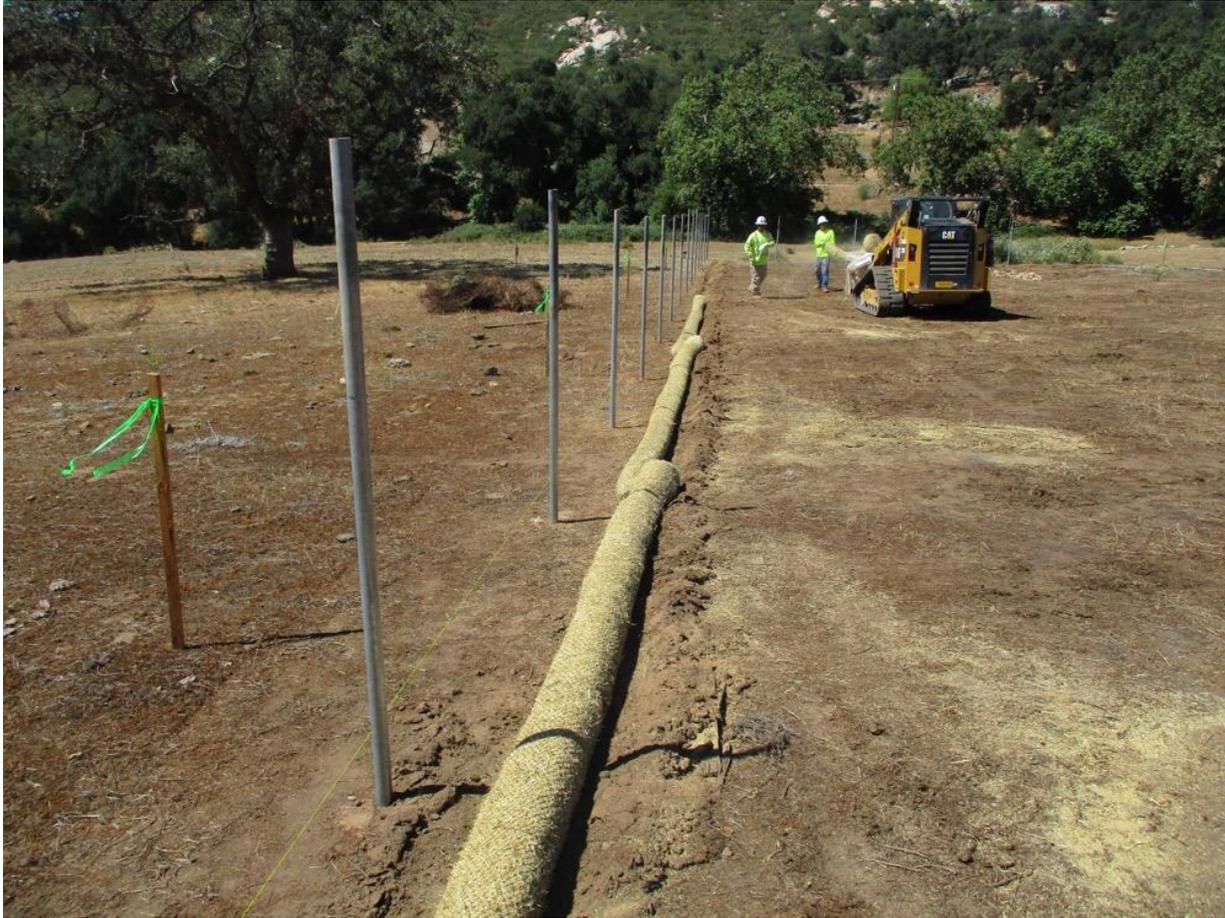
**Photo 6:** Crews were observed installing perimeter chain link fence and fiber rolls at Cuca Loop Staging Yard in accordance with the Erosion Control Plan and SWPPP (MM HYD-1, MM BIO-7).
