<p>California Public Utilities Commission <i>Mitigation Monitoring, Compliance, and Reporting</i> <i>Program</i></p>
	<p>Cleveland National Forest Power Line Replacement Projects</p> <p>Compliance Status Report: 049</p> <p>August 5, 2018</p>

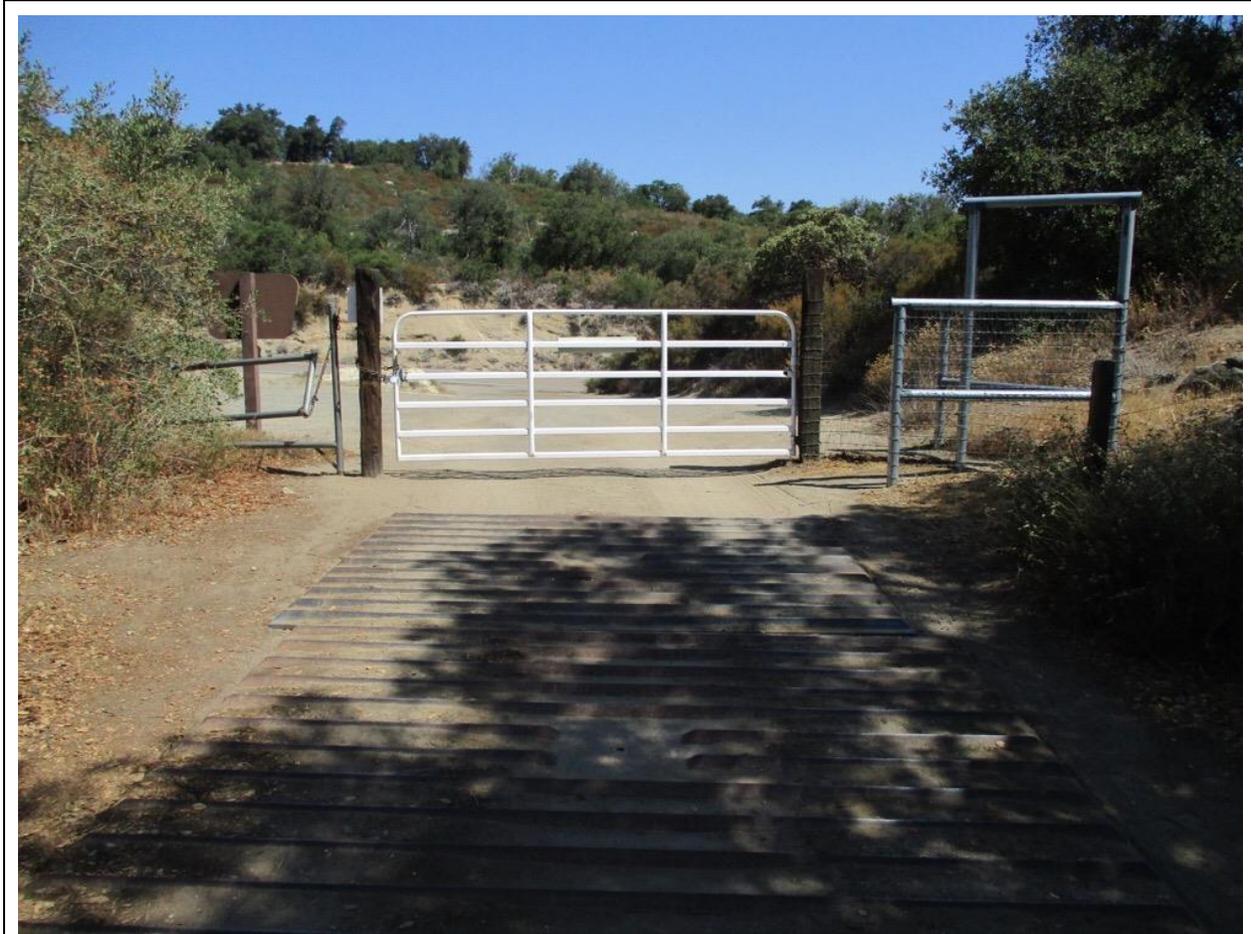
During this reporting period, CPUC ECMs observed implementation of dust control measures including the application of water on access roads and in work areas in accordance with APM AIR-02. Project personnel were observed maintaining posted speeds of 15 miles per hour on unpaved roads, in accordance with APM AIR-03 and MM BIO-24. Track-out was not observed along paved access roads in accordance with APM AIR-05 (See Photos 1 and 2 – Attachment A).

Photo 1: Track-out was not observed along paved access roads, in accordance with APM AIR-05 and the SWPPP (APM HYD-09, MM HYD-1, MM BIO-7). Rattle plates were documented at the ingress/egress of Love Valley Road, and the gate was kept closed and locked to prevent unauthorized access in accordance with MM REC-2.

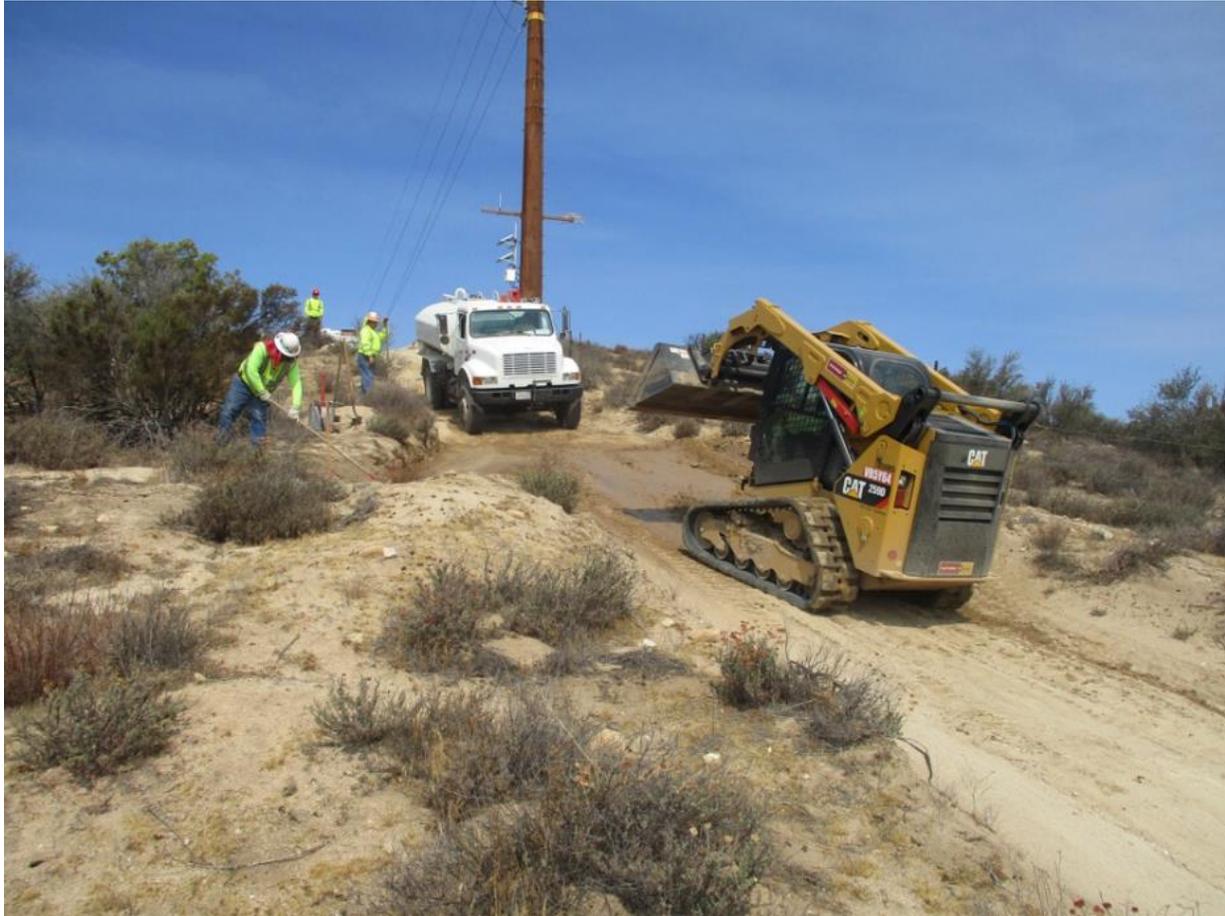
Photo 2: During water bar grading and energy dissipater maintenance between Poles Z44282 and Z44281 (TL 6931), a 150-gallon water truck was used to aid in soil compaction and dust control in accordance with APM AIR-02 and to comply with the CFPPP fire prevention matrix (off CNF land - FPI elevated) (MM FF-1)

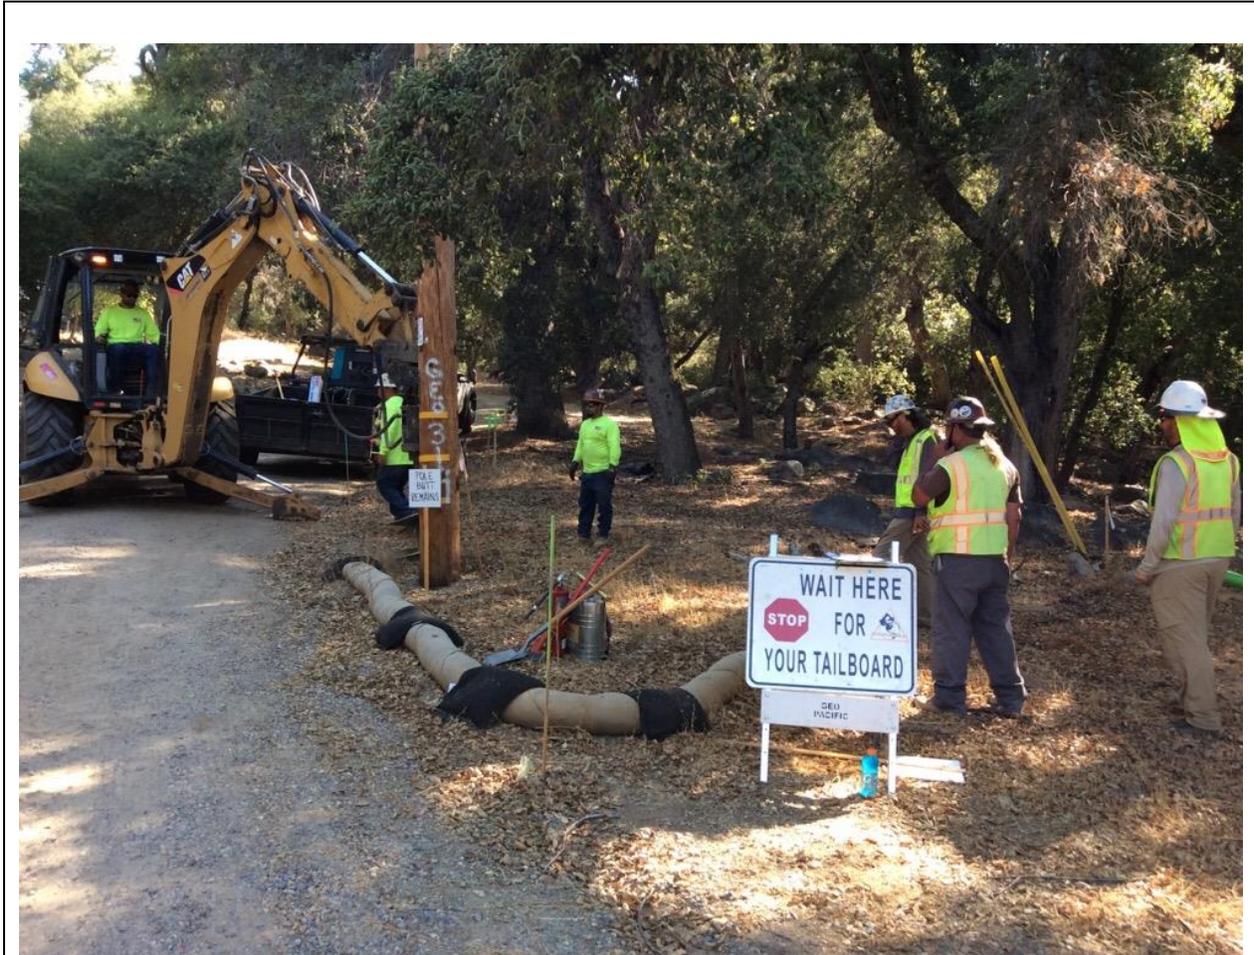
Cultural resource monitors, including Archaeological and Native American Monitors, were observed monitoring ground disturbing activities in accordance with the Historic Properties Management Plan (HPMP), MM CUL-1, MM CUL-3, and APM CUL-04 (See Photo 3 – Attachment A). In addition, cultural resources ESAs were fenced and signed to prevent unauthorized access into areas with previously recorded cultural resources.

Photo 3: Biological, archaeological, and Native American monitors were present for initial ground disturbance at Pole P103493 (TL682) in accordance with MM BIO-3, MM BIO-22, APM CUL-04, MM CUL-1e, and the HPMP. A complete set of fire tools as required by the CFPPP (MM FF-1) were on site, and work limits were clearly delineated in accordance with MM BIO-1. Erosion control BMPs were installed and in good condition in accordance with the SWPPP (APM HYD-09, MM HYD-1, MM BIO-7).

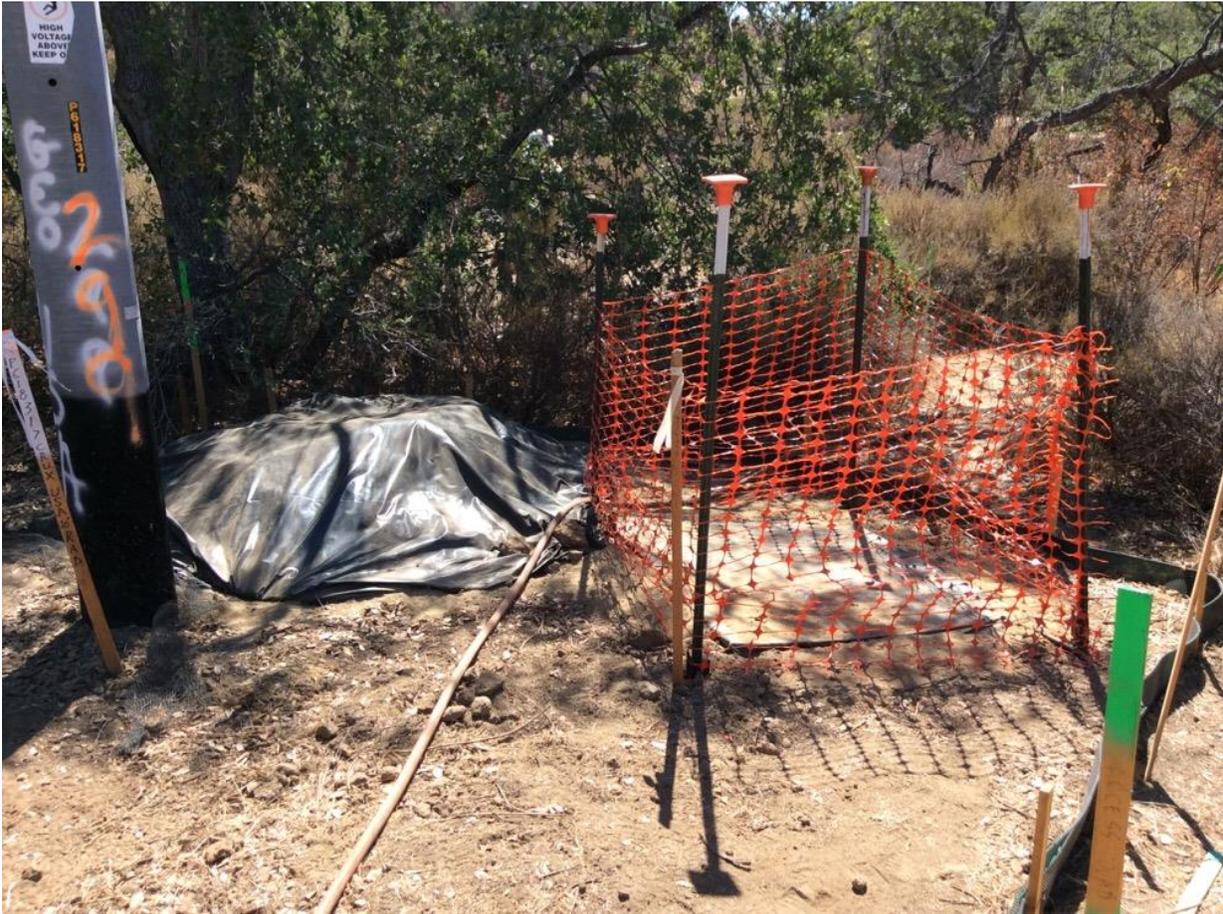
Photo 4: A completed pole hole at Pole P618317 (TL682) was observed securely covered to prevent wildlife entrapment in accordance with MM BIO-23. In addition, the spoils stockpile was covered with plastic sheeting to prevent erosion in accordance with the Erosion Control Plan and SWPPP (APM HYD-09, MM HYD-1, MM BIO-7).

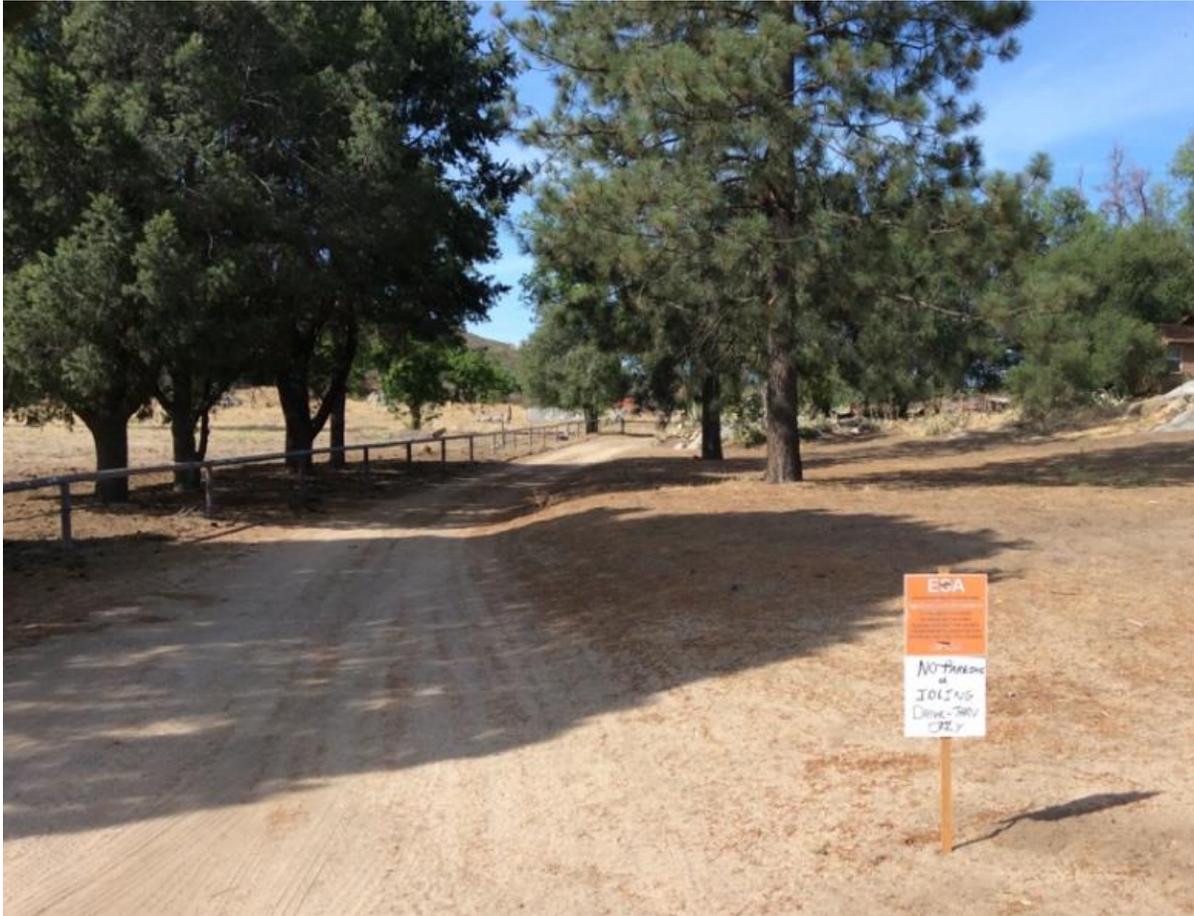
Photo 5: In accordance with MM BIO-30, a 100-foot exclusion buffer was observed around a maternity bat roost at C157.

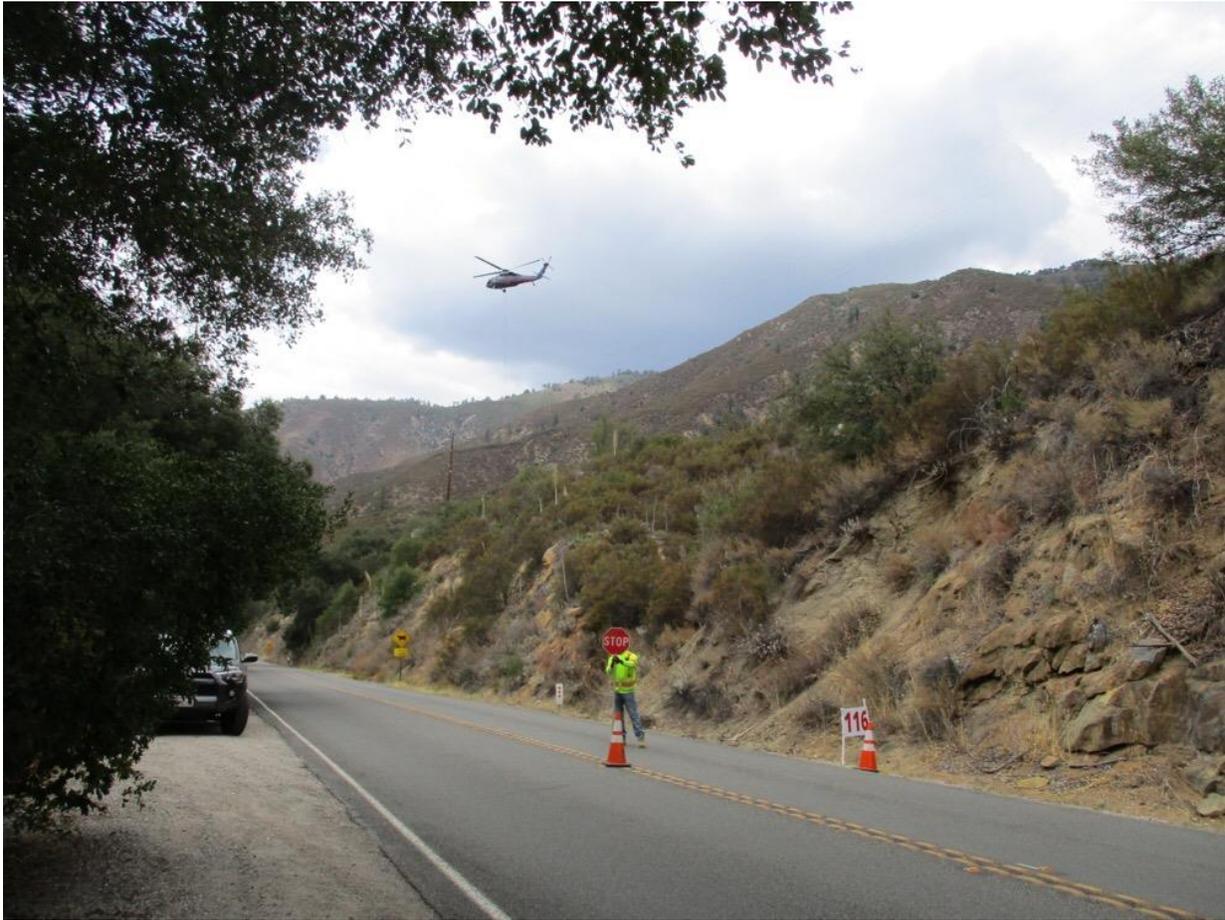
In accordance with APM TRANS-02, traffic control measures were implemented. Traffic control measures, including the placement of signage and cones as well as the use of flag persons were observed along Highway 76 and along Lyons Valley Road (See Photo 6 – Attachment A).

Photo 6: During helicopter external load operations assisting activities at Z118101 (TL682), flaggers were observed temporarily stopping traffic along Highway 76 in accordance with the Aviation Safety Plan (MM PHS-5) and APM TRANS-02.
