<p><b>California Public Utilities Commission</b> <b><i>Mitigation Monitoring, Compliance, and Reporting</i></b> <b><i>Program</i></b></p>
	<p><b>Cleveland National Forest Power Line Replacement</b> <b>Projects</b></p> <p><b>Compliance Status Report: 059</b></p> <p><b>December 23, 2018</b></p>

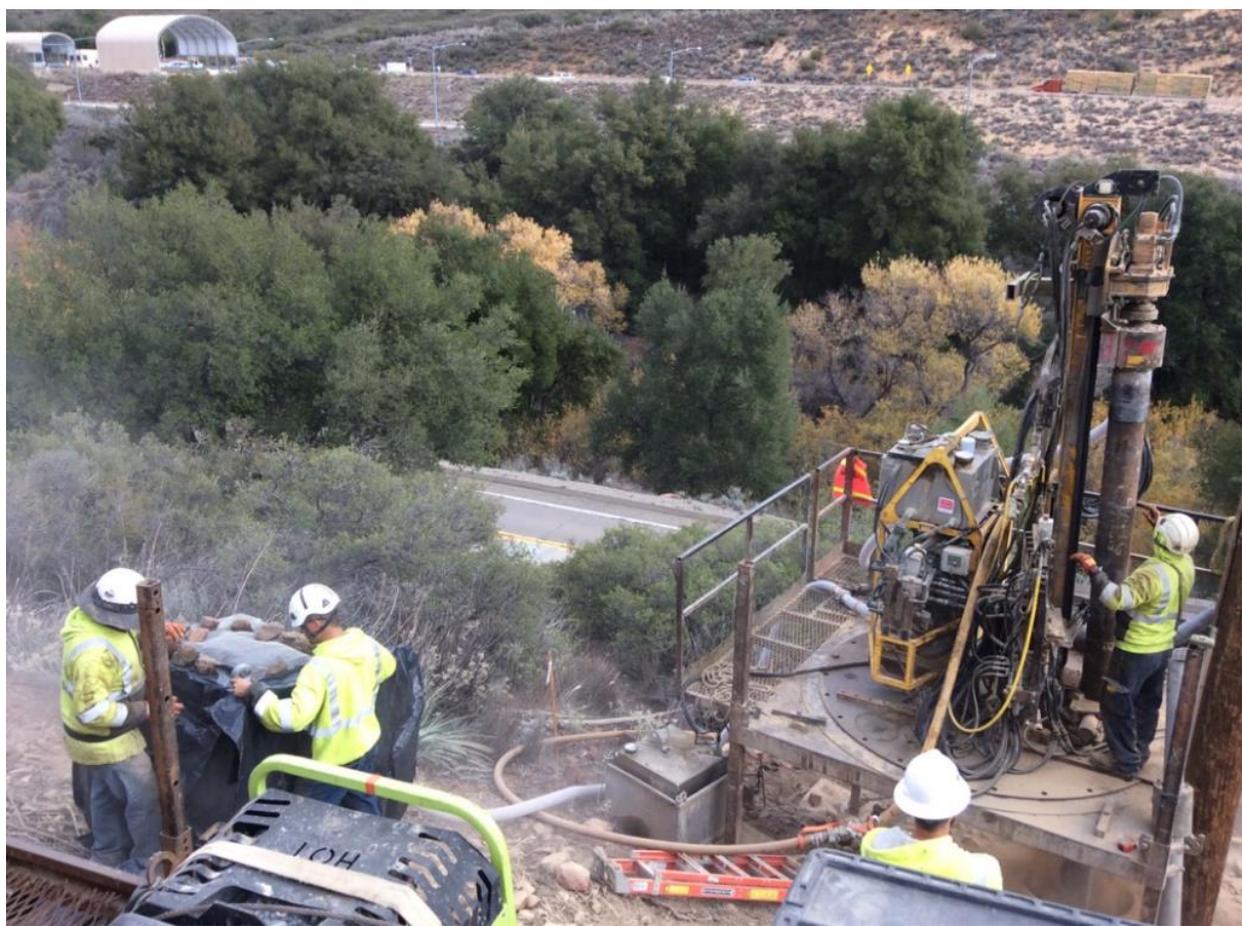
**Photo 1:** Crew members at Pole Z40423 (TL629C) were observed covering the drill cutting containment box to reduce dust emissions during micropile drilling in accordance with APM AIR-05.

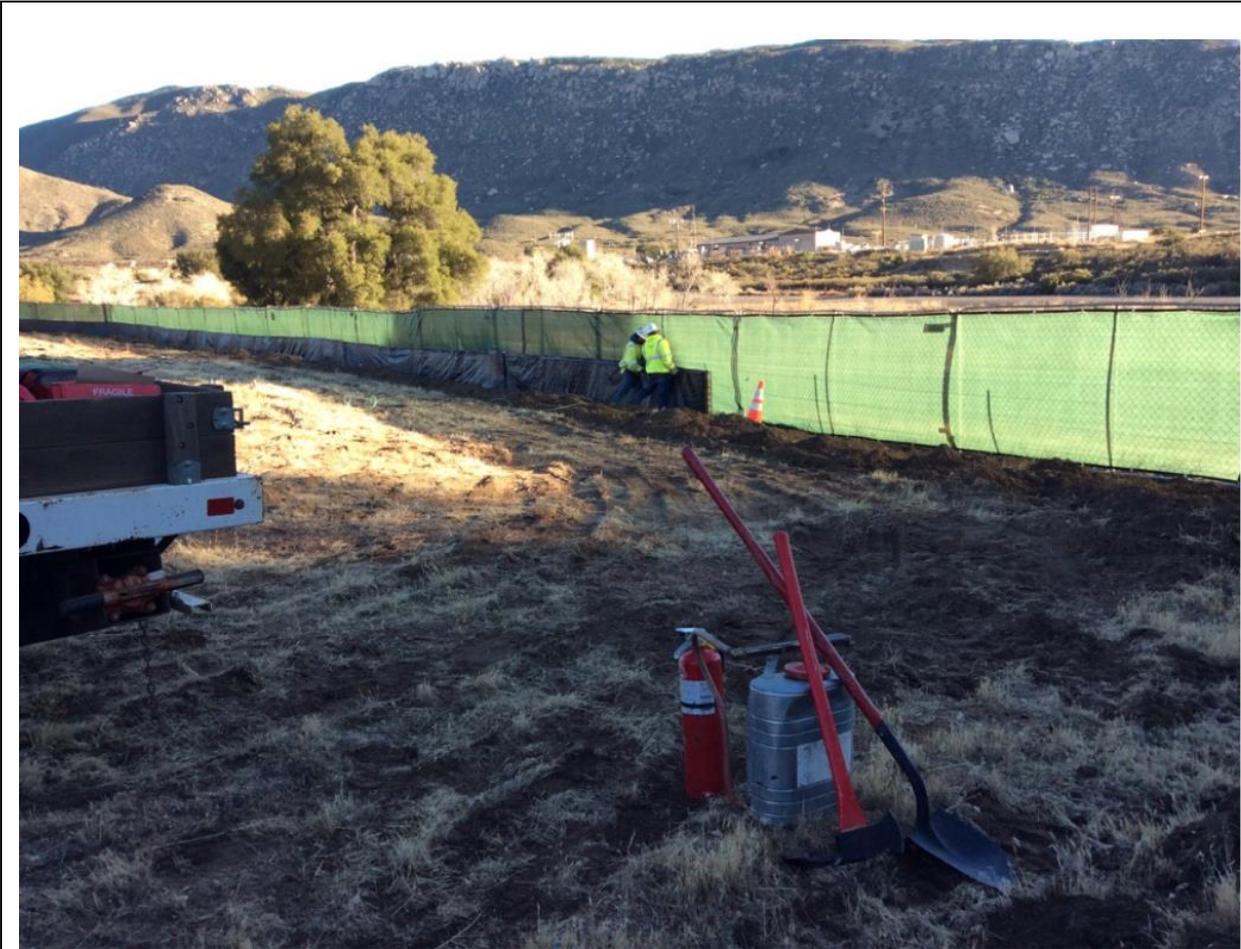
In accordance with APM VIS-02, construction sites were kept as clean and inconspicuous as possible, and opaque visual screening was present around staging yards (See Photo 2—Attachment A). New poles observed being installed were reddish-brown in color and weathered-steel in accordance with APM VIS-05, and newly installed conduit was non-specular in accordance with APM VIS-03.

**Photo 2:** Arroyo toad fence was observed being installed at the Buckman Springs Fly Yard expansion site in accordance with the Streambed Alteration Agreement (TL 629C). Additionally, opaque visual screening was observed along the perimeter of the yard in accordance with MM VIS-1.

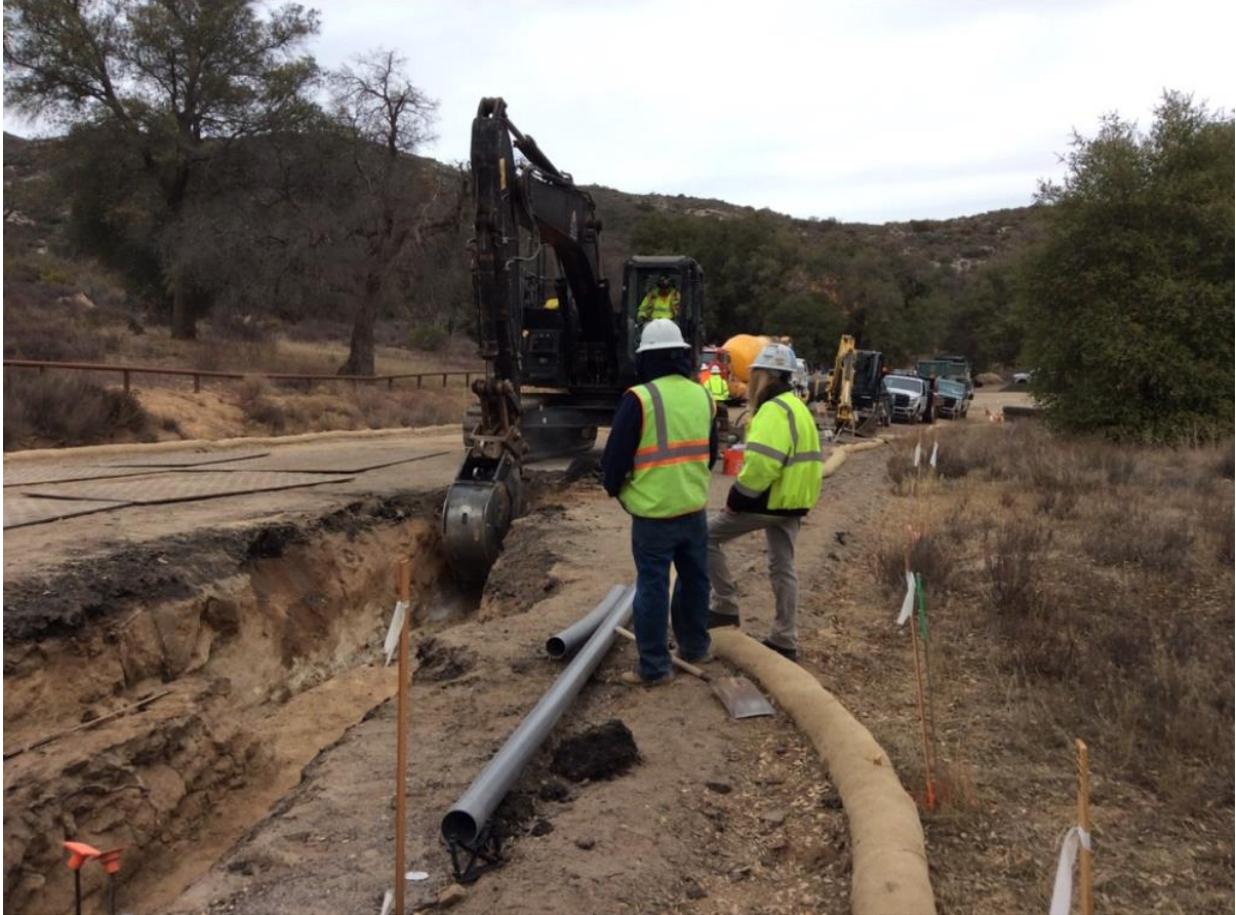
prevent unauthorized access into areas with previously recorded cultural resources in accordance with the Historic Properties Management Plan (HPMP), MM CUL-1, MM CUL-3, APM CUL-04, and APM CUL-05 (See Photo 3—Attachment A).

**Photo 3:** Archaeological and Cultural Monitors were present during trenching along Morena Stokes Road (C449) in accordance with the HPMP, APM CUL-03, and MM CUL-1. Work was observed occurring within the delineated work limits in accordance with MM BIO-1.

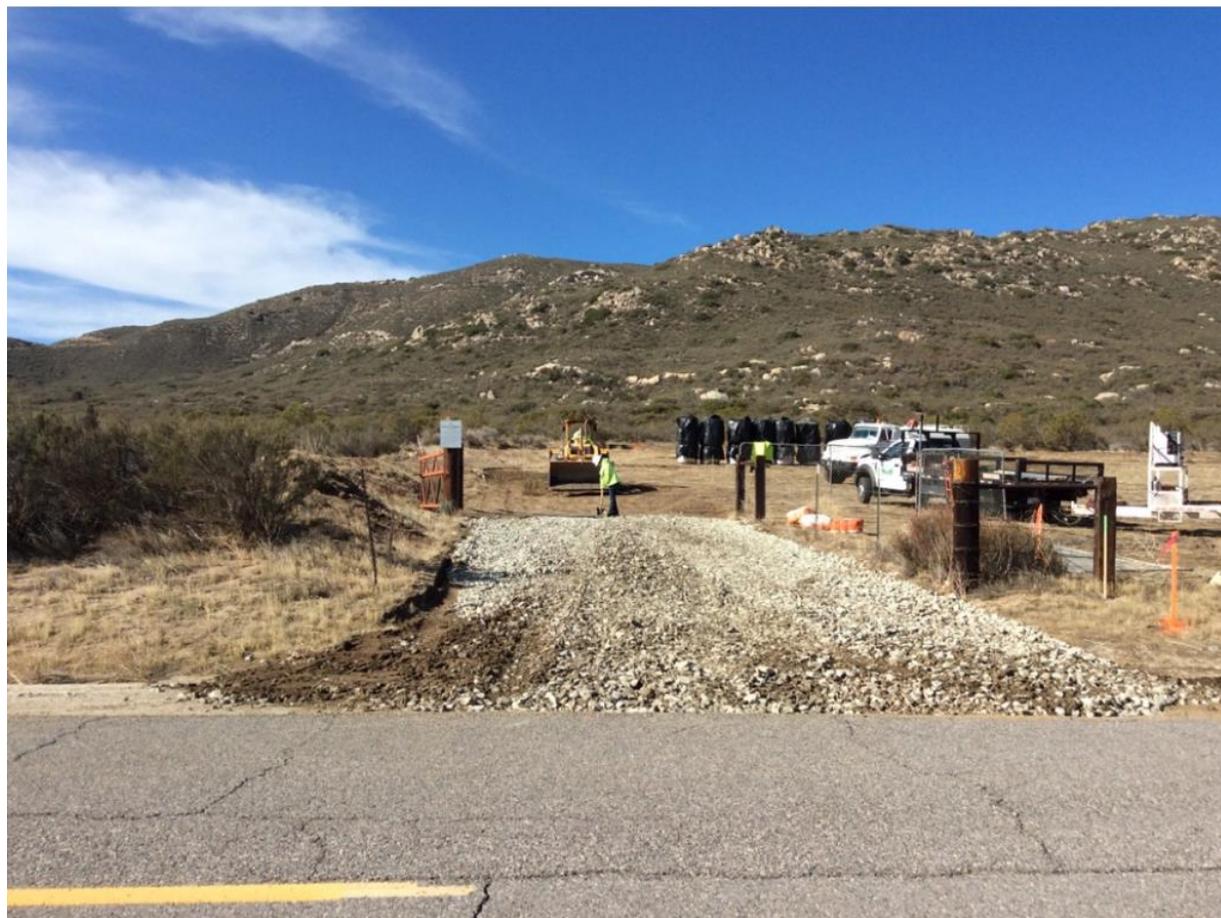
**Photo 4:** In accordance with the SWPPP (MM HYD-1, MM BIO-7) crews were observed installing a rock apron and rattle plates at the entrance to the Old Buckman Springs Staging Yard to prevent sediment track out onto the paved roadway.

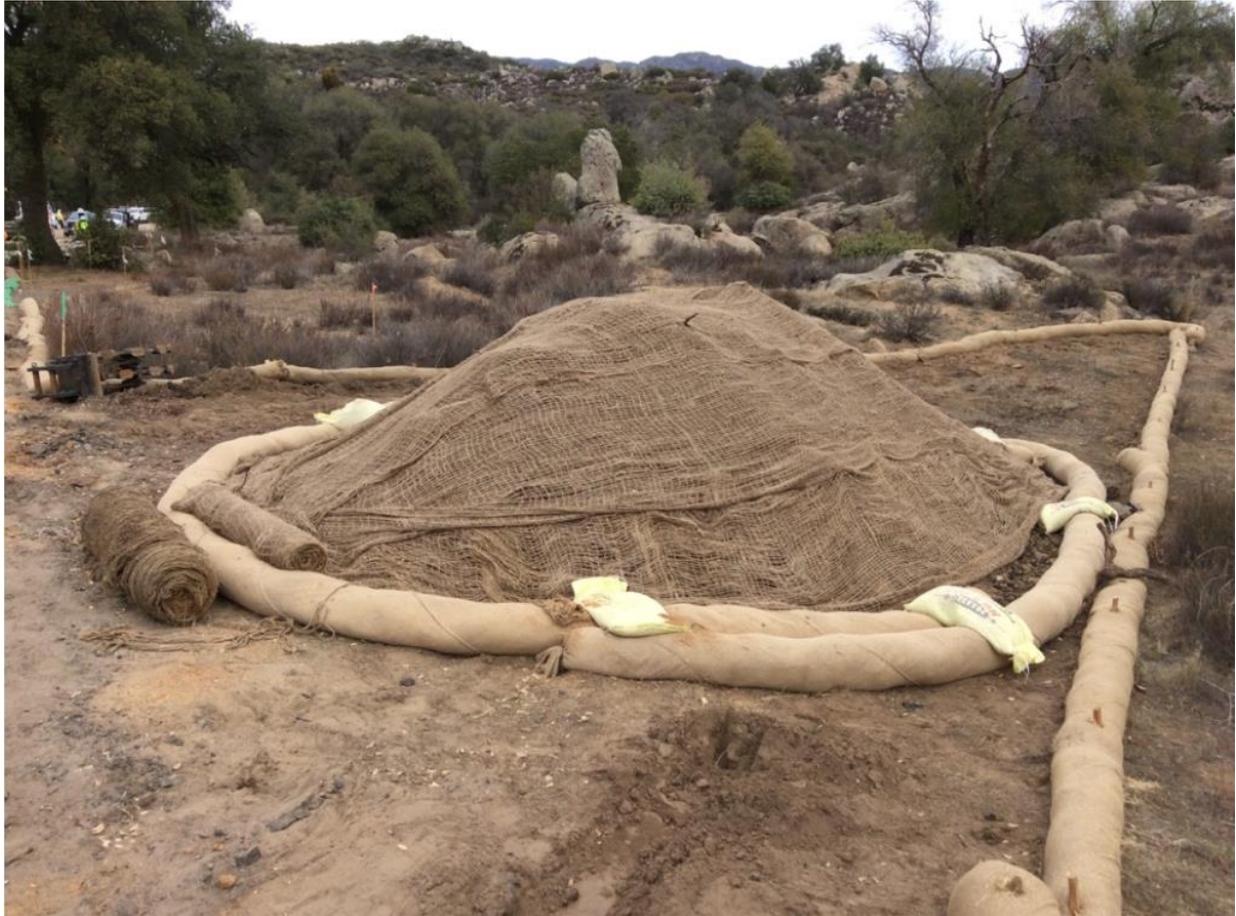
**Photo 5:** A topsoil stockpile near St 93+65 along Morena Stokes Road (C449) was observed securely covered with jute netting and enclosed by fiber rolls in accordance with the Habitat Restoration Plan (MM BIO-4), and Erosion Control Plan and SWPPP (MM HYD-1, MM BIO-7).

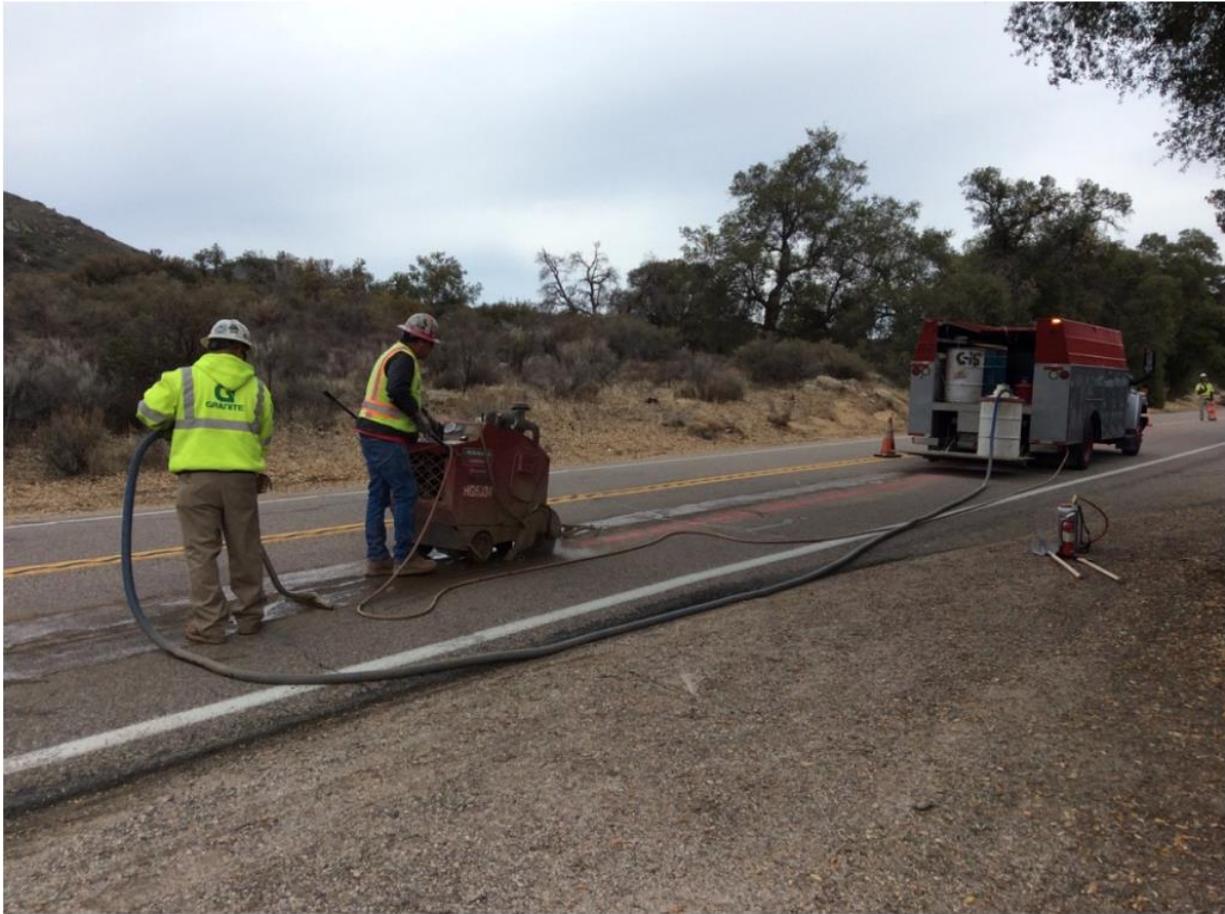
**Photo 6:** In accordance with the SWPPP (MM HYD-1, MM BIO-7), a vacuum was used to remove debris resulting from saw cutting along Buckman Springs Road. In addition, crews were equipped with a complete set of fire tools (5-gallon backpack pump, round point shovel, Pulaski, and 2A10BC fire extinguisher) in accordance with the CFPPP (MM FF-1).
