California Public Utilities Commission <i>Mitigation Monitoring, Compliance, and Reporting Program</i>
	Cleveland National Forest Power Line Replacement Projects Compliance Status Report: 009 January 22, 2017

This compliance status report covers construction activities from January 8 through January 22, 2017.

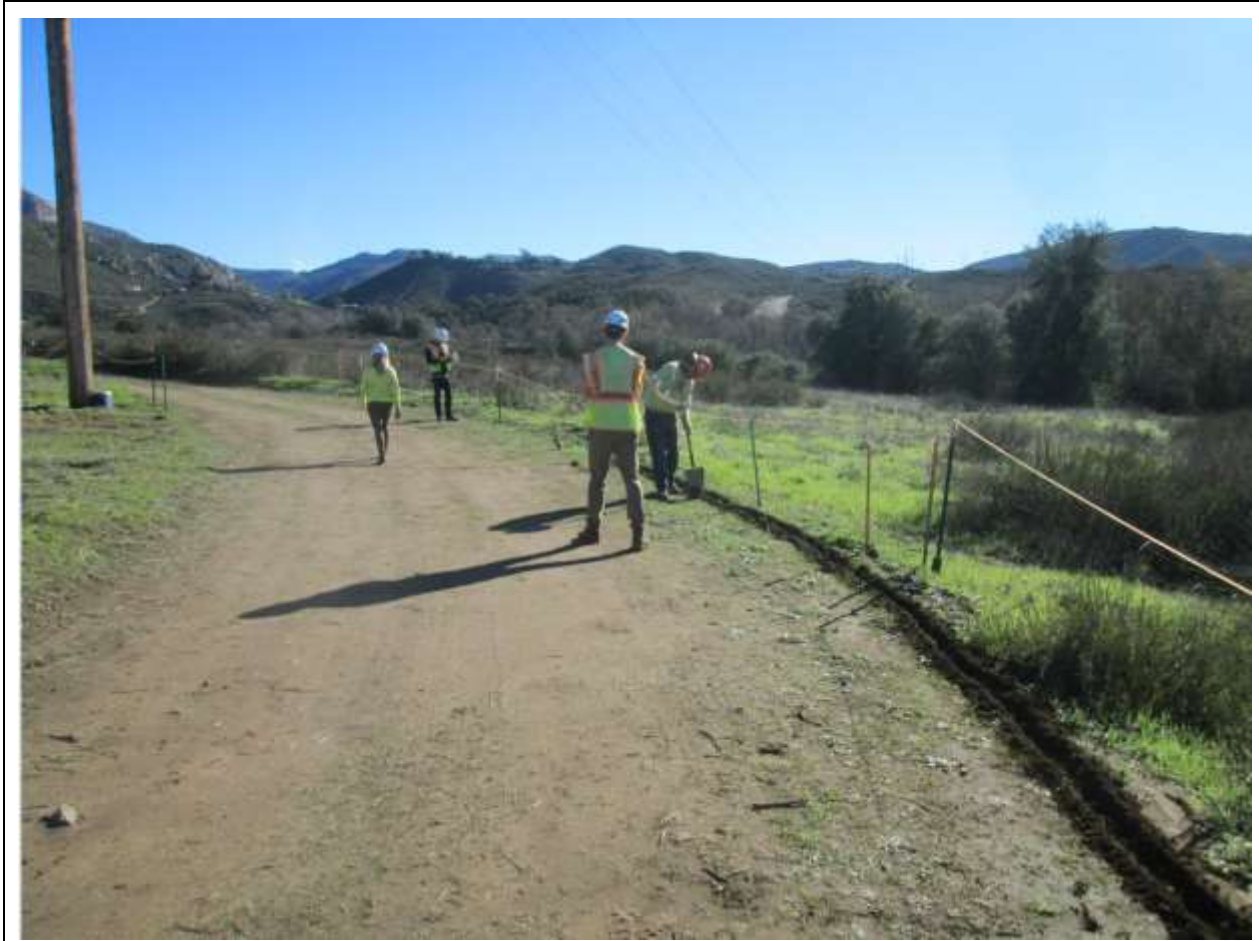
Photo 1: Archaeological monitors were observed overseeing installation of SWPPP BMPs along TL 625B adjacent to ESAs in accordance with the HPMP (MM CUL-1).

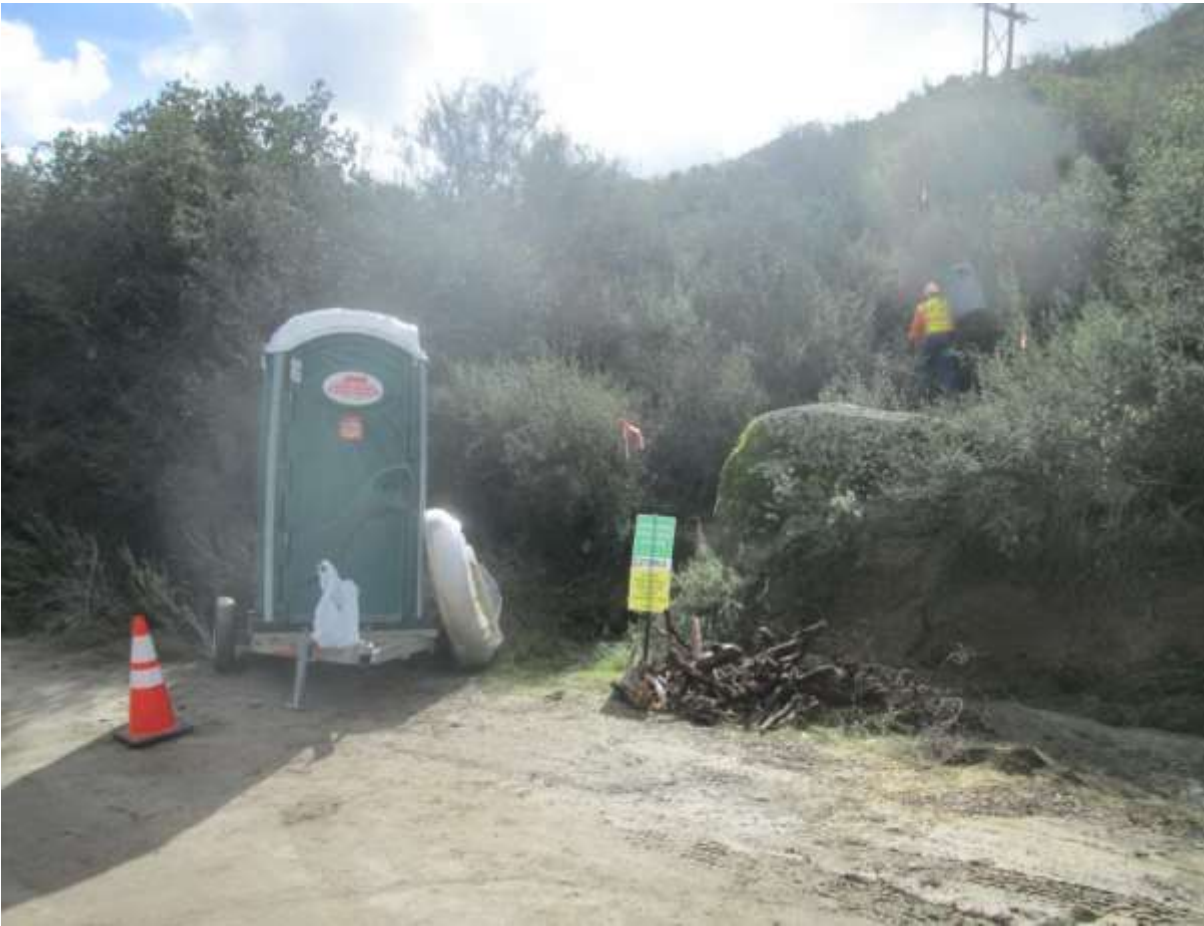
Photo 2: Approved access routes (footpaths) for sites inaccessible by vehicles (TL 625B, pole Z272893, above) were marked prior to vegetation clearing and adhered to in accordance with MM BIO-1. Crews were observed carrying in trash bins to transport removed vegetation via foot.

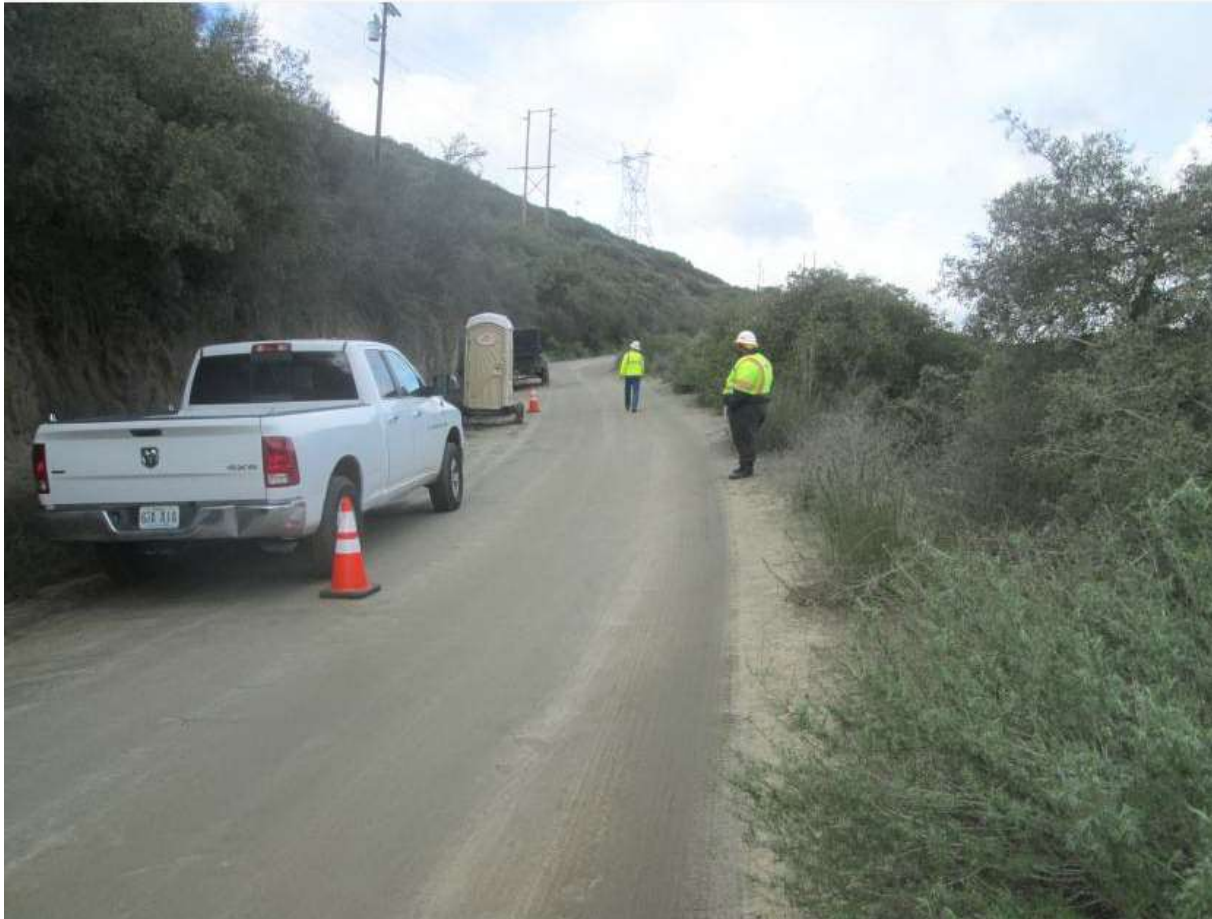
HYD-05, MM BIO-7, and MM HYD-1), and trimming vegetation within work areas. During activities, work limits were observed clearly delineated and being adhered to by crews per MM BIO-1 and pre-determined access roads, including footpaths (where vehicular access was infeasible) were observed signed and maintained in accordance with MM BIO-22 (See Photo 1—Attachment A). Prior to vegetation removal biological monitors were observed sweeping areas in accordance with MM BIO-3 and were observed present during vegetation removal activities. A five-gallon backpack pump, round point shovel, Pulaski, and 2A10BC fire extinguisher were observed within 50 feet of the vegetation chipping activities in accordance with the Construction Fire Prevention/Protection Plan (CFPPP) (MM FF-1). Environmentally Sensitive Areas (ESAs) were observed delineated in accordance with APM CUL-03 and the Historic Properties Management Plan (HPMP) (MM CUL-1) and archaeological monitoring was observed during BMP installation in required areas in accordance with the HPMP (See Photo 2—Attachment A). Crews were observed using traffic control measures such as cones and flag persons along access roads during vegetation removal activities in accordance with APM TRANS-02 (See Photo 3—Attachment A).

Photo 3: During vegetation removal activities along TL 625B (Pole Z272892, above), Traffic Control personnel and equipment were present in accordance with APM TRANS-02.

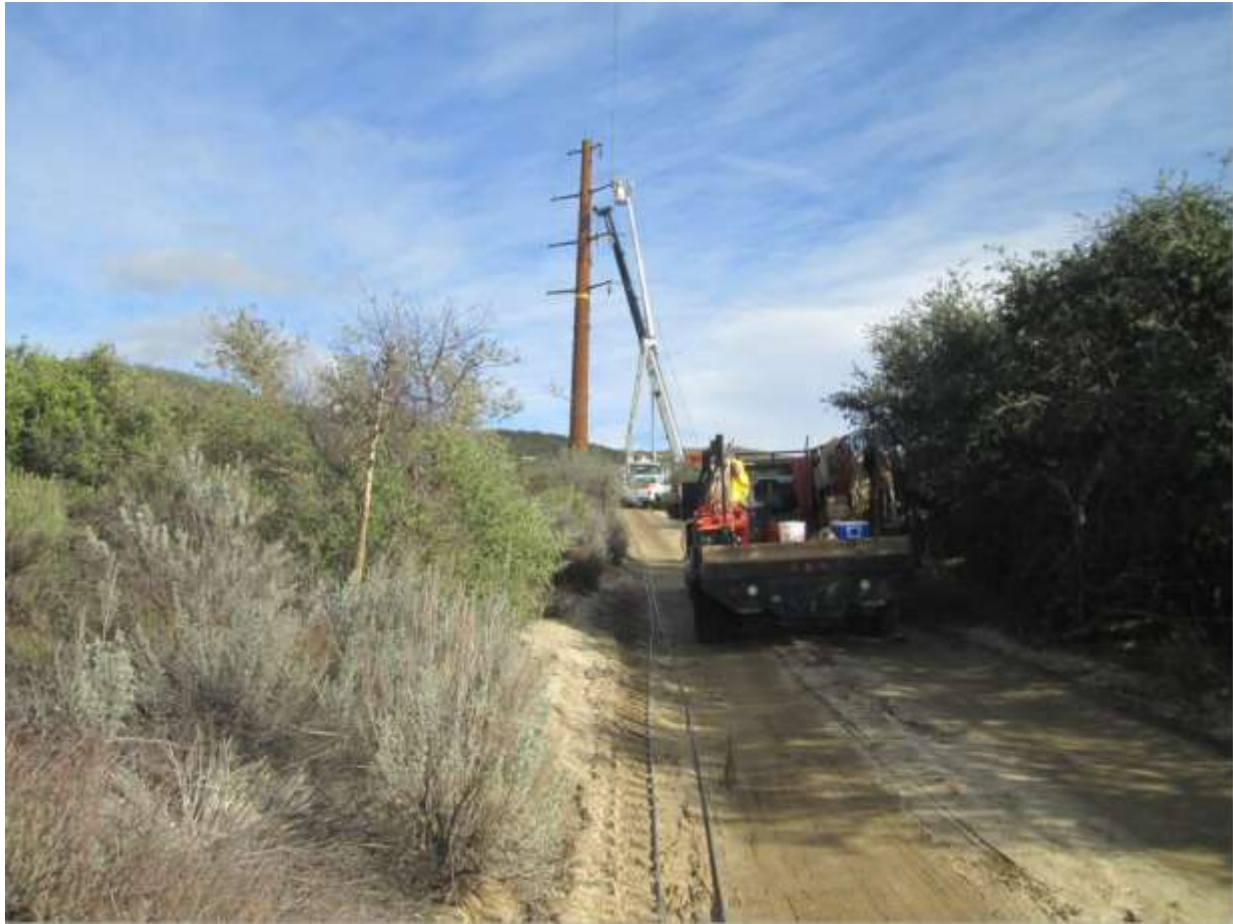
During this reporting period, micro pile foundation activity continued, which included drill set up, platform set up, and drilling activities, installing/capping/testing micro pile foundations, grouting, and installing grounding rods and wires. Poles were staged, assembled, and installed along the right-of-way. Stringing activities occurred between Poles Z44194 and Z44186, which included securing sock lines to new conductors, dead-ending wires, installing double-socking, repairing distribution conductors, and performing stringing operations (See Photo 4—Attachment A).

Photo 4: Wire stinging activities occurred along TL629E (transferring wire at Pole Z44186, above).

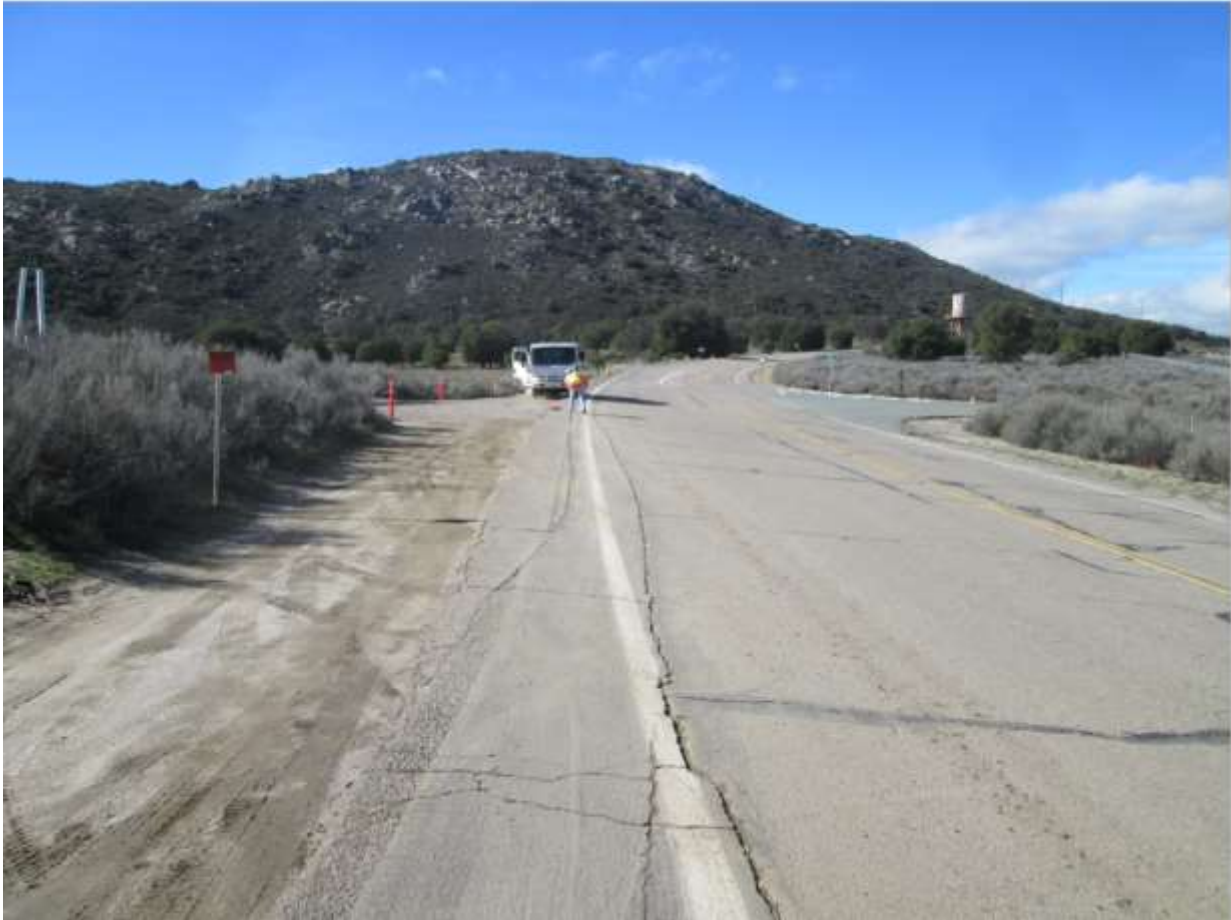
Access roads were observed signed and maintained in accordance with MM BIO-22, and posted with approved project speed limits in accordance with APM AIR-03 and MM BIO-24. Rumble plates installed at construction entrances/intersection of paved and unpaved roads (such as La Posta Road, entrances to established staging yards, etc.) were observed being kept clear of debris and street-sweeping vehicles and/or street sweepers were observed clearing remnant sediment track-out from paved roadways in accordance with APM AIR-05 and the project SWPPP (See Photo 5—Attachment A).

Photo 5: Crews were observed sweeping sediment track-out at the intersection of the Kitchen Creek Staging Yard and Old Highway 80 in accordance with APM AIR-05 and the project SWPPP.

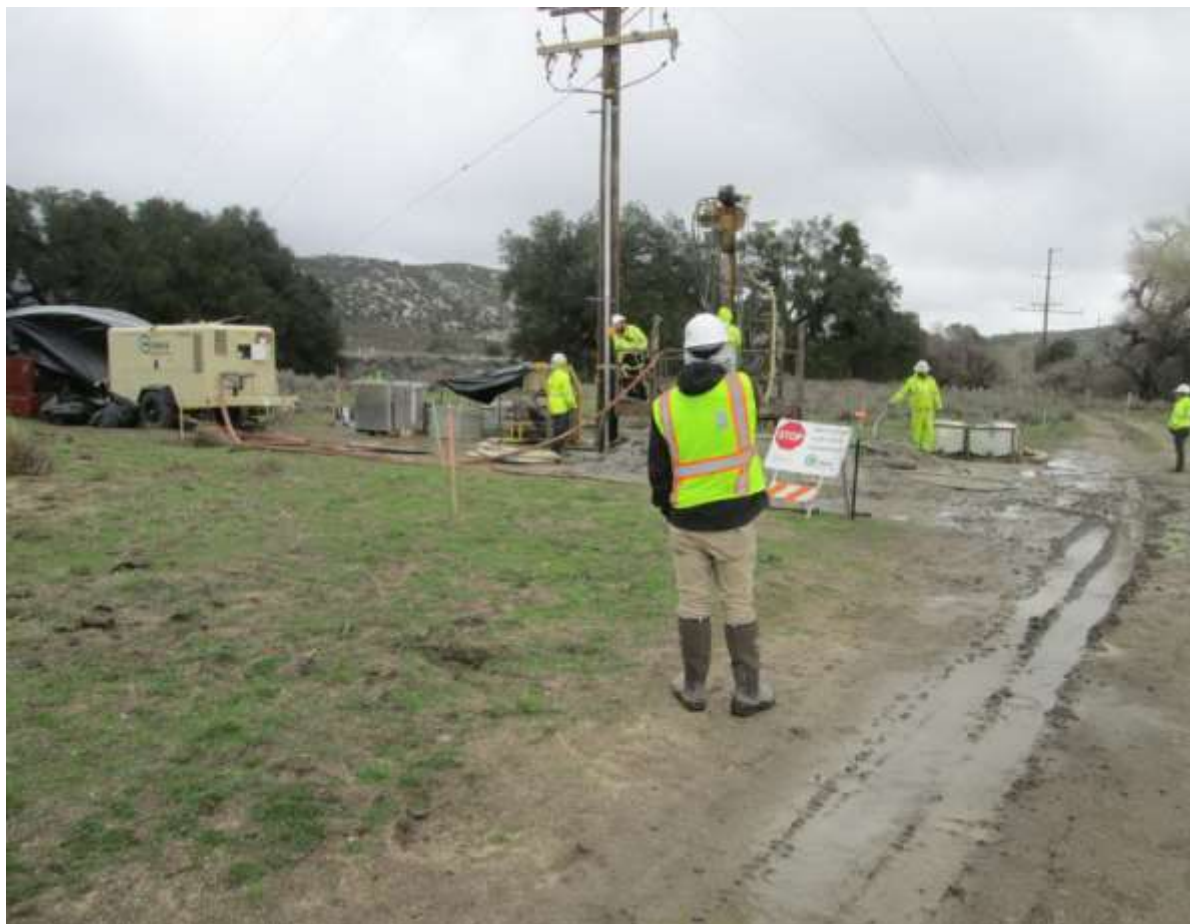
Biological monitors were observed conducting pre-construction sweeps and monitoring during micropile activities (MM BIO-22) (See Photo 6—Attachment A). Work limits were observed delineated and adhered to and were marked with signage indicating that the area was an active construction/work zone requiring safety tailboards (MM BIO-1). Due to the rain event that occurred during this reporting period, several existing roads were observed to be saturated and during morning tailboards, crews were informed which work areas would be inaccessible by vehicle, requiring crews to walk into work areas where equipment was previously staged to prevent rutting and erosion in the road system. Crews were observed inspecting and repairing BMPs throughout the right-of-ways and road easements, including repairing silt fencing, fiber rolls, water bars and replacing filter bags used for dewatering. Where groundwater was observed being encountered during micropile foundation drilling activities, sump

Photo 6: Biological monitors were observed at micropile foundation work areas (TL 629E, Pole Z40582, above) in accordance with MM BIO-22. Where roads were determined too saturated for vehicles, crews walked to sites to prevent rutting and erosion on existing access roads.
