<p><b>California Public Utilities Commission</b>  <b><i>Mitigation Monitoring, Compliance, and Reporting Program</i></b></p>
	<p><b>Cleveland National Forest Power Line Replacement Projects</b></p> <p><b>Compliance Status Report: 086</b></p> <p><b>January 12, 2020</b></p>

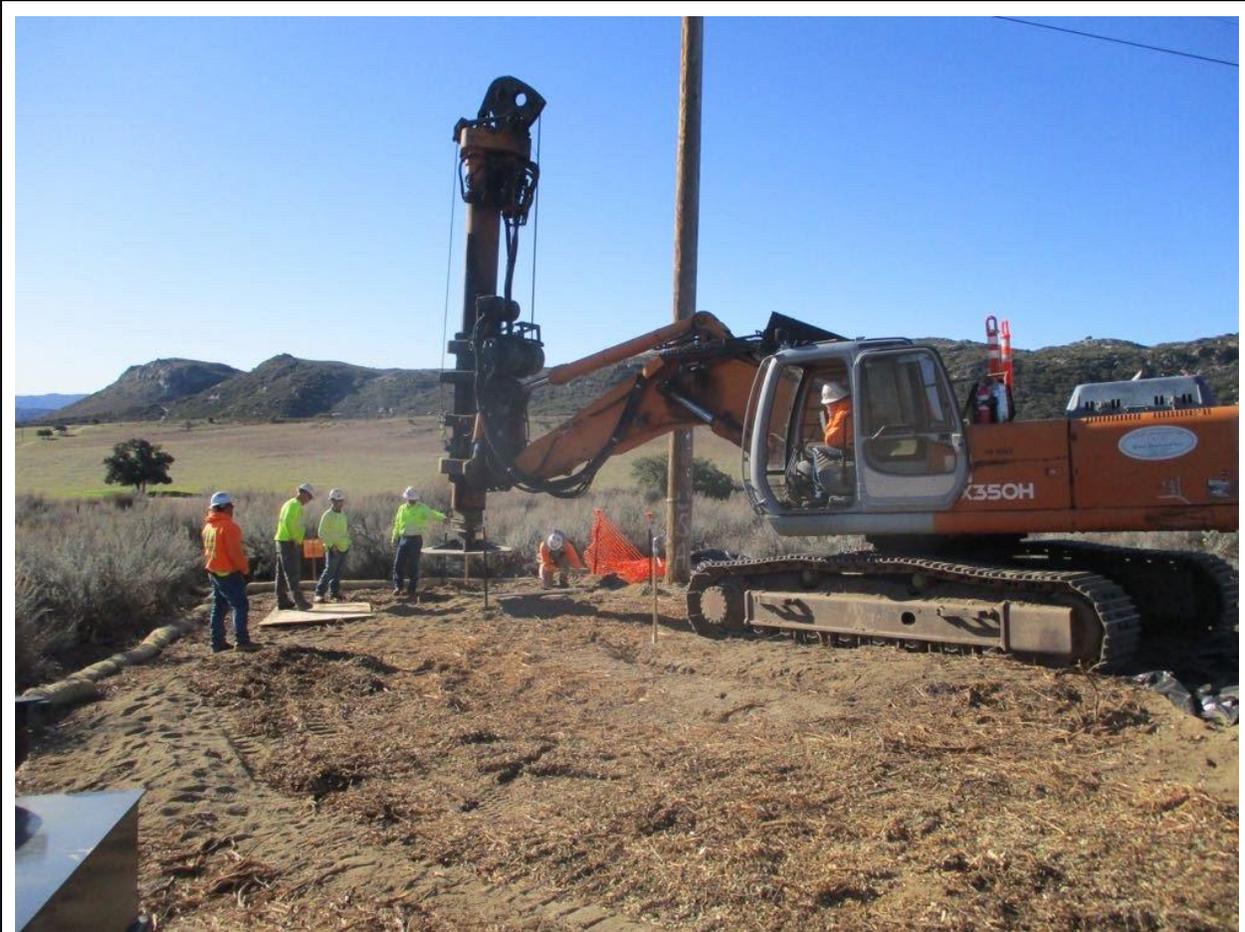
Approved workspaces were observed delineated with staking and flagging, and work crews were observed adhering to work space limits and staying on approved access roads in accordance with MM BIO-1 (Photo 1 – Attachment A). In order to ensure crews were clear on approved access routes, CPUC ECMs observed “no project access” and “approved access” signs at the entrances to access roads. Workers were observed having completed the Worker Environmental Awareness Program (WEAP), as shown by project hard hat stickers in accordance with MM BIO-2. Biological monitors were observed conducting full-time monitoring of initial ground-disturbing activities such as vegetation removal in accordance with MM BIO-3, and monitoring all other construction activities to ensure compliance with mitigation measures, applicant proposed measures, and permit conditions in accordance with MM BIO-22. CPUC ECMs confirmed with biological monitors that surveys for nesting raptor species were conducted prior to vegetation clearing activities along TL 6293. Excavations were observed covered to prevent wildlife entrapment in accordance with MM BIO-23, and crews were observed containing trash at work areas in accordance with MM BIO-26. Where construction can occur in habitat where Arroyo toads are widely distributed, work sites were fenced at the direction of the Arroyo Toad Authorized Biologist in accordance with APM BIO-3 (Photo 2 – Attachment A).

**Photo 1:** A crew was observed drilling a direct bury pole hole at Pole Z46586 (TL 6923) within the approved work limits in accordance with MM BIO-1 and with a complete set of fire tools on the drill equipment in accordance with APM HAZ-04 and the CFPPP.

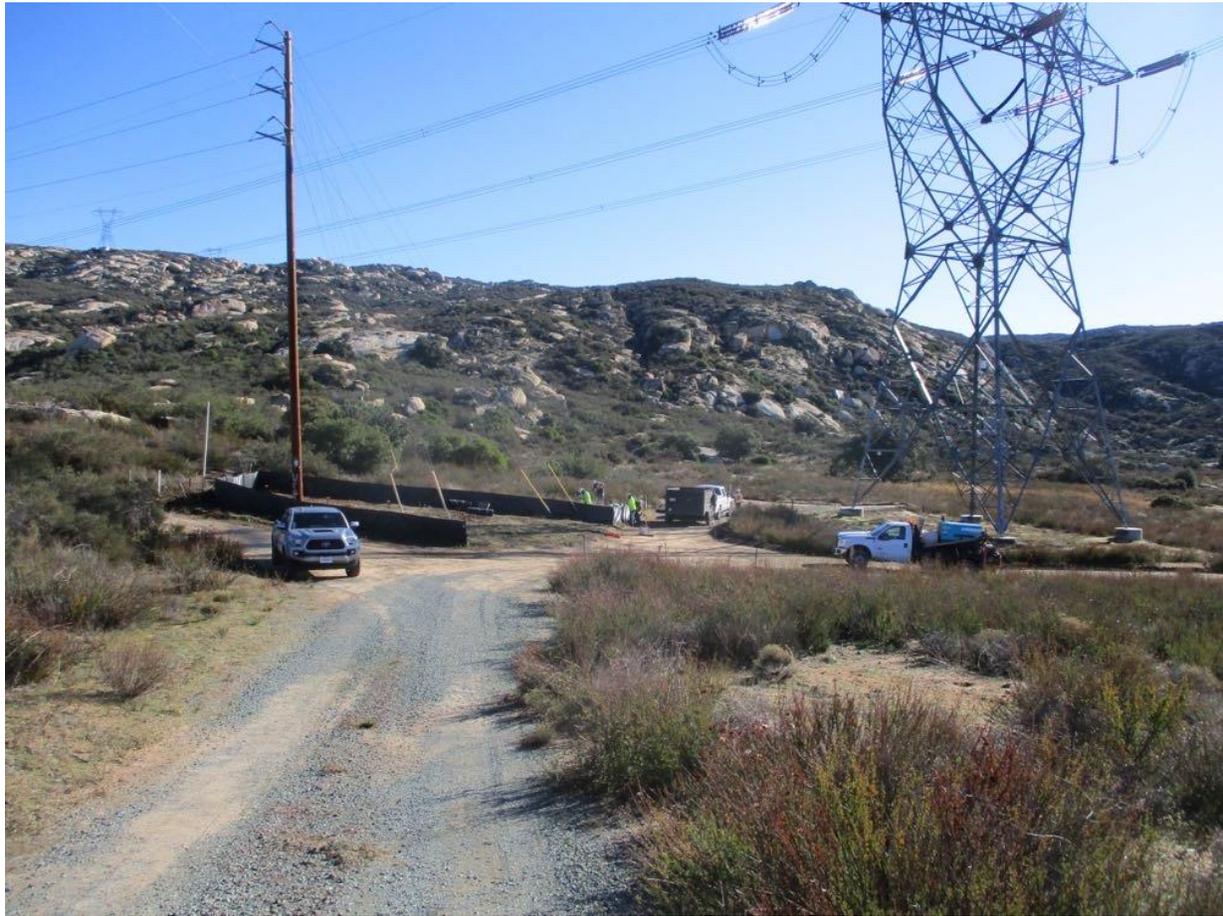
**Photo 2:** In accordance with APM BIO-3, a crew was observed installing Arroyo toad exclusionary fencing at Pole Z972845 (TL 6923) at the direction of the Arroyo Toad Authorized Biologist.

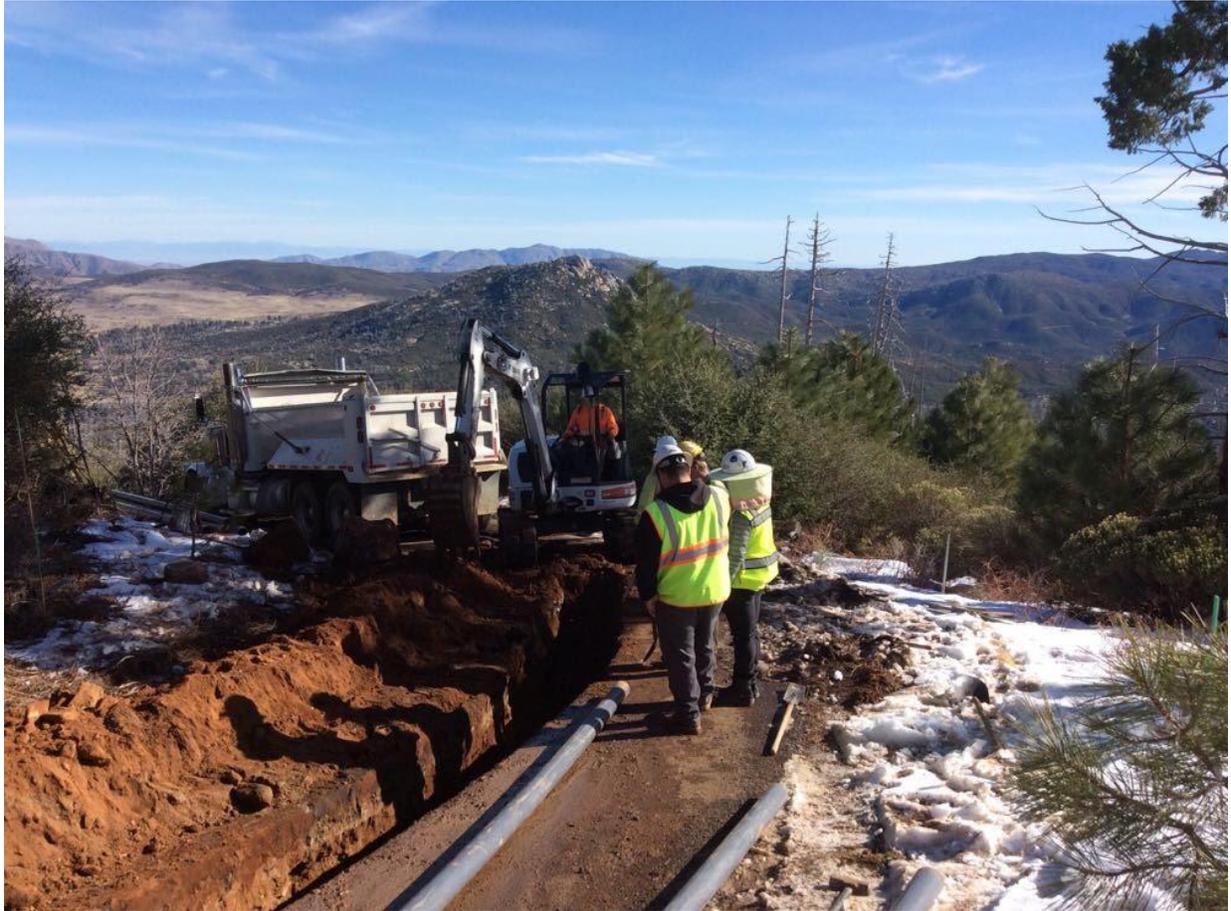
**Photo 3:** During trenching along C 79A, Archaeological and Cultural Monitors were observed inspecting soils and viewing trench sidewalls in accordance with the HPMP, MM CUL-1, and APM CUL-04.

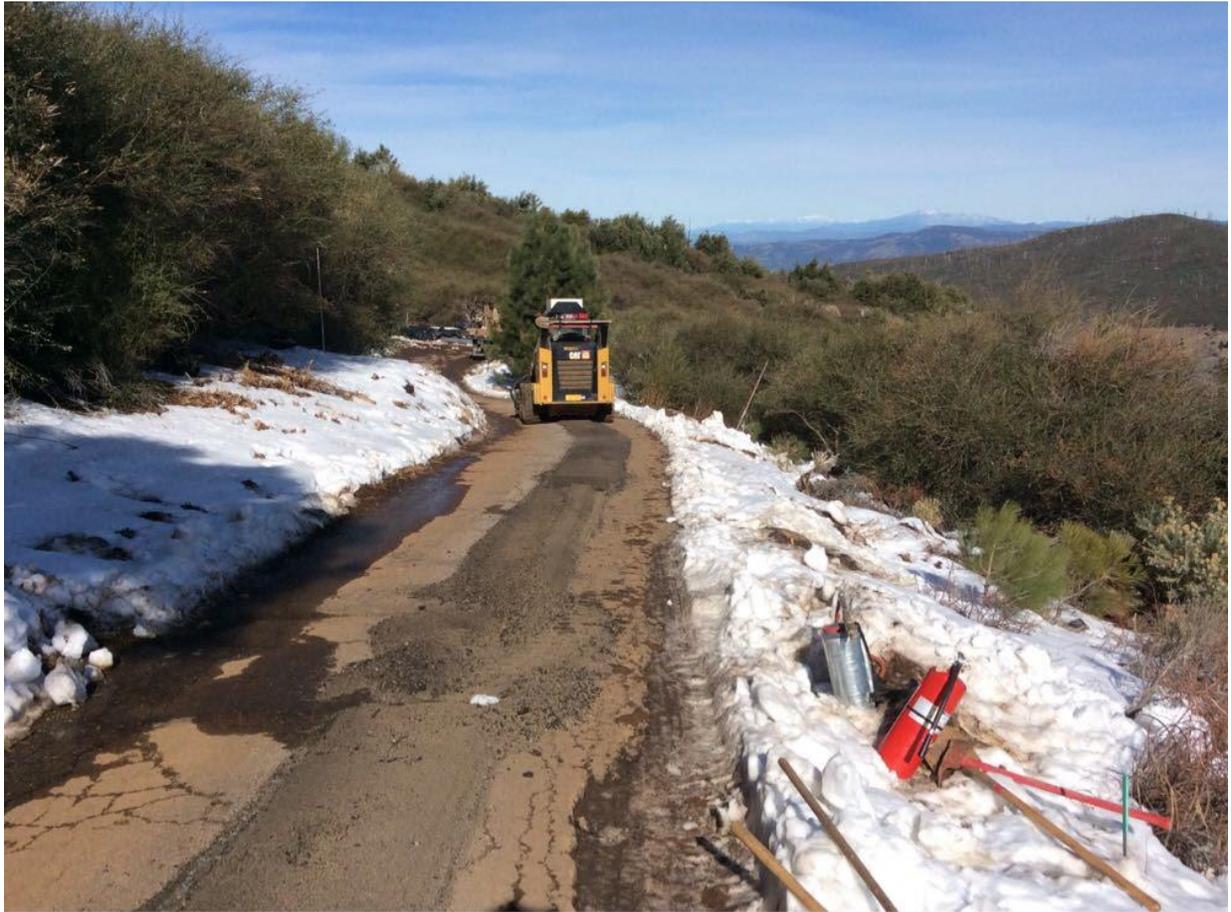
**Photo 4:** During grinding near station 57+50 on C 79A, a full set of fire tools (5-gallon backpack pump, round point shovel, Pulaski, and 2A10BC fire extinguisher) was staged within 50 feet of the activity in accordance with APM HAZ-04 and the CFPPP.

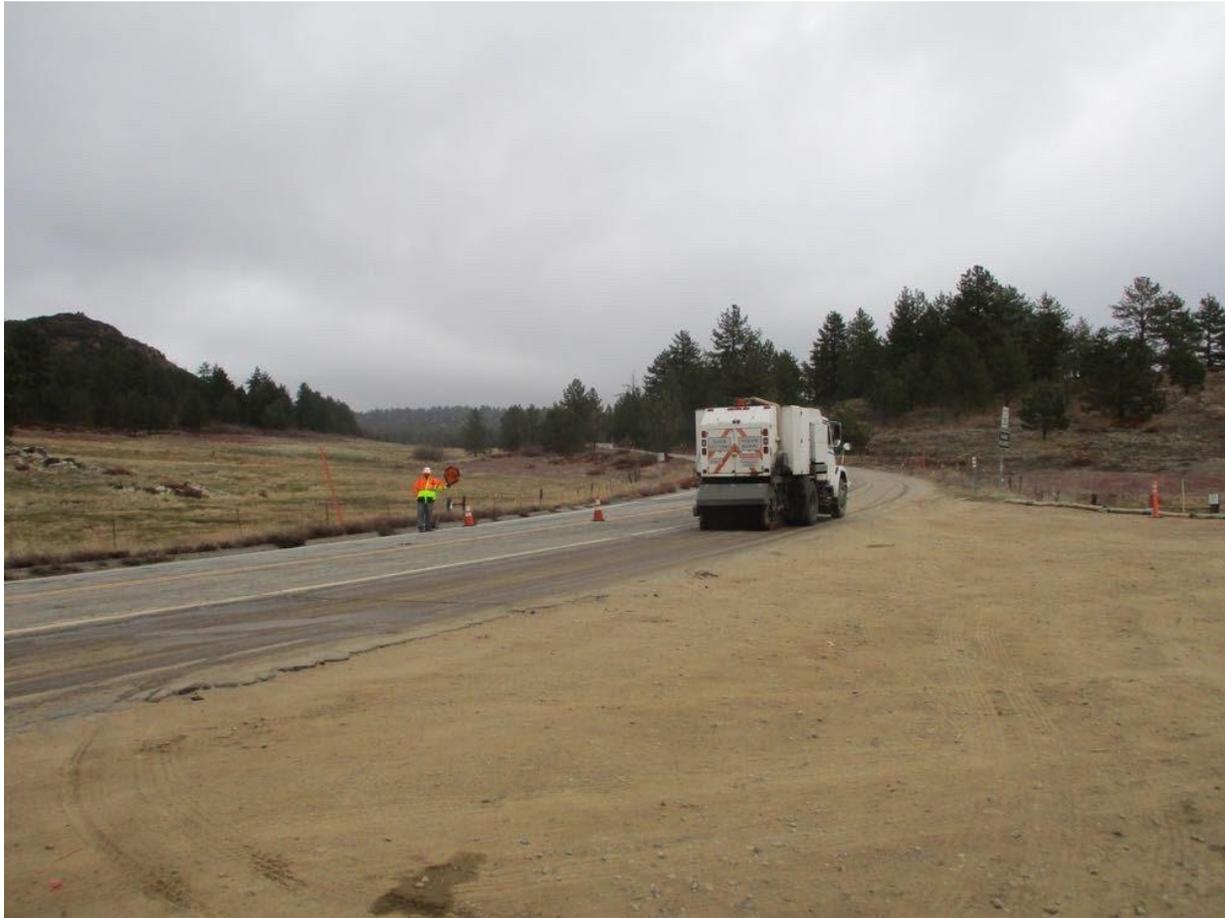
**Photo 5:** A street sweeper was used to clean up debris resulting from saw cutting near station 230+50 (C 440) along Sunrise Highway, in accordance with the ECP and SWPPP.

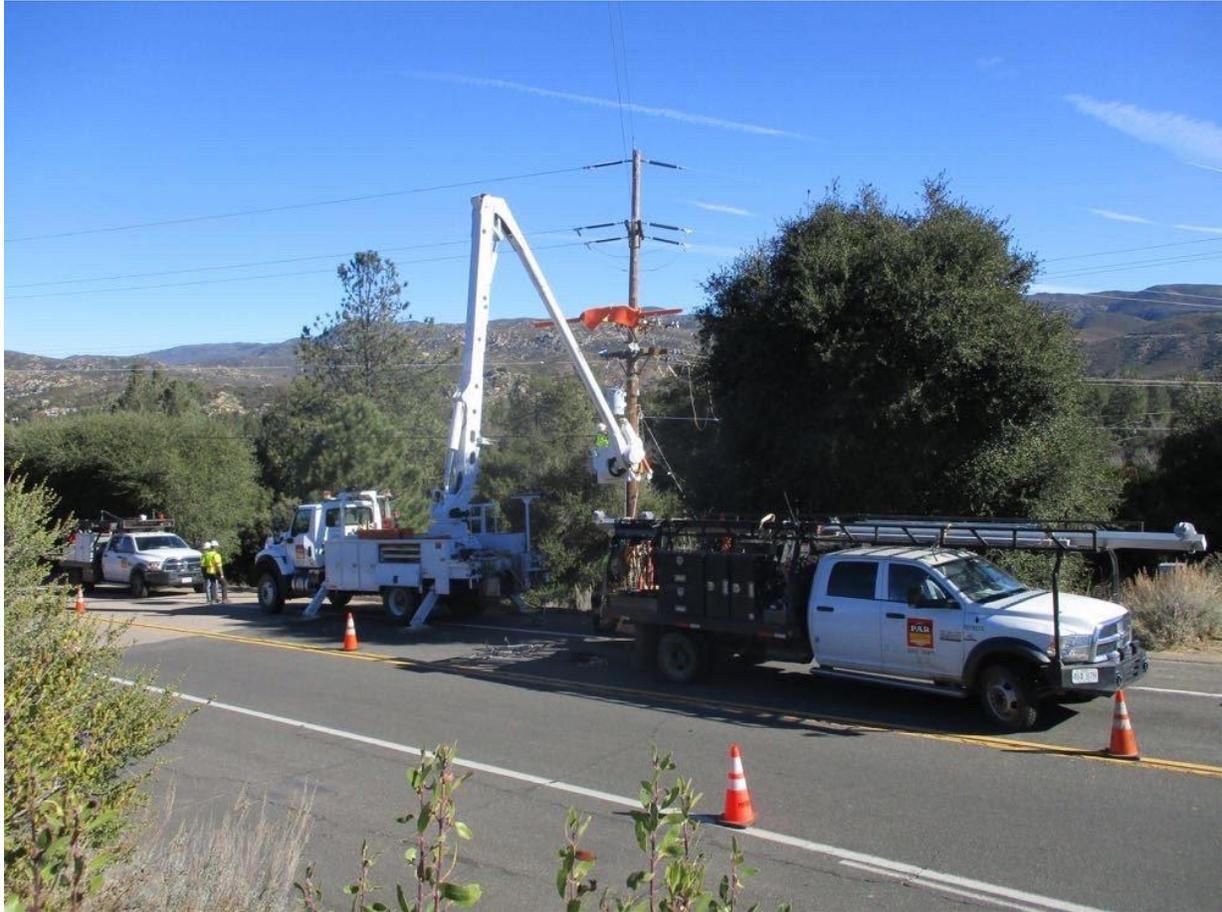
**Photo 6:** During wire work associated with the stringing of a customer service line at Pole Z774865 (TL 629A), cones and flagpersons were used to direct one-way traffic around construction equipment on Pine Valley Road in accordance with APM TRANS-02.
