| | <p><b>California Public Utilities Commission</b><br/><b><i>Mitigation Monitoring, Compliance, and Reporting Program</i></b></p> |
| | <p><b>East County (ECO) Substation Project</b></p> |
| | <p><b>Compliance Status Report: 033</b></p> <p><b>July 6, 2014</b></p> |

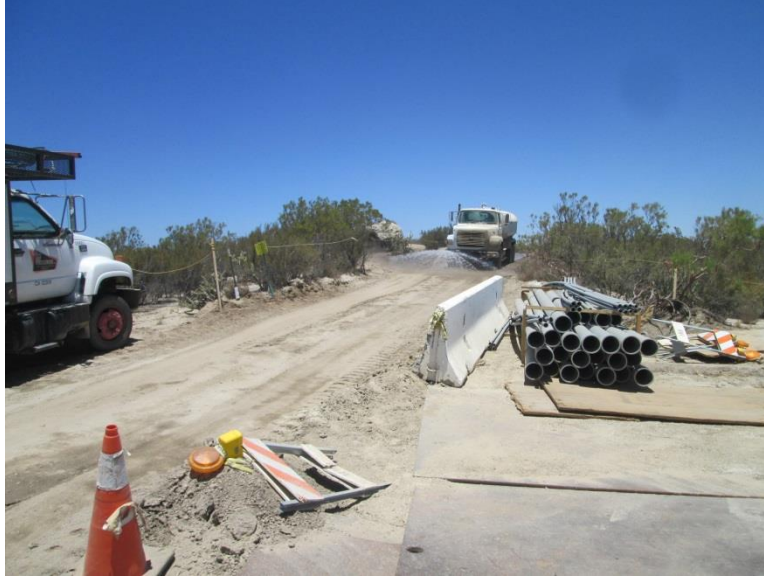
Dust control measures were observed being implemented in accordance with MM-AQ-1 and MM-BIO-4a, including watering of active construction areas (See Photo 1 - Attachment A). Track-out measures consisting of rumble plates and rock aprons were in place and maintained, and traffic control crews were observed manually sweeping up project related track out throughout and at the end of the day.

**Photo 1:** Water trucks were observed applying water to project access roads to minimize potential for fugitive dust in accordance with MM AQ-1.

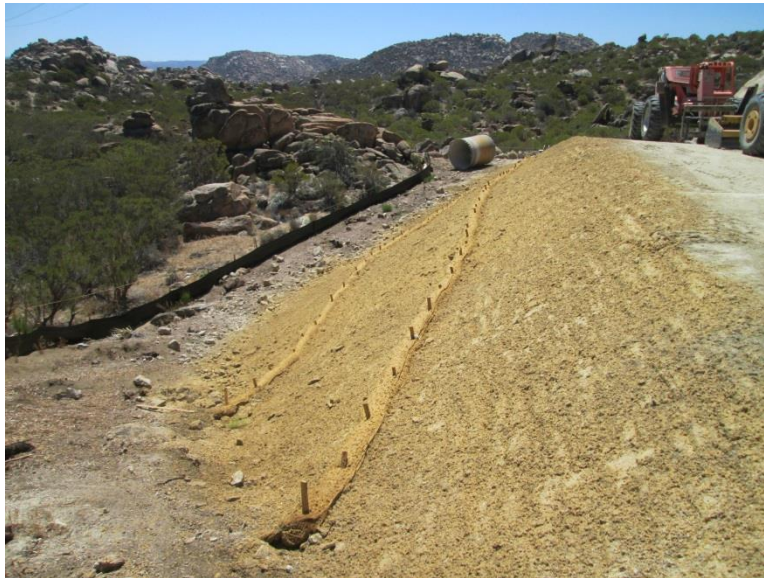
Erosion control measures consisting of straw wattles, silt fence and gravel bags are being maintained along the ROW in accordance with the SWPPP and MM-HYD-1 (See Photo 2—Attachment A). Fill slopes were sprayed with hydro mulch in an effort to reduce soil erosion in accordance with BIO1-d and the Habitat Restoration Plan. Staged and active stationary equipment featured containment as required by MM-HAZ-1a (See Photo 3—Attachment A). Jurisdictional waterways were marked off with blue flagging to highlight their location for avoidance. ESAs were marked, including special species flagging for plants as stipulated by BIO-5b.

**Photo 2:** In accordance with the BIO1-d and the Habitat Restoration Plan, pad fill slopes are sprayed with hydro mulch in an effort to reduce soil erosion. Erosion control measures consisting of straw wattles, silt fence and gravel bags are being maintained in accordance with the SWPPP and MM-HYD-1.

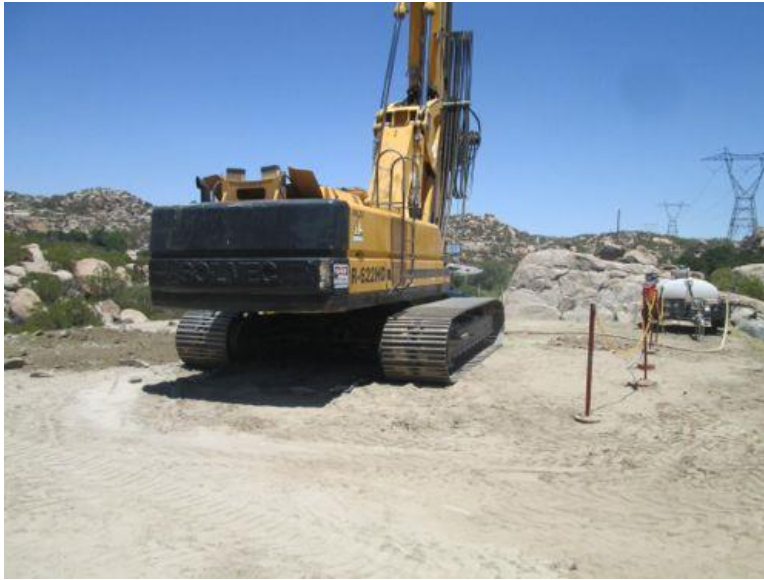
**Photo 3:** Visqueen was observed staged beneath vehicles in accordance with the SWPPP and MM-HYD-1.

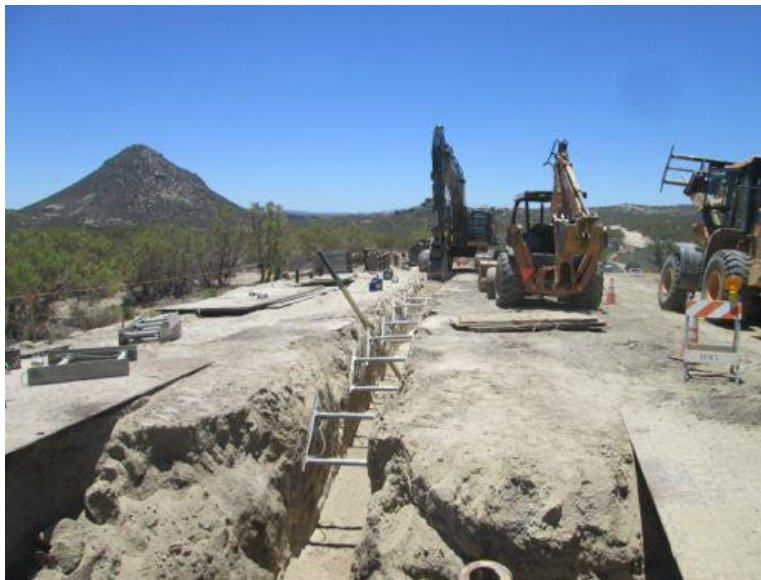
Trenching for the underground utilities included exporting soils offsite to the Domingo Lake Construction Yard (See Photo 4—Attachment A). Open trenches and excavation areas were constructed with wildlife escape ramps and/or appropriately covered at the end of each workday in accordance with MM-BIO-7a.

**Photo 4:** Trenching for the underground utilities included exporting soils offsite to the Domingo Lake Construction Yard.

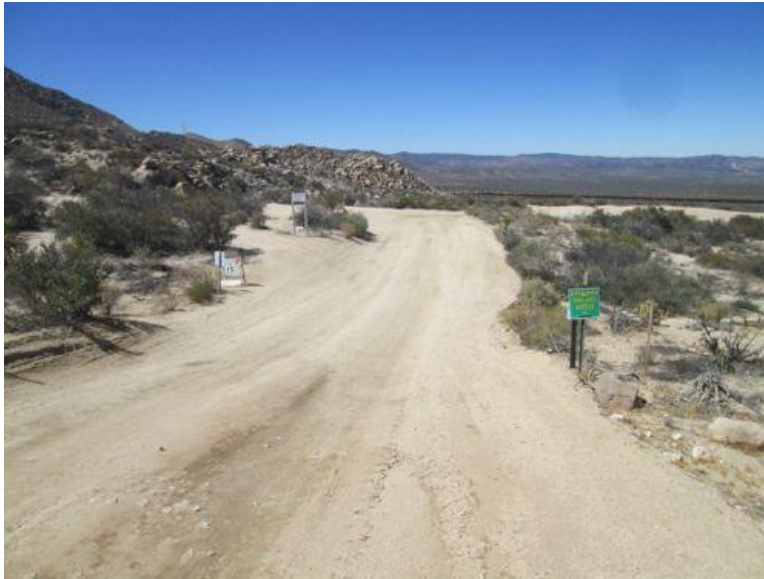
Water trucks were being utilized during excavation and backfilling activities and along common used access roads to minimize fugitive dust emissions in accordance with the Dust Control Plan and MM-BIO-4a. Trucks used during spoil removal associated with excavation were observed covering loads prior to entering publicly accessed roads in accordance with MM-BIO-4a and MM-AQ-1. Access roads were clearly delineated along the right-of-way and speed limits posted to ensure prevention of fugitive dust (See Photo 5 - Attachment A).

**Photo 5:** Signage indicating approved access road and speed limit restrictions were observed in-tact and installed along the project.

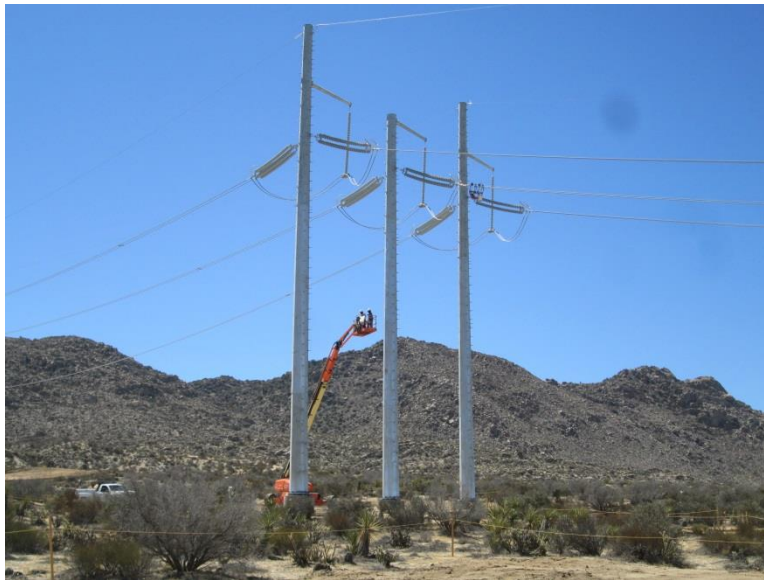
Construction activities during this reporting period consisted of setting of steel structures, pulling wire, installing conductors, installing jumpers and spacers on lines (See Photo 6 - Attachment A), and clipping-in conductors to the SWPL loop-in structures.

**Photo 6:** Crews were observed installing spacer carts at the SWPL overhead transmission line.
