<p>California Public Utilities Commission <i>Mitigation Monitoring, Compliance, and Reporting Program</i></p>
	<p>Lassen Substation Project</p> <p>Compliance Status Report: 01</p> <p>May 31, 2021</p>

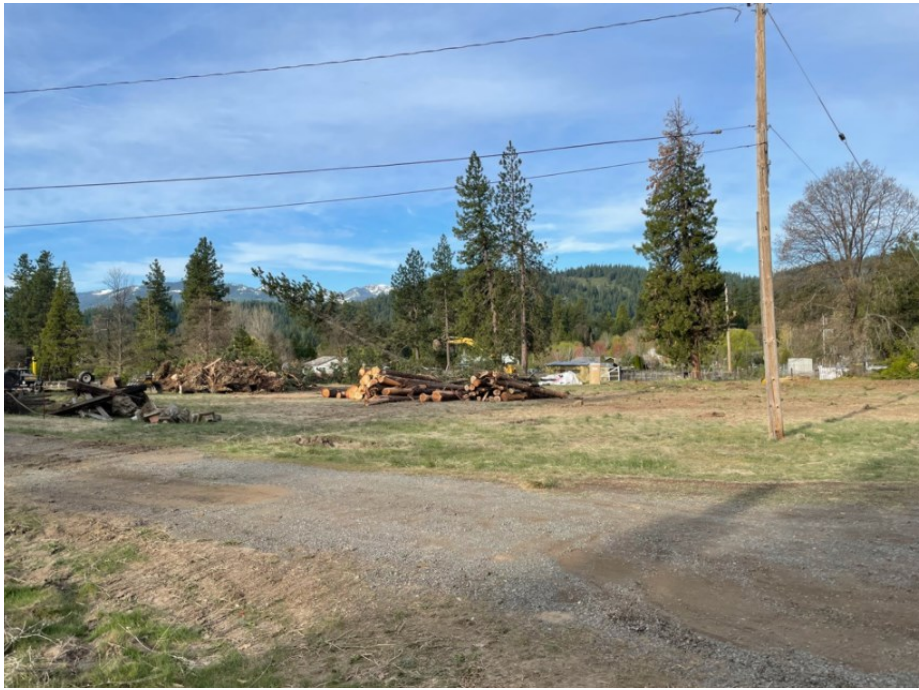
During this reporting period, crews delivered equipment and materials; removed trees (see Photo 1—Attachment A), tree stumps, and fence; demolished two structures at the new substation location; installed storm water pollution and prevention plan (SWPPP) best management practices (BMPs) (straw wattles); grubbed and excavated soils (see Photo 2—Attachment A); delivered, installed, and compacted base layer material (see Photo 3—Attachment A); installed riprap; built forms; laid out and tied rebar; set up foundation and walls for concrete pouring; and removal of spoils from site.

Photo 1: Tree removal at the new substation location was observed.

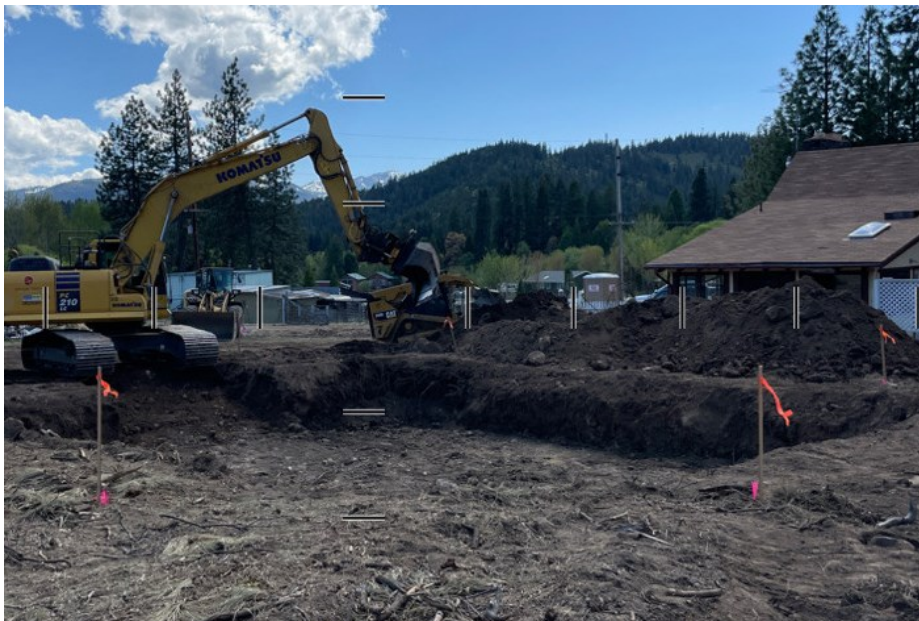
Photo 2: Crews excavated an area on site for a new substation transformer.

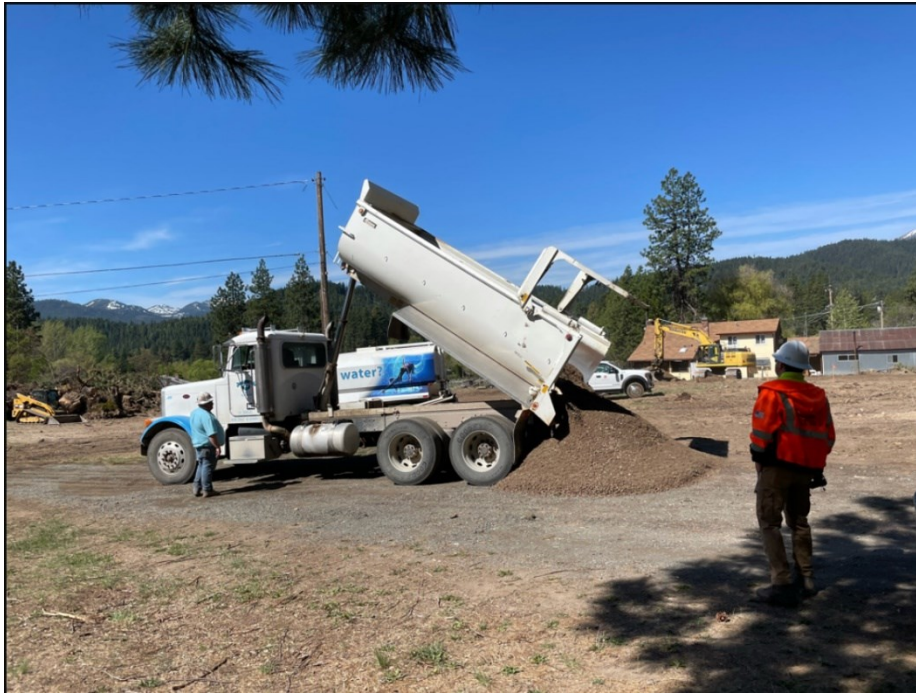
Photo 3: Base gravel for the new substation delivered on site.

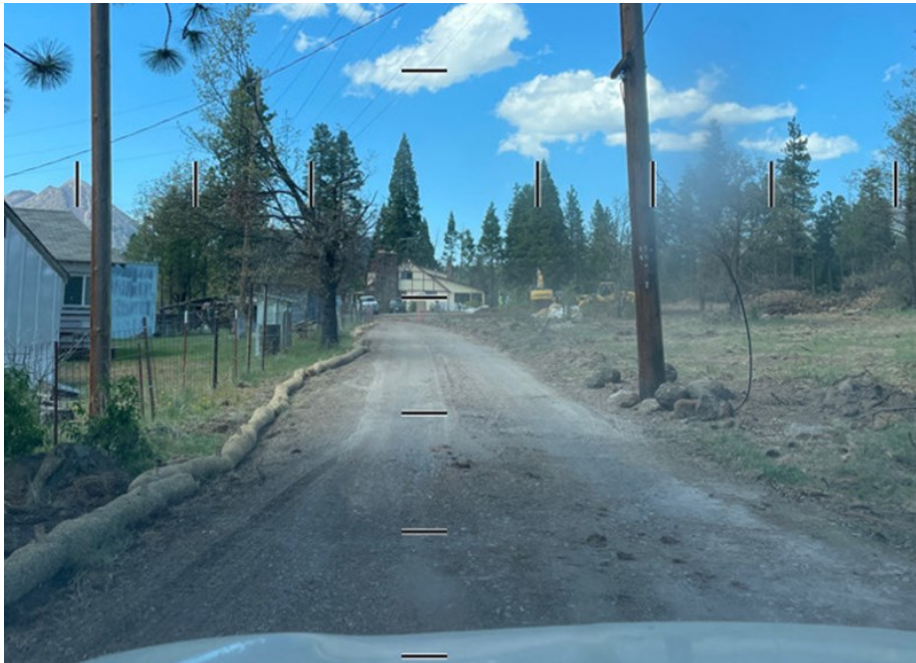
Photo 4: SWPPP BMPs (fiber rolls) were placed along access roads in accordance with APM WQ-1.

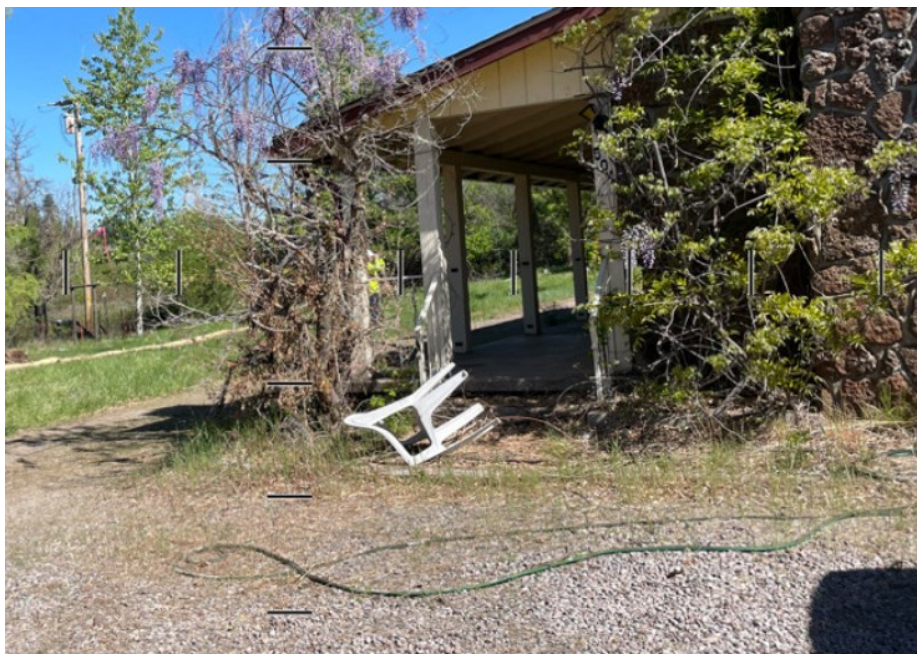
Photo 5: An EM was observed monitoring status of active nest on one of the structures to be demolished in accordance with APM BIO-7.

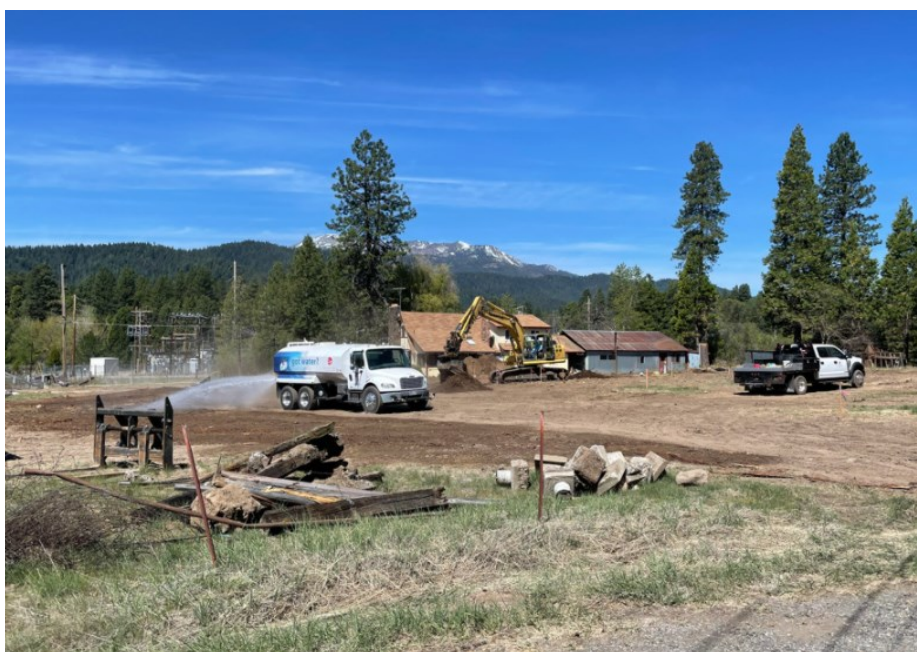
Photo 6: During site preparation activities, water trucks were observed on site applying water to soils to control particulate matter emissions in accordance with APM AQ-1.
