California Public Utilities Commission Mitigation Monitoring, Compliance, and Reporting Program

Lassen Substation Project

Compliance Status Report: 02

June 30, 2021

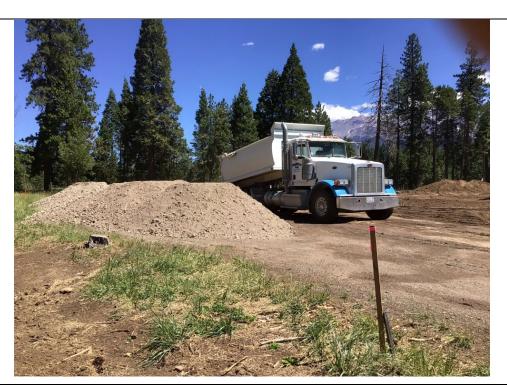
Photo 1: Delivery/import of soil and rock materials

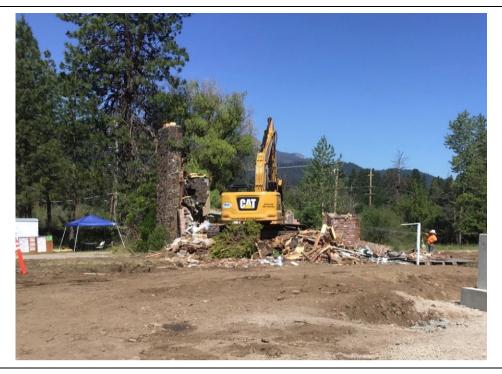
PacifiCorp reported one non-compliance incident that occurred on June 01, 2021, which included the contractor performing work without an environmental monitor present (APM BIO-06) and resulted in the removal of a bird nest during demolition of an existing structure. At the time of demolition, there was a buffer area in place for a Steller's Jay nest located in a bush next to the residence. PacifiCorp immediately notified the CPUC of the issue via a telephone call and follow-up email. PacifiCorp also provided written notification of the non-compliance event to CPUC CDFW on June 6, 2021. PacifiCorp would follow up with documentation of corrective actions.

Photo 2: House demolition with dust control being implemented during demolition

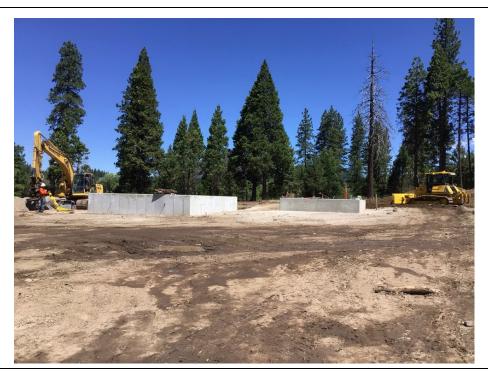
Photo 3: Grading and compaction work within project area

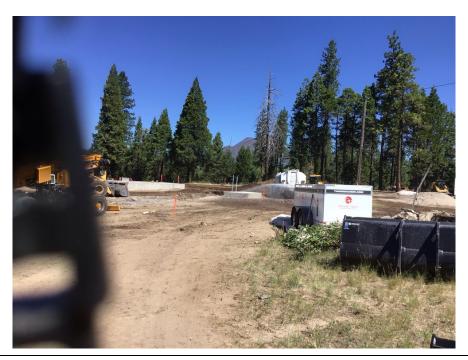
Photo 4: Dust control being implemented (water truck) in accordance with APM AQ-1

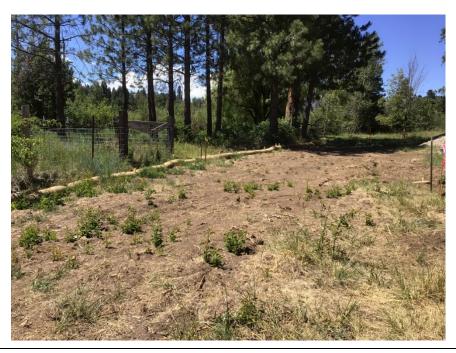
Construction vehicles were not directly observed being delivered to the project site but upon inspection were determined to be free of soil build-up in accordance with APM BIO-2. During site preparation activities, water trucks were observed on site applying water to soils to control particulate matter emissions in accordance with APM AQ-1 (see Photo 4—Attachment A) and use of previously established roadways was observed (APM BIO-10). Erosion control best management practices (BMPs), such as fiber rolls and coverings for spoils piles were observed installed in accordance with the locations identified in the project's Stormwater Pollution Prevention Plan (SWPPP) (APM WQ-1) (see Photo 5—Attachment A).

Photo 5: SWPPP BMPs (fiber rolls) were placed along northern site boundary in accordance with APM WQ-1

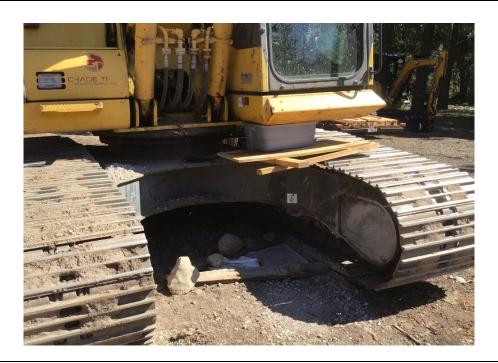
During site inspections, the EM monitored containment/fueling and secondary containment areas and procedures in accordance with APM HAZ-2 and HAZ-3. Small spills noted on site were immediately contained and cleaned up in conformance with the SPCC in accordance with APM HAZ-3. The EM continued to monitor placement of materials and equipment to ensure compliance in accordance with APM HAZ-2 and HAZ-3. The CPUC ECM observed occurrences of some equipment with leakage to be repaired being adequately contained with tubs/pans in accordance with APM HAZ-2 (see Photo 6—Attachment A). The site was observed to be free of trash during site inspections per APM BIO-11.

PacifiCorp reported a few compliance incidents involving on-site minor leaks and stained soil came up during this reporting period. Corrective actions taken included ensuring the leaks and soil were cleaned up and debris was disposed of properly.

Photo 6: Excavator with leakage being adequately contained with tubs/pans in accordance with APM HAZ-2
