<p>California Public Utilities Commission <i>Mitigation Monitoring, Compliance, and Reporting Program</i></p>
	<p>Lassen Substation Project</p> <p>Compliance Status Report: 05</p> <p>September 30, 2021</p>

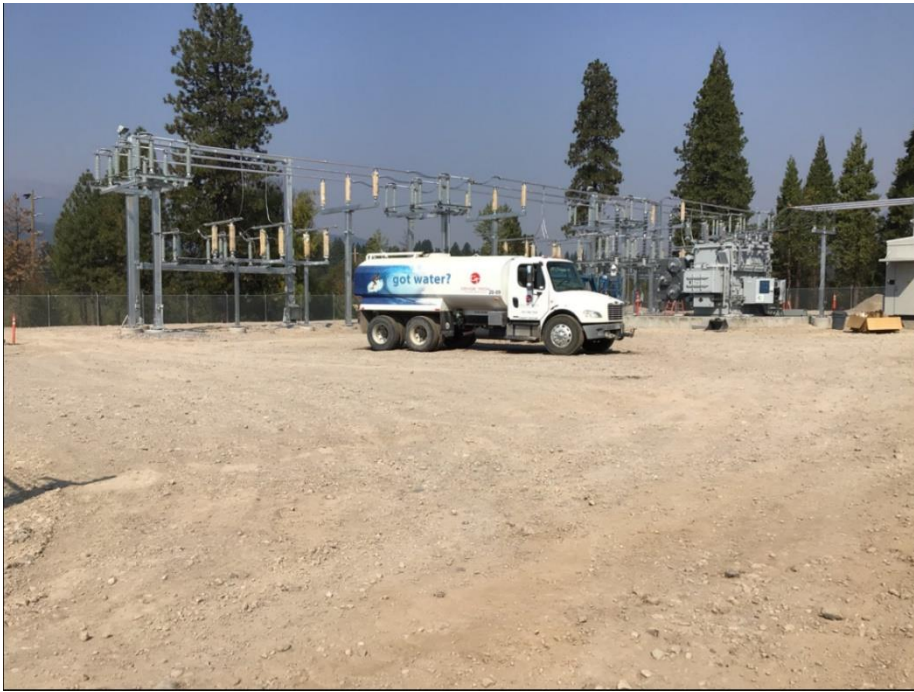
Access roads appeared to be sufficiently watered by water trucks to control particulate matter emissions in accordance with APM AQ-1 (see Photo 1—Attachment A).

Photo 1: A water buffalo was observed on site and has been actively wetting roads and unpacked construction areas, in compliance with SWPPP and dust (APM AQ-1).

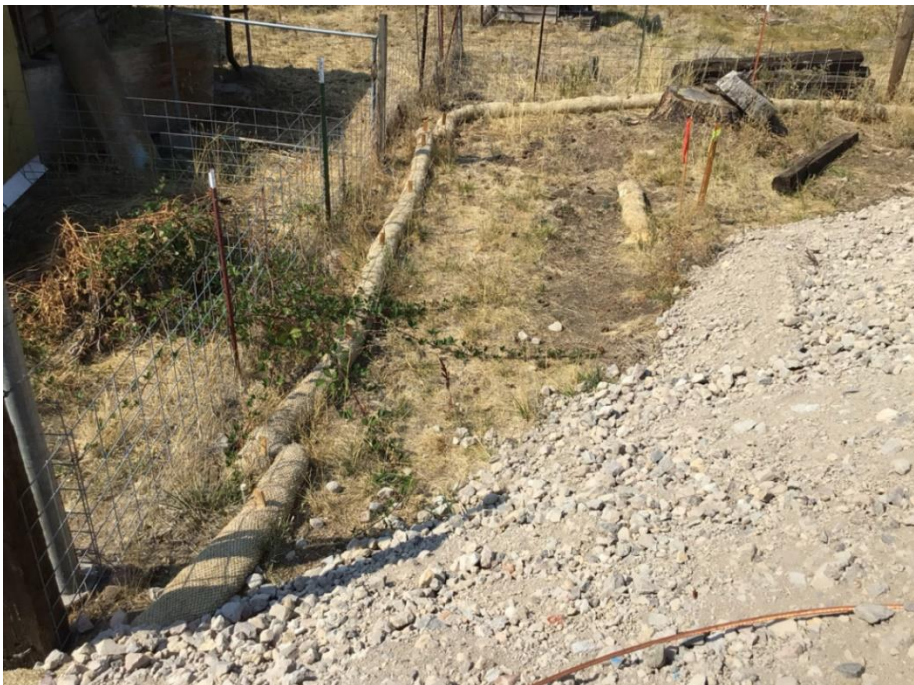
Erosion control best management practices (BMPs), such as fiber rolls were observed to be in good condition in accordance with the locations identified in the project's SWPPP (APM WQ-1) (see Photo 2—Attachment A) and topsoil piles were observed stabilized in accordance with the SWPPP. No dust or trackout issues were observed at the project's gravel entrance (see Photo 3—Attachment A). During a site inspection last month, the ECM observed that the integrity of the concrete washout liner was compromised and discussed it with the onsite EM. The damaged liner was no longer observed on site.

Photo 2: SWPPP erosion control BMPs (fiber rolls) were observed in good condition along the project boundary in accordance with APM WQ-1.

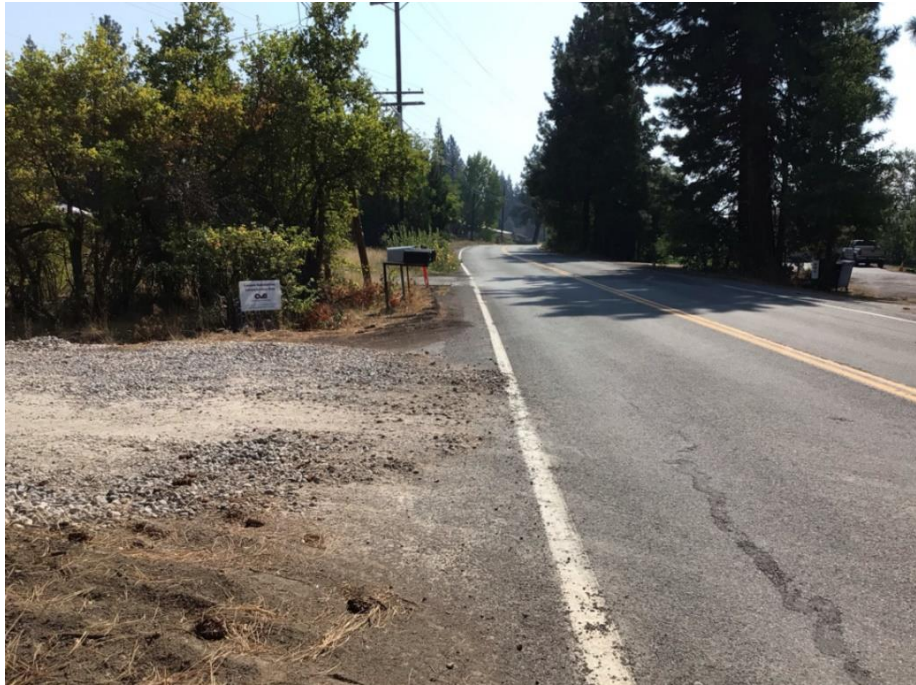
Photo 3: The stabilized construction entrance (gravel base) was observed in compliance with the SWPPP (APM WQ-1).

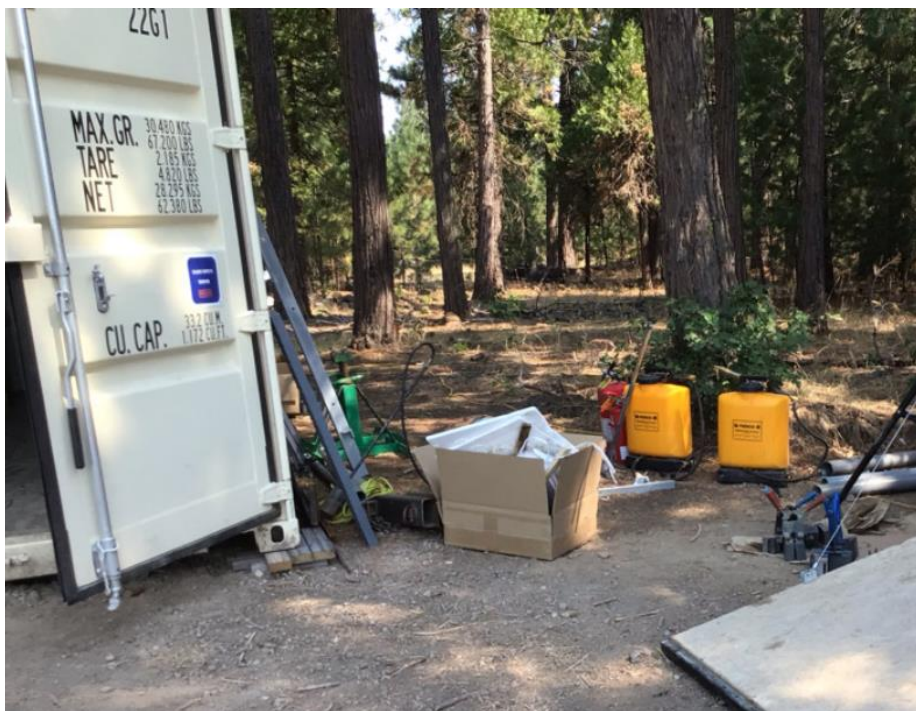
Per the Fire Plan for the project (MM HAZ-2) fire suppression tools, including extinguishers, Pulaski's, and 5-gallon pumps were observed staged on site in accordance with MM HAZ-2 (see Photo 4—Attachment A). Vehicles were observed parked on previously disturbed areas in accordance with the Fire Plan.

Photo 4: Fire Equipment was staged on site in accordance with the project's Fire Plan (MM HAZ-2).
