# California Public Utilities Commission Mitigation Monitoring, Compliance, and Reporting Program

**Lassen Substation Project**

**Compliance Status Report: 06**

October 31, 2021

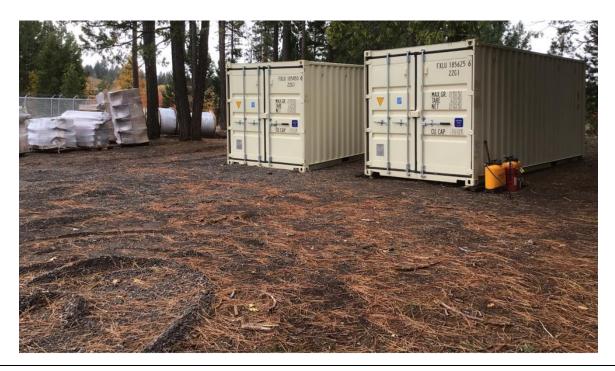
Per the Fire Plan for the project (MM HAZ-2) fire suppression tools, including extinguishers, Pulaski's, and 5-gallon pumps were observed staged on site in accordance with MM HAZ-2 (See Photo 1—Attachment A).

**Photo 1**: Stored equipment was observed tidy and fire equipment was staged on site in accordance with the project's Fire Plan (MM HAZ-2).

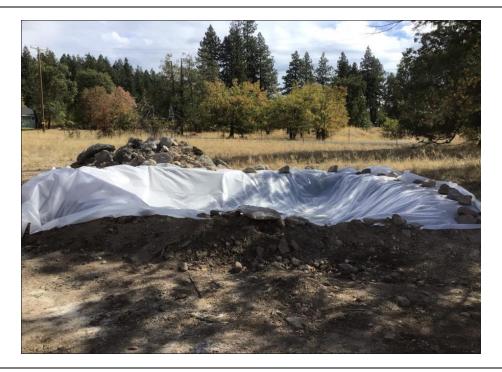
Photo 2: The concrete washout was re-lined prior to use.

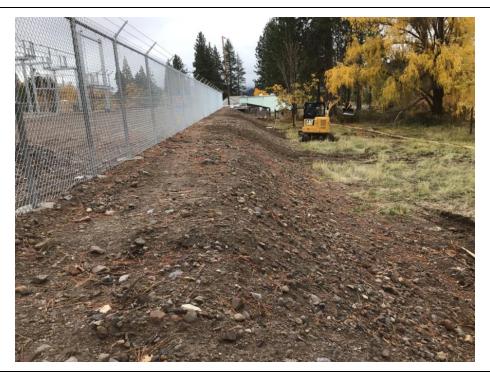
**Photo 3:** Operator restoring the west side of the substation.

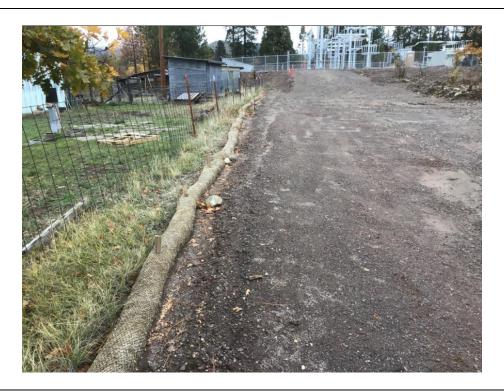
**Photo 4:** SWPPP erosion control BMPs (fiber rolls) were observed in good condition along the project boundary in accordance with APM WQ-1.

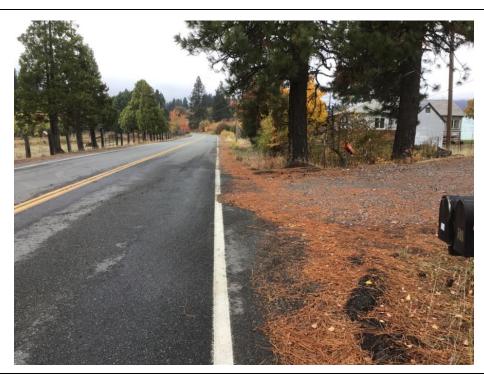
**Photo 5:** The stabilized construction entrance (gravel base) was observed in compliance with the SWPPP (APM WQ-1).
