California Public Utilities Commission <i>Mitigation Monitoring, Compliance, and Reporting Program</i>
	Lassen Substation Project Compliance Status Report: 07 September 30, 2022

SUMMARY

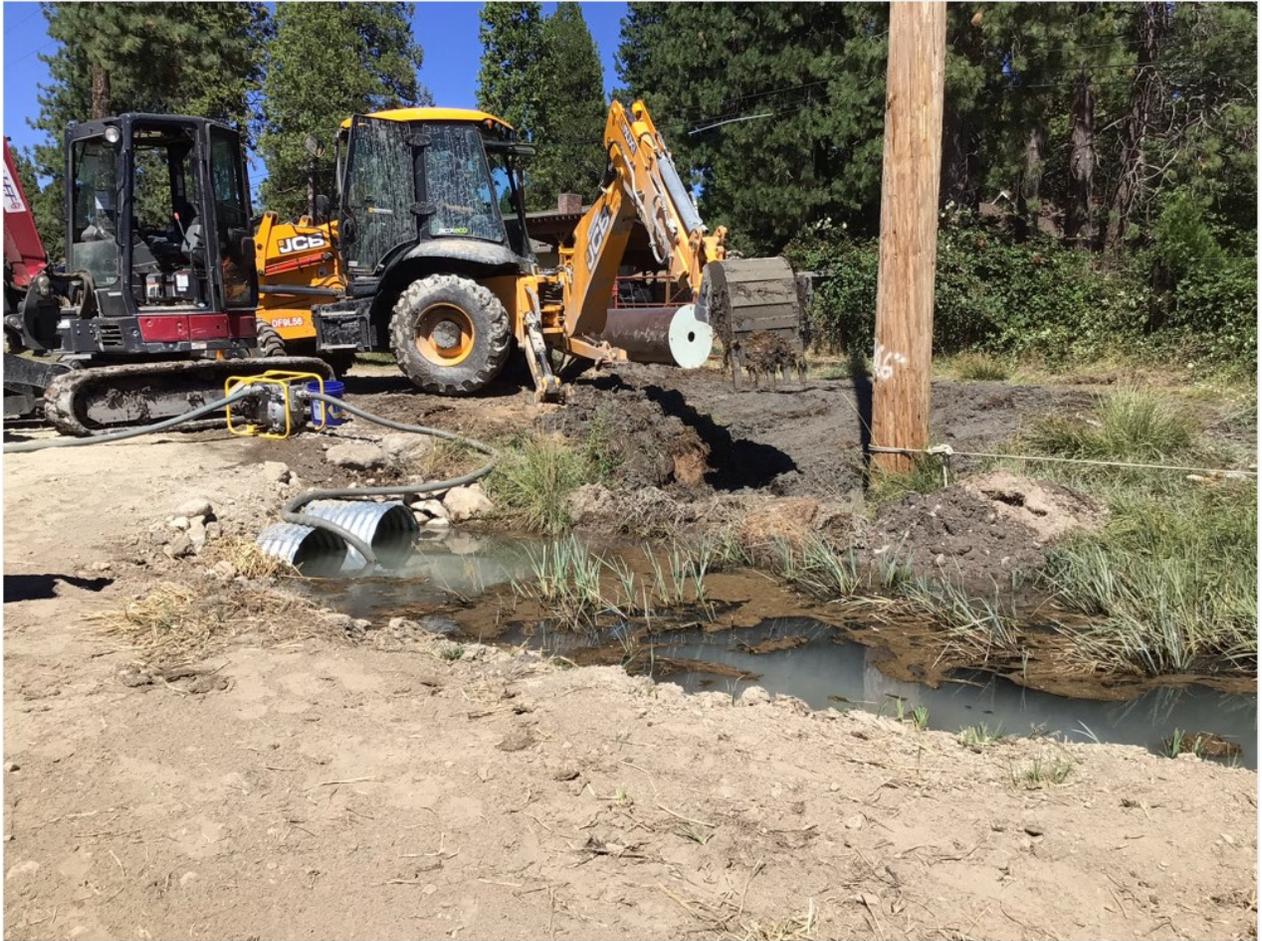
Photo 1: Work discontinued at pole location 21/48.

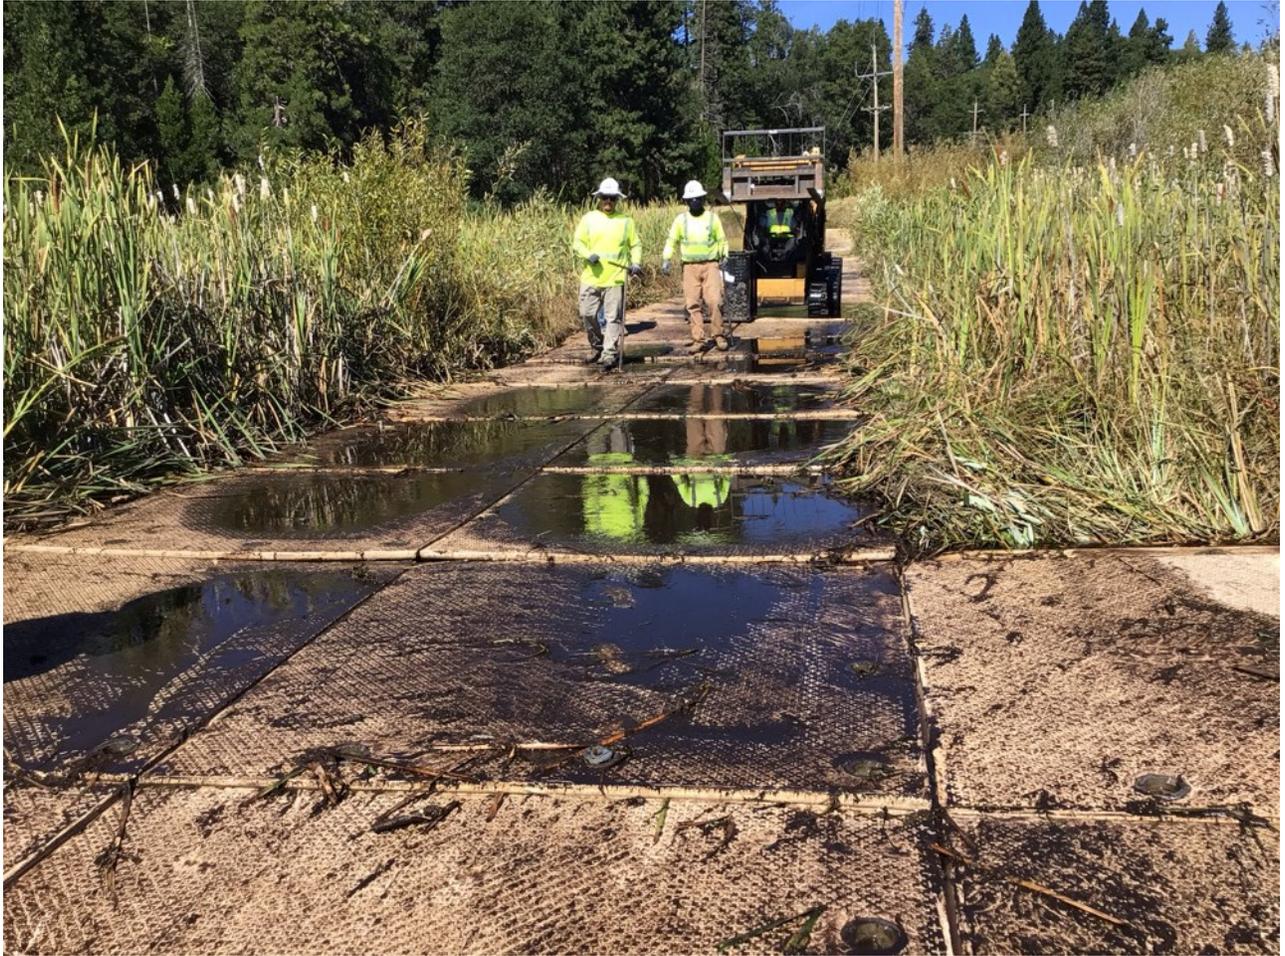
Photo 2: Mats were installed along the north end of the transmission line alignment in accordance with APM-BIO-5.

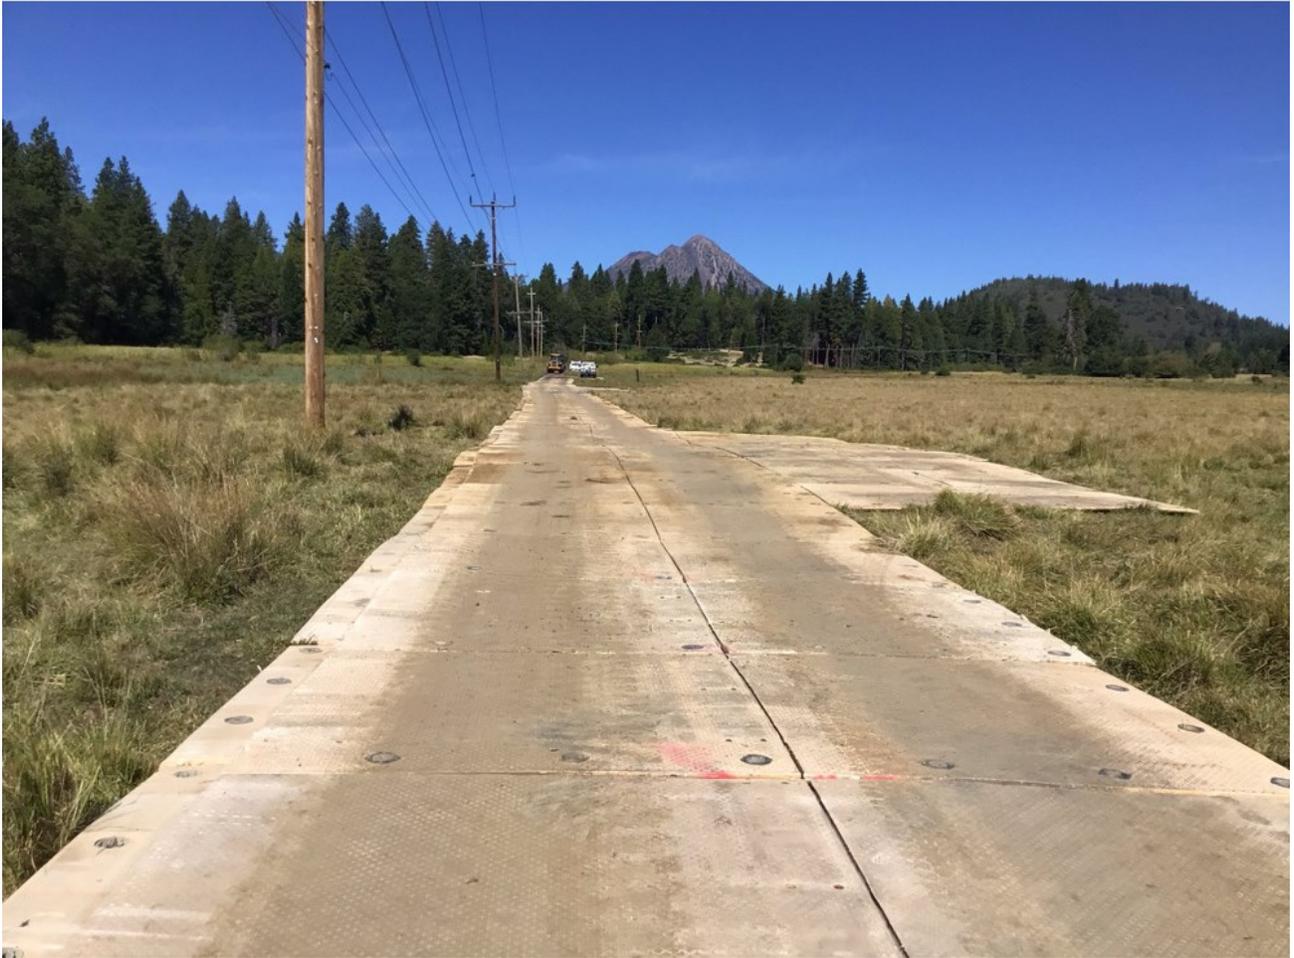
Photo 3: Mats were installed along Hatchery Road in accordance with APM-BIO-5.

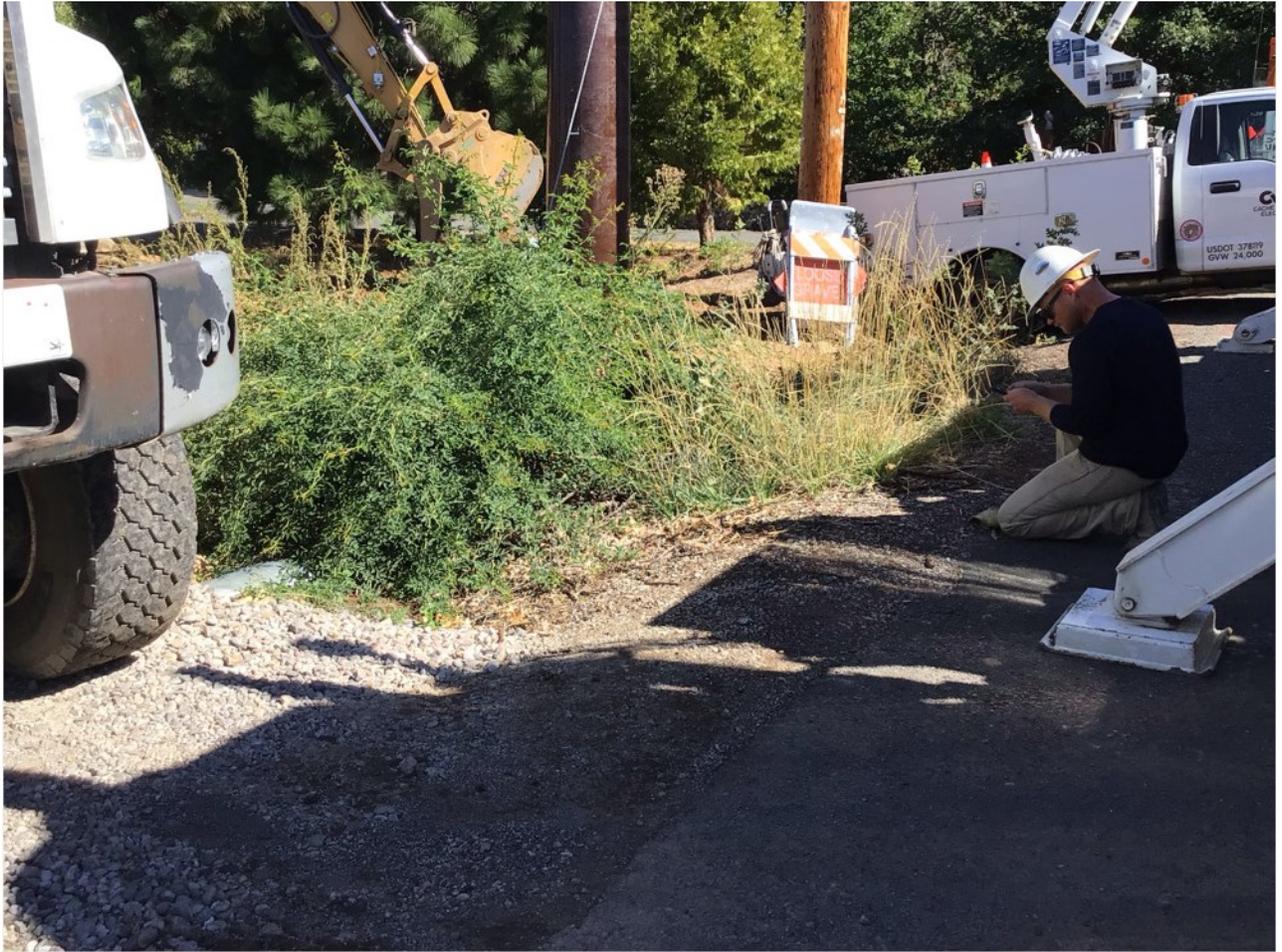
Photo 4: Work vehicles were staged previously established roadways during work at pole 2/48 (APM-BIO-10).

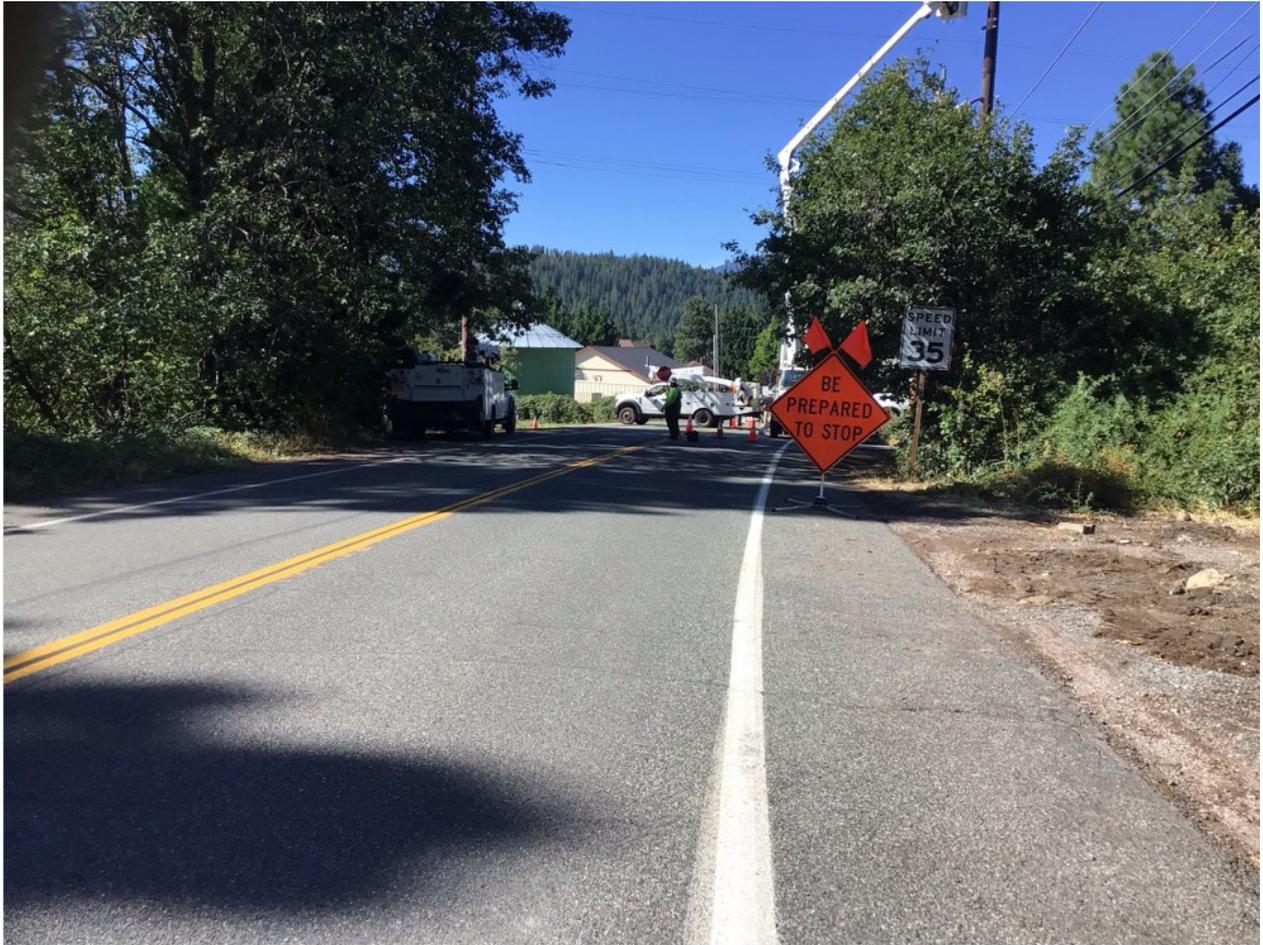
Photo 5: Traffic controls were observed in place on W. Ream Road for transmission pole 2/48 installation per APM TT-1.
