<p>California Public Utilities Commission <i>Mitigation Monitoring, Compliance, and Reporting Program</i></p>
	<p>Lassen Substation Project</p> <p>Compliance Status Report: 08</p> <p>October 31, 2022</p>

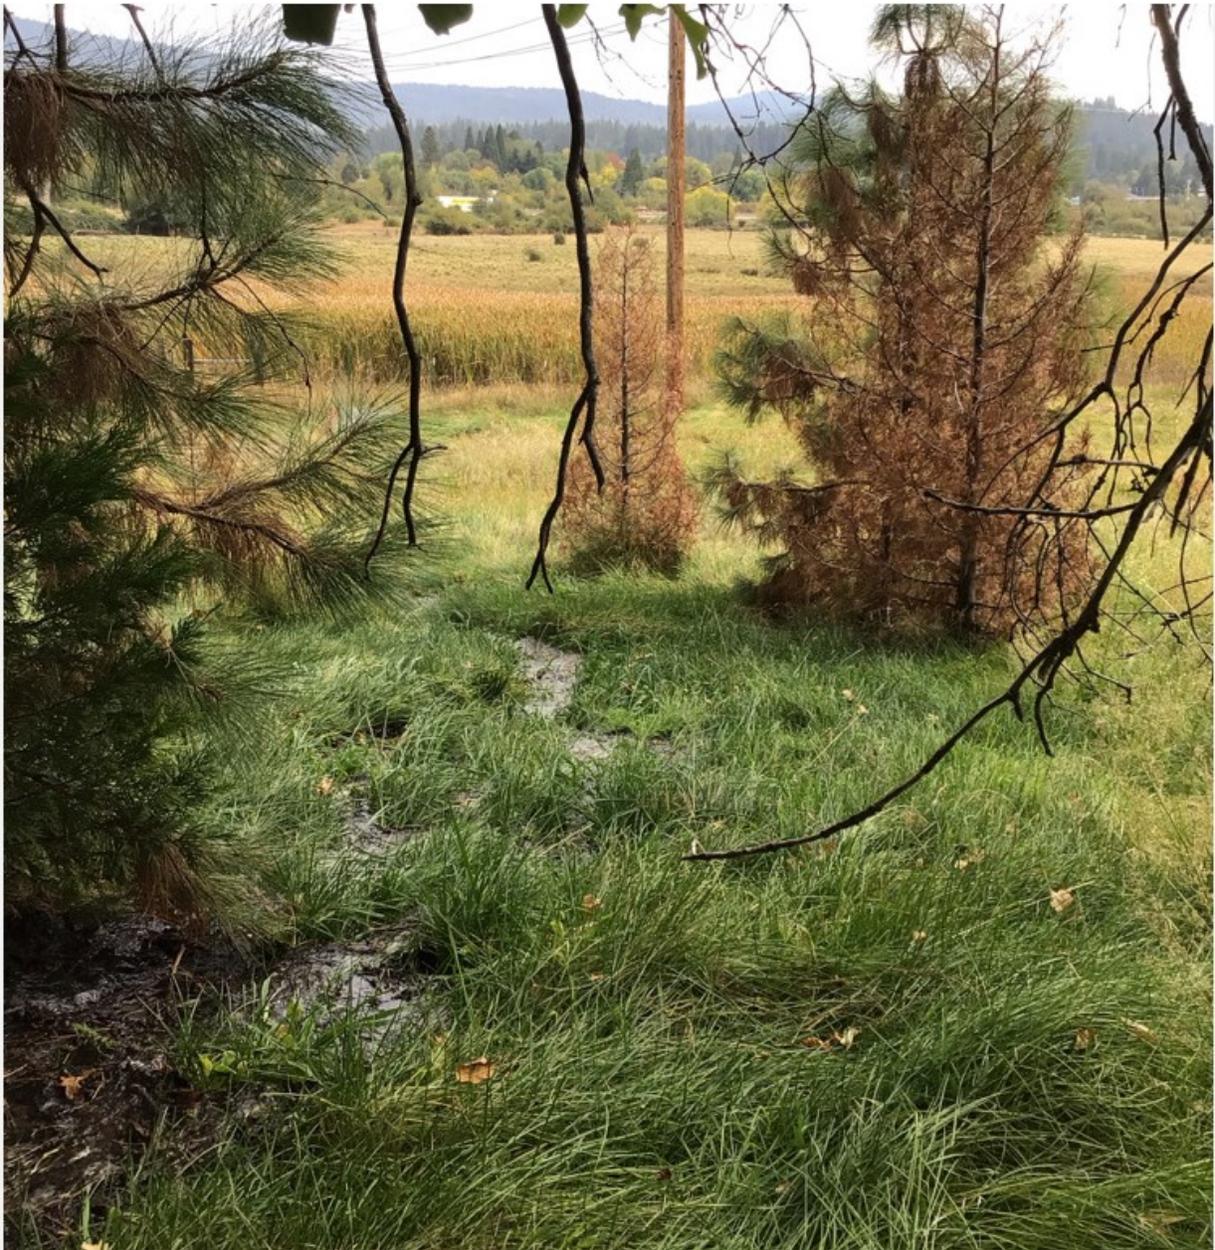
Photo 1: Non-project related water observed occurring northwest of location 19/48 at north end of the transmission alignment.

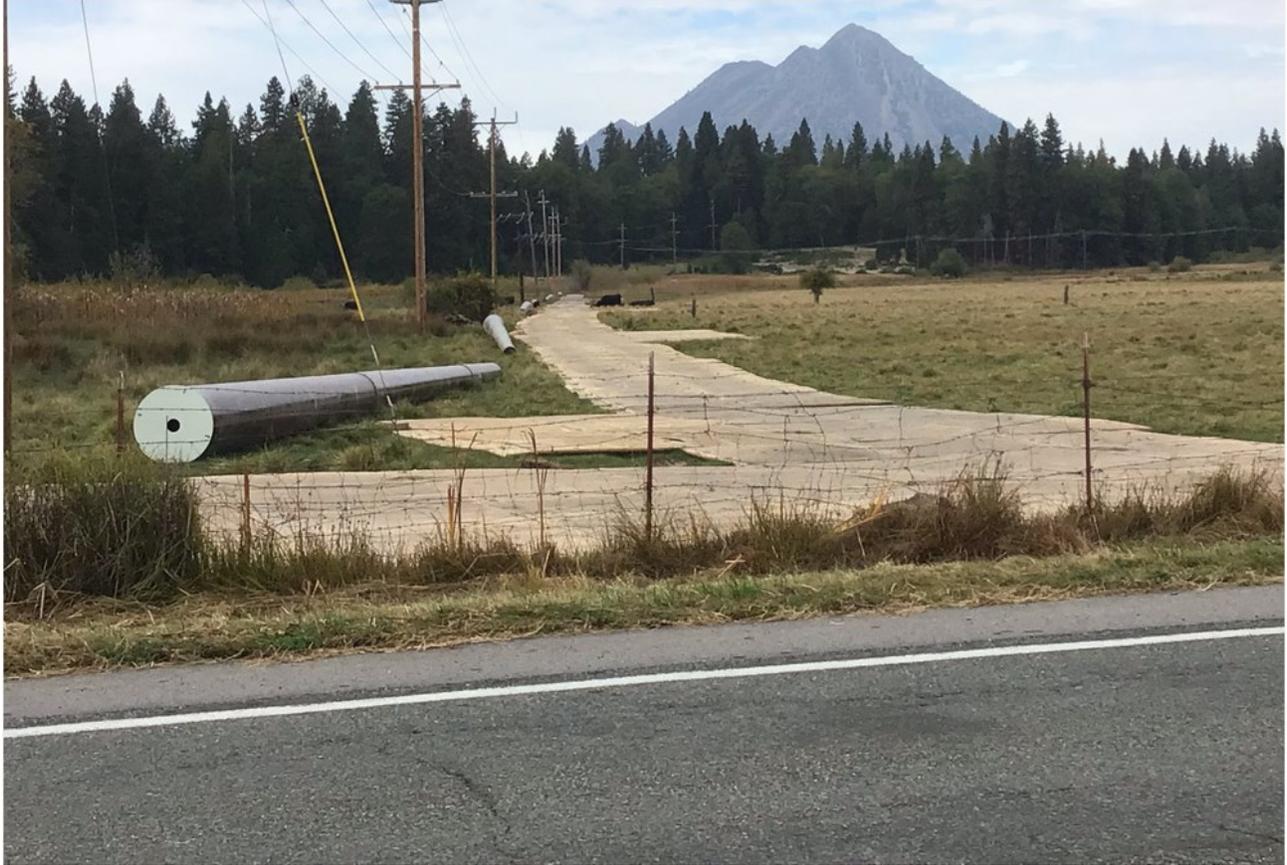
During this reporting period, the CPUC ECM spot-checked locations along the transmission line alignment and inspected the Lassen Substation. The ECM did not observe construction activities occurring at the time of inspection, but the lead Environmental Monitor (EM) on site communicated that a crew had been working on tower fixtures earlier that morning. The ECM and EM reviewed location 19/48 to review a drainage that had been reported by the EM northwest of pole location 19/48 (see Photo 1—Attachment A). The water, of undetermined origin, was observed flowing through a shallow/narrow channel then forming sheet flow through vegetation and through the project area at 19/48 before entering adjacent wetland to east. The EM communicated that they would notify the contractor and recommend extending mats into the work area to facilitate construction. The ECM observed poles staged and elevated along the ROW north of Hatchery Road, where timber mats were installed in accordance with APM-BIO-5 (see Photos 2 and 3—Attachment A).

Photo 2: Poles were observed staged along the ROW north of Hatchery Road. Timber mats were installed in accordance with APM-BIO-5.

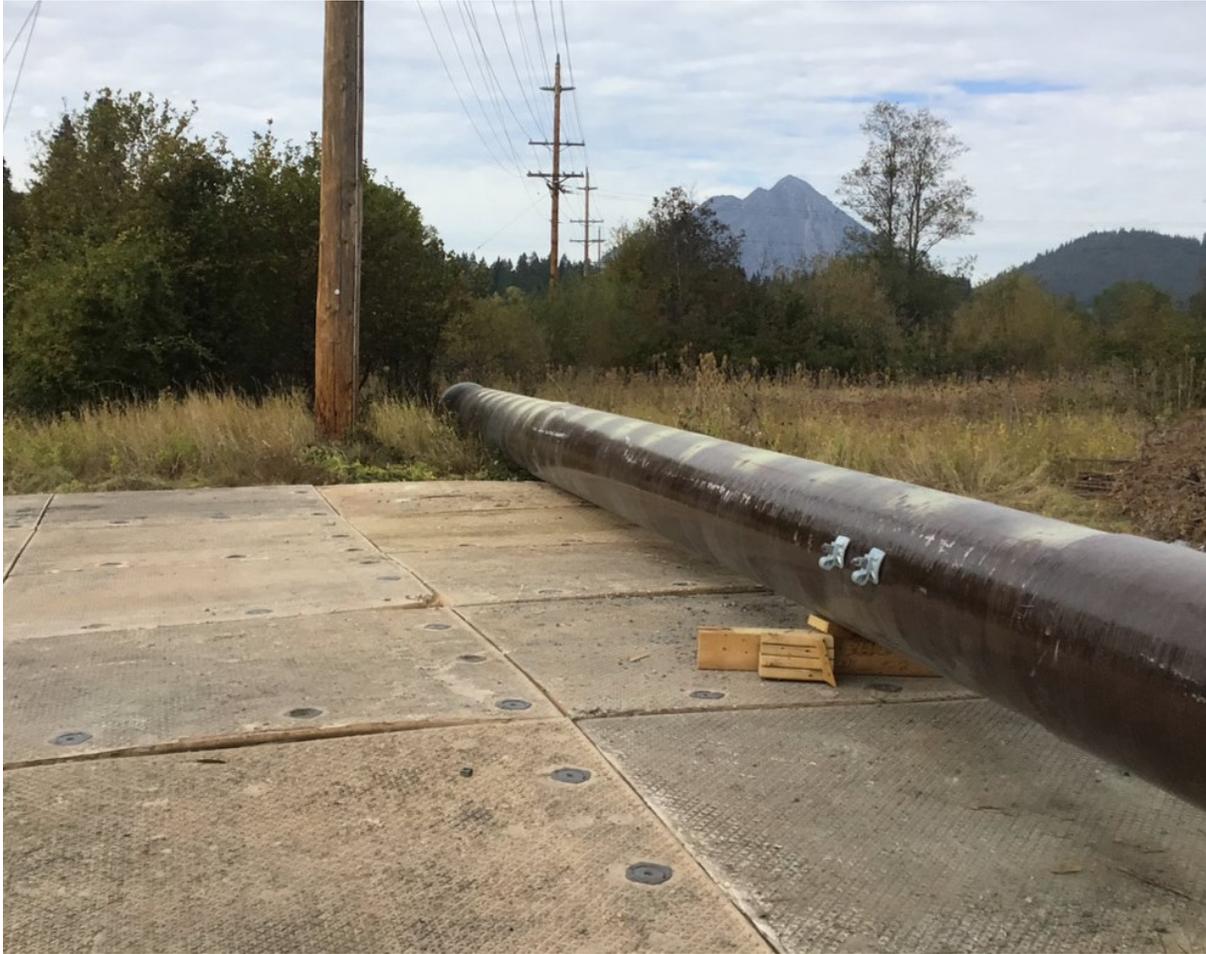
Photo 3: Pole staged at work area on mats near location 11/48.

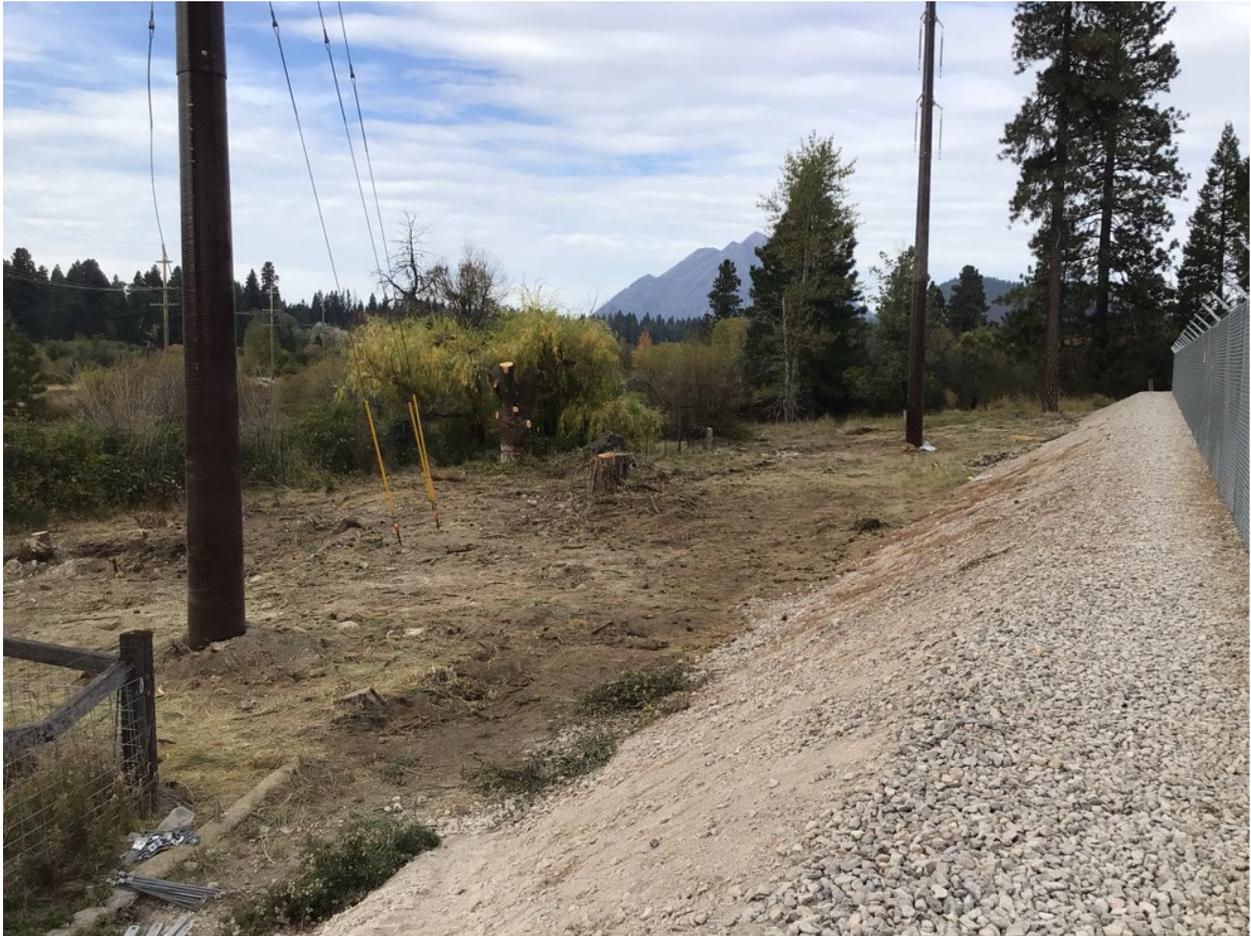
During inspection of the substation, fiber rolls were observed removed from line on west side of Lassen substation pad to accommodate installation of transmission poles between the Shasta and Lassen substations (see Photo 4—Attachment A). Observed dense ground vegetation between edge of finished pad and project boundary appeared to be capable of filtering sediment from runoff, however, the EM communicated that inspection during/after rain events will occur and contractor will be instructed to install Stormwater Pollution Prevention Plan (SWPPP) best management practices (BMPs) if any problems with runoff are observed. Restoration work was observed north of the substation project area per APM-WQ-2 (see Photo 5—Attachment A).

Photo 4: West side of substation pad area between Shasta and Lassen substations. SWPPP BMPs (fiber rolls) have been removed.

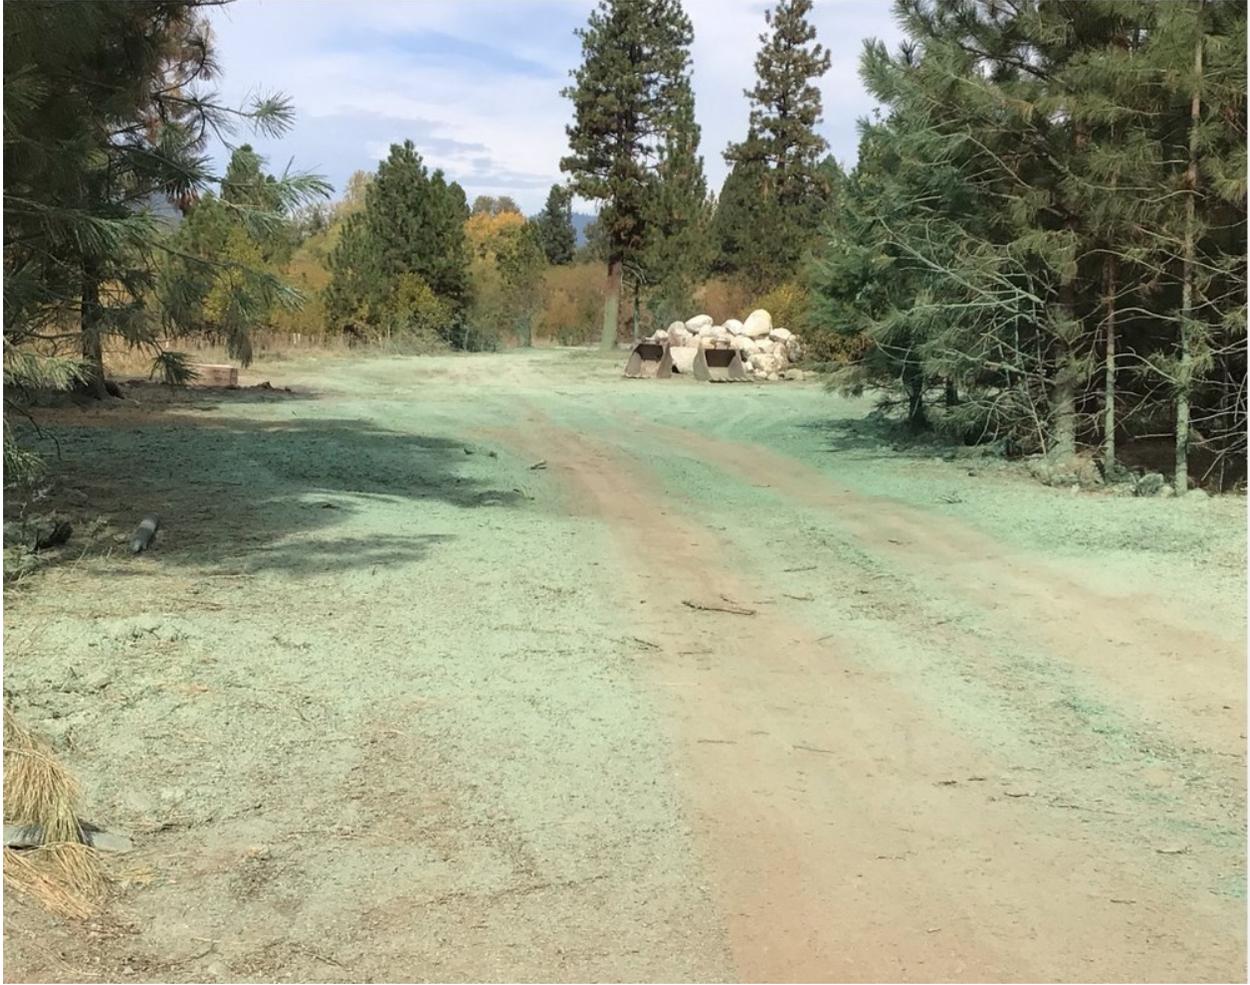
Photo 5: Restoration north of Lassen Substation.
