<p><b>California Public Utilities Commission</b> <b><i>Mitigation Monitoring, Compliance, and Reporting Program</i></b></p>
	<p><b>Tie Line (TL) 637 Wood-to-Steel Pole Replacement Project</b></p> <p><b>Compliance Status Report: 010</b></p> <p><b>July 6, 2014</b></p>

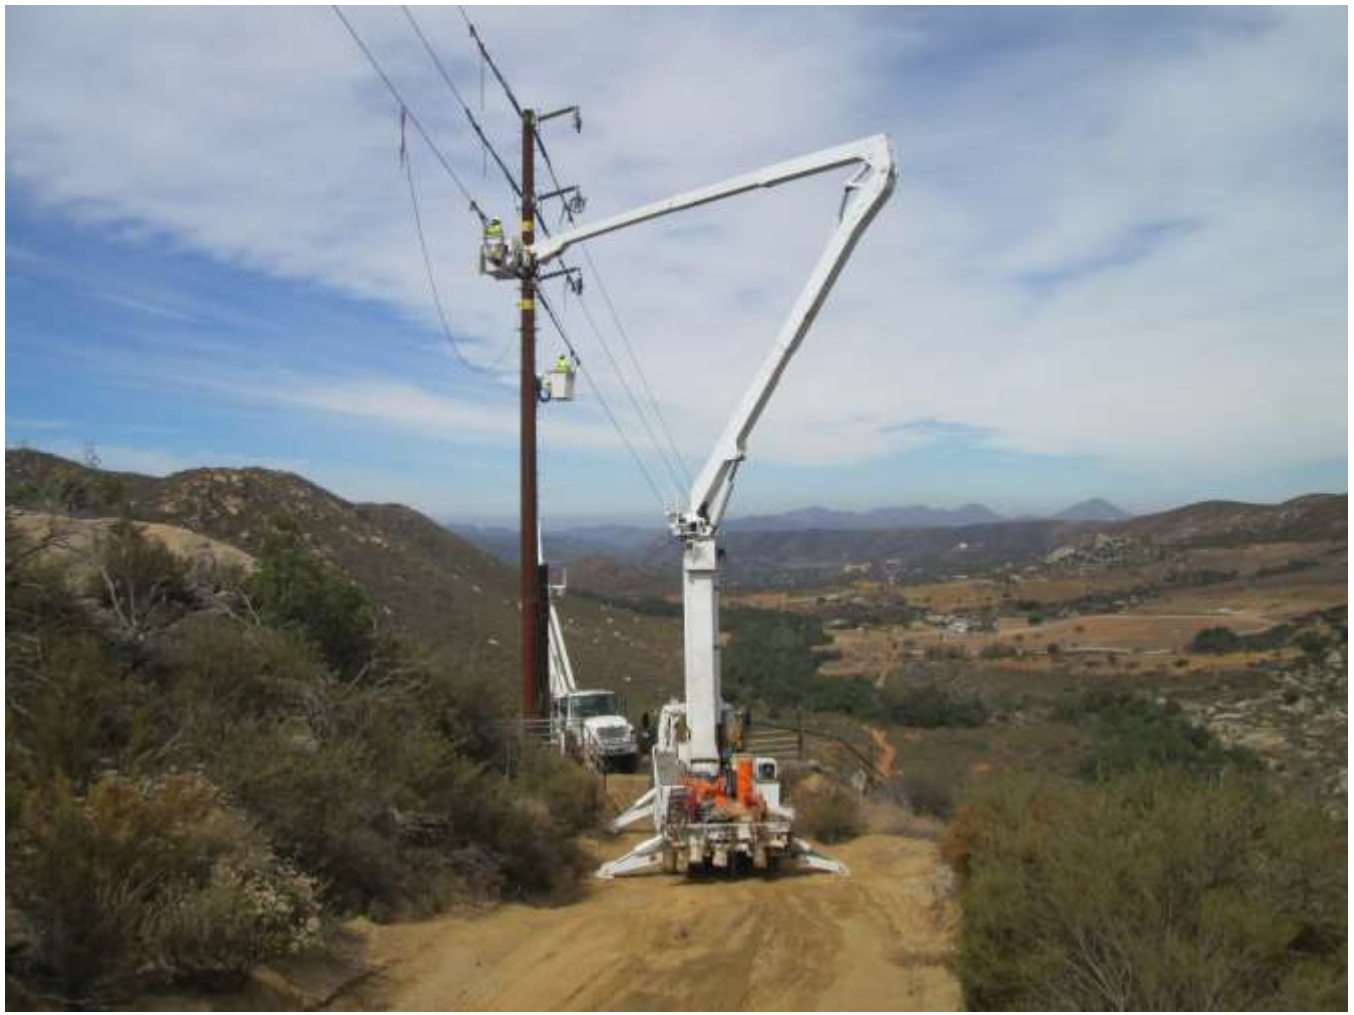
Construction crews were observed stringing, sagging, clipping-in (see Photo 1—Attachment A), and dead-ending conductor wire, and pulling ropes.

**Photo 1:** Construction crews were observed conducting wire stringing activities, which included dead-ending and sagging the wire (pictured above). Crews were observed staying on existing approved roads for this activity.

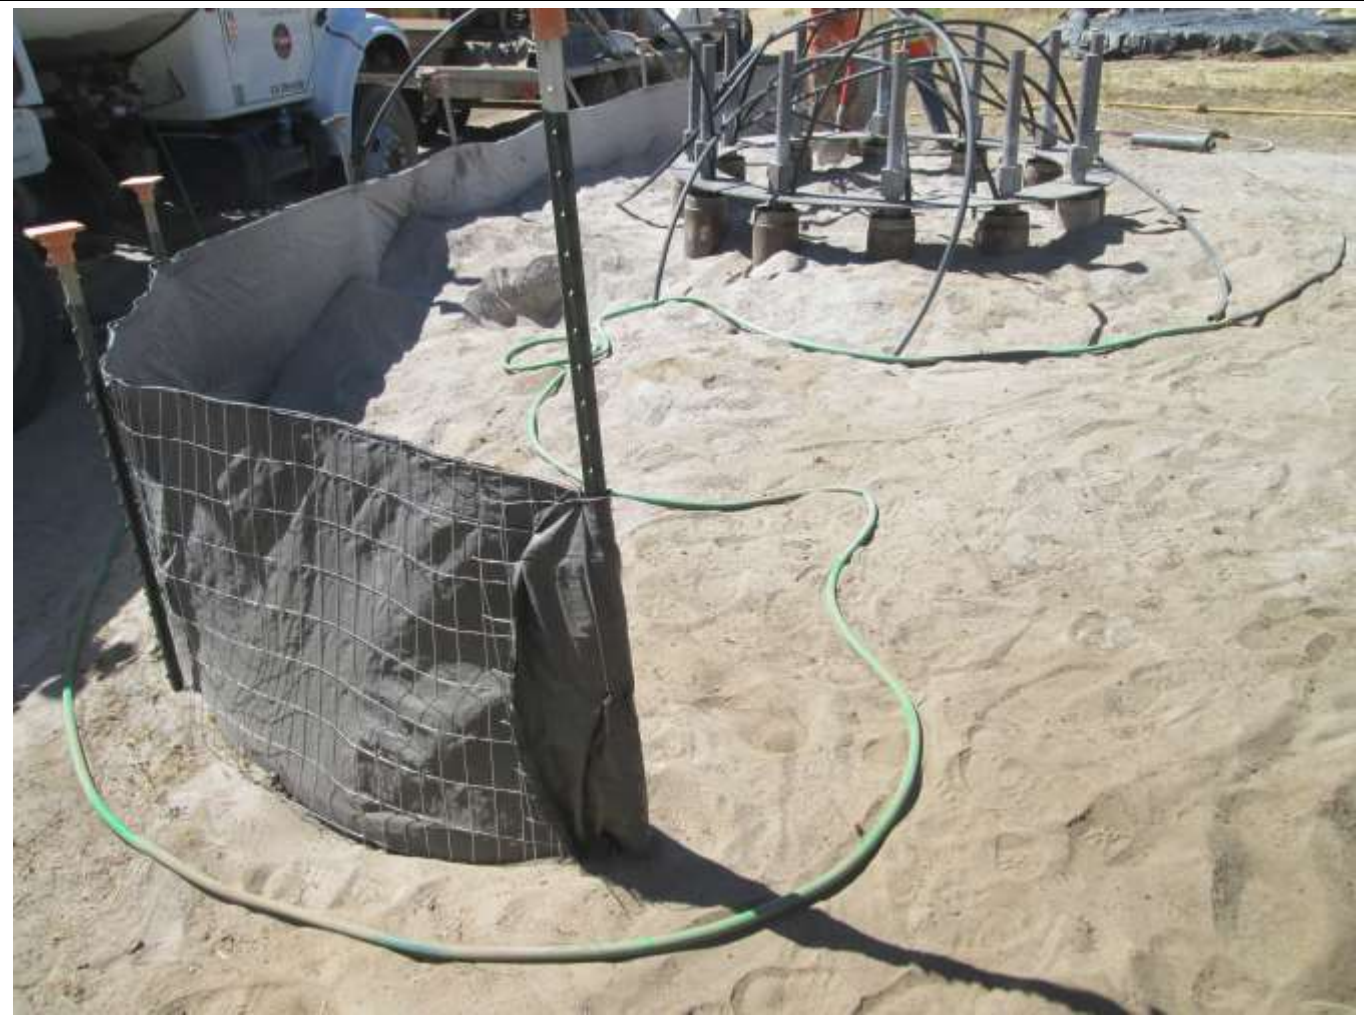
At micropile drill sites, construction crews were observed mobilizing/setting-up at pole locations, drilling, grouting (see Photos 2 and 3—Attachment A), and strength testing micro pile foundations. Crews were also observed de-mobilizing foundation equipment and preparing for pole erection (see Photo 4—Attachment A).

**Photo 2:** During grouting activities at micropile pole locations, silt fencing was observed utilized and intact/containing sediment in accordance with the project SWPPP.

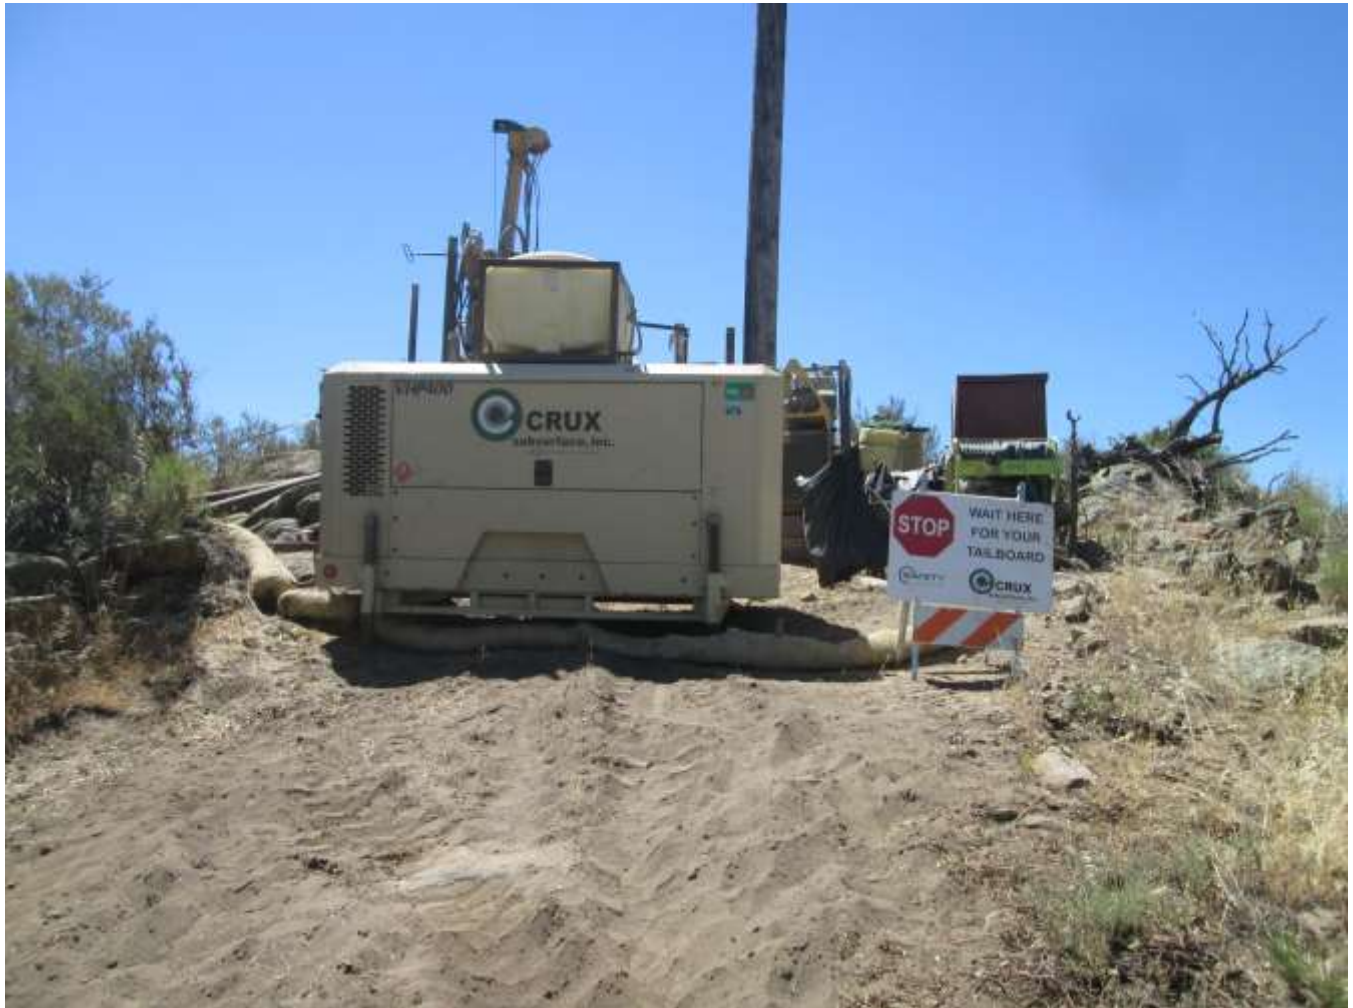
**Photo 3:** During micropile activities, erosion control features such as straw wattles were installed around project equipment and remained in-tact. Signage reminding crews of additional safety requirements (briefings) prior to entering the work area was observed at the edge of work limits.

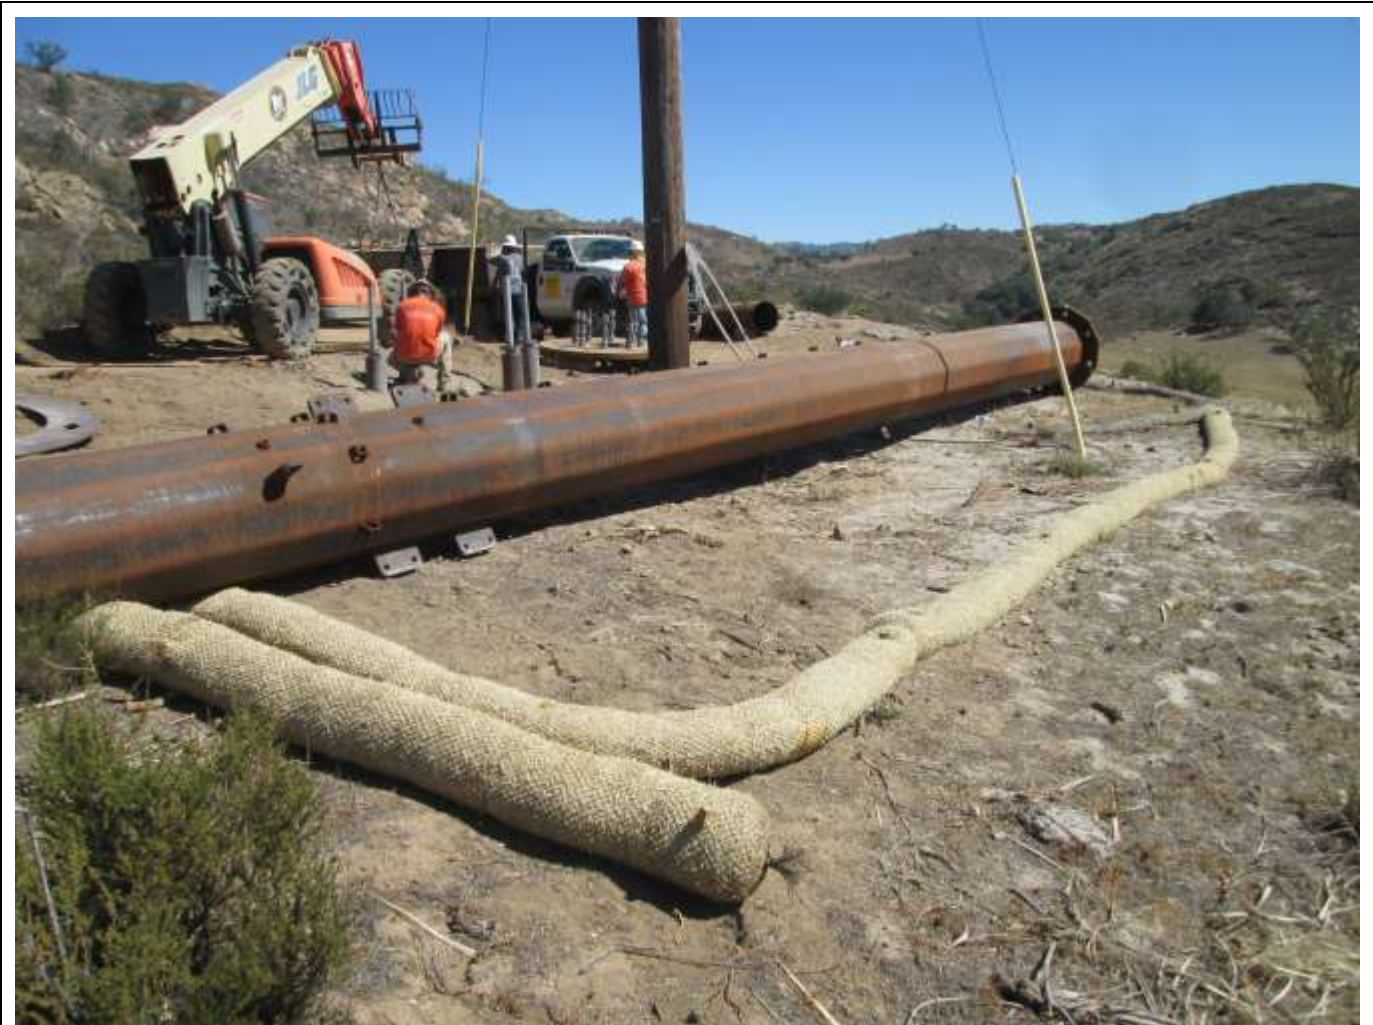
**Photo 4:** Crews were observed de-mobilizing micropile foundation equipment once foundations were completed and steel poles were staged at pole replacement locations. Erosion control features such as straw wattles (pictured above) remained in-tact and were observed being inspected by aquatic monitors (APM HYD-4).

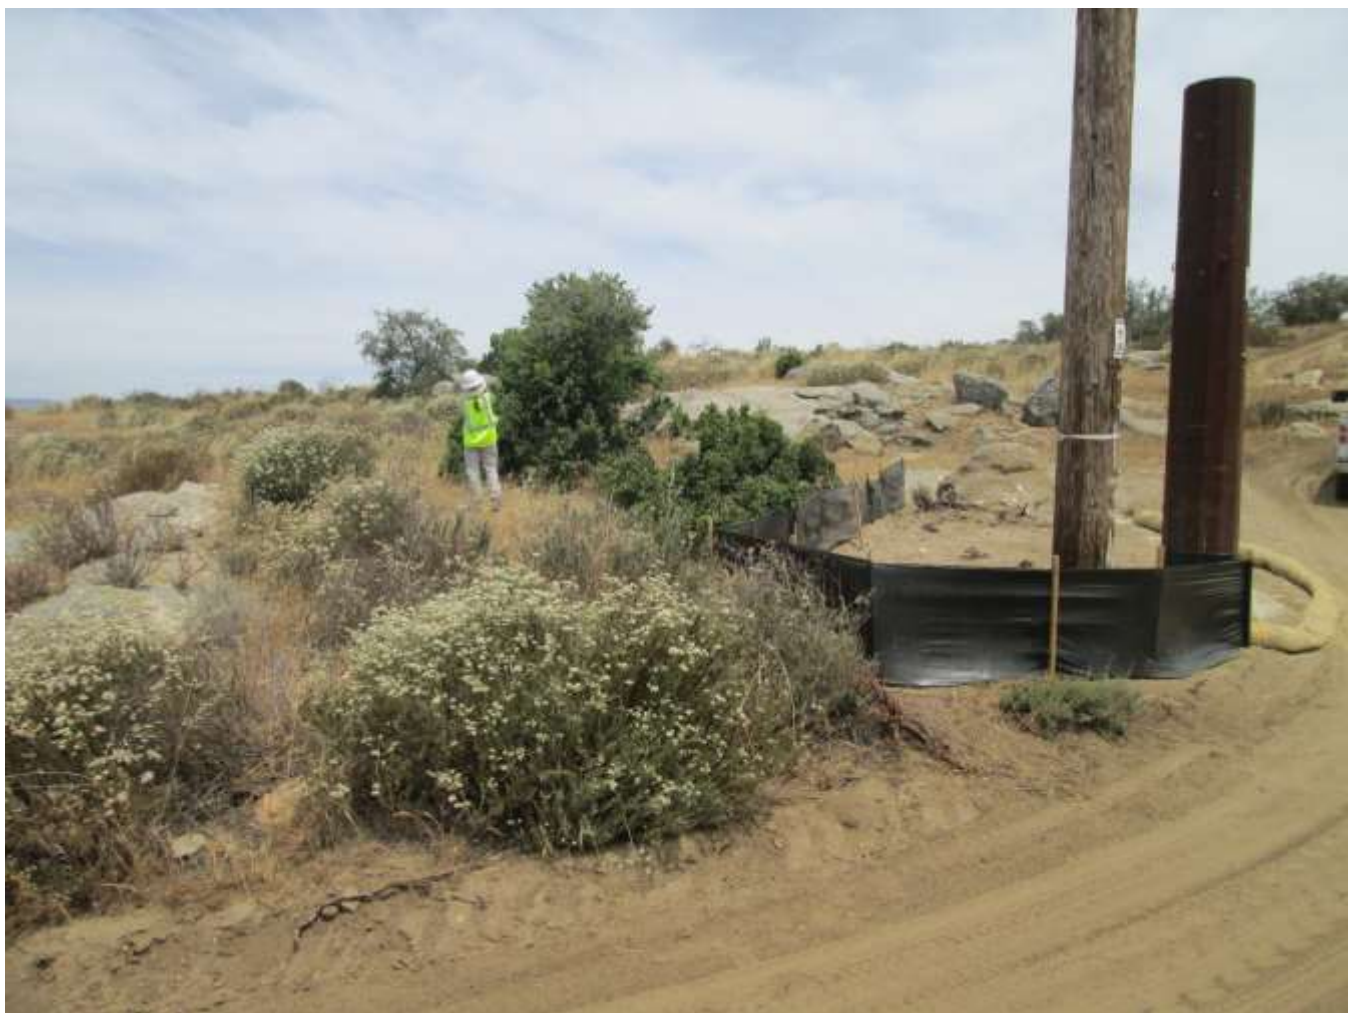
**Photo 5:** Biological monitors were observed surveying for nesting bird activity prior to work activities in accordance with MM BIO-4.

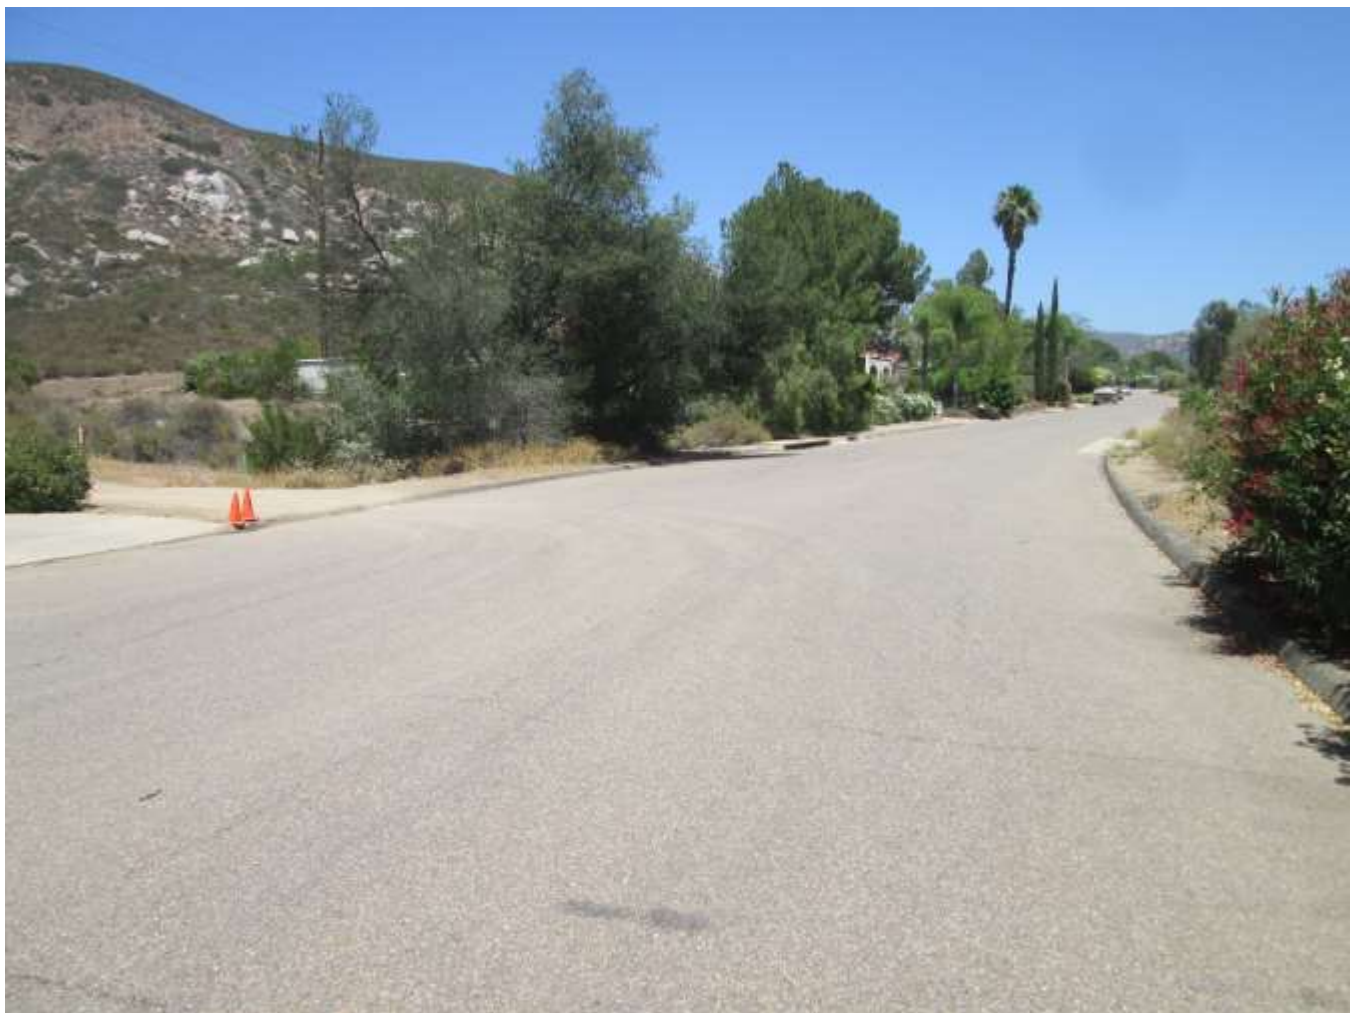
**Photo 6:** Access roads intersecting with paved community access roads were observed to be free of sediment track- out.

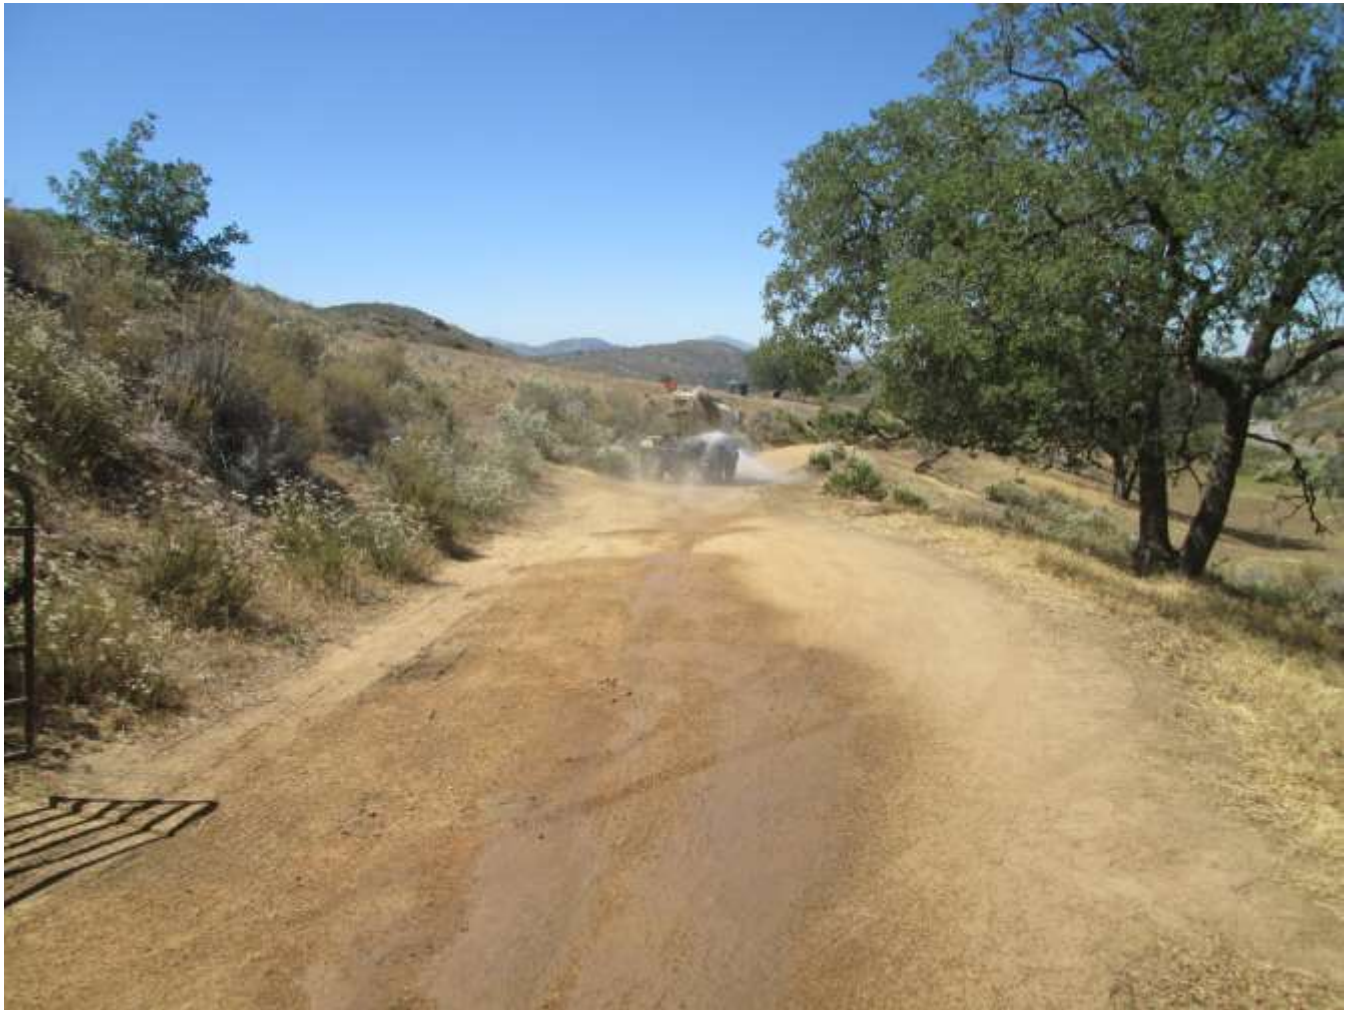
In accordance with the project Storm Water Pollution Prevention Plan (SWPPP) (a requirement of APM HYD-1), SDG&E was observed implementing construction Best Management Practices (BMPs) to reduce potential impacts to water quality (see Photos 2 through 6—Attachment A). No spills, leaks, or discharges were observed during the reporting period. Sediment control BMPs such as straw wattles and silt fencing were observed being maintained at work locations, and dirt spoil piles continued to be covered with visqueen to prevent erosion. Track-out was not observed to be an issue at intersections of unpaved and paved roadways, including points of ingress/egress to the laydown yards, communities with paved roads (see Photo 6—Attachment A), or along Highway 78. Rock aprons and street sweeping were observed in accordance with the project SWPPP. Crews were observed spraying unpaved access roads with water in order to ensure dust was minimized in accordance with APM BIO-1 (see Photo 7—Attachment A).

**Photo 7:** Project access roads were observed being watered in order to prevent fugitive dust in accordance with APM BIO-1.

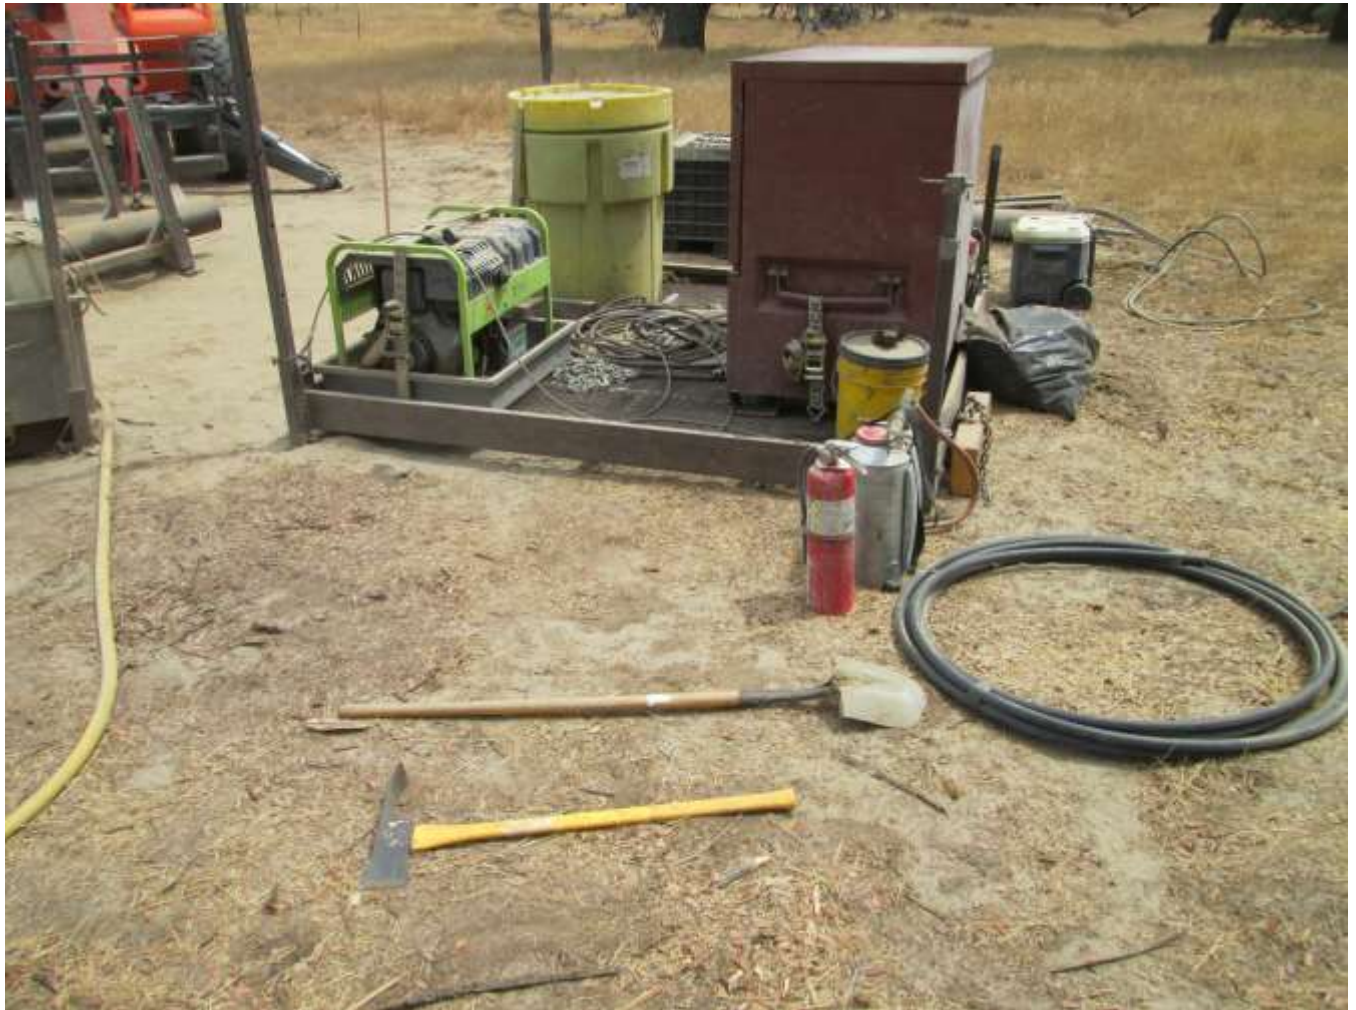
Fire risk was observed being minimized during project construction through the implementation of measures in the Project Fire Plan and APM HAZ-2. All crews were observed carrying fire suppression tools (pulaski, shovel, fire extinguisher, and 5-gallon water pumps) in vehicles and staging suppression tools at work locations (see Photo 8—Attachment A).

**Photo 8:** During micropile activities, in accordance with the Project Fire Plan and APM HAZ-2, fire suppression tools (Pulaski, shovel, fire extinguisher, and 5-gallon water pump) were observed staged at work locations. Secondary containment was observed staged under generators in accordance with the SWPPP.
