California Public Utilities Commission Mitigation Monitoring, Compliance, and Reporting Program

Tie Line (TL) 637 Wood-to-Steel Pole Replacement Project

Compliance Status Report: 011

July 20, 2014

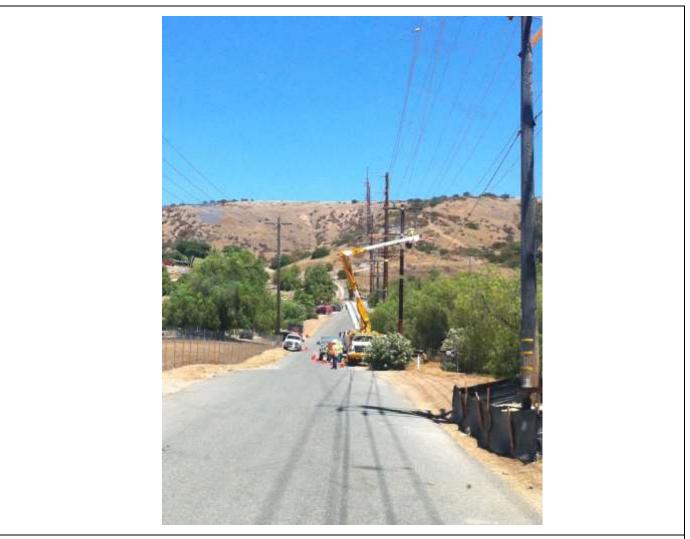
Overhead wire activities such as installing in-line disconnects (see Photo 1—Attachment A) continued along Creelman Lane this reporting period. During these activities, construction crews were observed utilizing traffic control measures around work areas including signage, flags, cones and traffic directors in accordance with APM TRA-1.

Photo 1: Construction crews were observed conducting overhead wire activities along Creelman Lane, which included installing in-line disconnects (pictured above). Traffic control measures including signage, flags, cones and traffic directors were implemented around work areas in accordance with APM TRA-1.

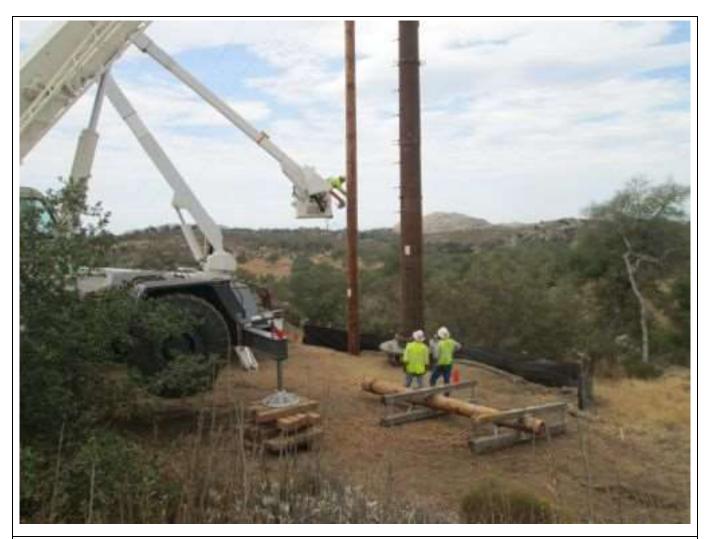
Crews were observed setting or transferring bases/tops, installing hardware, removing poles from service (see Photo 2—Attachment A), framing 12kV cross arms, re-framing structures, installing ground rods, and removing pole butts.

Photo 2: Crews were observed removing older wooden poles from service (left pole).

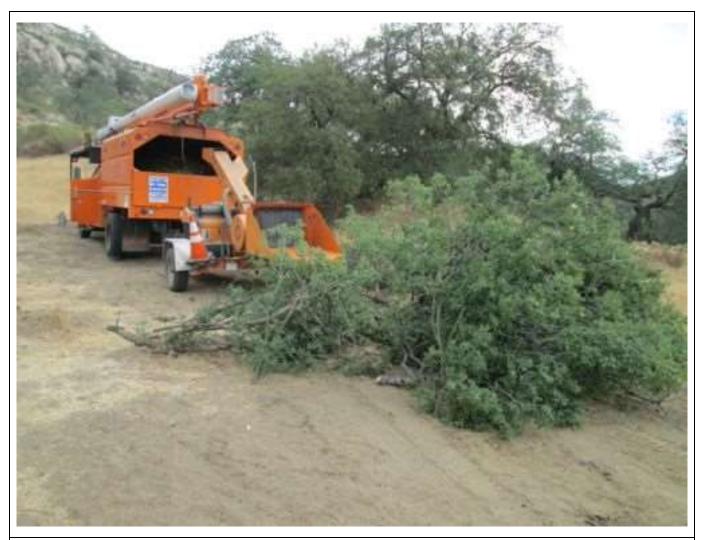
Construction crews were observed trimming vegetation along overland travel paths and trimming trees under portions of the tie- line (see Photo 3—Attachment A) and inspecting/maintaining BMPs.

Photo 3: Tree trimming crews were observed trimming trees between P151 and P152 beneath the tieline alignment. Biological monitors were on-site during these activities in accordance with MM-BIO-2.

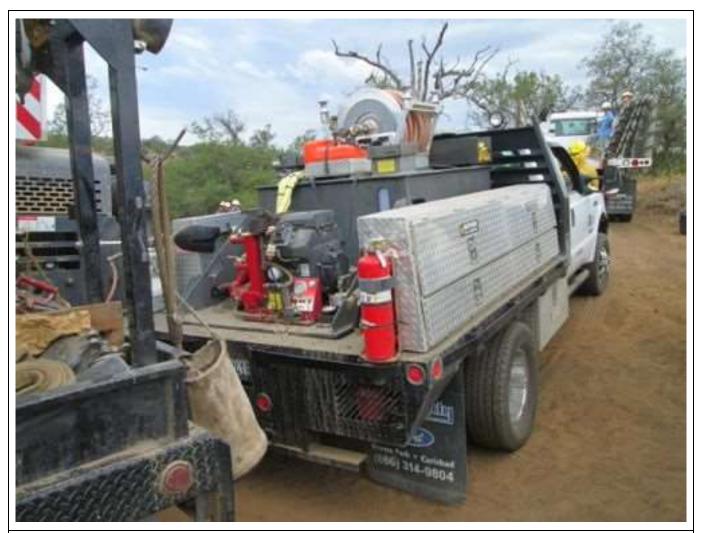
Photo 4: During micropile activities, in accordance with the Project Fire Plan and APM HAZ-2, fire suppression tools (pulaski, shovel, fire extinguisher, and 5-gallon water pump) were observed staged at work locations and carried within project vehicles. "Fire watch" individuals and response vehicles (such as a Type 6 fire engine, above) were designated and mobilized for project activities along the right-of-way.

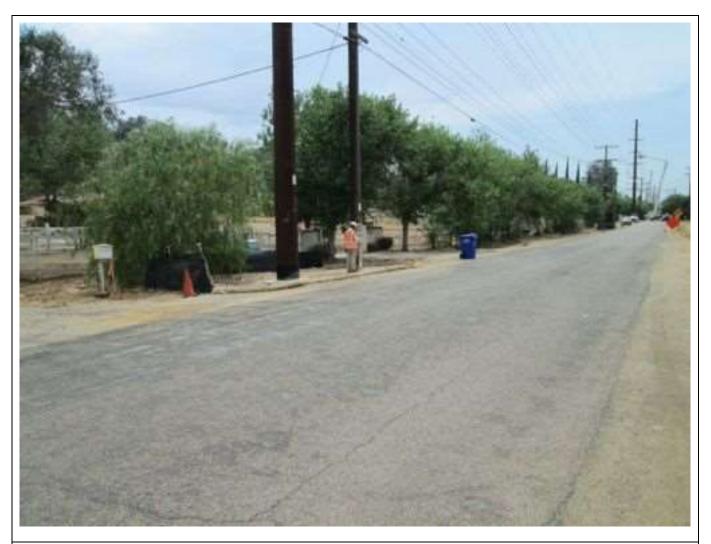
Photo 5: Biological monitors were observed conducting nesting bird surveys prior to work activities in accordance with MM BIO-4.

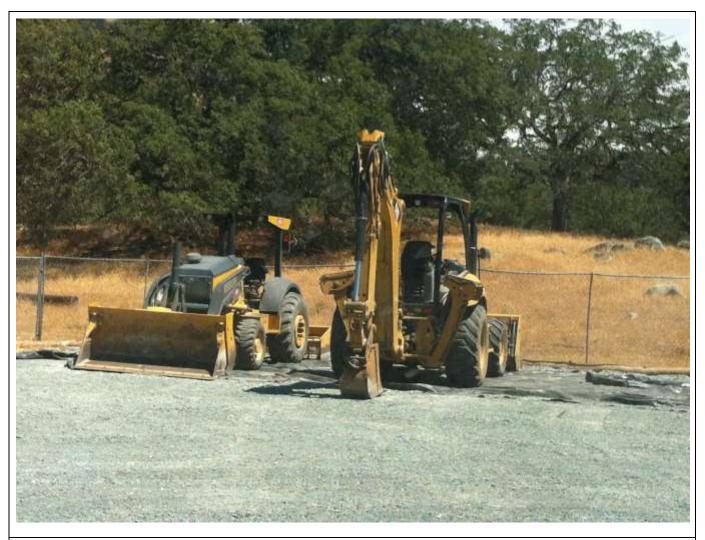
Photo 6: Visqueen was staged under equipment at the Santa Ysabel Yard in order to prevent any potential equipment leaks from contaminating soils.

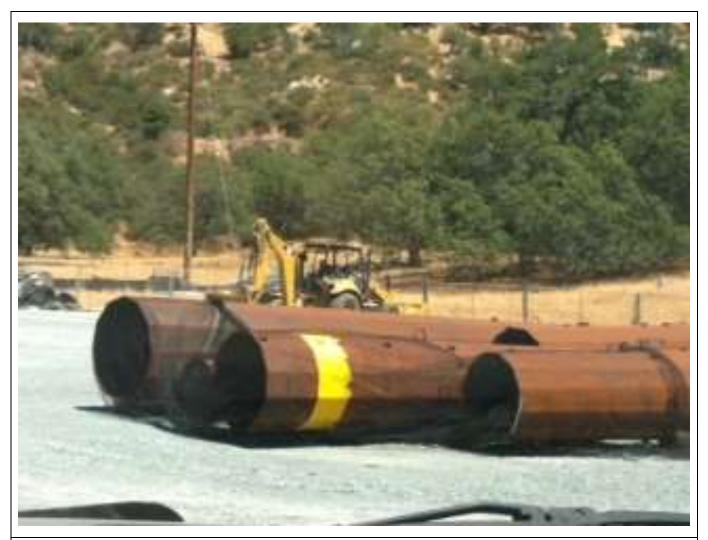
Photo 7: Netting was placed over openings of staged steel poles at the Santa Ysabel Yard in order to prevent nesting activity or wildlife entrapment.

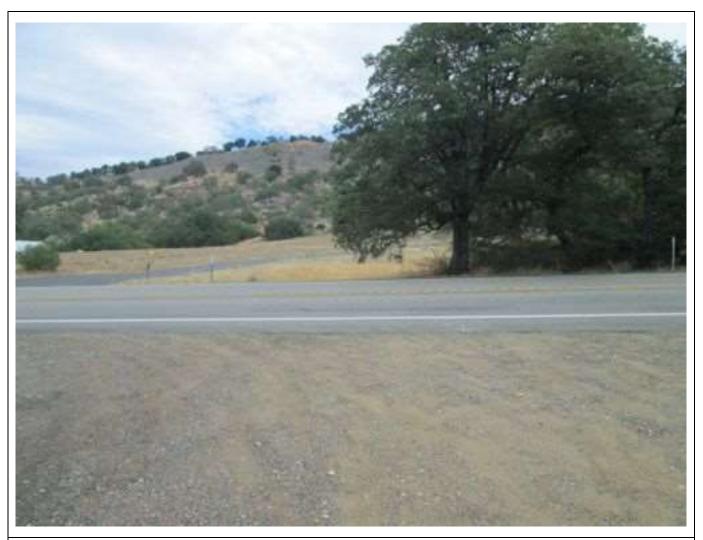
Photo 8: The intersection of a project access road and Highway 78 remained free of sediment track-out in accordance with the SWPPP.
