<b>California Public Utilities Commission</b> <b><i>Mitigation Monitoring, Compliance, and Reporting Program</i></b>
	<b>Tie Line (TL) 637 Wood-to-Steel Pole Replacement Project</b>
	<b>Compliance Status Report: 012</b>  <b>August 3, 2014</b>

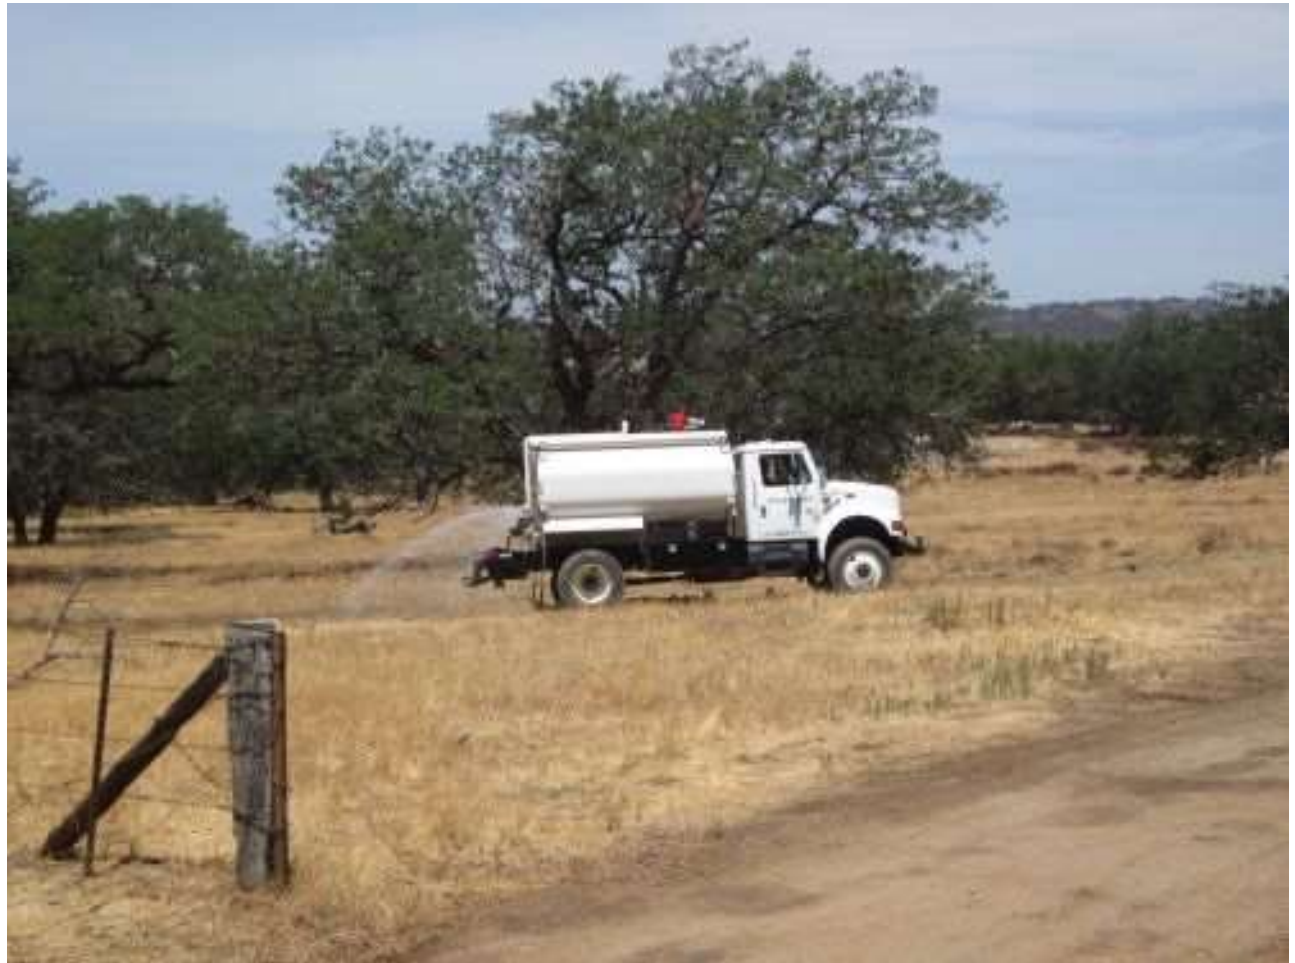
Throughout this reporting period, water trucks were observed applying water to access roads used for pole location access along the right of way in order to prevent fugitive dust in accordance with APM BIO-1 (See Photo 1—Attachment A).

**Photo 1:** Trucks were observed applying water along project access roads in order to prevent fugitive dust in accordance with APM BIO-1.

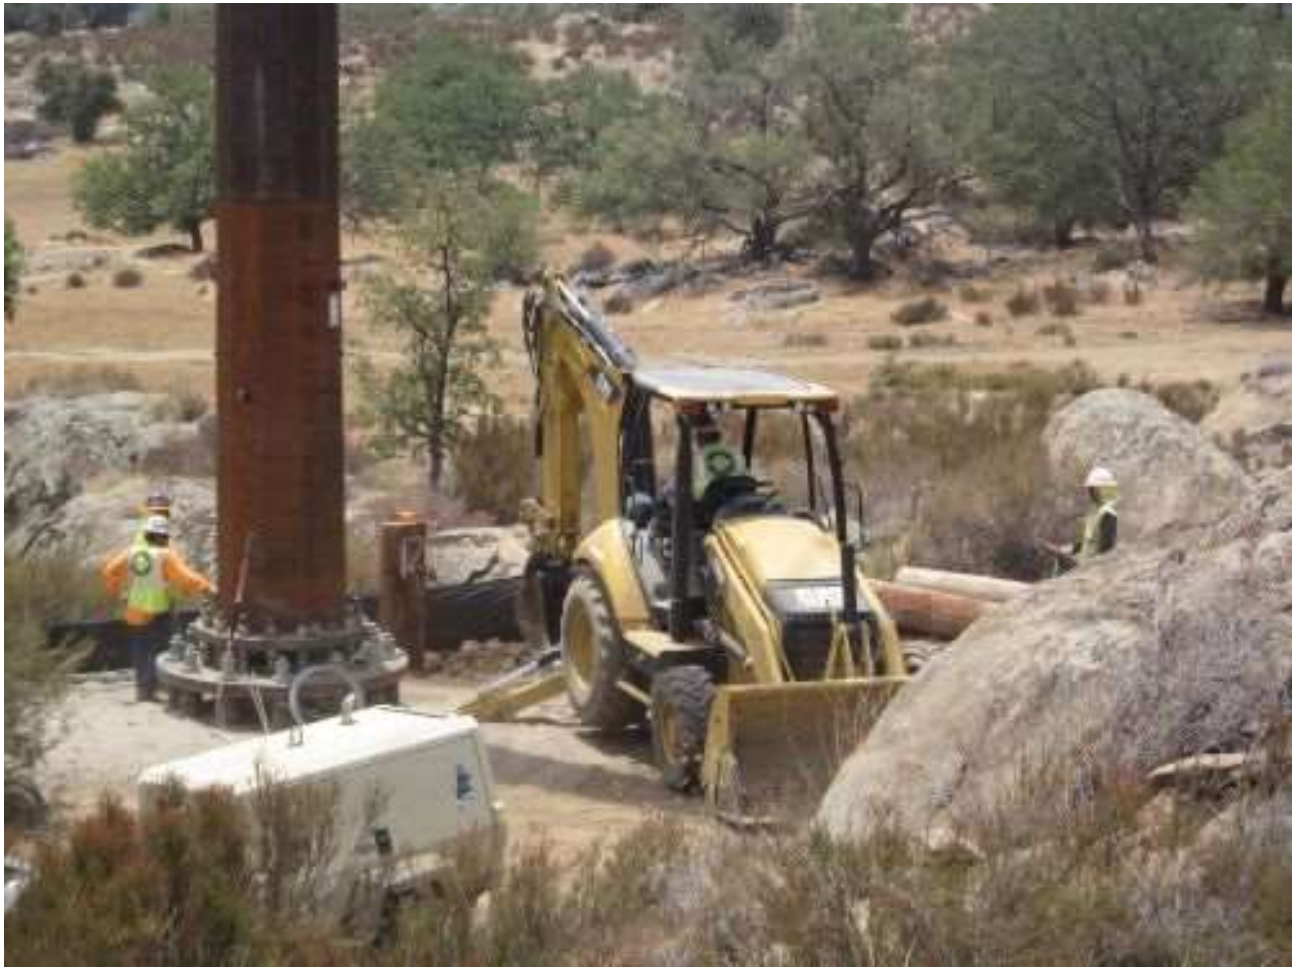
Crews were observed decommissioning wooden poles, removing pole butts and hauling waste materials off the project right of way (See Photos 2 and 3—Attachment A). Fire tools were observed in vehicles and staged in active work areas in accordance with the Project Fire Plan (APM HAZ-2). Erosion control devices were observed installed and intact at work sites in accordance with the project Storm Water Pollution Prevention Plan (SWPPP) BMPs (APM HYD-1), and waste material, such as debris and spoil, was hauled off the right of way in covered trucks in order to prevent sediment transport.

**Photo 2:** Crews were observed removing pole butts at Location 123 and hauling materials off site.

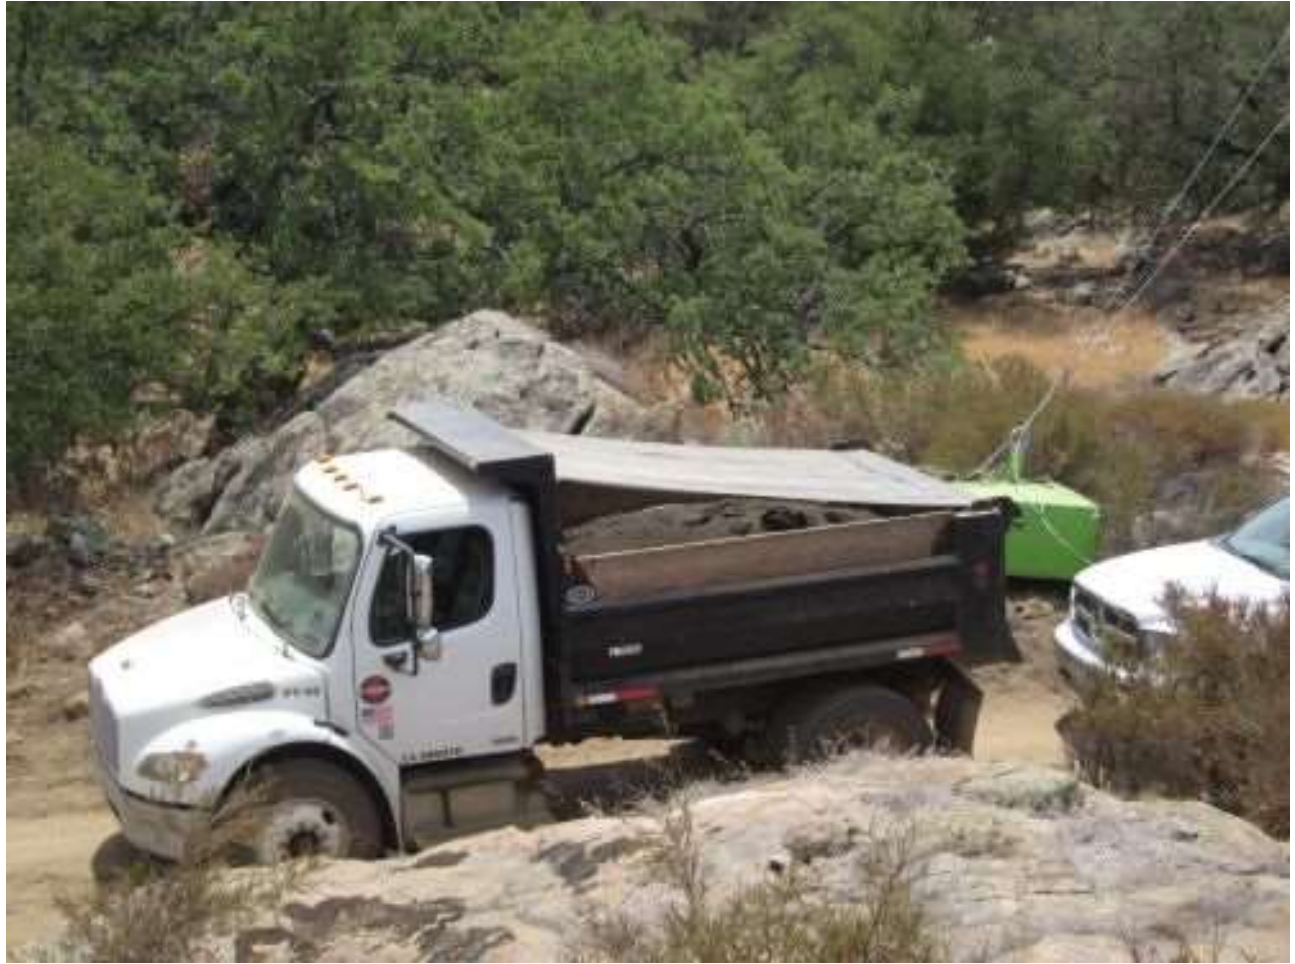
**Photo 3:** Loads of spoil and construction waste debris were observed covered when hauled off site in order to prevent sediment transport.

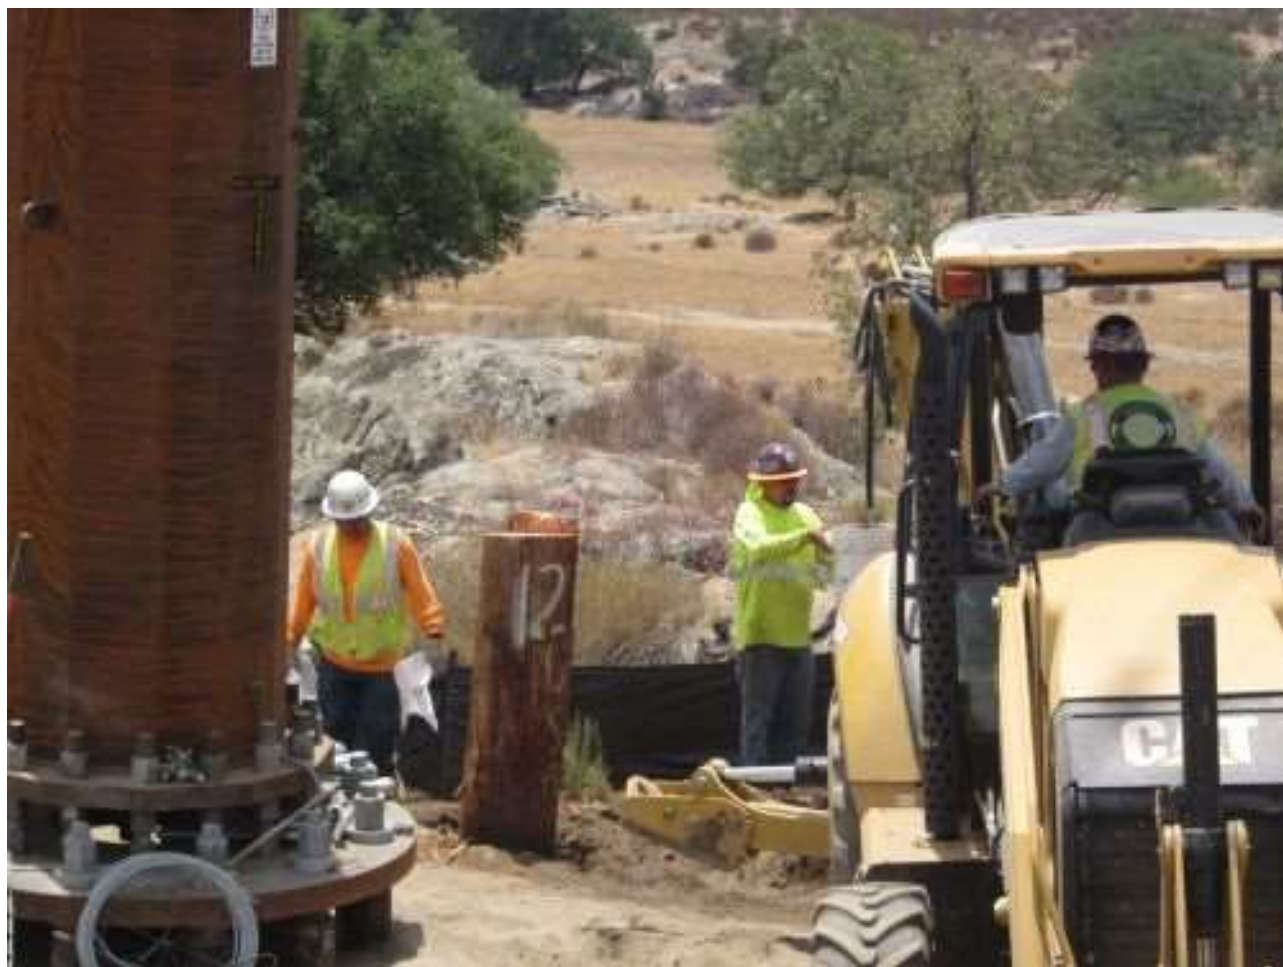
At one pole removal location, crews were observed stopping work due to a broken hydraulic hose on project equipment (backhoe) that was leaking hydraulic fluid. Crews and a biological monitor on site (in accordance with MM BIO-2) were observed cleaning up the leaking hydraulic fluid with a spill kit in accordance with MM HAZ-2 (See Photo 3—Attachment A). Work was observed suspended until the area was cleaned and the broken hose was fixed.

**Photo 4:** Crews were observed using a spill kit in accordance with MM HAZ-2 at Location 123 to clean up a hydraulic fluid leak resulting from a broken hose on a piece of equipment.

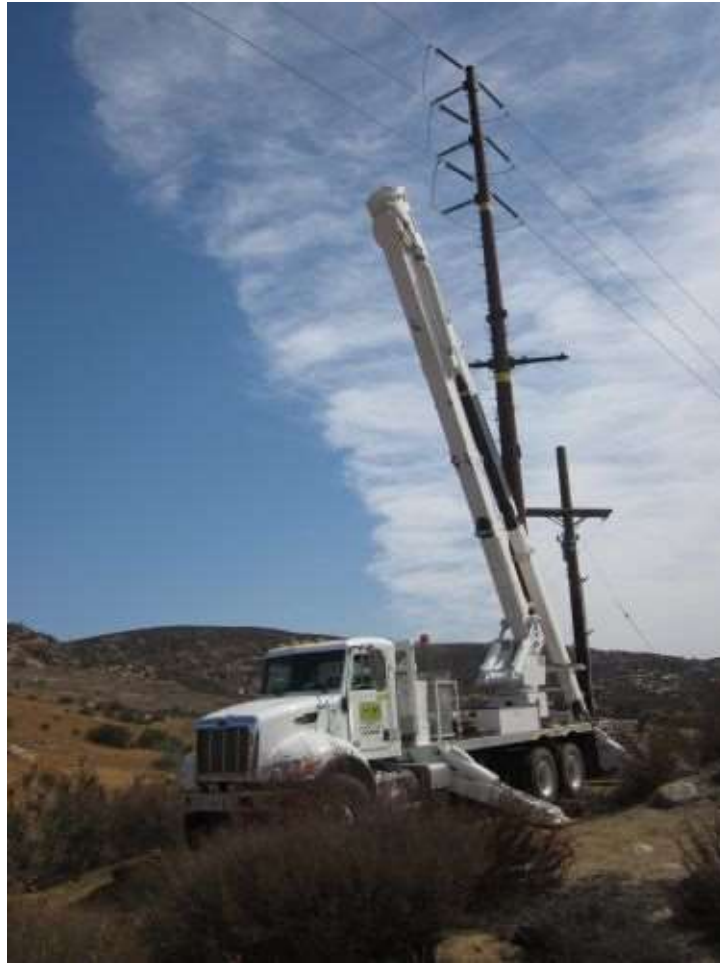
Biological monitoring crews were observed continuing to perform nesting bird surveys per MM BIO-4 requirements. Crews that were setting up work sites in preparation for installing davit arms at Location 71 (See Photo 5—Attachment A) were accompanied by biological monitors who were monitoring work activities and also spot checking adjacent sites where bird activity had been previously spotted in pole cavities. During davit arm installation, fire tools were observed staged on equipment (including a shovel, a 5-gallon water pump, fire extinguisher and pulaski) and “fire watch” was observed present in accordance with the Project Fire Plan (APM HAZ-2) (See Photo 6—Attachment A).

**Photo 5:** Construction crews were observed preparing to hang davit arms at Location 71.

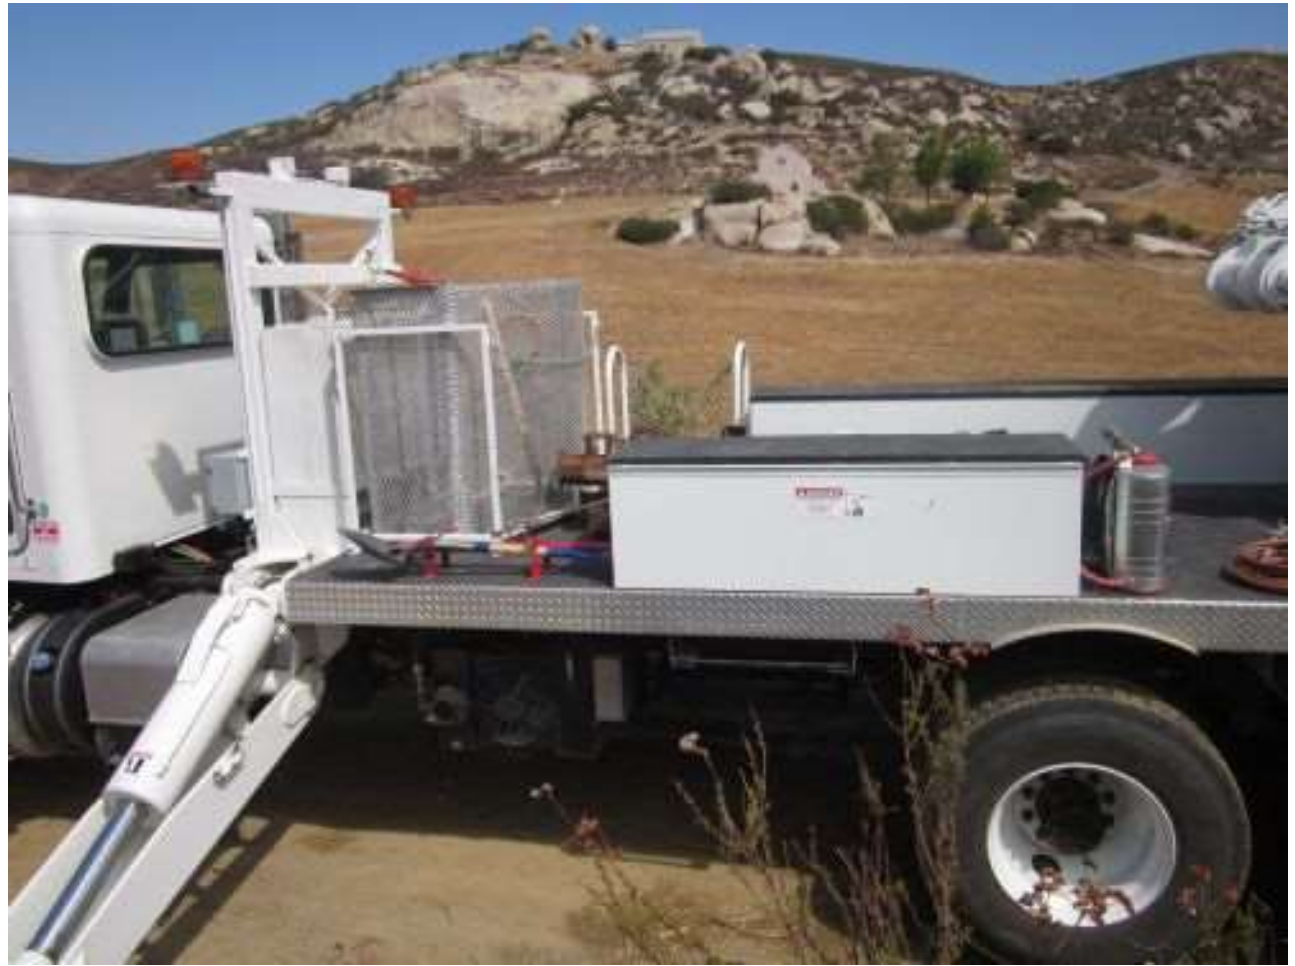
**Photo 6:** Fire tools (a shovel, a 5-gallon water pump, fire extinguisher, and pulaski) were observed staged in vehicles and “fire watch” was observed designated during overhead line work in accordance with the Project Fire Plan (APM HAZ-2).

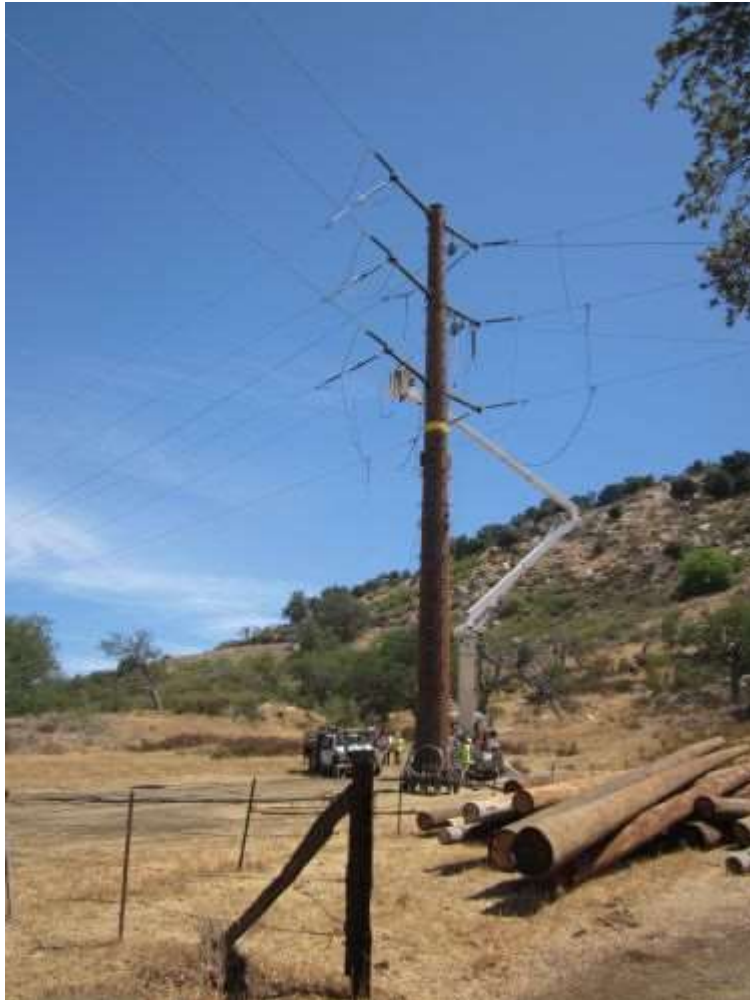
Traffic control measures in accordance with APM TRA-1 were observed being implemented near Locations 151-163 during wire pulling activities (See Photos 7 and 8—Attachment A). Traffic control, in the form of flaggers and cones, were in effect along Old Julian Highway. Fire tools were on site and “fire watch” was observed present at Location 151 in accordance with the Project Fire Plan (APM HAZ-

**Photo 7:** Between Locations 151 and 163, wire pulling for the 69kV line was observed.

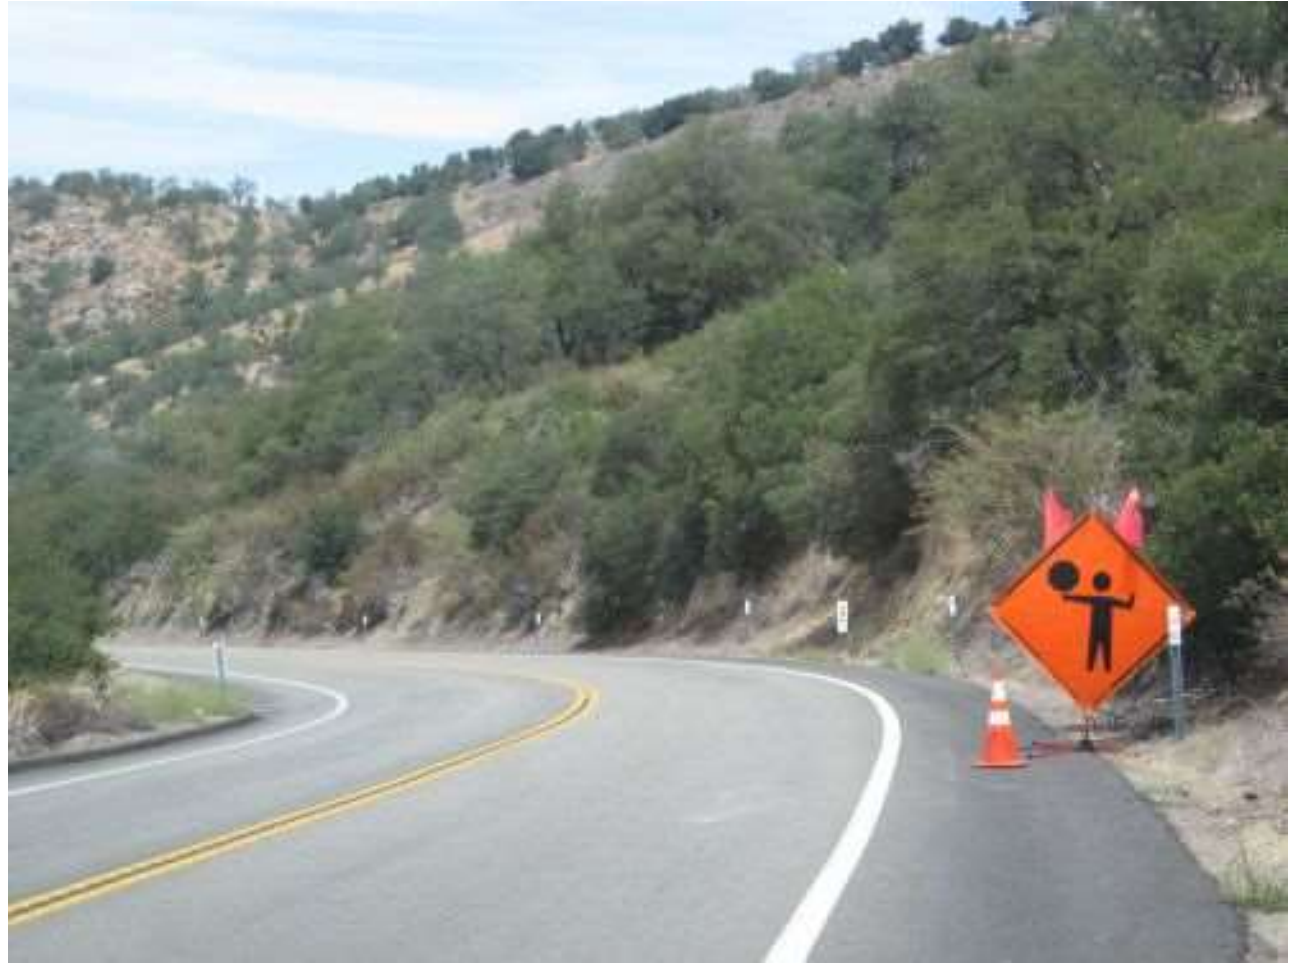
**Photo 8:** Traffic control measures were implemented along Old Julian Highway during wire pulling activities in accordance with APM TRA-1.
