<p>California Public Utilities Commission <i>Mitigation Monitoring, Compliance, and Reporting Program</i></p>
	<p>Tie Line (TL) 637 Wood-to-Steel Pole Replacement Project</p>
	<p>Compliance Status Report: 004 April 13, 2014</p>

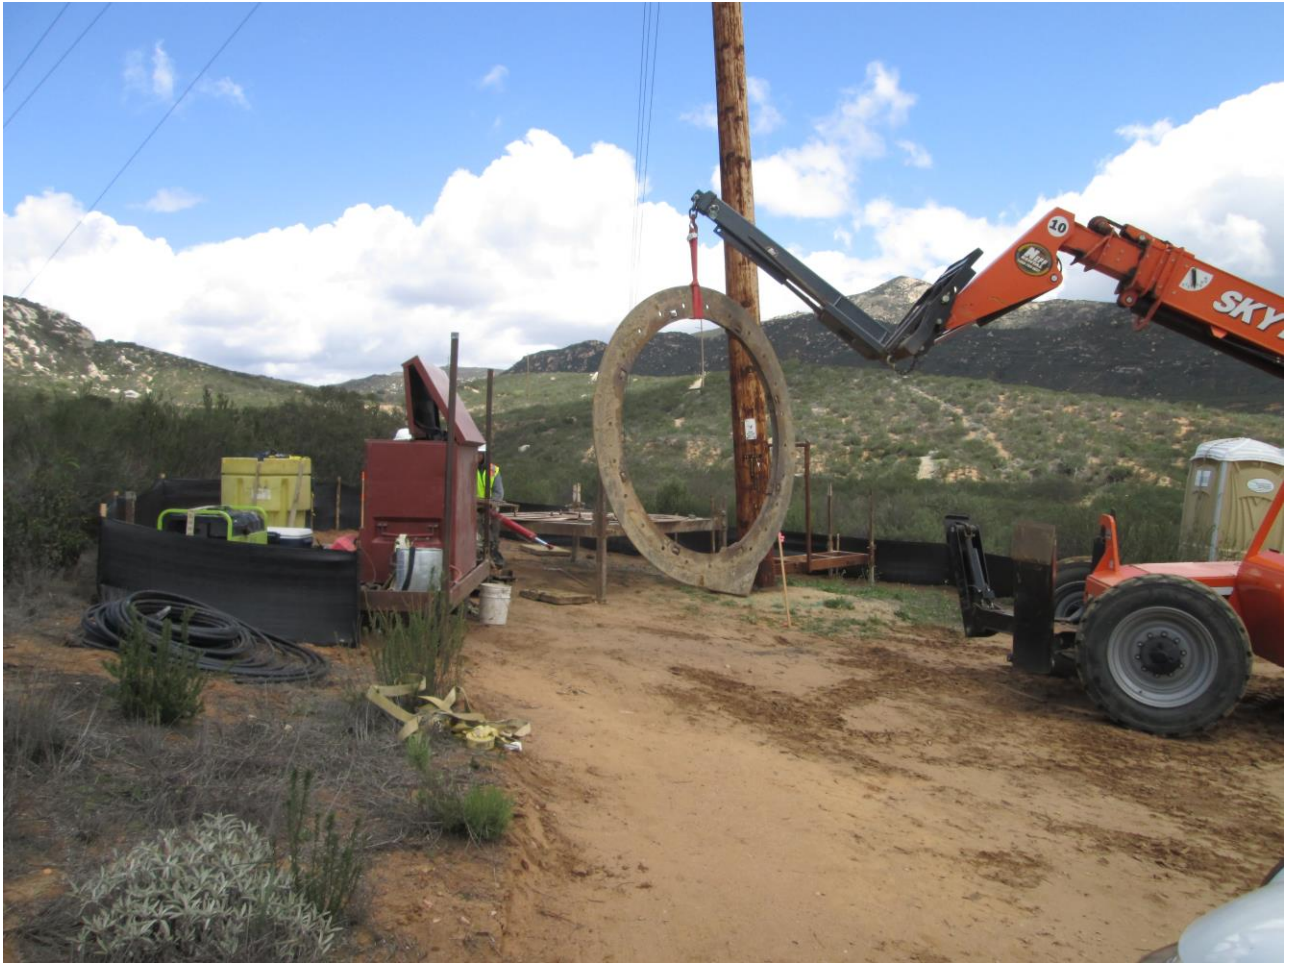
Crews were observed conducting the following activities associated with micro pile sites: setting up and demobilizing equipment at pole locations (see Photo 1—Attachment A), micropile drilling, micropile strength tests, grouting, and capping foundations (see Photo 2—Attachment A).

Photo 1: Crews were observed setting up drill platforms for micropile sites (Above, Location 30). Silt fencing was observed installed and intact in accordance with the Project SWPPP/APM HYD-1. Portable restrooms were observed staged on secondary containment in accordance the Project SWPPP.

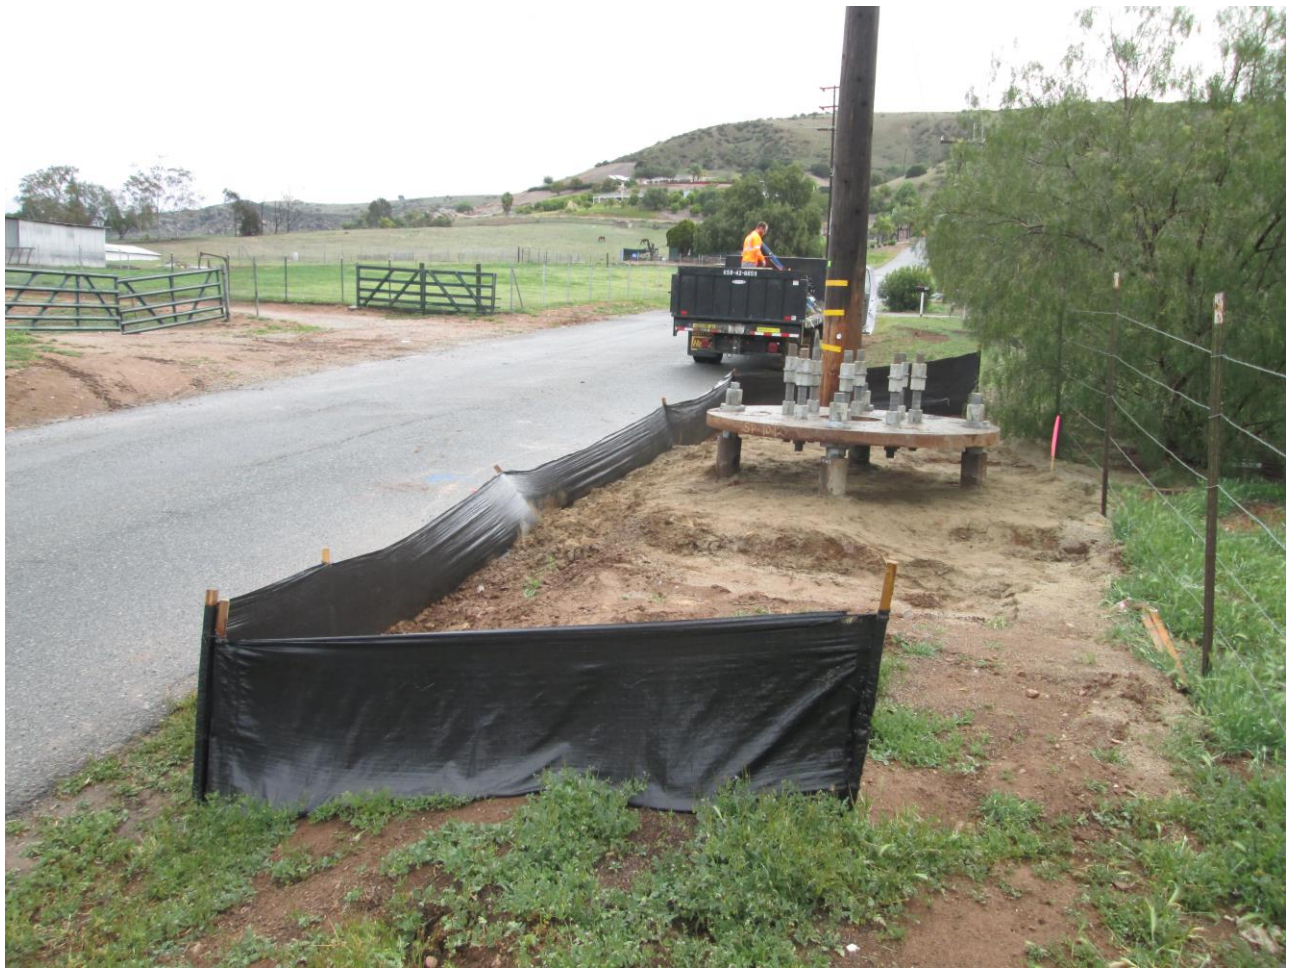
Photo 2: Finished/Capped Micro Pile foundation. Silt fencing was observed installed and intact in accordance with the Project SWPPP/APM HYD-1 and crews were observed cleaning all excess grout with shovels and buckets. Due to this location being situated near a jurisdictional waterway, an aquatic resource monitor was observed present during activities in accordance with MM HYD-4 and the Section 401 Certification.

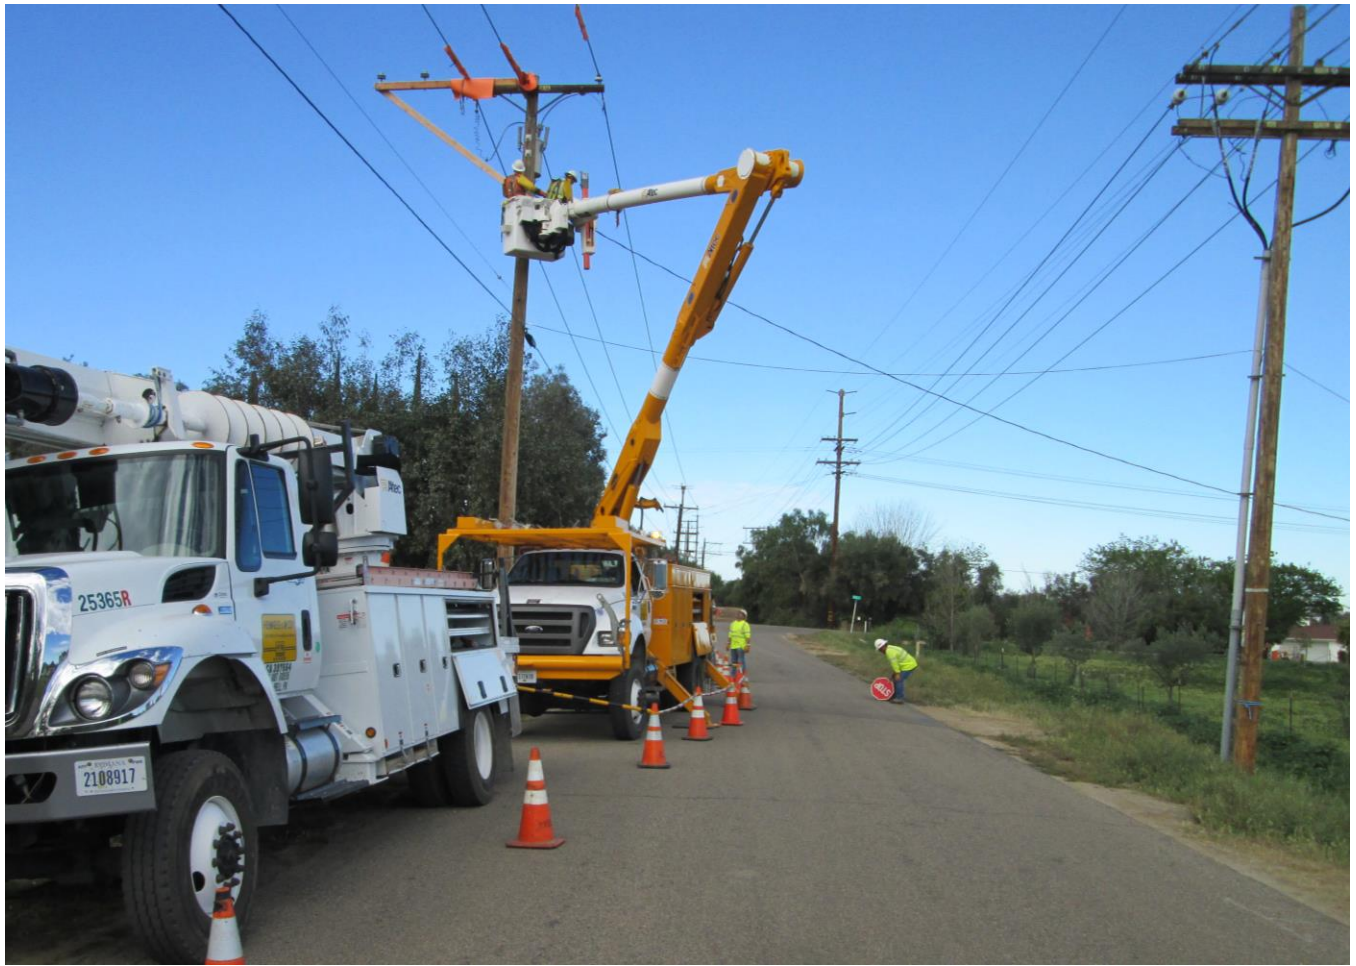
Crews were observed preparing for wire spreading and setting pole tops (see Photo 3—Attachment A), vegetation trimming (including tree trimming) along access roads and at pole locations sites (see Photo 4—Attachment A), compacting spoils on existing access roads, installing or maintaining BMPs at pole location sites (silt fencing, straw wattles, covering and securing spoils with visqueen, etc.), and refreshing access roads.

Third-party monitors observed crews preparing poles for wire spreading along Creelman Lane this reporting period. In accordance with APM TRA-1, flaggers and signage were utilized to direct traffic around equipment partially impeding road access.

Photo 3: Traffic Control along Creelman Lane was observed being implemented in accordance with MM TRA-1 during pole topping/ wire spreading activities.

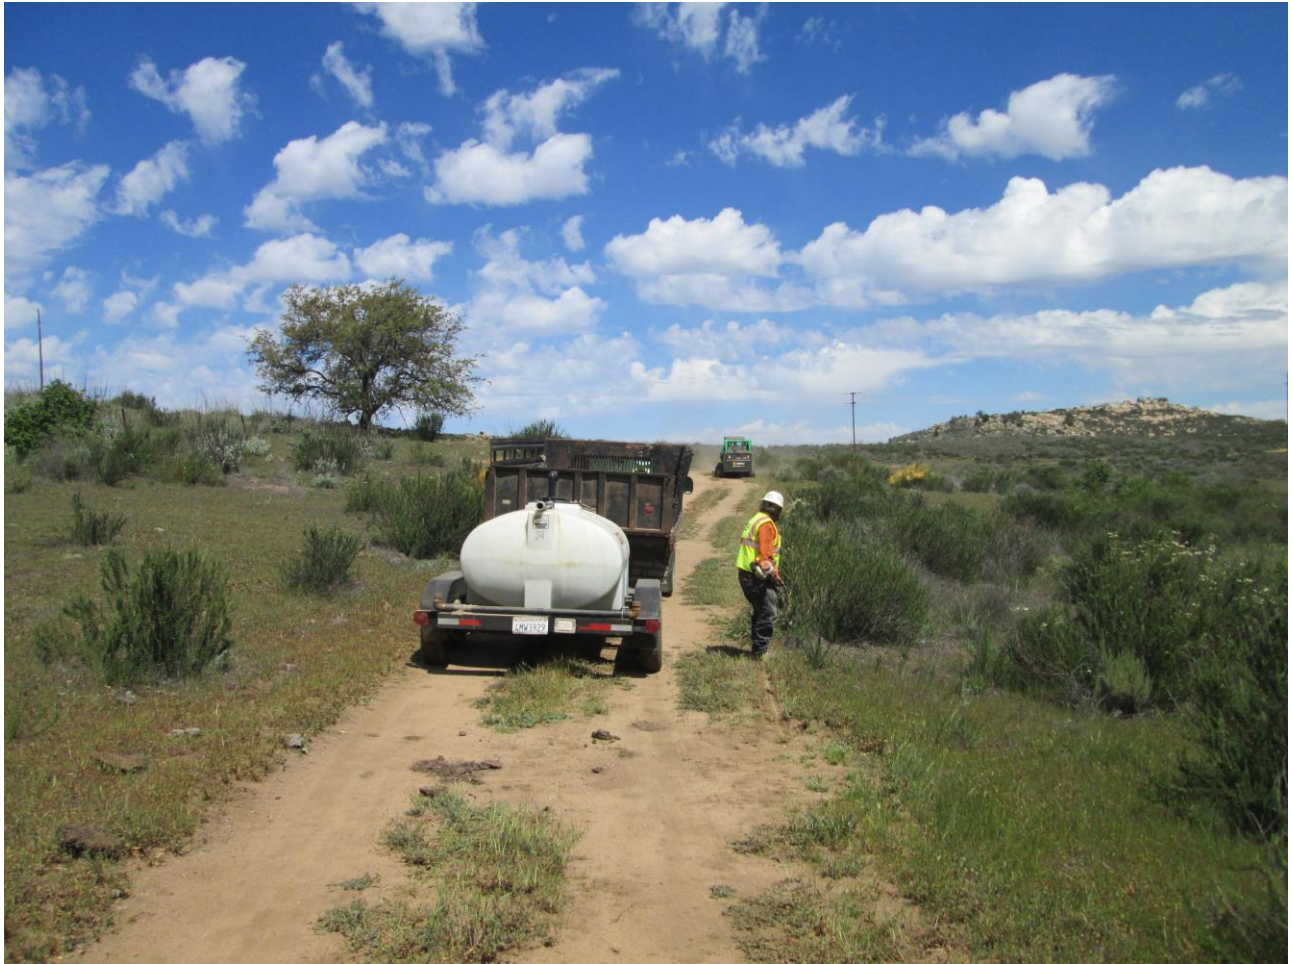
In order to minimize fire risk during pole replacement activities or travel on access roads, crews were observed hauling water buffalos behind vegetation disposal equipment during vegetation trimming activities (see Photo 4—Attachment A) and with traditional pole hole auguring equipment (see Photo 5—Attachment A) in accordance with the project Fire Plan (Applicant Proposed Measure (APM) HAZ-2). Several fire extinguishers were observed at pole location sites during drilling, where equipment with internal combustion engines were used and other equipment such as backpack pumps and shovels were observed mounted on vehicles and/or available at each work site.

Photo 4: Mowing and vegetation trimming was observed along access roads. Crews were observed towing a water buffalo behind vegetation containment equipment to ensure fire prevention measures were being adhered to in accordance with the Project Fire Plan/APM HAZ-2.

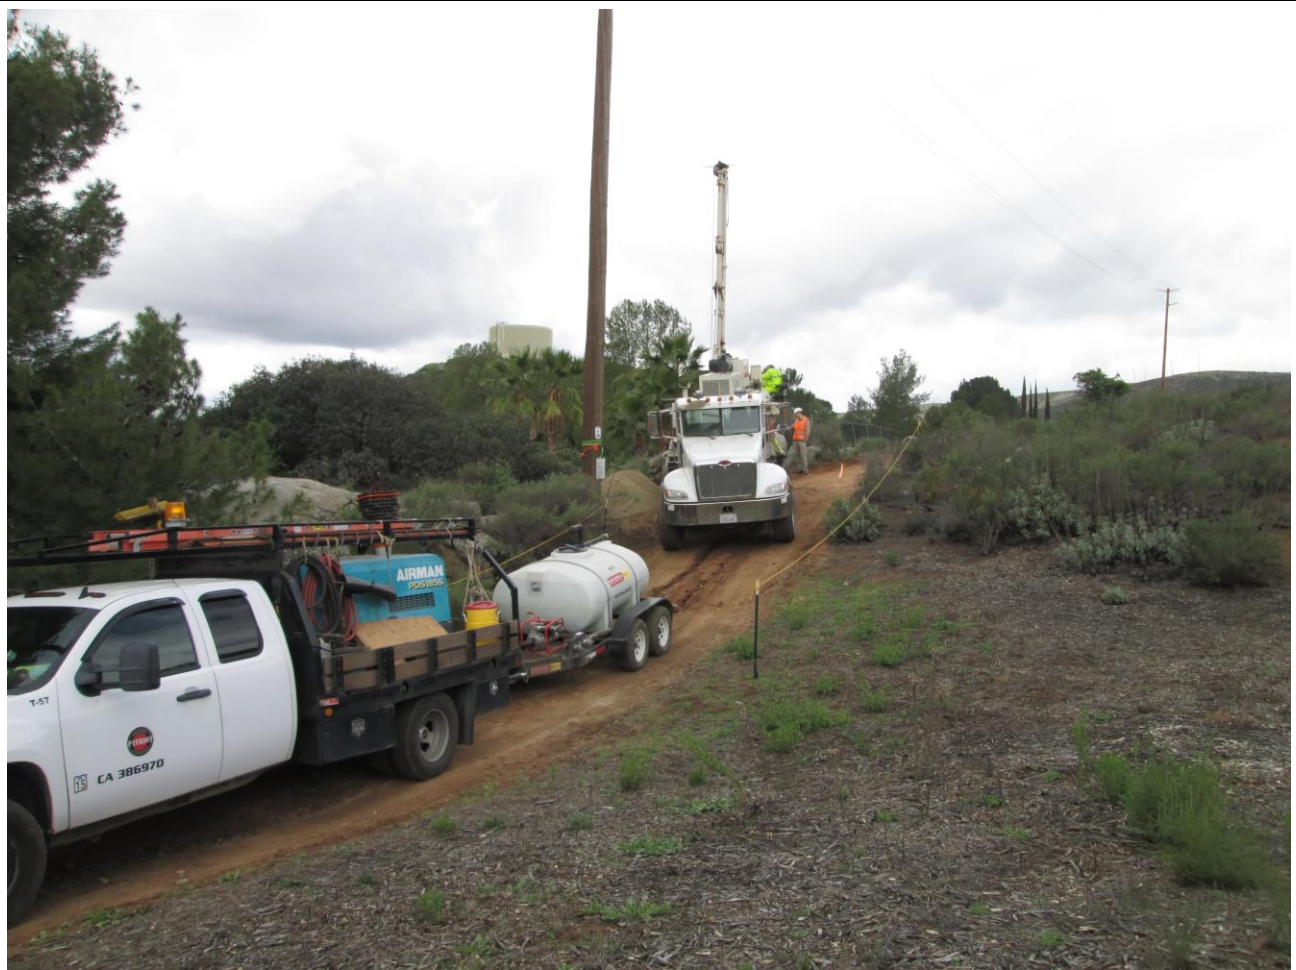
During wood pole replacement activities, CPUC third-party monitors observed biological, archaeological, and aquatic monitoring as required under mitigation measures (MM) BIO-2, MM CUL-1, and MM HYD-4 (see Photo 5—Attachment A). In accordance with MM BIO-4, prior to activities commencing at work sites, CPUC-approved biological monitors conducted nesting bird surveys and staked buffers around active nest areas for avoidance. Nest buffers were delineated with wooden stakes that were painted green and displayed the words “do not enter without bio.” CPUC-approved biological monitors were observed sweeping for nests immediately prior to work occurring in areas (see Photo 6—Attachment A) and monitored buffer zones to ensure full avoidance by crews. During infrequent instances where activities were performed at pole location sites not included on the work plan of the day, CPUC third-party monitors verified time and currency of nesting bird surveys.

Photo 5: Crews observed avoiding environmentally sensitive areas marked with yellow rope in accordance with MM CUL-1. A CPUC-approved archaeological monitor was observed present during ground disturbance in this area in accordance with MM CUL-3 and a CPUC-approved biological monitor was observed monitoring nesting bird activity in accordance with MM BIO-4. Dirt spoils from traditional drilling were observed placed adjacent to the hole and contained with on-site silt fencing in accordance with the project SWPPP/APM HYD-1.

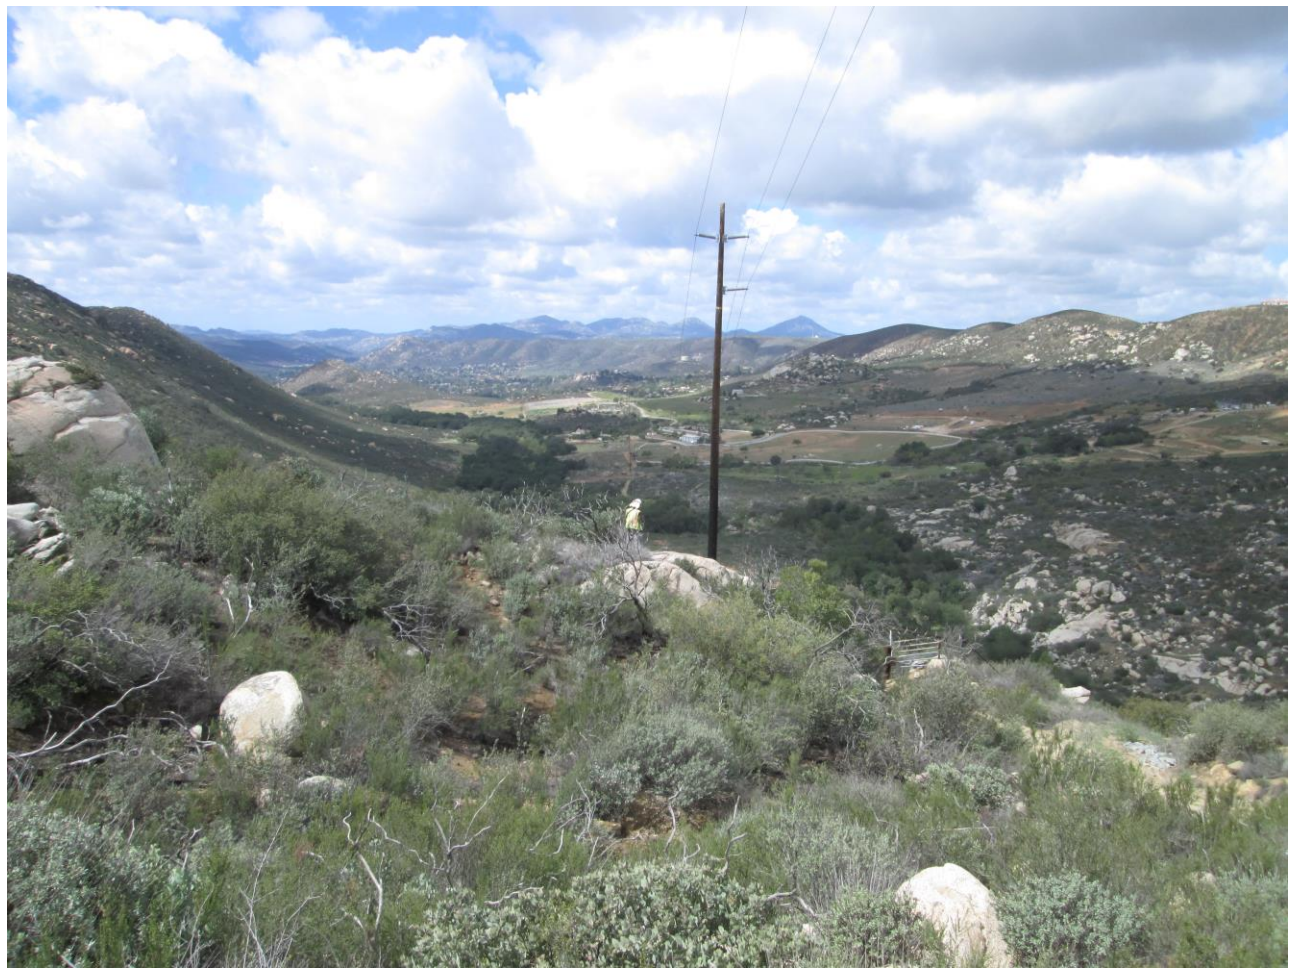
Photo 6: CPUC-approved biological monitors were observed conducting nesting bird surveys prior to work occurring at pole locations in accordance with MM BIO-4.

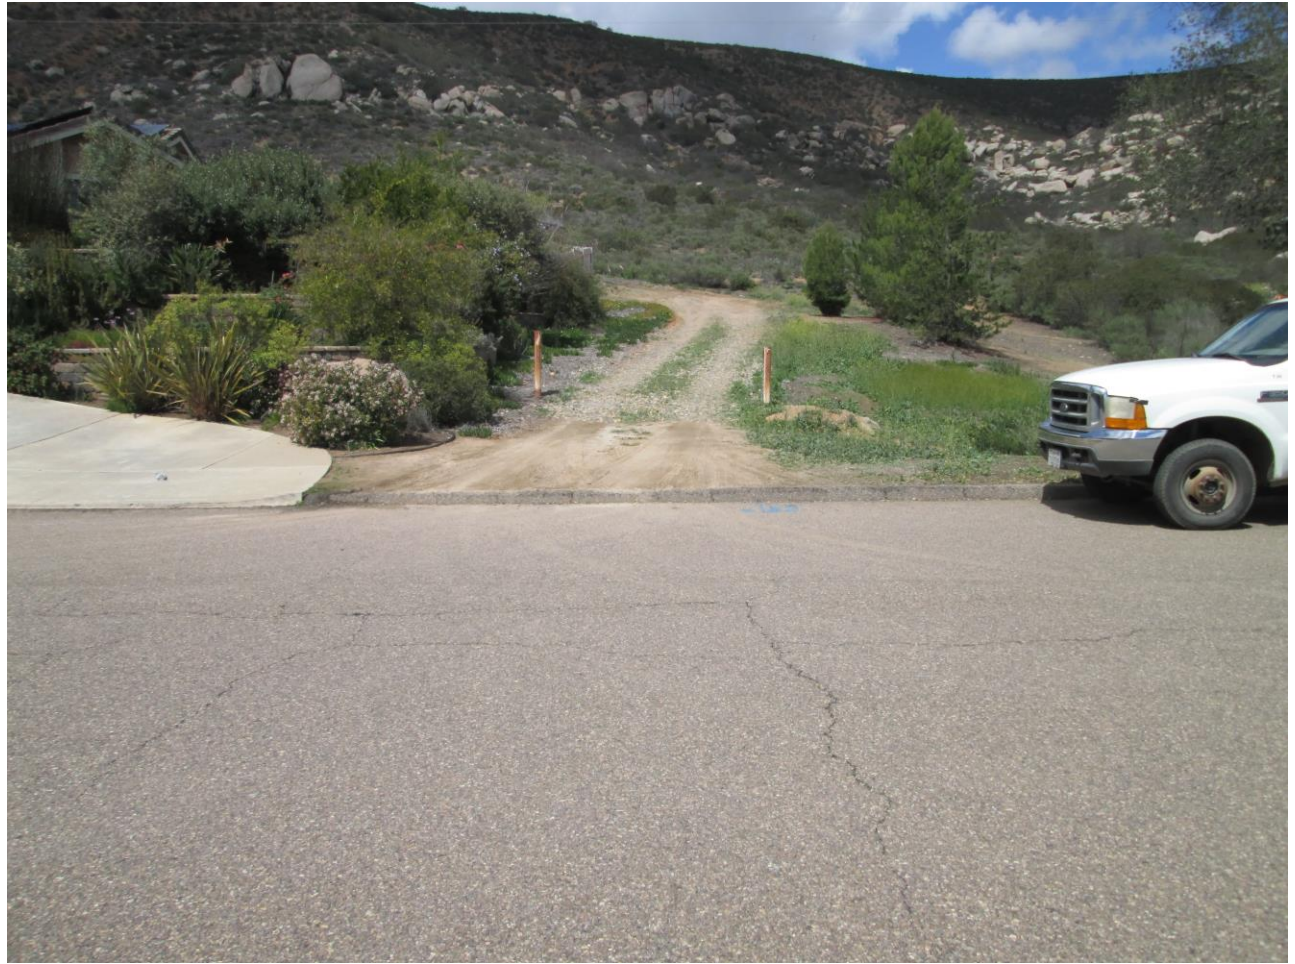
In accordance with the project SWPPP and APM-HYD-1, erosion control BMPs such as silt fencing were observed being maintained at all sites and water bars were observed along the access road to appropriately divert running water. Crews were observed staging equipment on visqueen to ensure containment of any potential mechanical leaks while not in use at pole location sites. CPUC third-party monitors continued to observe track-out cleaning activities as required by the project SWPPP (see Photo 7—Attachment A).

Photo 7: Points of ingress and egress to project pole locations were observed free of track-out in accordance with the Project SWPPP.

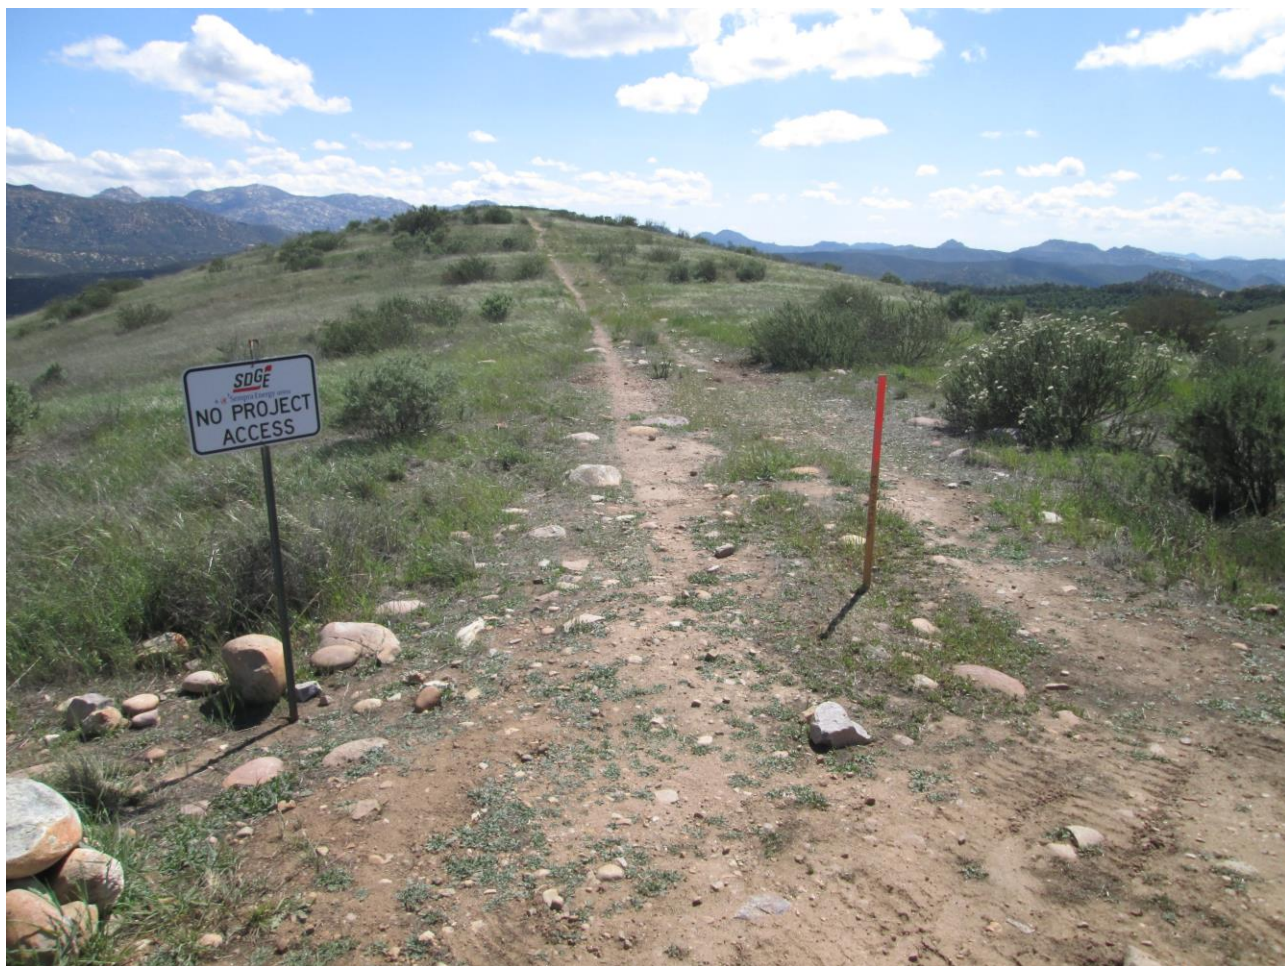
With the exception of the minor deviation reported below, crews were observed adhering to requirements to stay within approved access roads to pole location sites. Third-party monitors observed an increase in further delineation of approved work areas and access to ensure crews were aware of authorized spaces. Additionally, signs stating “NO PROJECT ACCESS” were observed posted on existing roads that could be mistaken for approved project access roads (see Photo 8—Attachment A).

Photo 8: In order to facilitate awareness of approved access roads, signage and red-colored posts were placed in areas that could be mistaken for project roads indicating “NO PROJECT ACCESS.”
