<b>California Public Utilities Commission</b> <b><i>Mitigation Monitoring, Compliance, and Reporting Program</i></b>
	<b>Tie Line (TL) 637 Wood-to-Steel Pole Replacement Project</b>
	<b>Compliance Status Report: 009</b>  <b>June 22, 2014</b>

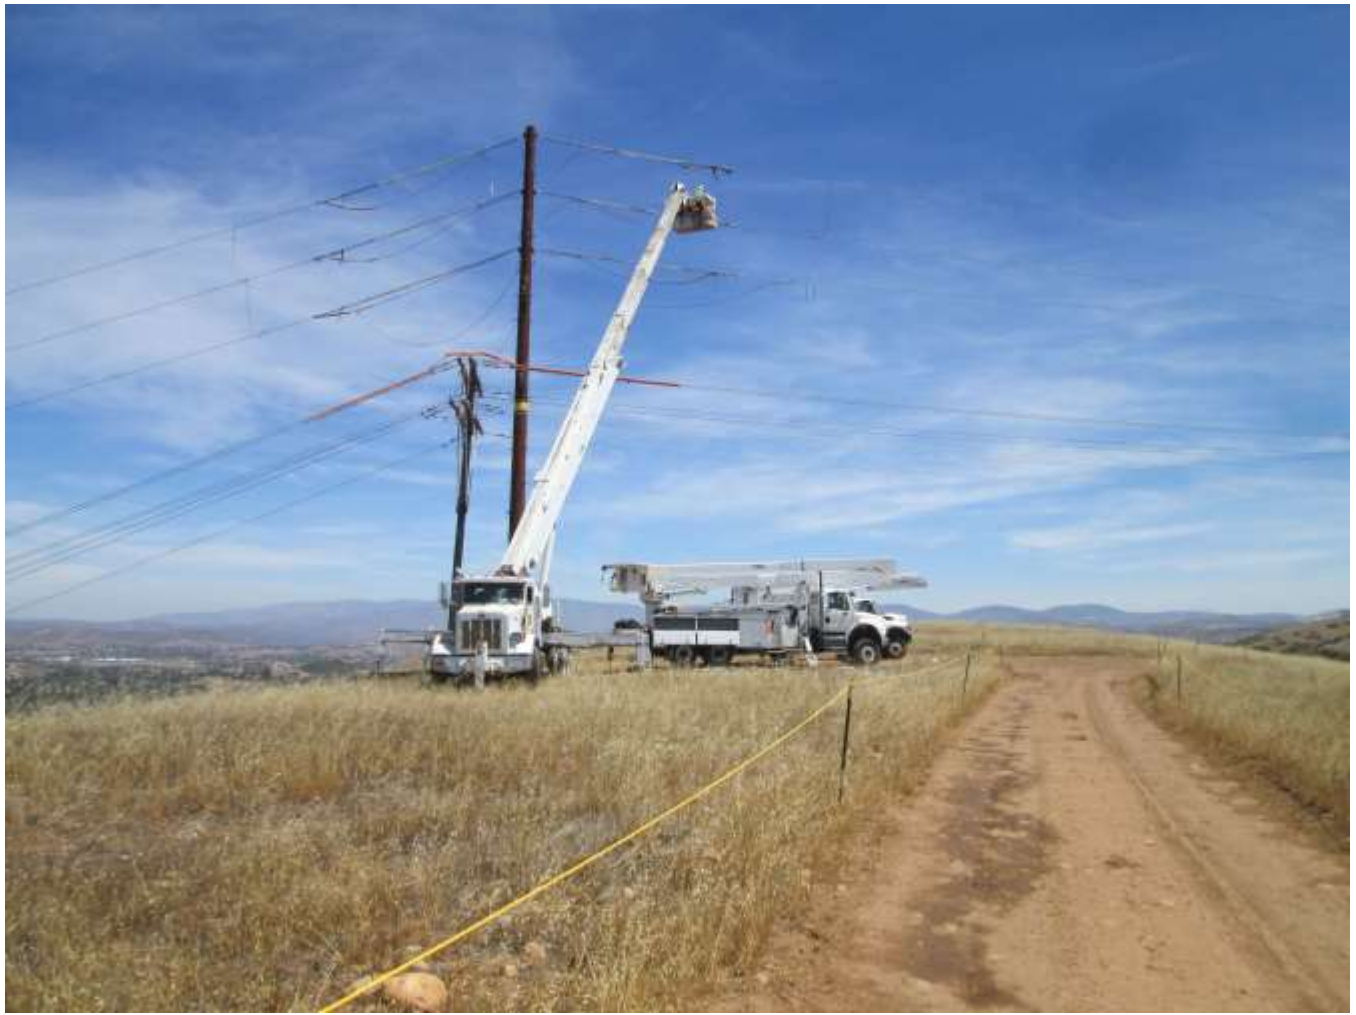
Construction crews were observed stringing, sagging (see Photo 1—Attachment A, clipping-in, and dead-ending conductor wire, and installing ground rods. Crews were also observed trenching for underground utilities.

**Photo 1:** Construction crews were observed conducting wire stringing activities, which included dead-ending and sagging the wire (pictured above).

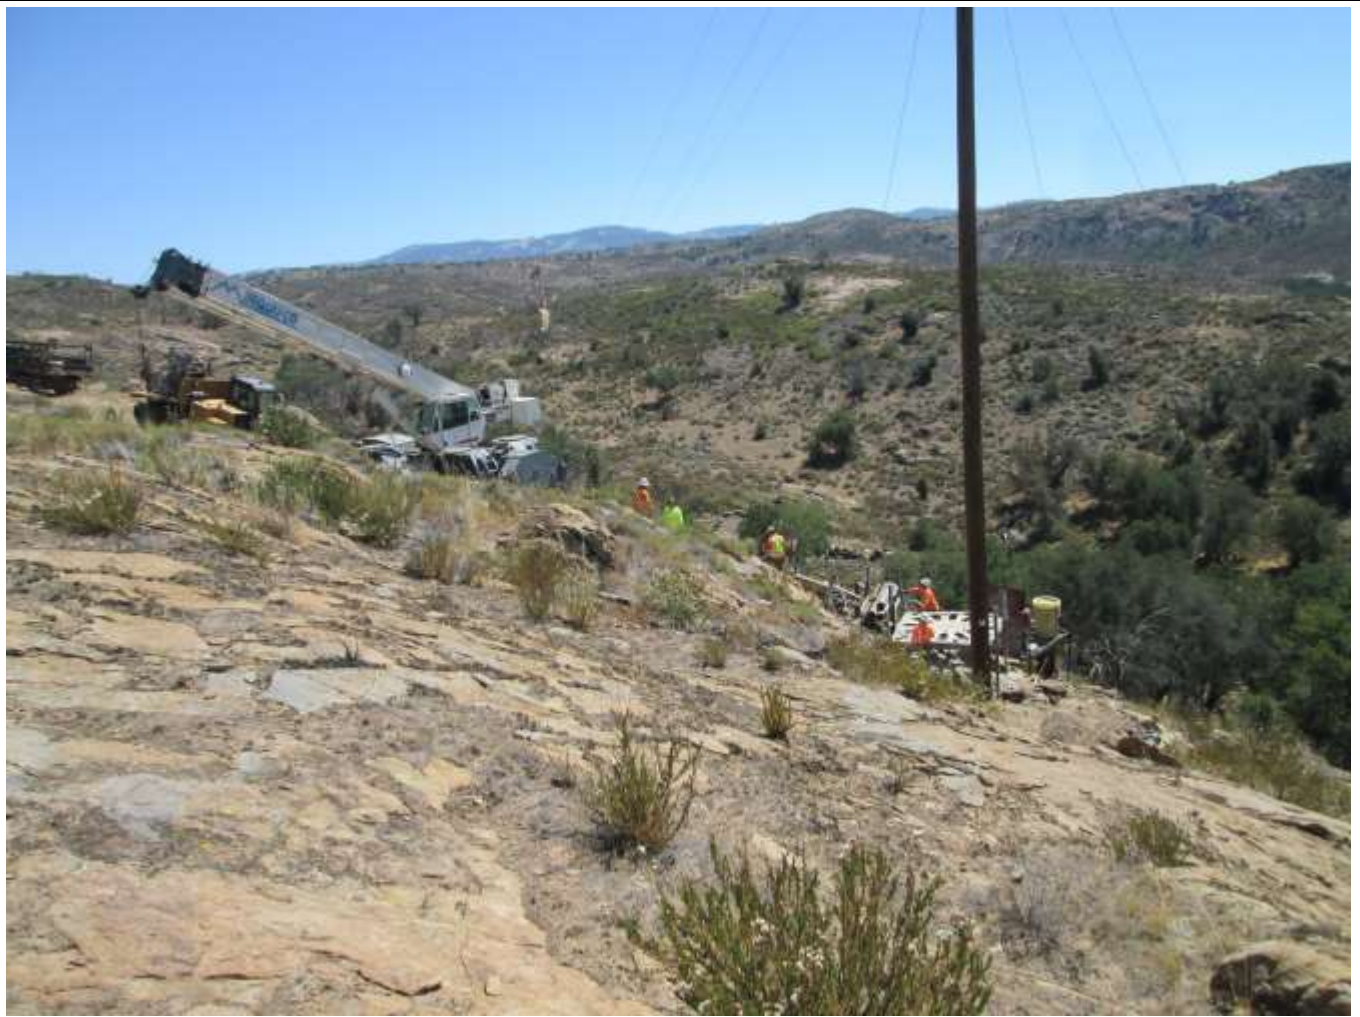
At micropile drill sites, construction crews were observed mobilizing/setting-up at pole locations (see Photo 2—Attachment A), drilling, grouting, strength testing and trimming micro pile foundations.

**Photo 2:** Crews were observed setting up micropile foundation staging equipment.

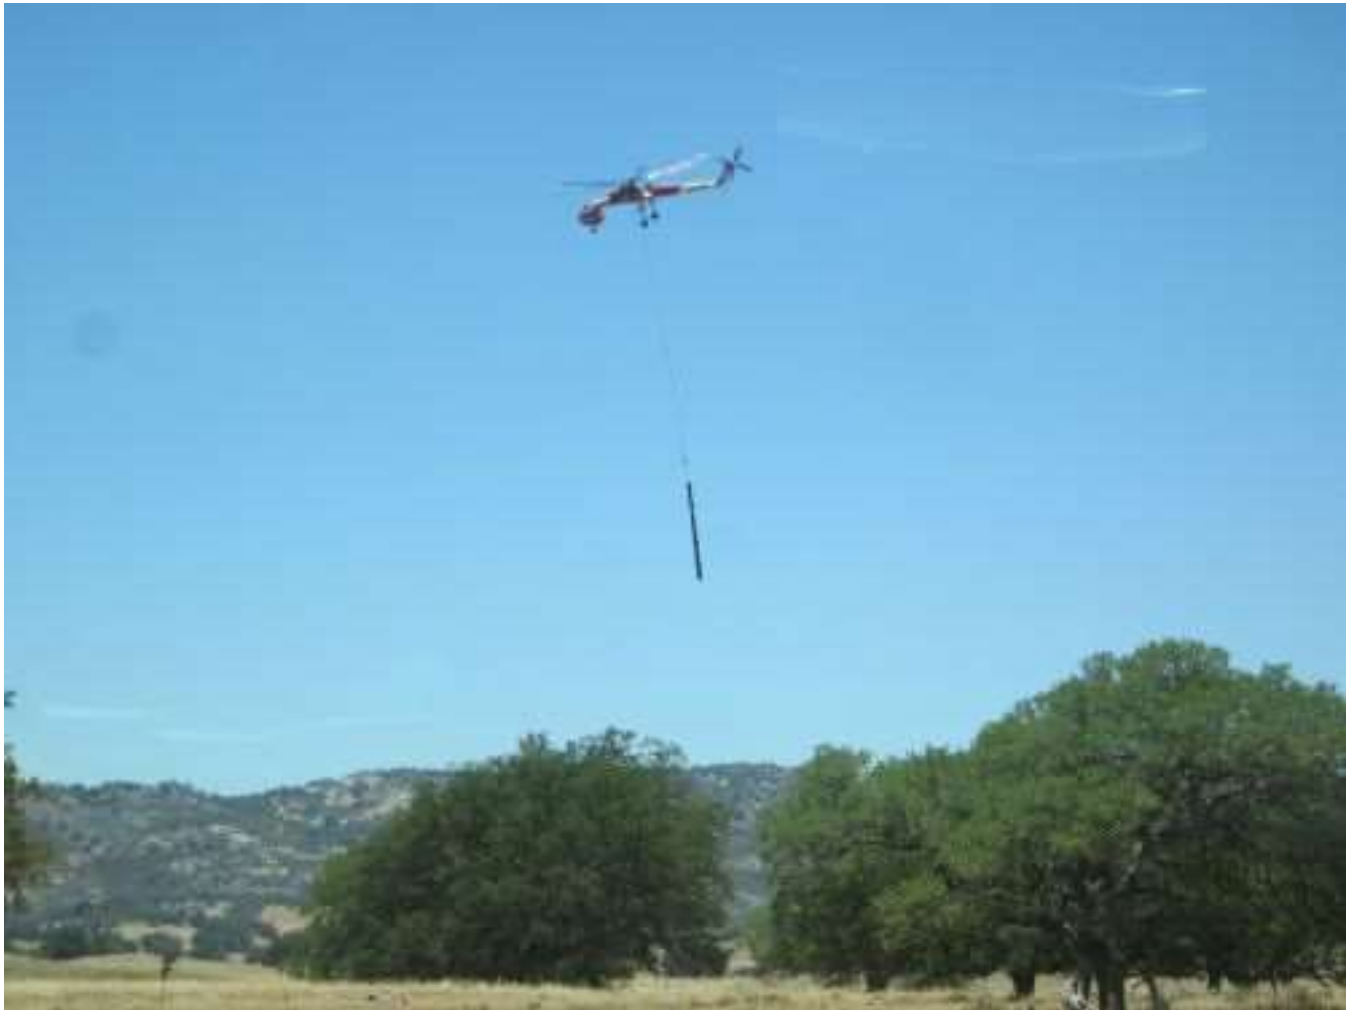
Crews were observed setting bases, spotting poles, removing poles from service, removing and/or setting pole tops/butts, installing grounding rods, and working on pole framing. Skycrane operations were observed out of the Santa Ysabel Staging Yards, transporting pole bases and pieces out to pole replacement locations (see Photo 3—Attachment A).

**Photo 3:** Skycrane helicopter operations were observed being conducted out of the Santa Ysabel Staging Yard this reporting period.

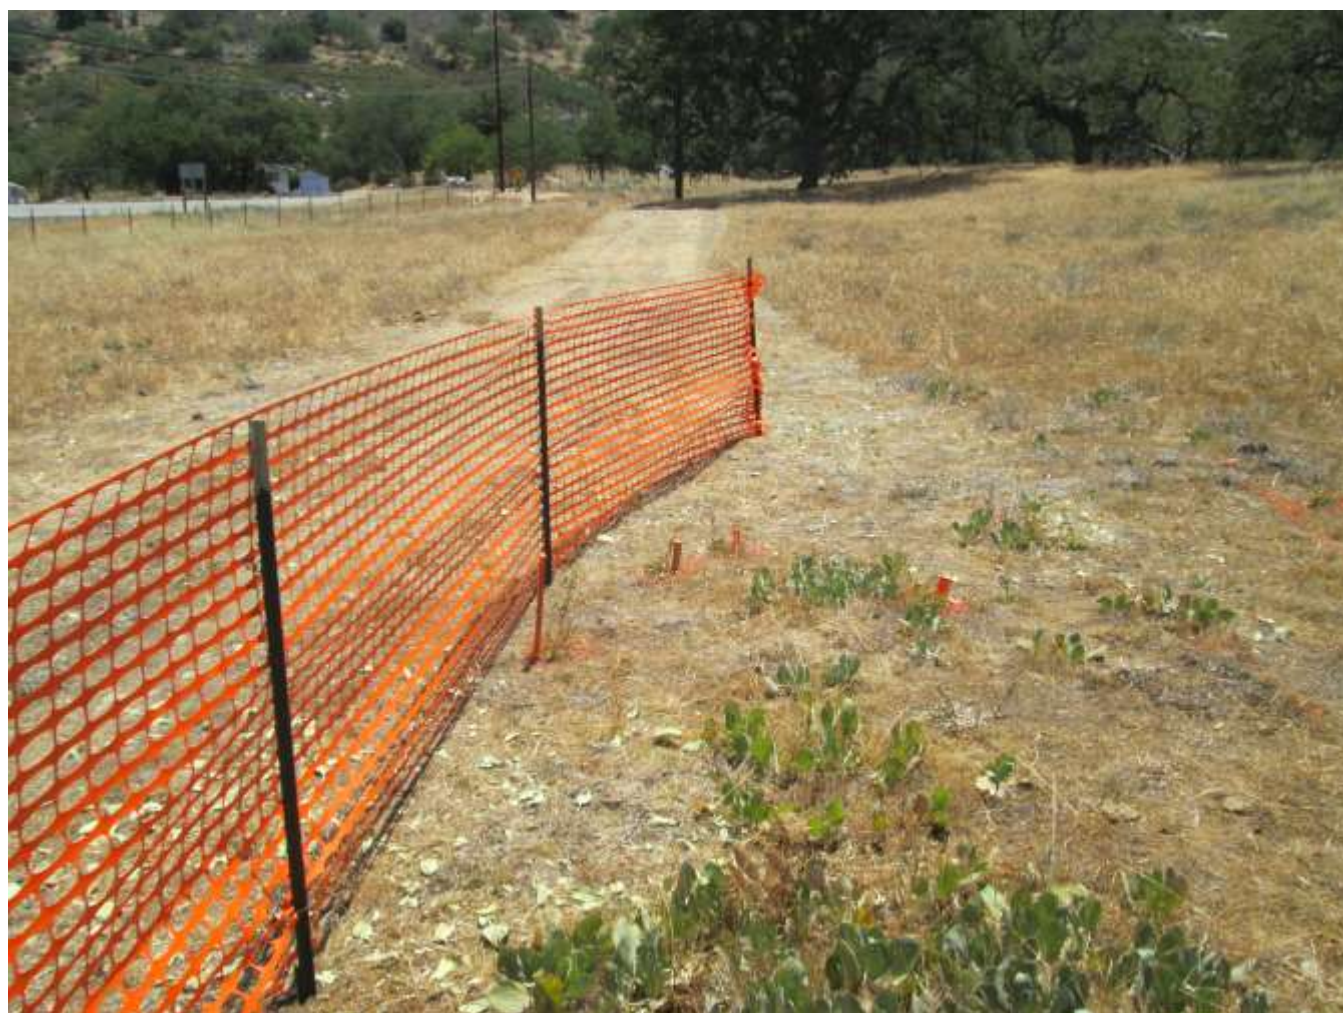
Biological monitors were observed monitoring construction activity and ensuring crews avoided areas with sensitive resources. In accordance with APM BIO-1, sensitive plant species including San Diego gumplant were marked for avoidance with green colored stakes and with temporary orange fencing in (see Photo 4—Attachment A). Also in accordance with APM BIO-1, water trucks were observed applying water to access roads approved for the project in order to control dust (see Photo 5—Attachment A). Biological Monitors were observed monitoring activities adjacent to nesting areas in order to ensure crews were observing avoidance buffers in accordance with MM BIO-2 and that noise barriers were implemented according to mitigation (see Photo 6—Attachment A).

**Photo 4:** Sensitive plant species (San Diego gumplant, above) were marked for avoidance with green colored stakes and in certain areas with temporary orange fencing (above) in accordance with APM BIO-1.

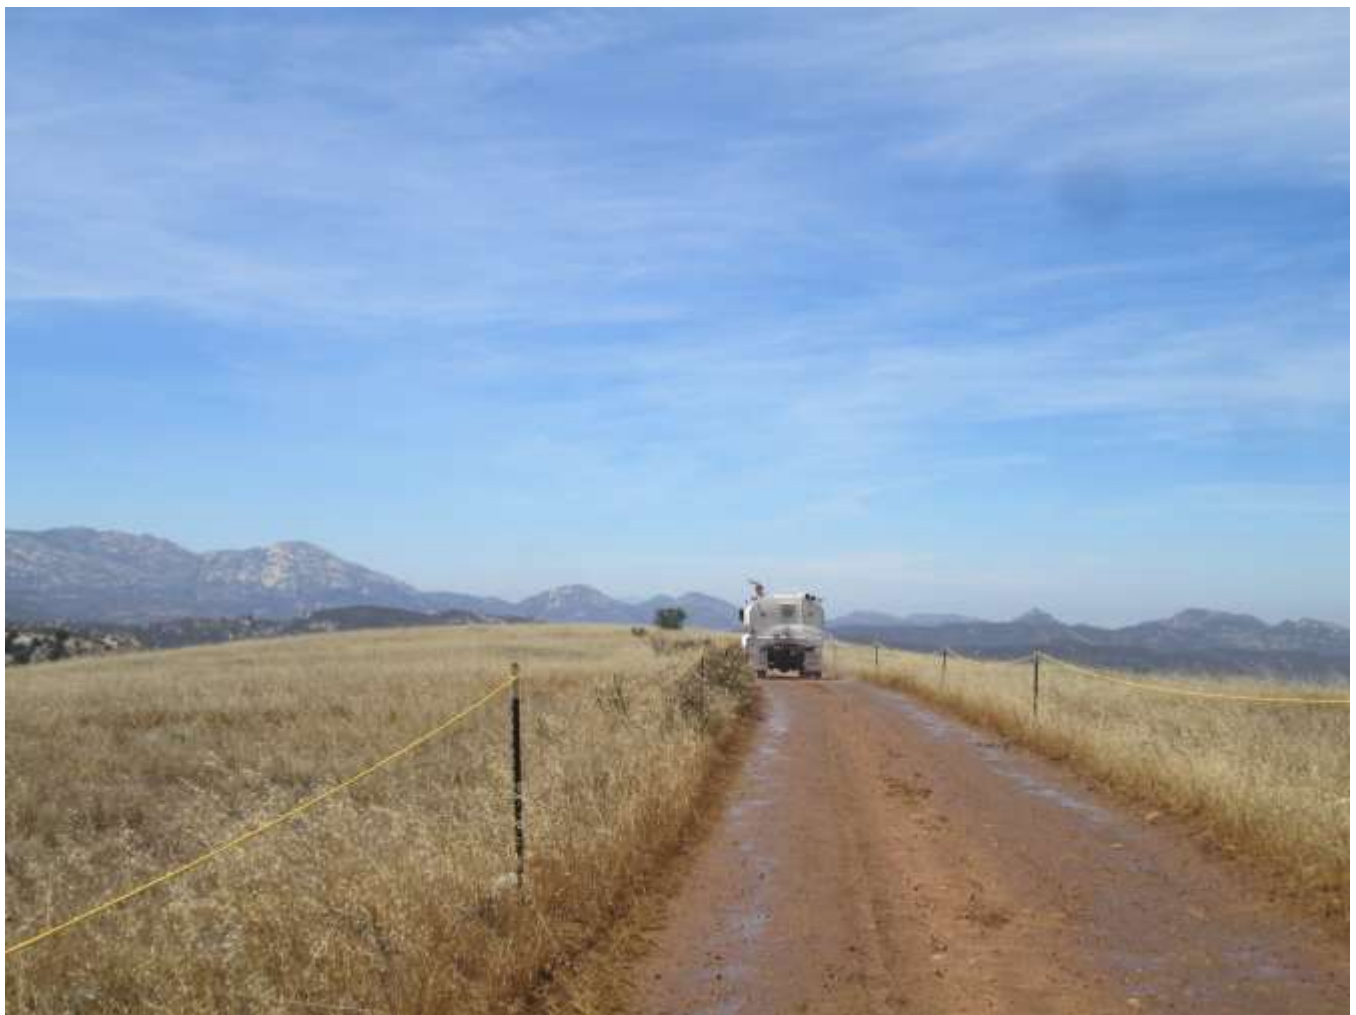
**Photo 5:** Water trucks were observed watering roads in order to ensure dust control in accordance with APM BIO-1.

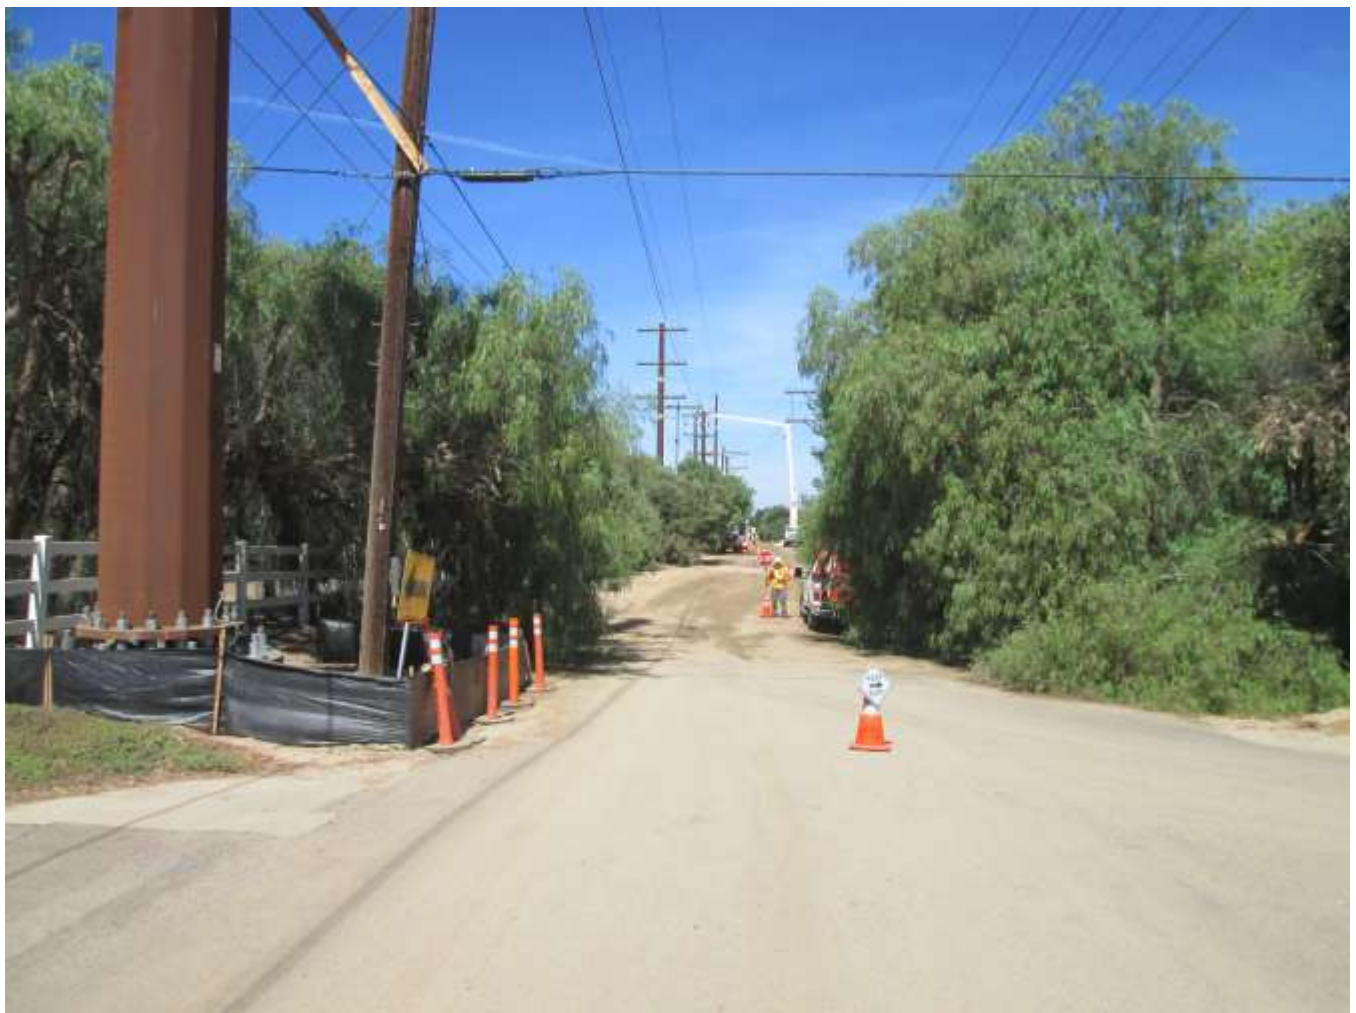
In accordance with APM TRA-1, traffic control flaggers, construction notification signage, and cones were observed along public roadways with construction activity (see Photo 6—Attachment A).

**Photo 6:** In accordance with APM TRA-1, traffic control crews and cones were mobilized during pole re-framing activities along Creelman Lane. Additionally, biological monitors were observed monitoring a nearby nest during these activities, which was marked with green lathe signage for avoidance (BIO-2).

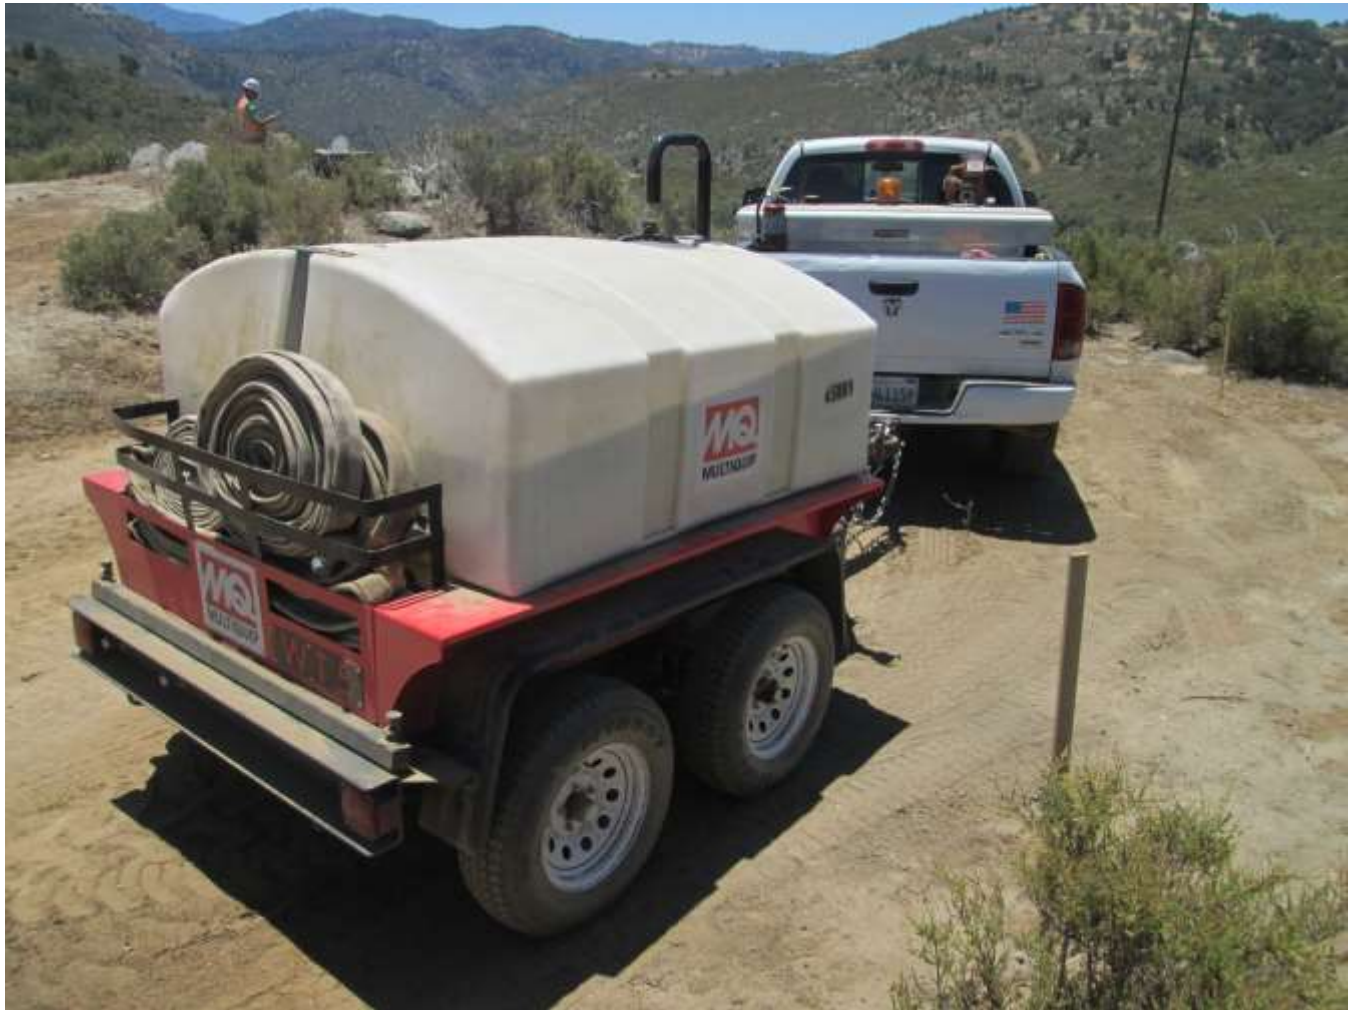
Fire risk was observed being minimized during project construction through the implementation of measures in the Project Fire Plan and APM HAZ-2. Fire patrols carrying fire suppression tools and water for firefighting were observed monitoring work activity and inspecting work locations for fire safety compliance. Construction crews were observed carrying fire tools (backpack pump, fire extinguisher, shovel, and Pulaski), and staging tools on site at work locations. Fire extinguishers were observed next to or mounted on internal combustion engines. Water buffalos were staged within two minutes travel time of construction activities (see Photo 7—Attachment A).

**Photo 7:** In accordance with the Project Fire Plan and APM HAZ-2, fire patrols were observed monitoring construction activities and inspecting work locations for fire safety compliance. Mobile water buffalos were observed nearby work activities in order to adhere to response times identified in the Project Fire Plan.

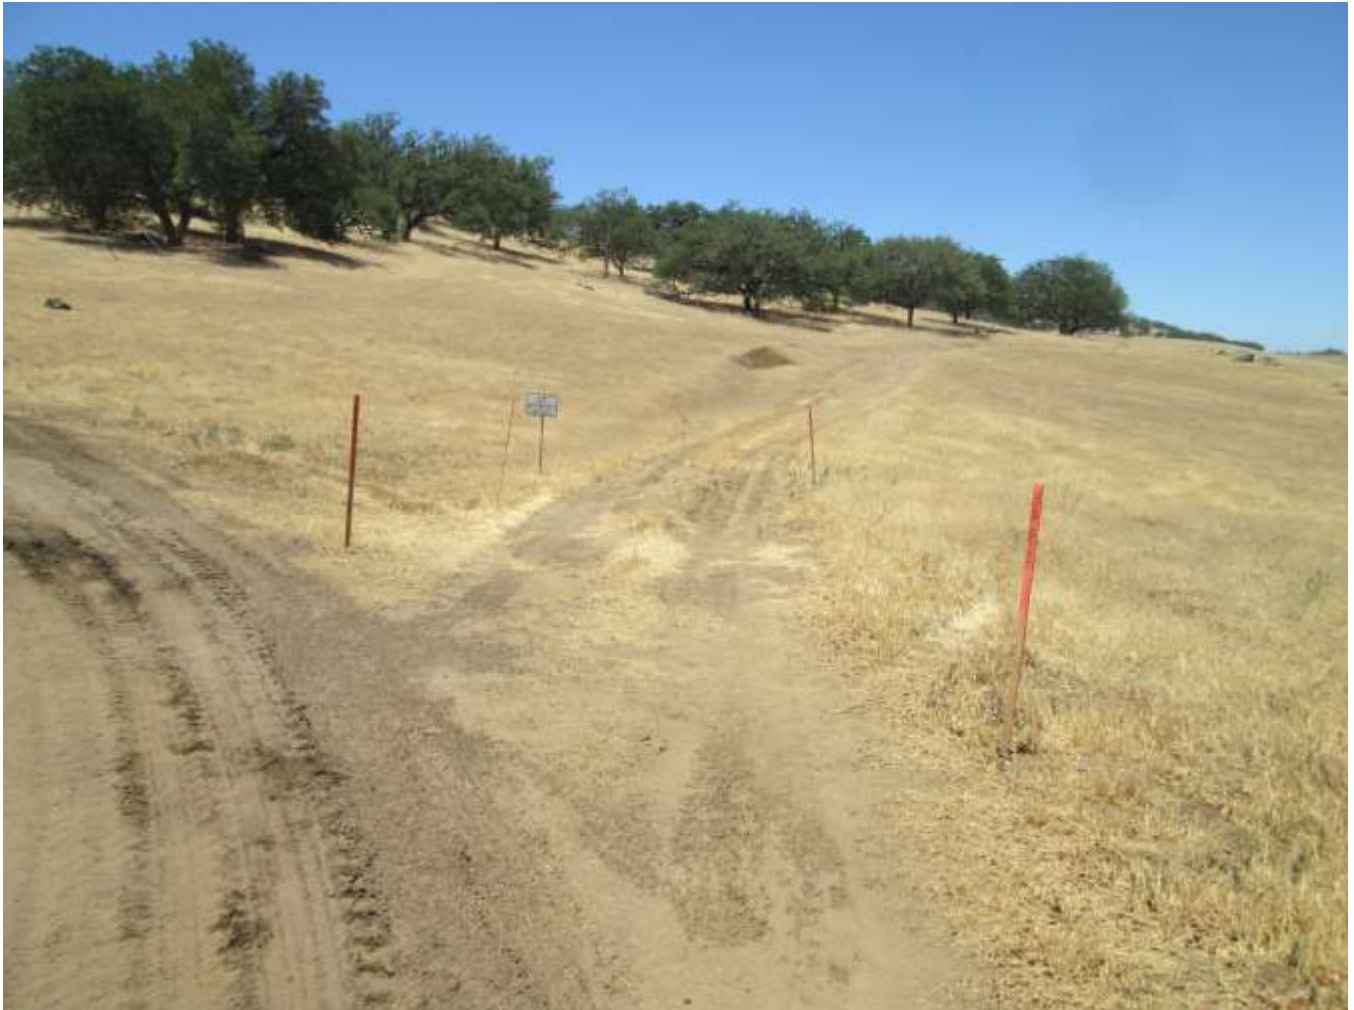
In order to ensure crews adhered to approved project access areas, a turn around area was observed delineated with orange staking at the intersection of the main access road with a non-approved dirt road near P146 and "SDG&E No Project Access" signage was observed at the back of the delineated turn around area (see Photo 8—Attachment A).

**Photo 8:** Orange-marked stakes were observed showing limits for approved turnaround areas and “No SDG&E Access” signs were installed to ensure that crews did not use the area behind the turnaround as an access road.
