<p>California Public Utilities Commission <i>Mitigation Monitoring, Compliance, and Reporting Program</i></p>
	<p>East County (ECO) Substation Project</p> <p>Compliance Status Report: 027</p> <p>April 13, 2014</p>

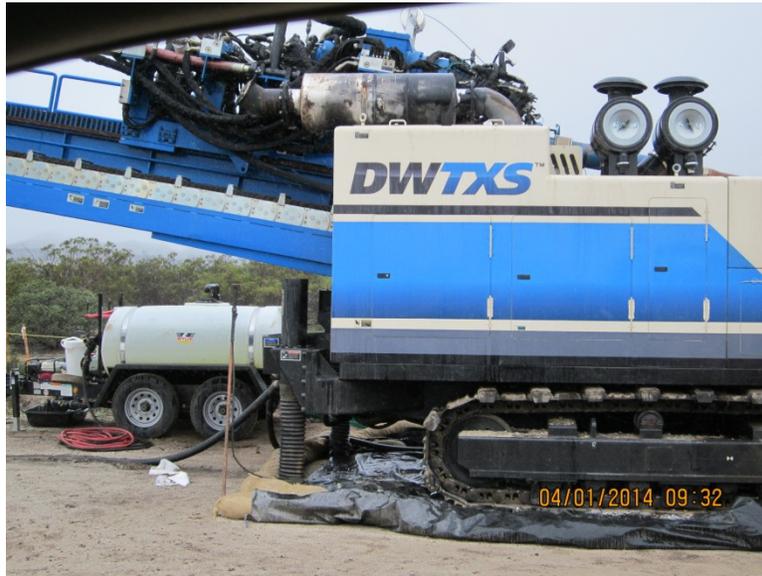
Erosion control measures consisting of straw wattles, silt fence and gravel bags are being maintained along the right-of-way in accordance with the SWPPP and MM-HYD-1. Staged and active stationary equipment had containment in place as required by MM-HAZ-1a (see Photo 1 – Attachment A). Jurisdictional waterways were marked off with blue flagging to highlight their location for avoidance. ESA's that identified special status plants as stipulated by MM-BIO-5b were clearly identified with signage throughout the right-of-way.

Photo 1: Staged and active stationary equipment was observed to have containment in place as required by MM-HAZ-1a.

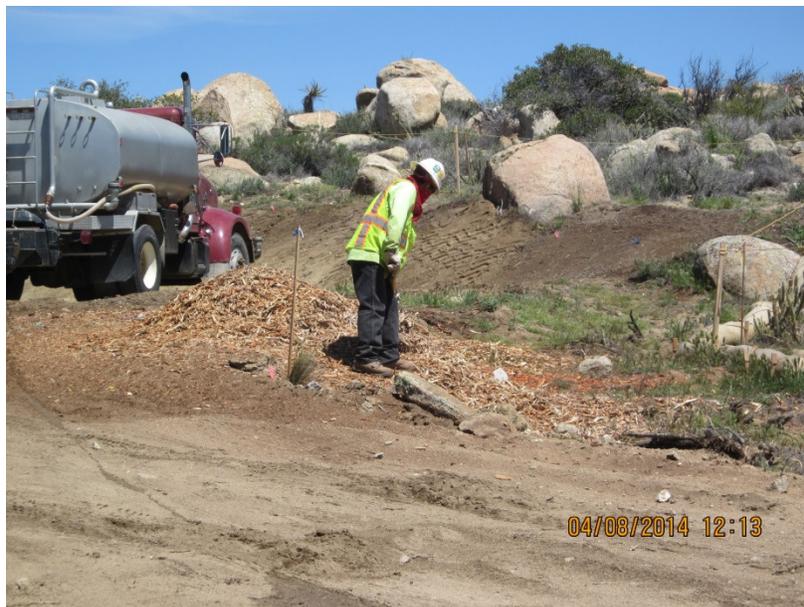
During chipping activities, crews were diligent in spreading vegetation and wood chippings to minimize fire risk (see Photo 2 – Attachment A).

Photo 2: During chipping activities along the 138 kV overhead alignment, crews were diligent in spreading vegetation and wood chippings to minimize fire risk.

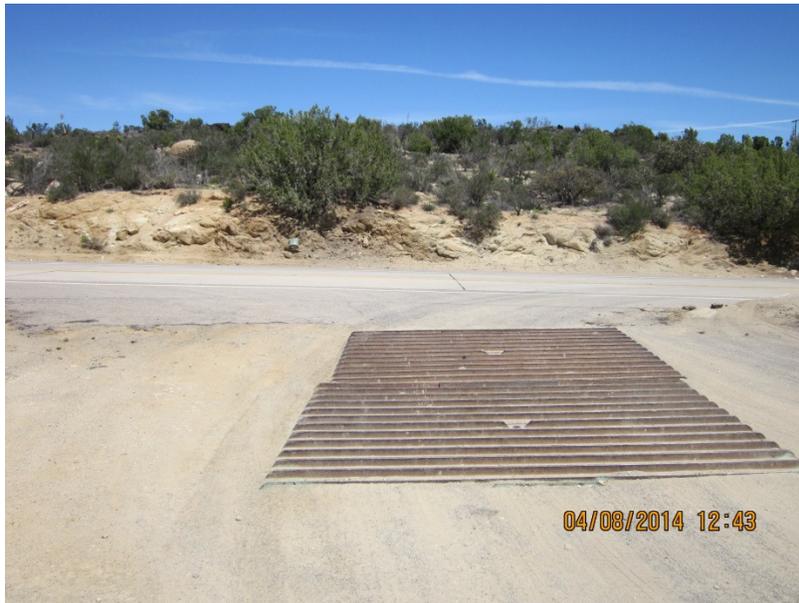
Water trucks were being utilized during rock breaking and pad site finish grading to minimize fugitive dust emissions in accordance with the Dust Control Plan and MM-BIO-4a. Track-out measures consisting of rumble plates and rock aprons were also observed to be in place and being maintained (see Photo 3 – Attachment A).

Photo 3: Track-out measures consisting of rumble plates and rock aprons were observed to be in place along the 138kv overhead alignment and being maintained in accordance with MM-AQ-1 and MM-BIO4-a.

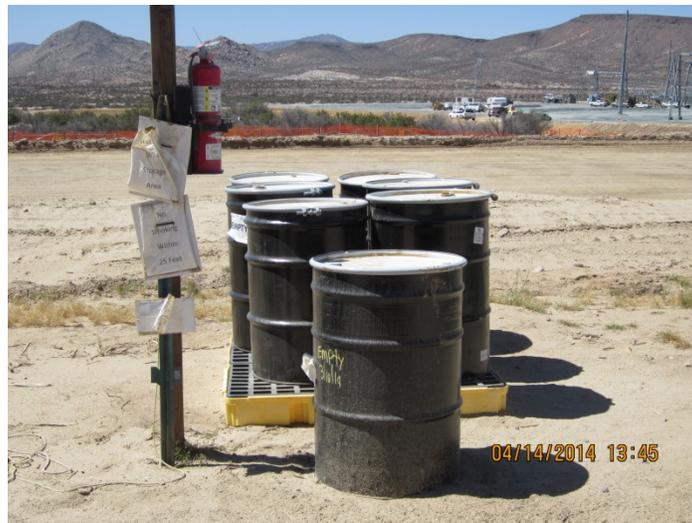
In accordance with MM-BIO-1a the limits of work were clearly delineated and respected by construction crews during ongoing construction activities along access road and within the substation. Erosion control measures consisting of straw wattles, silt fencing and hydromulched slopes were in place and being maintained in accordance with MM-HYD-1 and the Project SWPPP. Hazardous materials staged onsite were placed within proper containment and labeled in accordance with MM-HAZ-1a. No smoking signs were clearly marked and adjacent to the hazardous waste areas (see Photo 4 – Attachment A).

Photo 4: Hazardous materials staged on site at ECO Substation were placed within proper containment and labeled in accordance with MM-HAZ-1a. No smoking signs were clearly marked and adjacent to the hazardous waste areas.

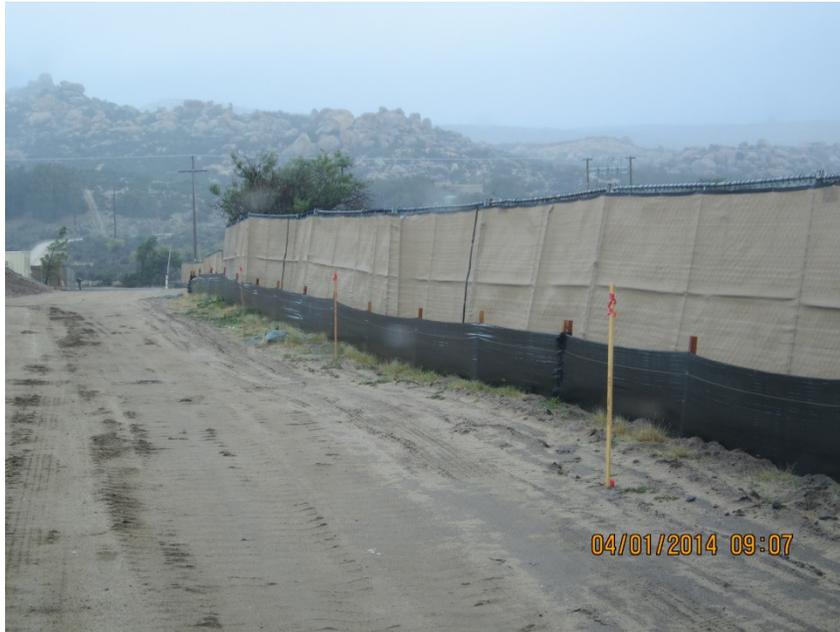
MM-VIS-3e requires that opaque visual screening material be used in areas of high public visibility to reduce visibility of construction activities and equipment. Project personnel responded in a timely manner when high winds resulted in the visual screening material needing to be repaired (see Photo 5 – Attachment A).

Photo 5: Opaque visual screening material is being maintained along the fence line at the Boulevard Substation in accordance with MM-VIS-3e.

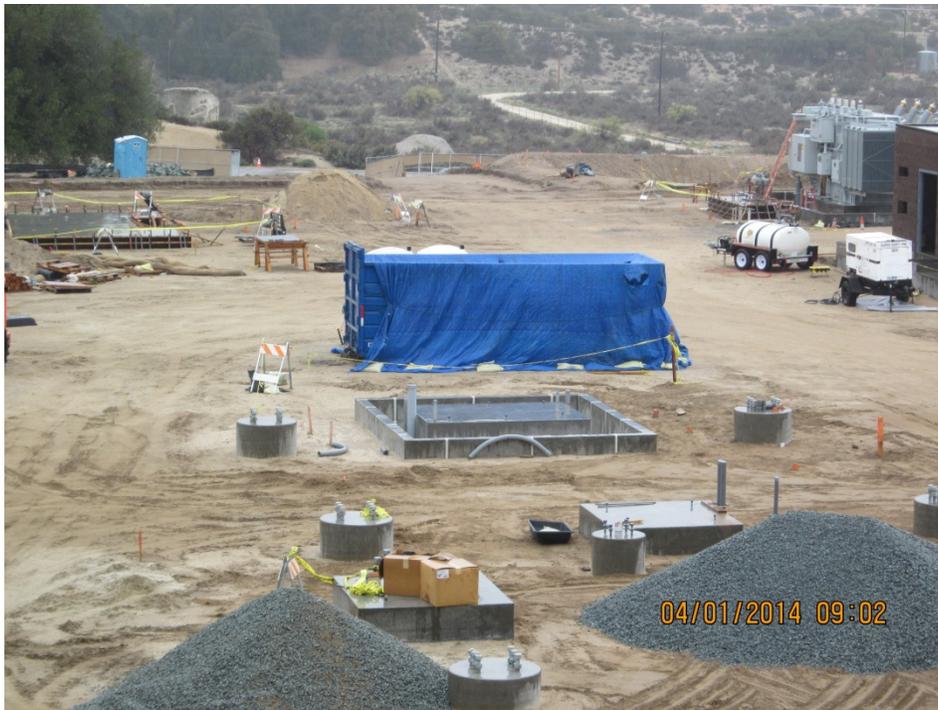
Construction equipment and staged materials throughout the substation were equipped with drip pan containment as stipulated by MM-HAZ-1a and fire suppression equipment per MM-FF-1. Fire patrol was on site and actively checking all entering personnel for SWEAP training stickers in accordance with MM-FF-1 and the Project Health and Safety Plan outlined in MM-HAZ1-b. As specified in MM-HAZ-1c, trash storage bins were equipped with covers to avoid dispersal due to weather or wildlife (see Photo 6 – Attachment A).

Photo 6: Trash storage bins at Boulevard Rebuild Substation were equipped with covers in accordance with MM-HAZ-1c.
