<p>California Public Utilities Commission <i>Mitigation Monitoring, Compliance, and Reporting Program</i></p>
	<p>East County (ECO) Substation Project</p> <p>Compliance Status Report: 028</p> <p>April 27, 2014</p>

SUMMARY

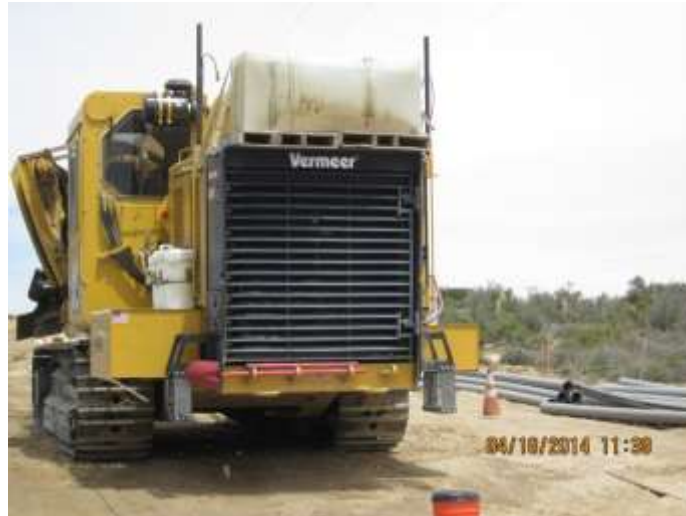
Drip pan containment bins were observed being placed beneath construction equipment staged along the right-of-way in accordance with MM-HAZ-1a and spill kits were readily accessible (see Photo 1 – Attachment A).

Photo 1: Drip pan containment bins beneath equipment staged along the right-of-way in accordance with MM-HAZ-1a.

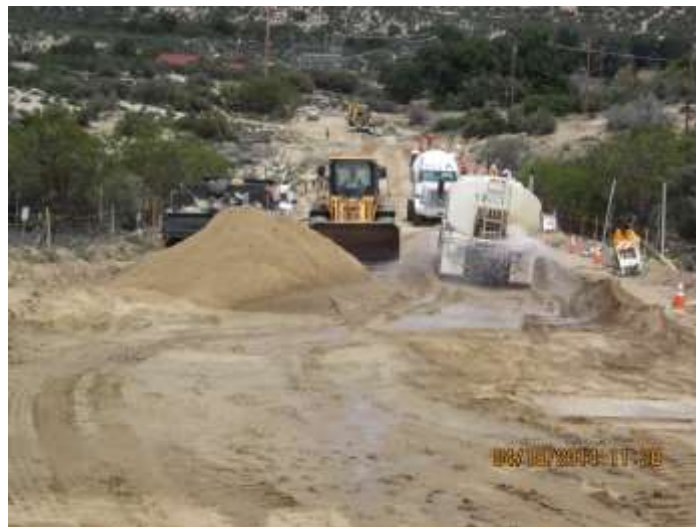
Water trucks were being utilized during excavation and backfilling activities and along common used access roads to minimize fugitive dust emissions in accordance with the Dust Control Plan and MM-BIO-4a (see Photo 2 – Attachment A). Trucks used during spoil removal associated with excavation were observed actively covering loads in accordance with MM-BIO-4a and MM-AQ-1 (see Photo 3 – Attachment A).

Photo 2: Water trucks being utilized during excavation and backfilling activities and along common used access roads to minimize fugitive dust emissions in accordance with the Dust Control Plan and MM-BIO-4a.

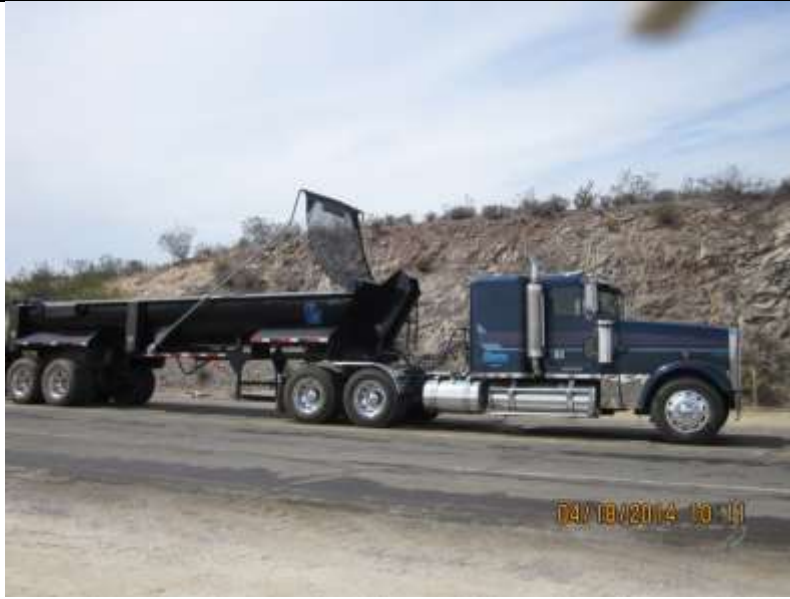
Photo 3: Trucks covering loads in accordance with MM-BIO-4a and MM-AQ-1.

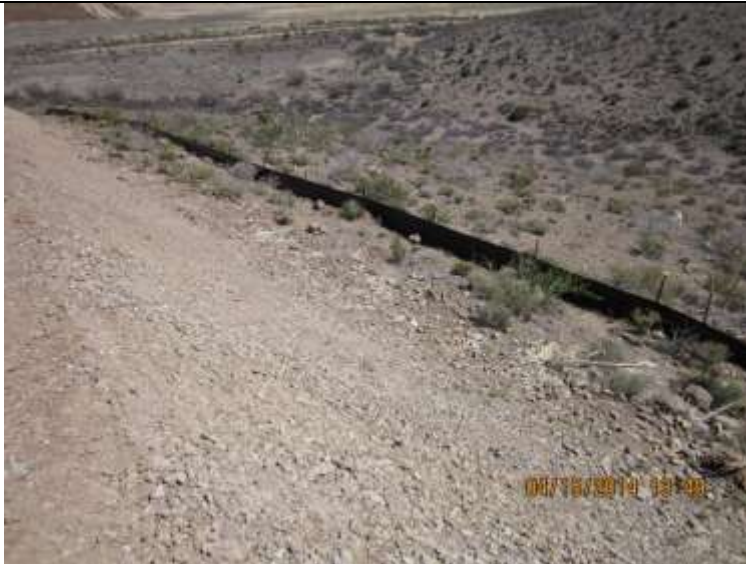
Erosion control measures consisting of straw wattles, silt fence and gravel bags are being maintained along the right-of-way in accordance with MM-HYD-1 (see Photo 4 – Attachment A). Staged and active stationary equipment featured containment as required by MM-HAZ-1a.

Photo 4: Erosion control measures consisting of straw wattles, silt fence and gravel bags are being maintained along the ROW in accordance with the SWPPP and MM-HYD-1.

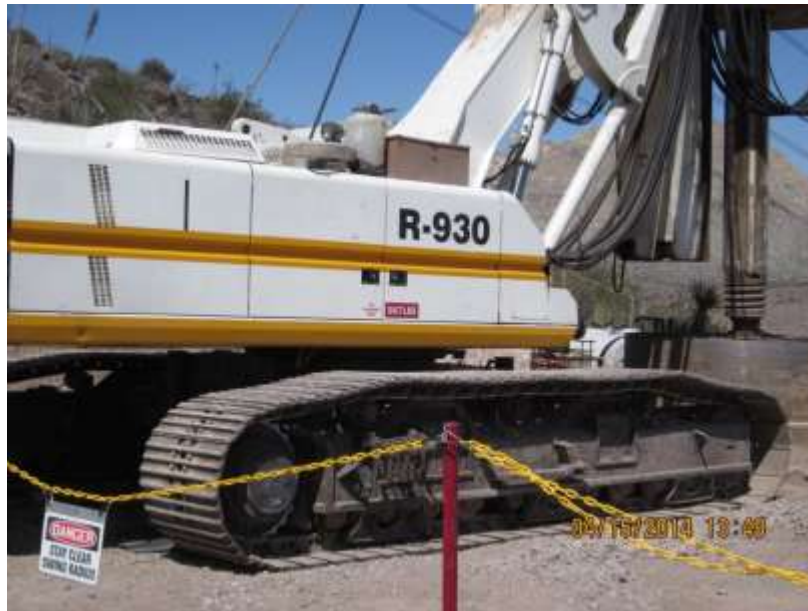
Per the Construction Fire Prevention/Protection Plan, SDG&E was observed inspecting equipment along the right-of-way to ensure fire suppression equipment was present. Routine patrols were completed by the fire inspection team throughout the construction activities and fire tools were observed at all construction sites as required by MM-FF-1 (see Photo 5 – Attachment A).

Photo 5: Routine patrols were completed by the fire inspection team throughout the construction activities and fire tools were observed at all construction sites as required by MM-FF-1.

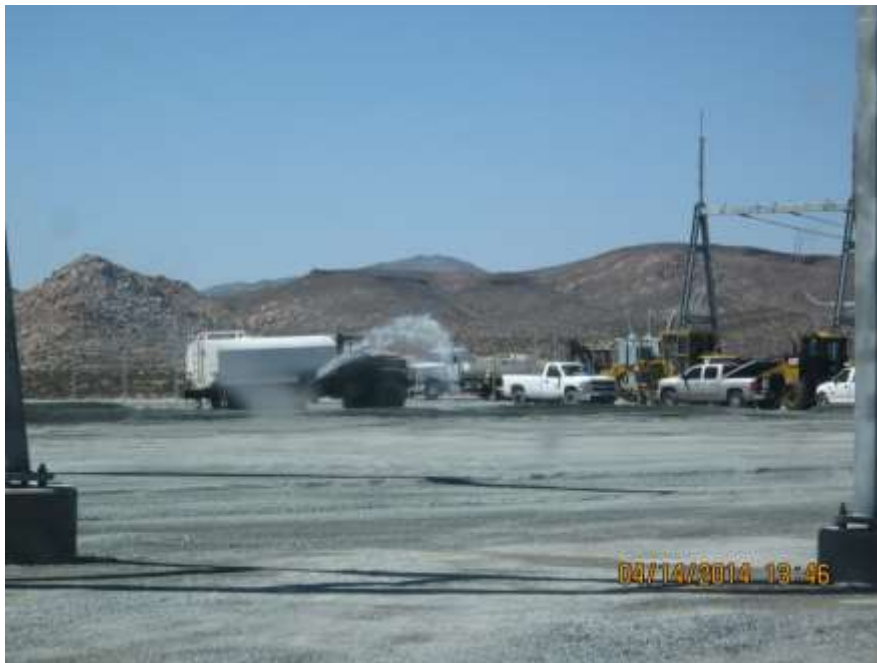
In accordance with MM-BIO4-A and MM-AQ-1, a consistent schedule of water trucks to control dust during rough-grading activities in the southeast corner of the 500 kV pad and along access roads and commonly used routes within the substation boundaries was observed during this reporting period (see Photo 6 – Attachment A). A rock apron and rattle plate was also observed being maintained at the primary point of ingress/egress along Old Highway 80 to minimize the potential for track-out and associated fugitive dust emissions.

Photo 6: In accordance with MM-BIO4-A and MM-AQ-1, water trucks are utilized to minimize dust along access roads and commonly used routes within the substation boundaries.
