<p>California Public Utilities Commission <i>Mitigation Monitoring, Compliance, and Reporting Program</i></p>
	<p>East County (ECO) Substation Project</p> <p>Compliance Status Report: 031</p> <p>June 8, 2014</p>

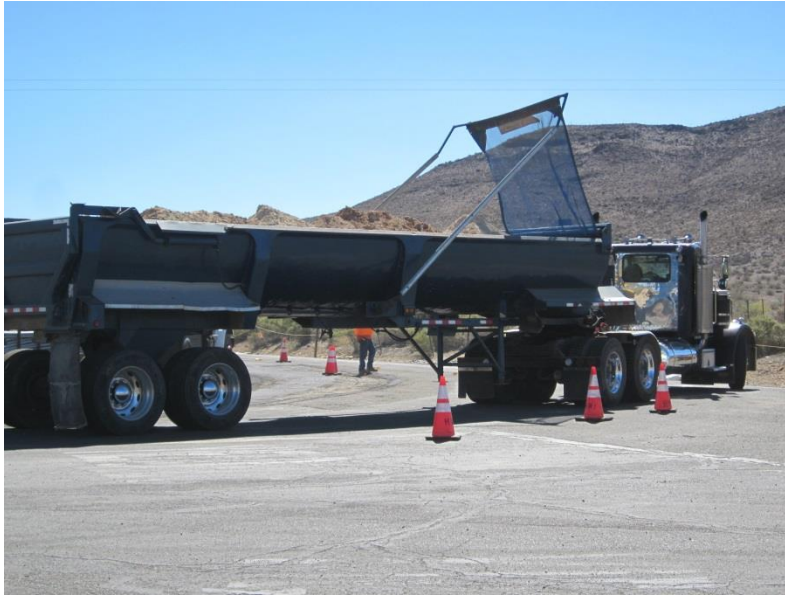
Water trucks were being utilized during excavation and backfilling activities and along common used access roads to minimize fugitive dust emissions in accordance with the Dust Control Plan and MM-BIO-4a. Trucks used during spoil removal associated with excavation were observed covering loads prior to entering publicly accessed roads in accordance with MM-BIO-4a and MM-AQ-1 (see Photo 1 – Attachment A).

Photo 1: Trucks used during spoil removal associated with excavation were observed actively covering loads prior to entering publicly accessed roads in accordance with the Project SWPPP and MM-BIO-4a and MM-AQ-1.

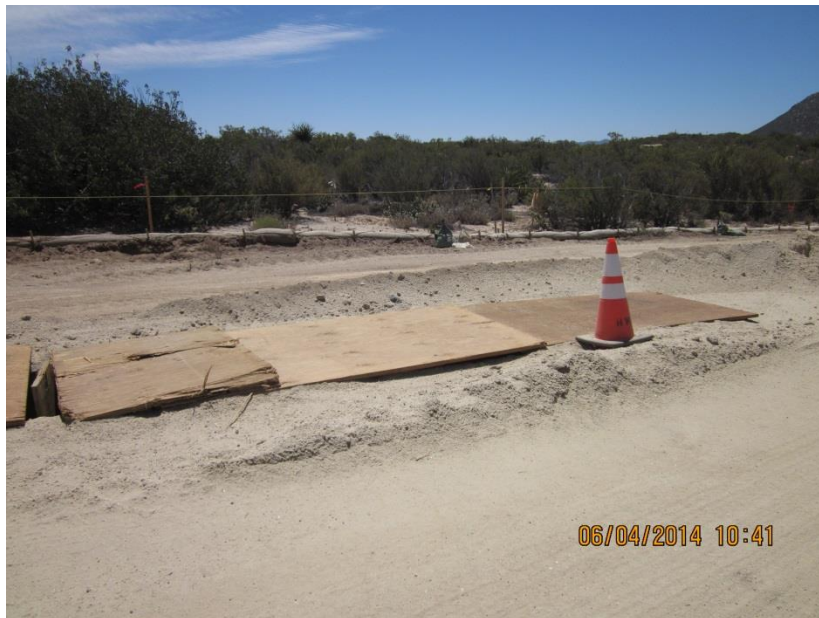
Throughout the ROW, trenches and excavations were observed covered to prevent wildlife entrapment in accordance with MM-BIO-7a (see Photo 2 – Attachment A). Nesting bird surveys and monitoring were conducted throughout the reporting period in accordance with the Nesting Bird Mitigation, Monitoring, and Reporting Plan and MM-BIO-7j. In an attempt to reduce the risk of nesting bird settlement, staged equipment in areas of high bird activity were covered with thin netting so as to avoid bird or wildlife settlement or entrapment.

Photo 2: Trenches and excavations were observed being covered to prevent wildlife entrapment in compliance with MM-BIO-7a.

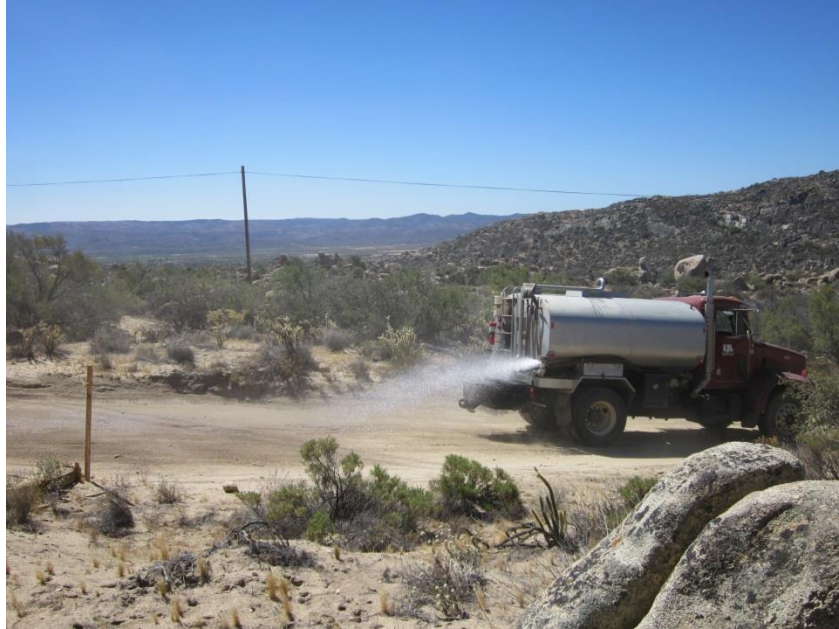
Dust control measures in line with MM-AQ-1 and MM-BIO-4a, including diligent watering during rough grading and access road maintenance were observed to be effective (see Photo 3 – Attachment A). Track-out measures consisting of rumble plates and rock aprons were in place and maintained, and traffic control crews were observed manually sweeping up project related track out throughout and at the end of the day.

Photo 3: Dust control measures including diligent watering during rough grading and access road maintenance were observed being implemented in accordance with MM-AQ-1 and MM-BIO-4a.

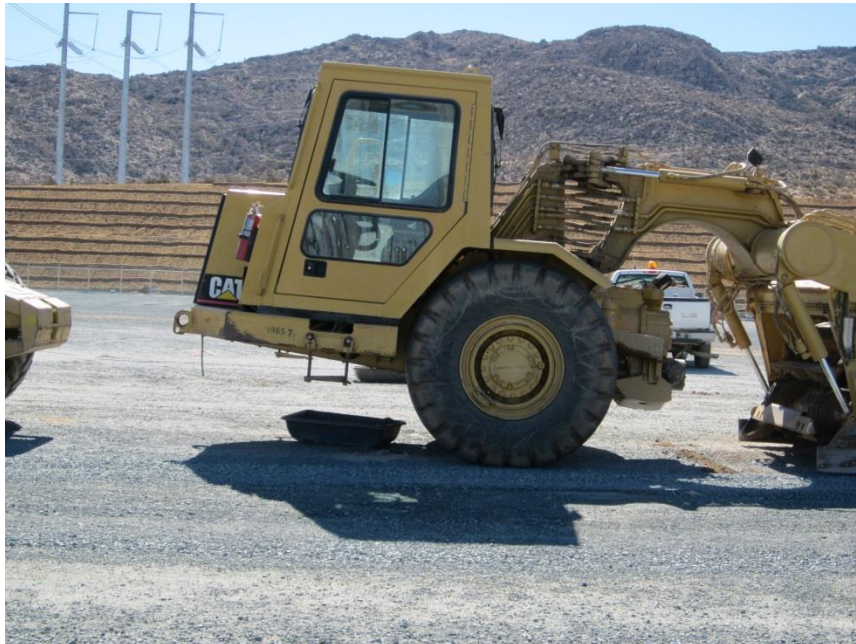
Construction equipment and staged materials throughout the substation were equipped with drip pan containment as stipulated by MM-HAZ-1a (see Photo 4 – Attachment A). Hazardous materials stored onsite were observed to be labeled and staged in proper containment bins per MM-HAZ-1a. As required by MM-HAZ1-c, trash storage bins were equipped with covers to avoid dispersal due to weather or wildlife.

Photo 4: Construction equipment and staged materials throughout the substation were equipped with drip pan containment as stipulated by MM-HAZ-1a.

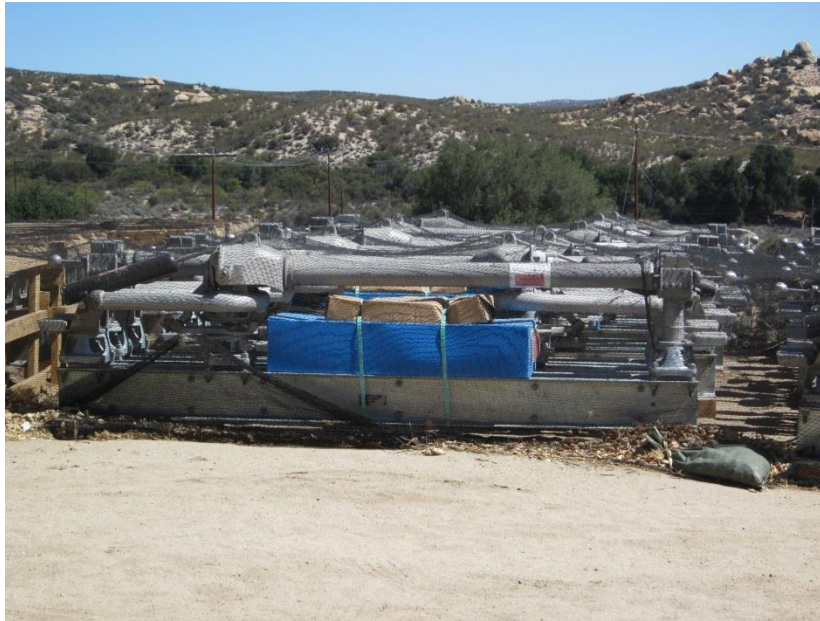
In compliance with BIO7j and in an attempt to reduce the risk of nesting bird settlement, staged equipment was being covered with thin netting so as to avoid bird or wildlife settlement or entrapment (see Photo 5 – Attachment A).

Photo 5: In compliance with BIO7j and in an attempt to reduce the risk of nesting bird settlement, staged equipment were observed being covered with thin netting so as to avoid bird or wildlife settlement or entrapment.

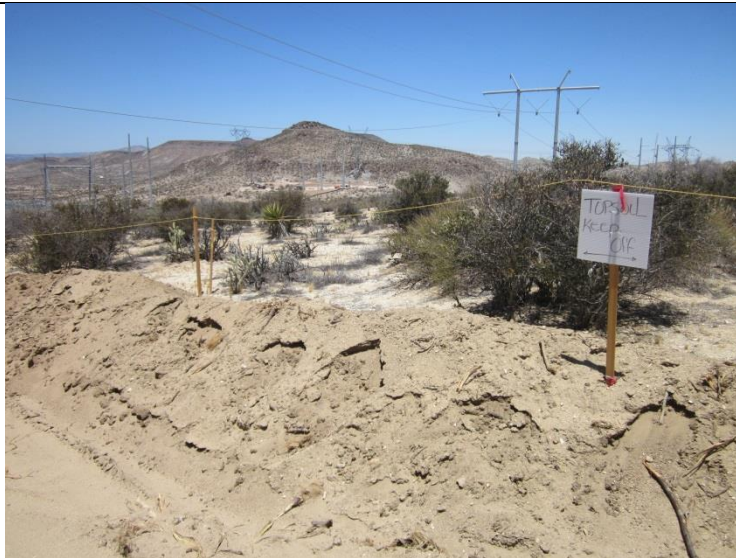
Topsoil salvaged during initial grading was stockpiled along slopes of the substation, set aside to be used during restoration efforts in accordance with MM-BIO-1d and the Habitat Restoration Plan (see Photo 6 – Attachment A).

Photo 6: Topsoil salvaged during initial grading was stockpiled along slopes of the substation to be used during restoration efforts in accordance with MM-BIO-1d and the Habitat Restoration Plan.
