<p>California Public Utilities Commission <i>Mitigation Monitoring, Compliance, and Reporting Program</i></p>
	<p>East County (ECO) Substation Project</p> <p>Compliance Status Report: 037</p> <p>August 31, 2014</p>

SUMMARY

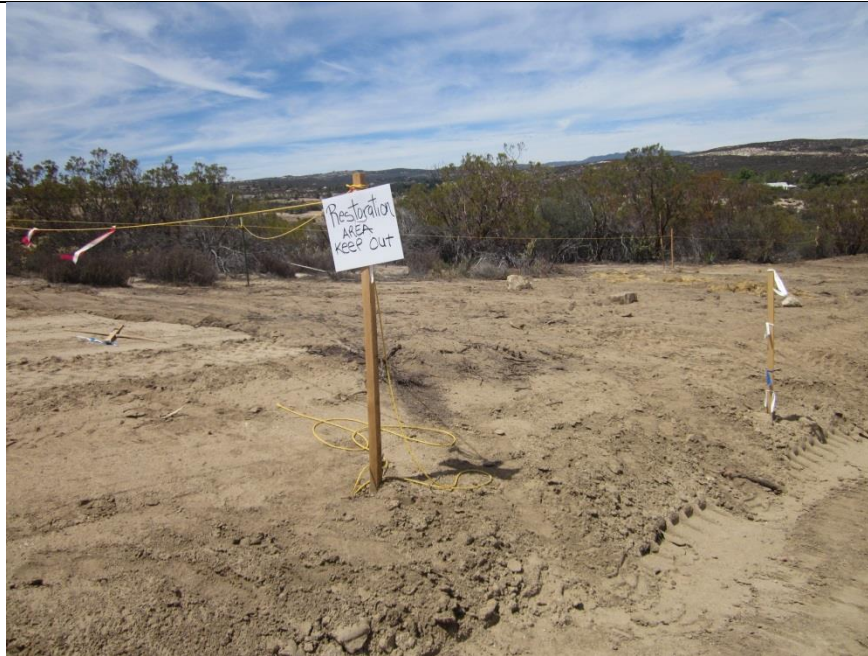
Topsoil was observed staged along the limits of work that will be utilized for restoration activities in accordance with MM-BIO-1d. In accordance with Habitat Restoration Plan, topsoil has been redistributed over a recontoured portion of the alignment and exclusion fencing has been installed to prevent access (See Attachment A- Photo 1).

Photo 1: In accordance with Habitat Restoration Plan and MM-BIO-1d, topsoil is redistributed over a recontoured portion of Section 1 underground, and exclusion fencing has been installed to prevent access.

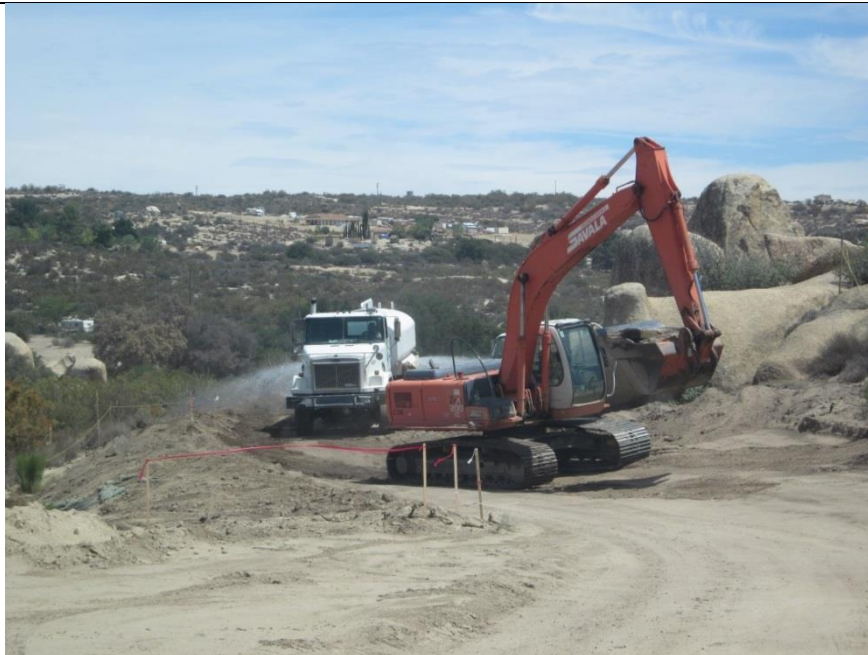
In accordance with MM-BIO4-A and MM-AQ-1, water trucks were used to control dust during finish grading of access roads north and south of Jewel Valley Road (See Attachment A- Photo 2). Drip pan containment bins were observed beneath equipment staged along the right-of-way in accordance with MM-HAZ-1a.

Photo 2: In accordance with MM-BIO4-A and MM-AQ-1, water trucks were used to control dust during finish grading of access roads north and south of Jewel Valley Road.

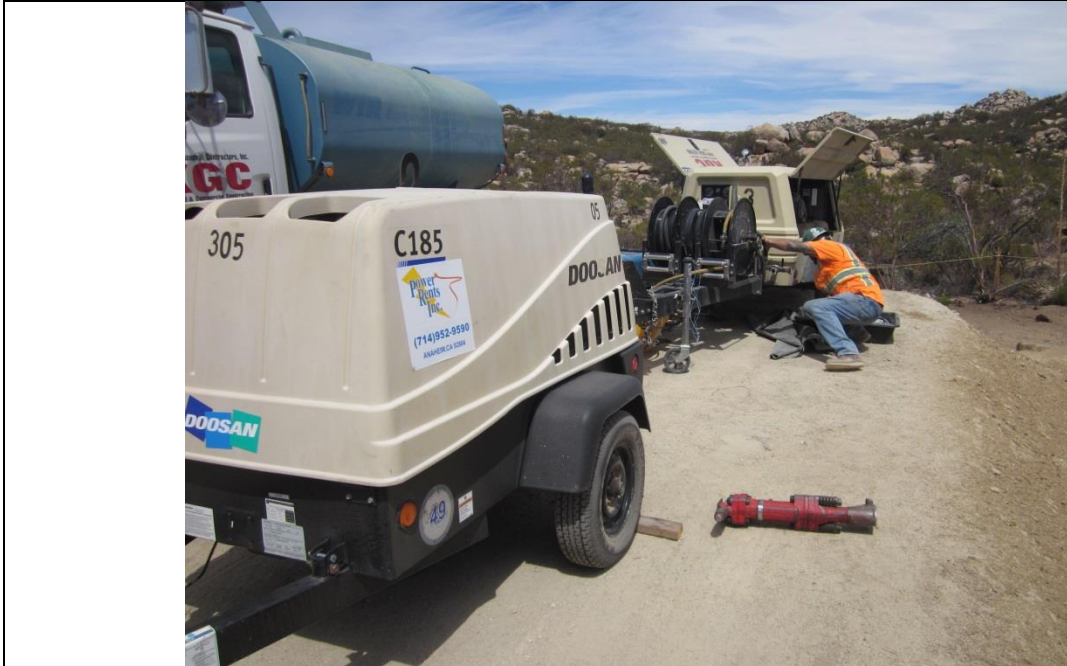
Erosion control measures consisting of straw wattles, silt fence and gravel bags are being maintained in accordance with the SWPPP and MM-HYD-1. Crews were diligent in placing drip pan containment under staged and active stationary equipment as required by MM-HAZ-1a (See Attachment A- Photo 3).

Photo 3: Crews at SP-50 were diligent in placing drip-pan containment under staged and active stationary equipment as required by MM-HAZ-1a.

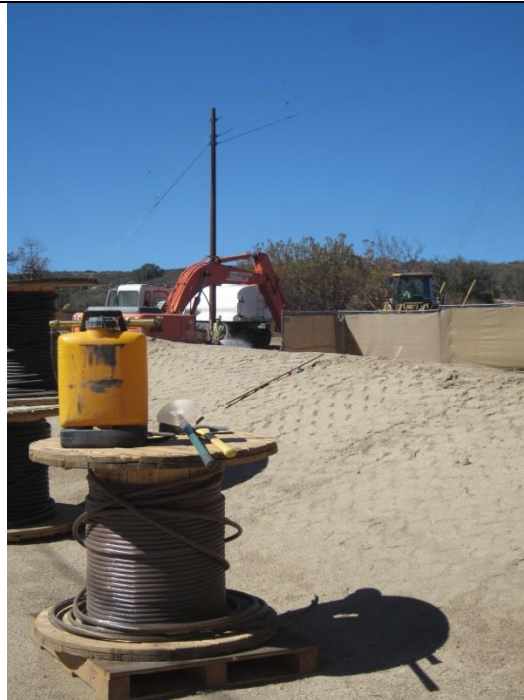
Throughout the substation, fire tools were set out at individual areas of work and attached to equipment for access in case of an emergency and in accordance with the Construction Fire Plan and MM-FF-1 (See Attachment A- Photo 4).

Photo 4: Throughout the substation, fire tools were set out at individual areas of work and attached to equipment for easy access in case of an emergency and in accordance with the Construction Fire Plan and MM-FF-1.

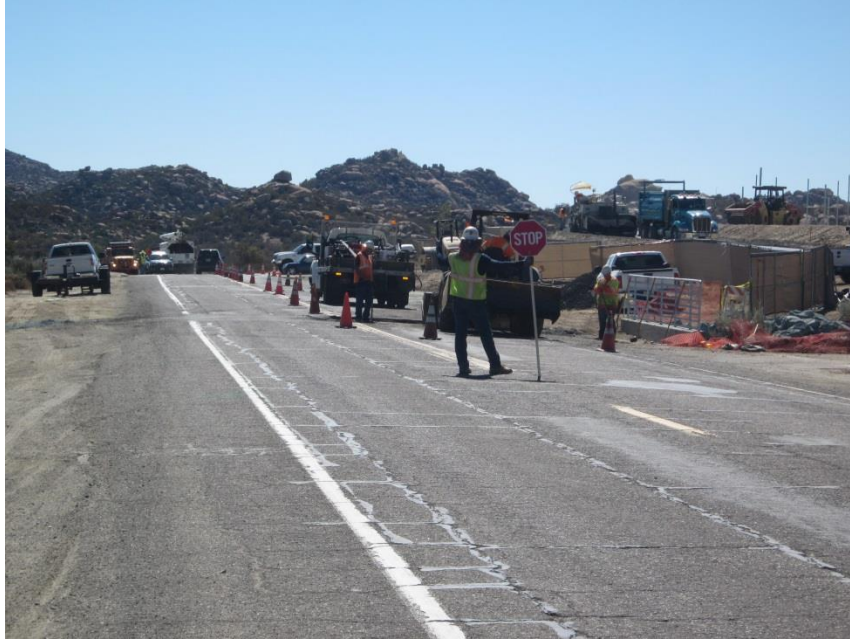
Traffic control was diligent in safely guiding local and project related traffic through flagged paving work areas on Old Highway 80 in accordance with MM-TRA-1 (See Attachment A- Photo 5).

Photo 5: Traffic control was diligent in safely guiding local and project related traffic through work areas on Old Highway 80 in accordance with MM-TRA-1.

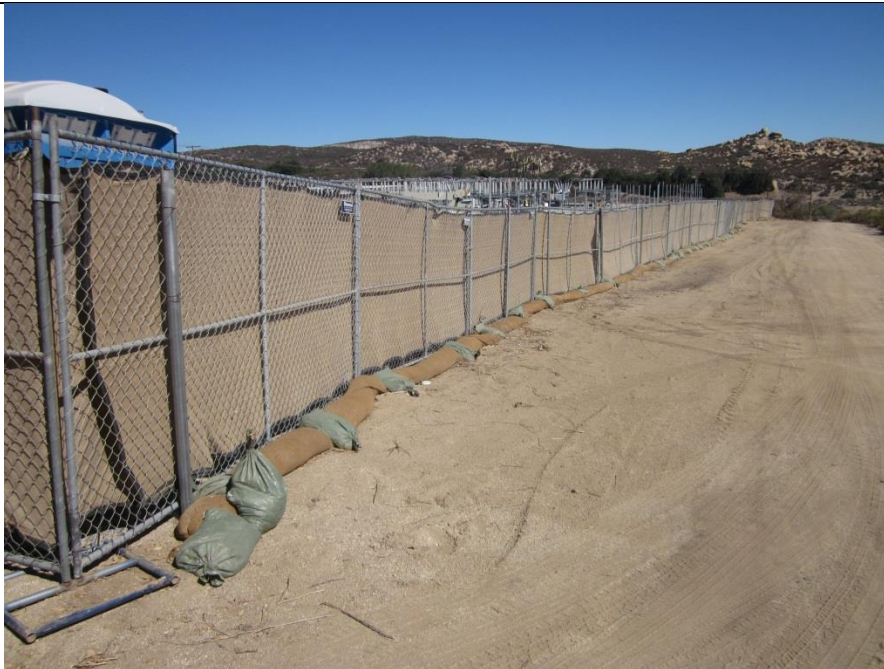
Erosion control measures consisting of straw wattle and silt fencing were observed installed and being maintained in accordance with MM-HYD-1 along the outside of the perimeter fencing. Visual screening fencing was in good condition in accordance with MM-VIS-3e (See Attachment A- Photo 6).

Photo 6: Erosion control measures consisting of straw wattles were observed installed and being maintained in accordance with MM-HYD-1. Visual screening fencing was in good condition in accordance with MM-VIS-3e.
