<p>California Public Utilities Commission <i>Mitigation Monitoring, Compliance, and Reporting Program</i></p>
	<p>East County (ECO) Substation Project</p> <p>Compliance Status Report: 038</p> <p>September 14, 2014</p>

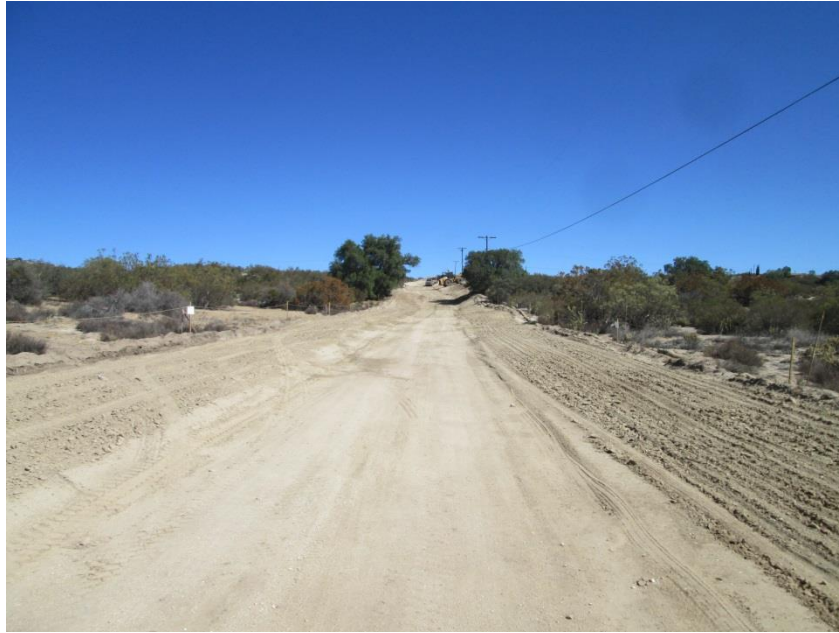
Restoration efforts were observed being completed in accordance with MM-BIO-1d and the associated Habitat Restoration Plan. Crews were observed re-contouring construction areas to pre-construction contours and elevations. Topsoil that was stockpiled during grading and grubbing was also being returned to restoration areas (see Attachment A – Photo 1). The restoration areas will continue to be monitored and measures implemented until success criteria is reached, which includes at least 60% of total vegetation cover to be achieved for each plant community, relative to the adjacent reference site with similar vegetation.

Photo 1: In accordance with Habitat Restoration Plan and MM-BIO-1d, construction crews return the right-of-way to pre-construction contour conditions.

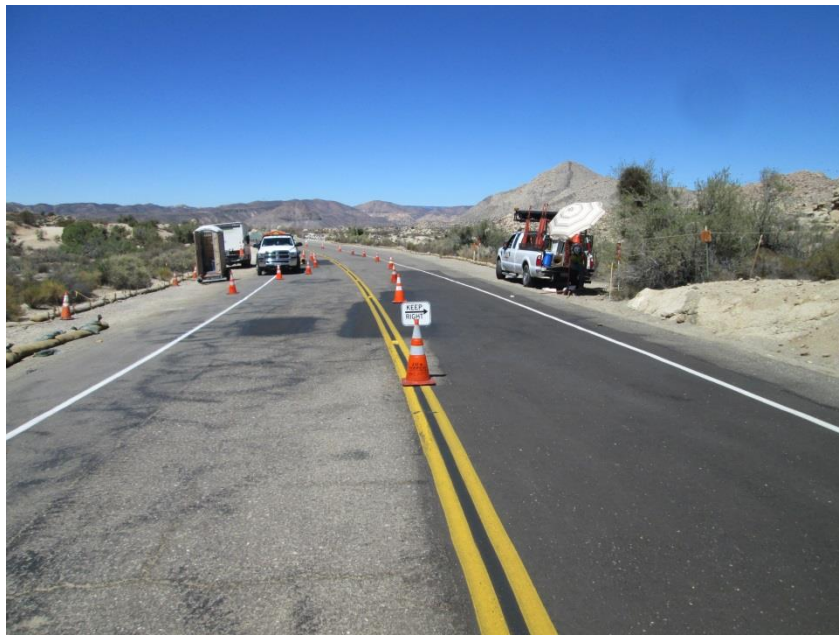
In accordance with MM-BIO4-A and MM-AQ-1, water trucks were used to control dust during construction activities. Drip pan containment bins were observed beneath equipment staged along the right-of-way in accordance with MM-HAZ-1a. Traffic control Measures including informational signs and flaggers were observed in place during construction activities along Old Highway 80 in accordance with MM-TRA-1 (see Attachment A – Photo 2).

Photo 2: Traffic control measures consisting of signage and flaggers were observed being implemented during construction along Old Highway 80 in accordance with MM-TRA-1.

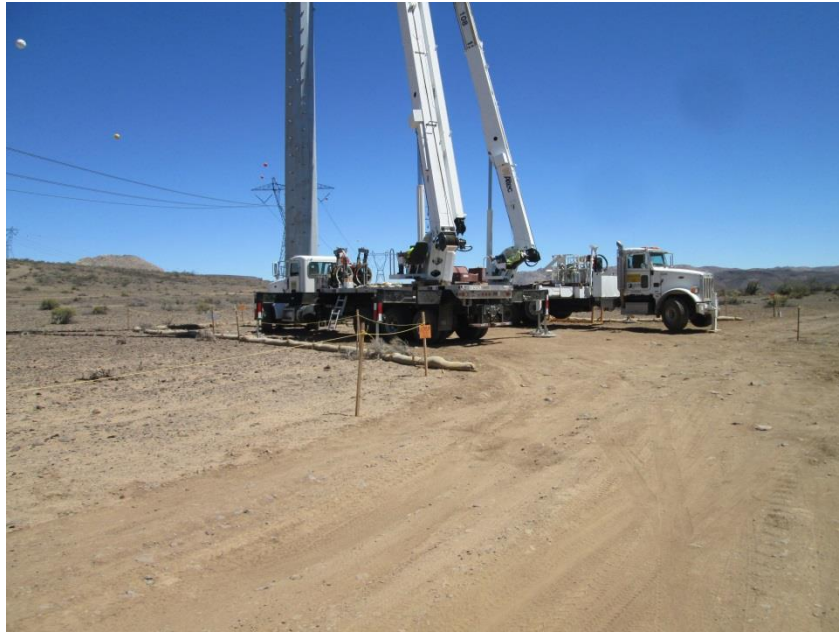
Erosion control measures consisting of straw wattles, silt fence and gravel bags are being maintained in accordance with the SWPPP and MM-HYD-1 (See Attachment A – Photo 3). In accordance with MM-Haz-1a and the associated Hazardous Materials Management Plan, secondary containment and countermeasures were observed to be in place and functional throughout construction so that if any leaks or spills occur, responses can be made immediately.

Photo 3: Erosion control measures consisting of straw wattles, silt fence and gravel bags are being maintained at steel pole pad sites in accordance with the SWPPP and MM-HYD-1.

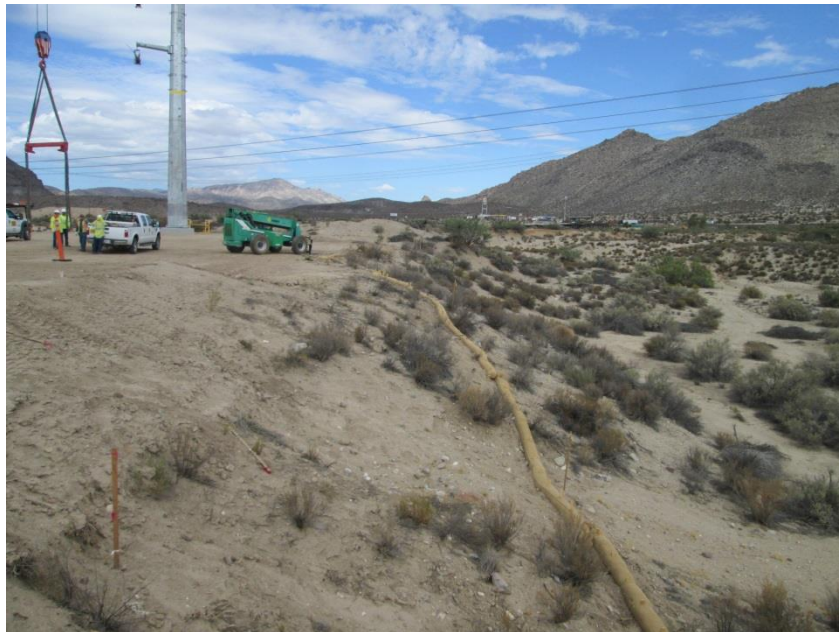
Biological monitors were on site to ensure construction activities remained within the approved work limits and to monitor for sensitive wildlife species (MM-BIO-1a and MM-BIO-1c) (see Attachment A – Photo 4). All excavations were inspected daily prior to construction activities and throughout the day to ensure that no wildlife species had become entrapped in accordance with MM-BIO-7e.

Photo 4: Biological monitors were on site to ensure construction activities remained within the approved work limits and to monitor for sensitive wildlife species (MM-BIO-1a and MM-BIO-1c).

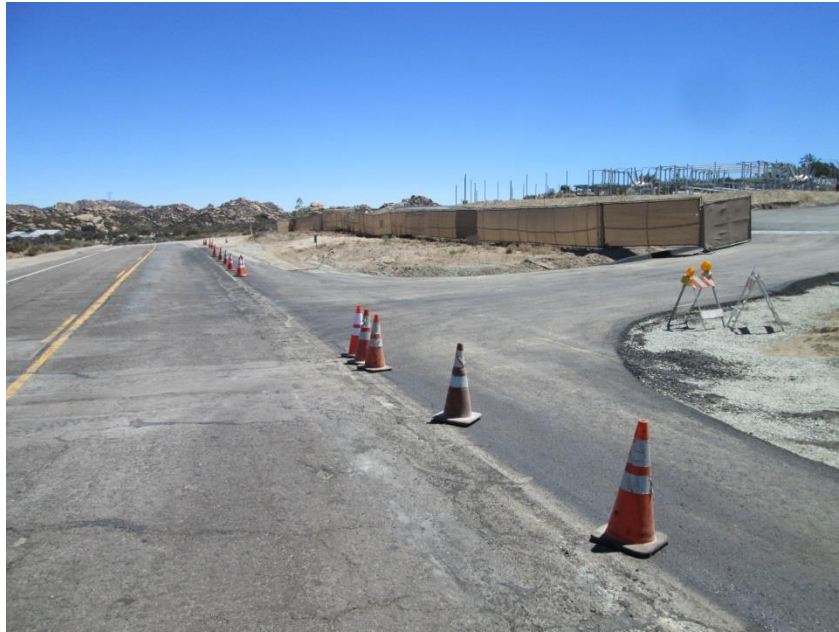
In accordance with MM-VIS-3a, the perimeter security fence includes screening material that is being maintained (see Attachment A – Photo 5). A 15,000 gallon water tank has been constructed at the Boulevard Substation in accordance with MM-FF-4 and the Fire Protection Plan (FPP) (see Attachment A – Photo 6). The water tank has been colored desert tan as specified in the Surface Treatment Plan (MM-VIS-3g).

Photo 5: In accordance with MM-VIS-3a, the perimeter security fence includes screening material that is being maintained.

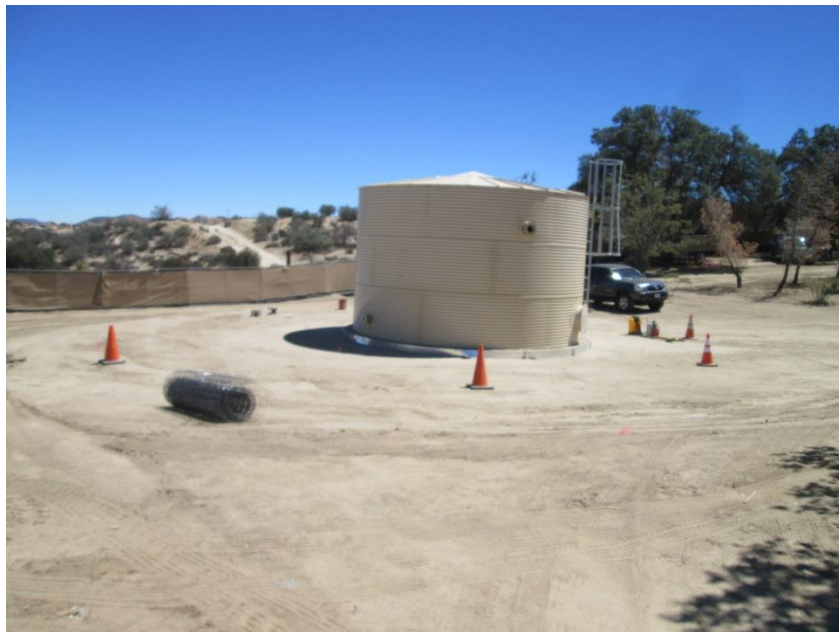
Photo 6: A 15,000 gallon water tank has been constructed at the Boulevard Substation Rebuild in accordance with MM-FF-4 and the Fire Protection Plan (FPP).
