<p><b>California Public Utilities Commission</b> <b><i>Mitigation Monitoring, Compliance, and Reporting Program</i></b></p>
	<p><b>East County (ECO) Substation Project</b></p> <p><b>Compliance Status Report: 041</b></p> <p><b>October 26, 2014</b></p>

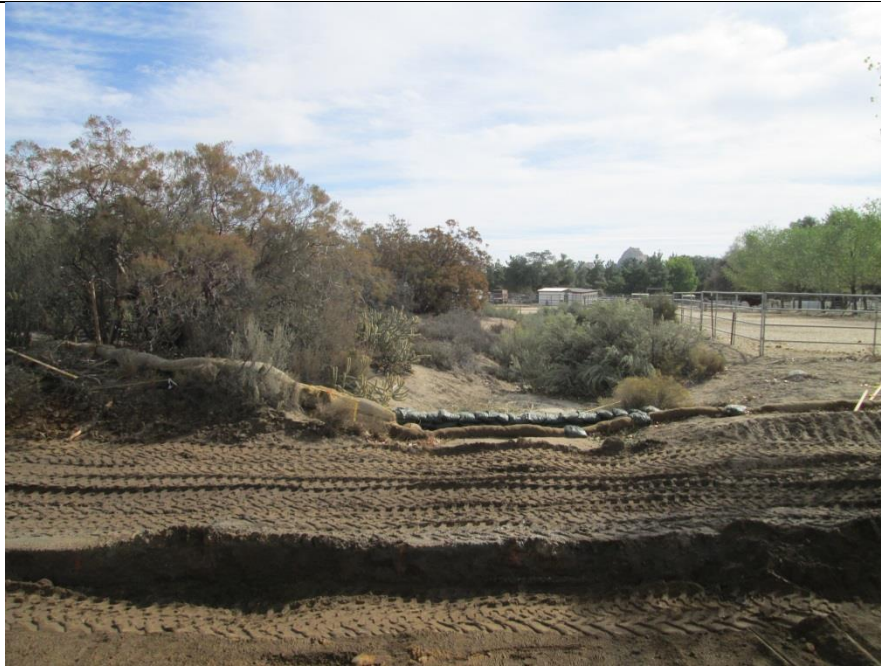
Erosion control measures consisting of straw wattles, silt fence and gravel bags are being maintained along the right-of-way in accordance with the SWPPP and MM-HYD-1 (see Photo 1 – Attachment A).

**Photo 1:** Erosion control devices were observed being maintained in accordance with MM-HYD-1.

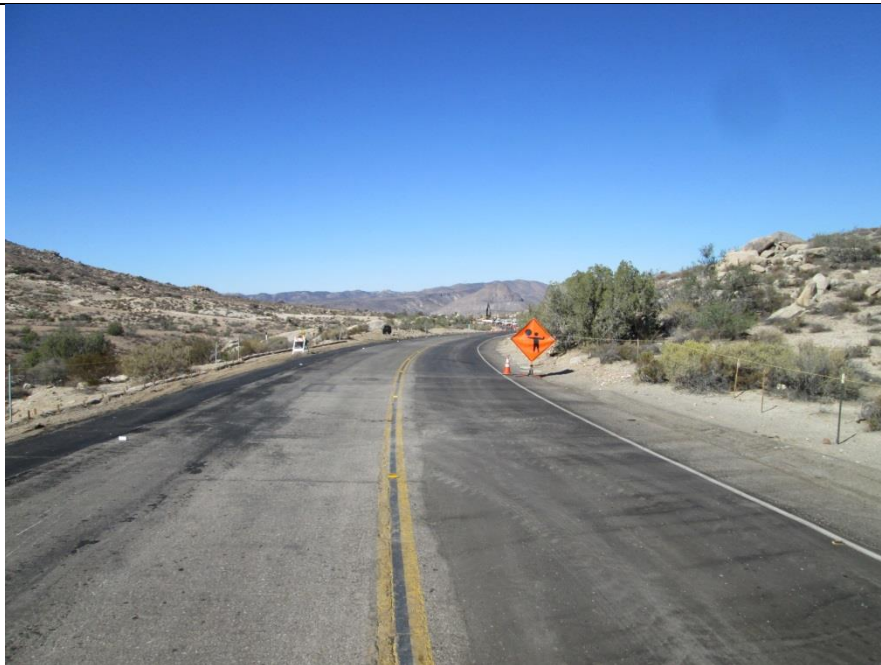
**Photo 2:** Signage is placed along Old Highway 80 notifying motorists of construction activities in accordance with MM-TRA-1.

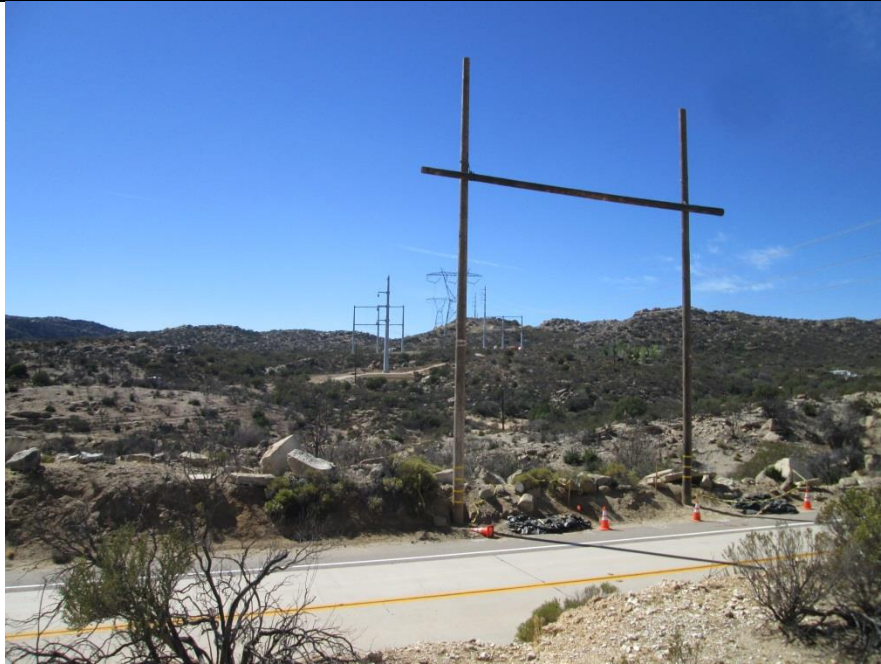
Traffic control measures consisting of a flagger and signage were in place during sock line flying across Old Highway 80 in accordance with MM-TRA-1. Temporary guard structures were observed constructed during activities associated with flying sock line to ensure safety for motorists along Old Highway 80 (see Photo 3 – Attachment A).

**Photo 3:** Temporary guard structures were observed constructed during activities associated with flying sock line to ensure safety for motorists along Old Highway 80.

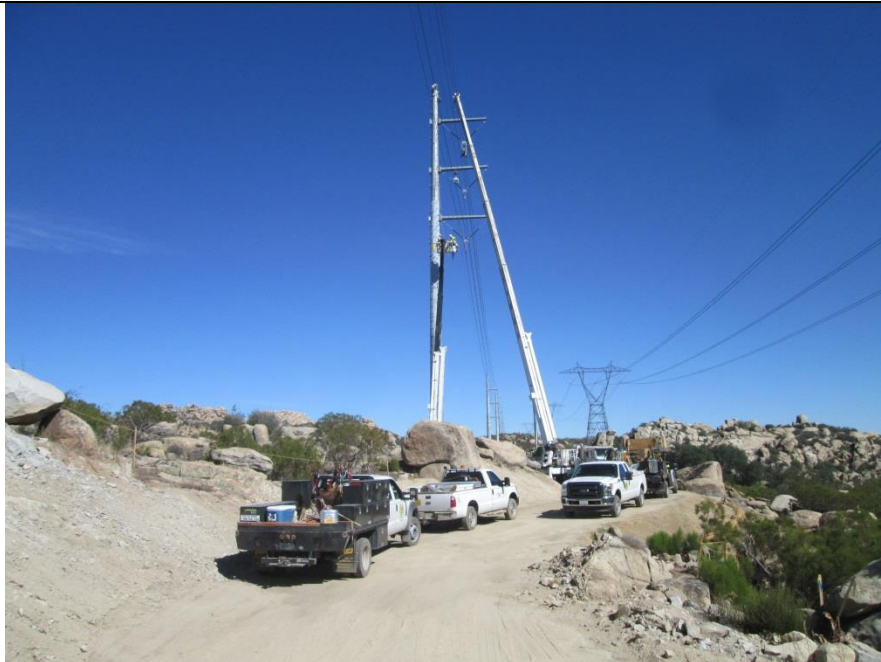
In accordance with MM-BIO-1c, biological monitors were onsite to survey areas of active construction for compliance with biological mitigation measures and crews were observed remaining within the approved work limits (see Photo 4 – Attachment A). Topsoil was observed staged along the limits of work that will be utilized for restoration activities in accordance with MM-BIO-1d. Drip pan containment bins were observed beneath equipment staged along the right-of-way in accordance with MM-HAZ-1a and spill kits were accessible in case of hazardous materials leak.

**Photo 4:** Crews were observed completing dead-end work at SP-48 within the approved work limits. Biological monitors were observed monitoring activities in accordance with MM-BIO-1c.

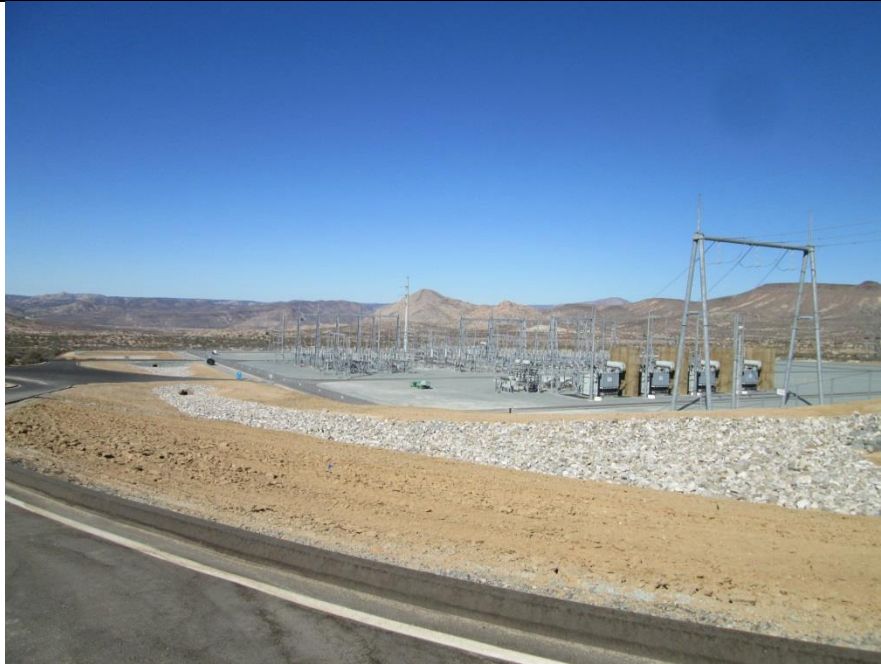
In accordance with MM-BIO-1d, crews were observed re-distributing topsoil where temporary trailers were staged, as well as staking locations for potted plants. In accordance with the Surface Treatment Plan and MM-VIS-3g, the Transformer Fire Walls at the ECO Substation have been surfaced treated “Toffee Bar” (see Attachment A — Photo 5).

**Photo 5:** In accordance with the Surface Treatment Plan and MM-VIS-3g, the Transformer Fire Walls at the ECO Substation have been surfaced treated “Toffee Bar”.

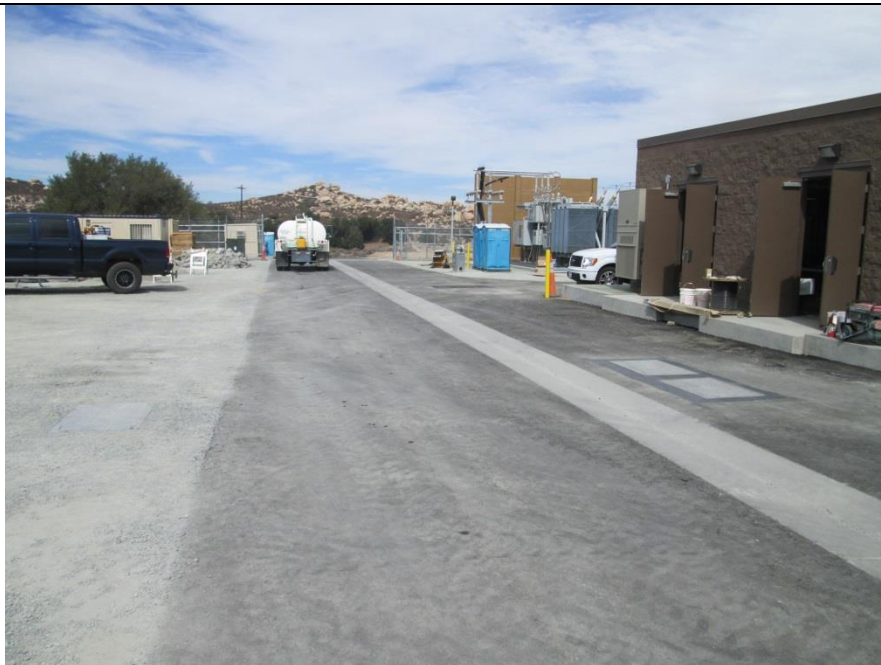
In accordance with the Surface Treatment Plan and MM-VIS-3g, the control shelter at the Boulevard Substation Rebuild have been surfaced treated “Otay Ranch Brown” (see Attachment A — Photo 6).

**Photo 6:** In accordance with the Surface Treatment Plan and MM-VIS-3g, the control shelter at the Boulevard Substation Rebuild have been surfaced treated “Otay Ranch Brown”.
