| | <p><b>California Public Utilities Commission</b><br/> <b><i>Mitigation Monitoring, Compliance, and Reporting Program</i></b></p> |
| | <p><b>East County (ECO) Substation Project</b></p> <p><b>Compliance Status Report: 019</b></p> <p><b>December 30, 2013</b></p> |

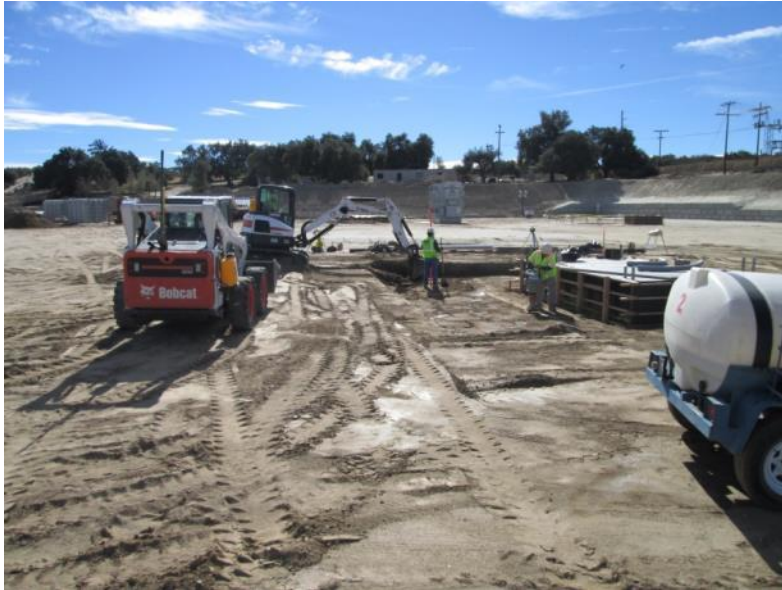
Concrete washout stations were being utilized by construction crews during foundation pours in accordance with the Stormwater Pollution Prevention Plan (SWPPP) and MM-HYD-1 (see photo 1 – Attachment A).

**Photo 1:** Construction activities associated with pouring concrete foundations at the Boulevard Substation continued during this reporting period. A concrete washout bin was observed being utilized and maintained in good condition in accordance with the SWPPP and MM-HYD-1.

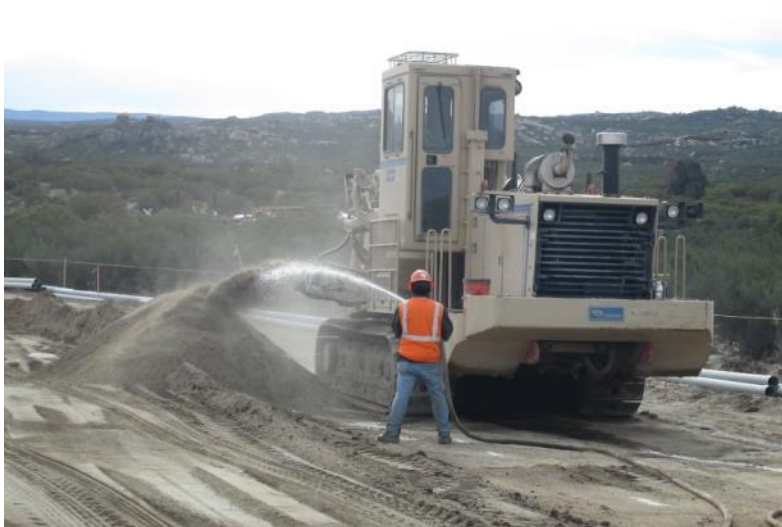
Dust control measures consisting of watering areas of active construction (see photo 2 – Attachment A), maintaining speed limits below 15 miles per hour along unpaved roads, and placement of rattle plates and rock aprons to minimize trac-out along paved roadway surfaces were being implemented in accordance with the Dust Control Plan and MM-BIO-4a.

**Photo 2:** Dust suppression measures consisting of watering down areas of active construction was observed being implemented during trenching activities in accordance with MM-Bio-4a and the Dust Control Plan.

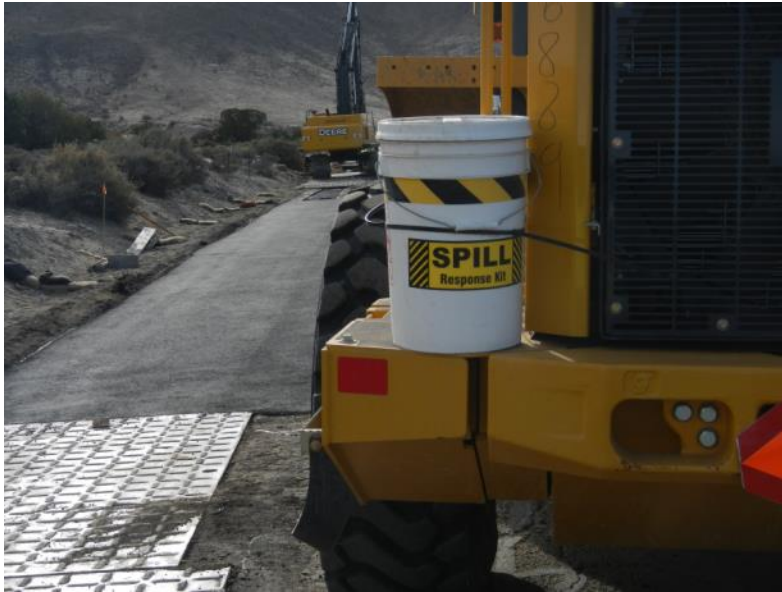
Spill kits were present on construction equipment in accordance with the Hazardous Materials Management Plan and MM-HAZ-1a. Spill kits are being maintained on construction equipment to ensure materials are readily accessible for clean-up of small spills (see photo 3 – Attachment A).

**Photo 3:** In accordance with MM-HAZ-1a and the Hazardous Materials Management Plan, spill response kits were observed being maintained on construction equipment.

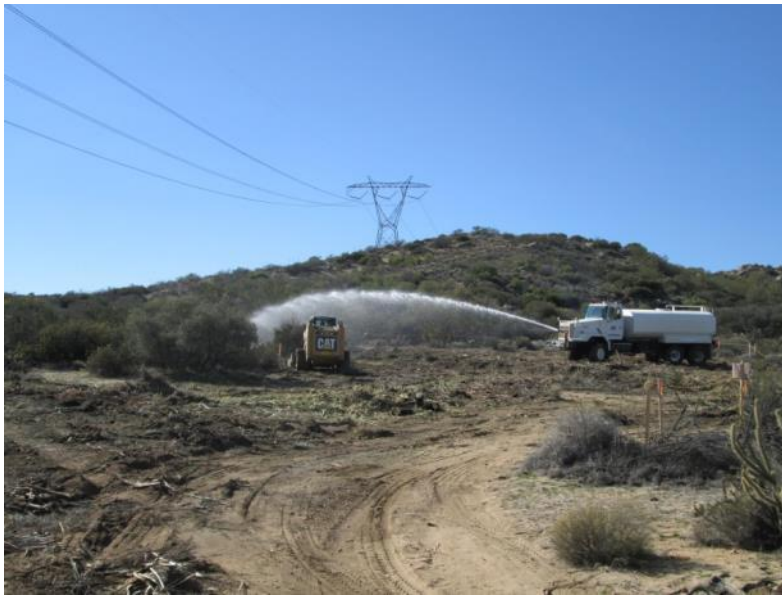
Construction crews were observed removing vegetation at steel pole #65 (see photo 4 – Attachment A). In accordance with the Dust Control Plan and MM-BIO-4a, water trucks were present watering down areas of active construction to minimize fugitive dust. Speed limit signs have also been posted along

**Photo 4:** Vegetation being removed within the approved work limits at the pad site for steel pole #65. Work was observed being completed within the approved work limits in accordance with MM-BIO-1a. A water truck was also observed to be present minimizing fugitive dust emissions in accordance with MM-BIO-4a and the Dust Control Plan.

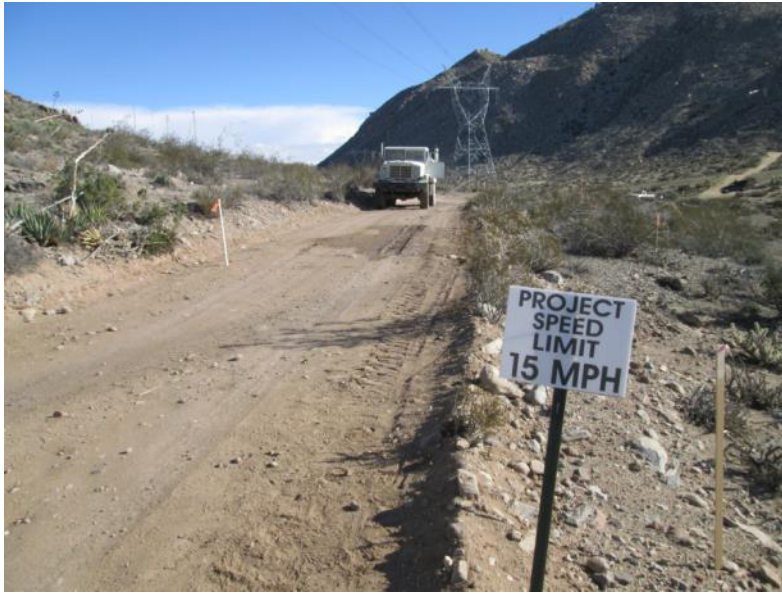
access roads as a reminder to construction personnel that project speeds are to be maintained below 15 miles per hour along unpaved roadway surfaces (see photo 5 – Attachment A).

**Photo 5:** Speed limit signs posted along access roads to remind construction crews to maintain speeds below 15 miles per hour while traveling along unpaved roads in accordance with MM-BIO-7b.

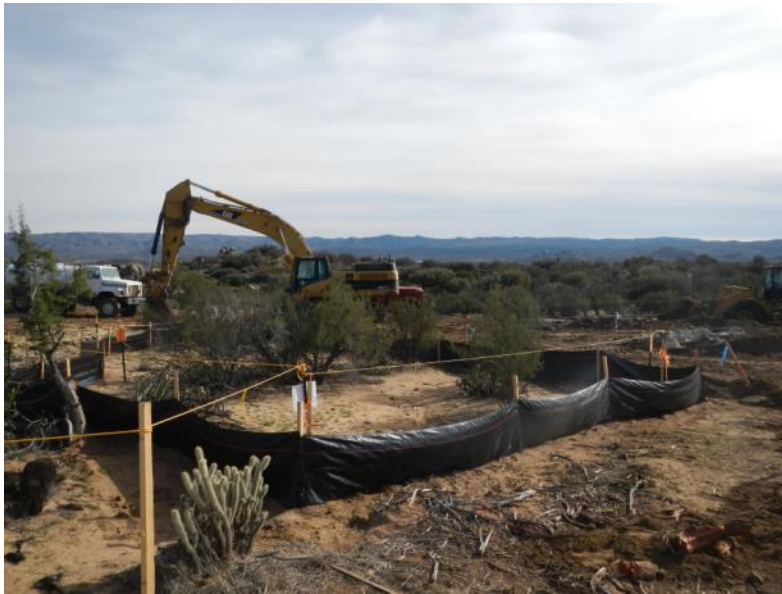
Erosion control measures consisting of silt fence, gravel bags and straw wattles have been placed along the right-of-way to minimize the potential for erosion to occur. Silt fences were observed in place and being maintained at steel pole #64 during ground disturbance activities (see photo 6 – Attachment A).

**Photo 6:** Erosion control measures consisting of silt fence was in place prior to ground disturbance activities and is being maintained at steel pole #64 in accordance with MM-HYD-1 and the SWPPP.

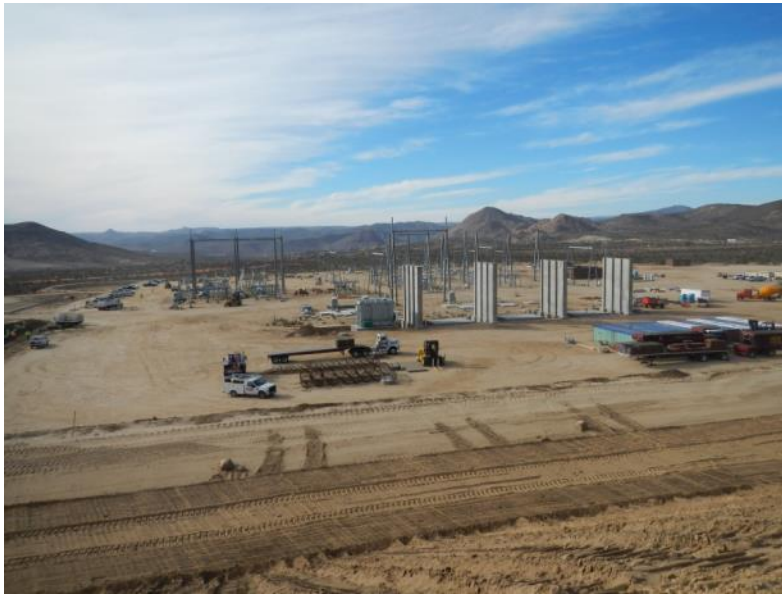
Construction activities at the ECO Substation consisted of pouring foundations for substation equipment, erecting A-frame structures, and installation of the 500 kV transformers (see photos 7 and 8 – Attachment A).

**Photo 7:** An overview of the ECO substation looking west towards Old Highway 80.

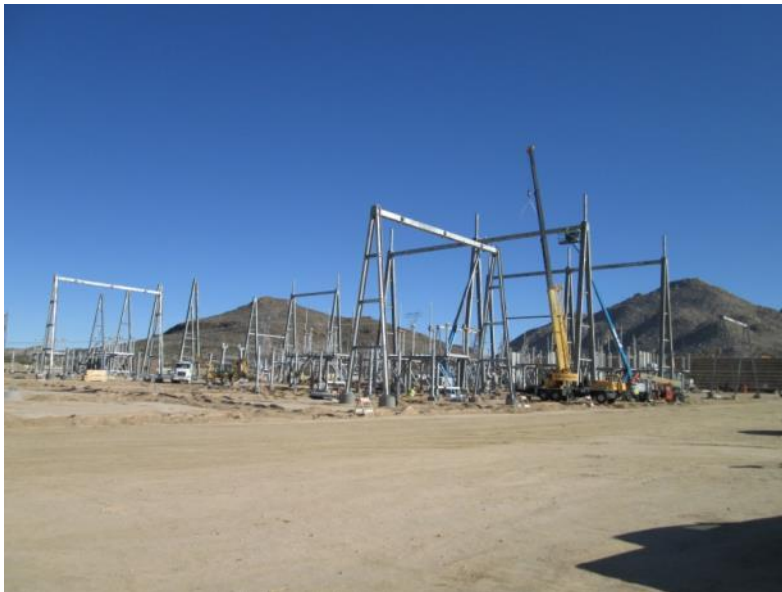
**Photo 8:** A crane is utilized to erect A-frame structures at the 230 kV bay within the ECO Substation.
