<p>California Public Utilities Commission <i>Mitigation Monitoring, Compliance, and Reporting Program</i></p>
	<p>East County (ECO) Substation Project</p> <p>Compliance Status Report: 008</p> <p>July 22, 2013</p>

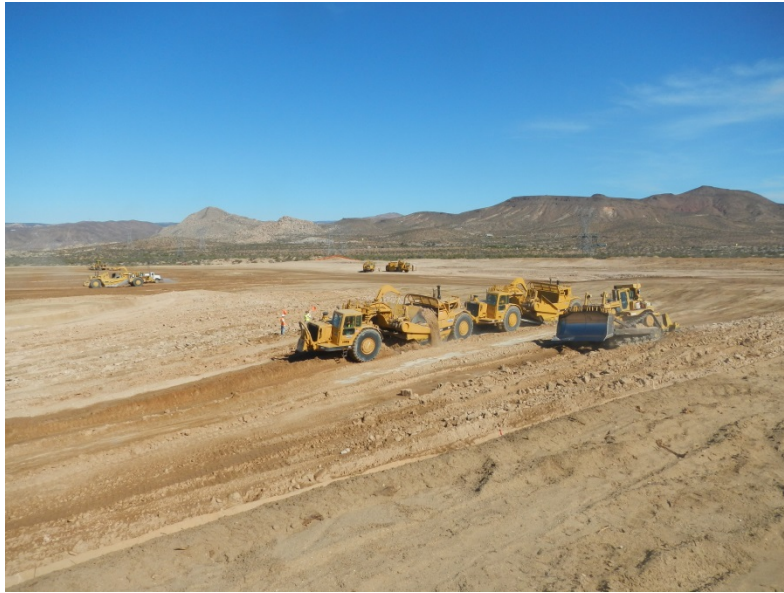
Constructions crews continued earthwork activities at the ECO Substation site during this reporting period (see Photo 1 –Attachment A). In accordance with Mitigation Measures CUL-1A and CUL-1D, Environmentally sensitive areas (ESAs) have been clearly identified in the field via use of signage and

Photo 1: Biological monitors ensured that all construction activities remain within the approved work limits in accordance with Mitigation Measure BIO-1A

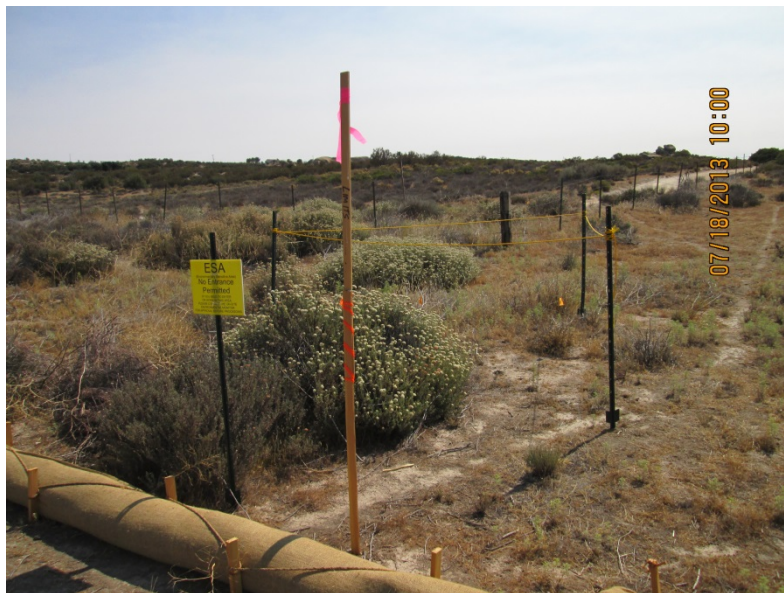
flagging material (see Photo 2 – Attachment A). Archeological and Biological monitors were present monitoring all earthwork activities..

Photo 2: Environmentally sensitive areas (ESAs) clearly delineated in accordance with Mitigation Measures CUL-1A and CUL-1D.

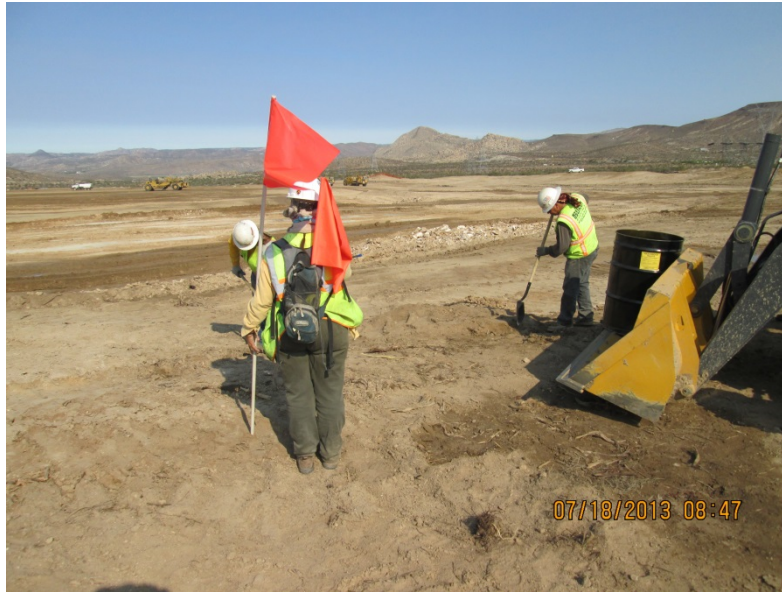
In accordance with Mitigation Measure HAZ-5a and the Spill Prevention Control and Countermeasure Plan, stained soils were observed being removed by construction crews via use of spill kits stored on-site (see Photo 3 – Attachment A). Contaminated soils and materials were placed in the appropriate storage bins and labeled (Photo 4 – Attachment A).

Photo 3: Construction crews remove stained soil in accordance with Mitigation Measure HAZ-5a and the Spill Prevention Control and Countermeasure Plan.

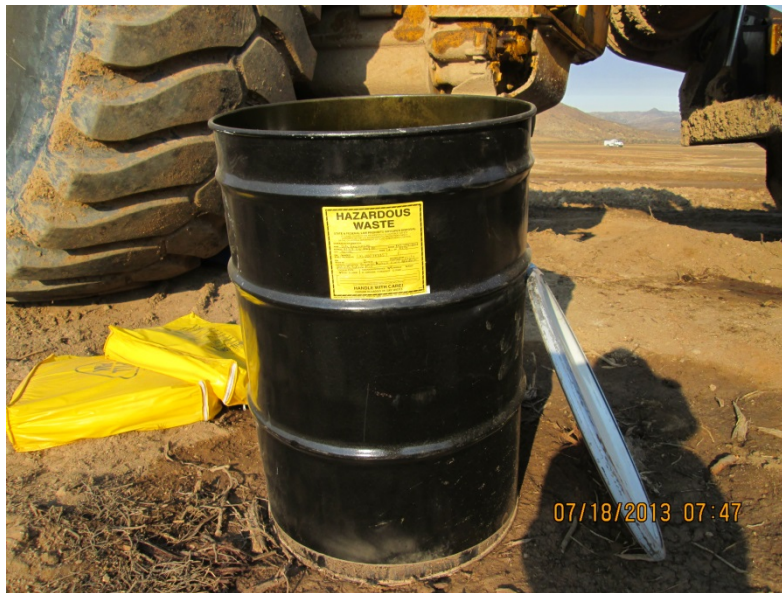
Photo 4: In accordance with Mitigation Measure HAZ-5a, waste is properly disposed of in a labeled container.

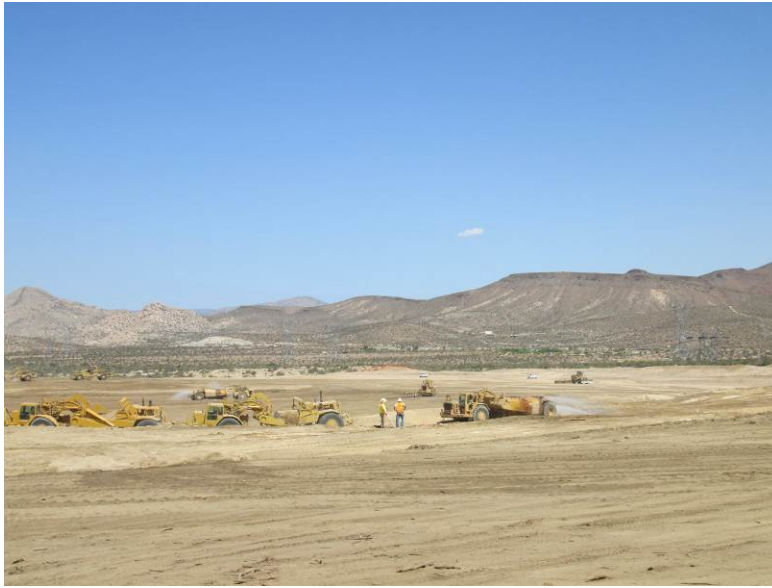
Water haul trucks were observed delivering water to the temporary retention basin, where water is being stored for use by water trucks and water pulls during grading activities. Crews were observed utilizing water to minimize fugitive dust emissions in accordance with Mitigation Measure AQ-1 (see Photo 5 – Attachment A).

Photo 5: Water being utilized for dust control during earthwork activities in accordance with Mitigation Measure AQ-1

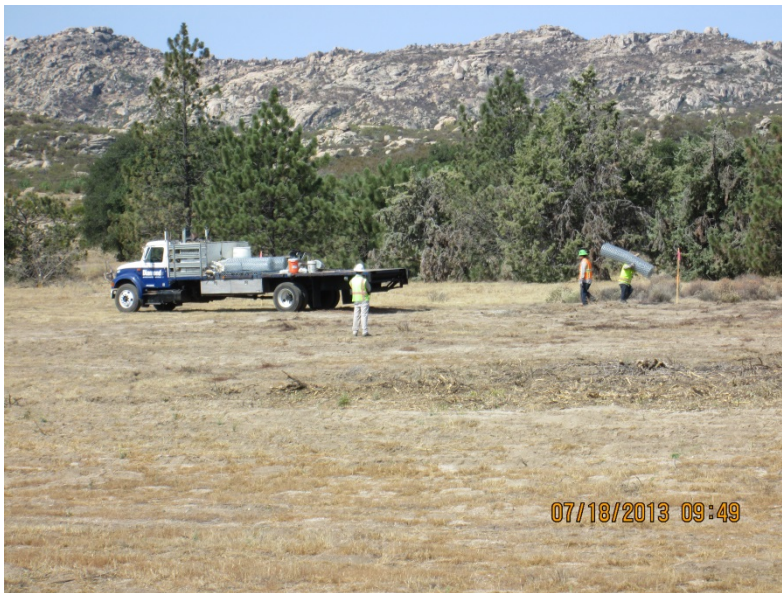
SDG&E continued clearing and grubbing activities at the Jewel Valley Fly Yard during this reporting period. The Jewel Valley Fly Yard will be utilized for the staging and storage of materials including but not limited to storage of construction equipment, temporary construction trailers field and for helicopter operations, maintenance, storage, and refueling. Fencing was installed around the fly yard in order to clearly designate the work limits. Biological monitors ensured that the construction of the fence occurred within approved work limits as required by Mitigation Measure BIO-1A (see Photo 6 – Attachment A).

Photo 6: A biological monitor oversees construction activities associated with fence installation in accordance with Mitigation Measure BIO-1a.

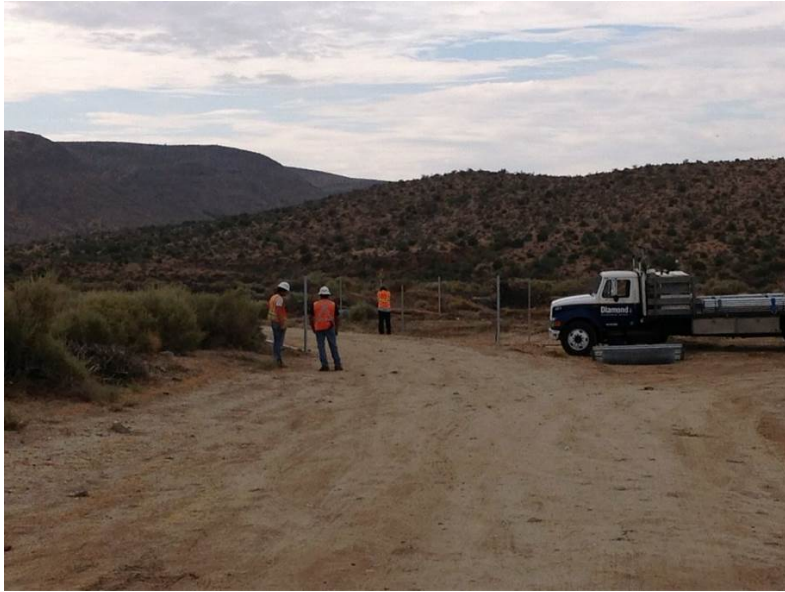
Photo 7: Native American and archaeological monitors present during fence installation at the Carrizo Gorge Yard #1 in accordance with Mitigation Measure CUL-1D.

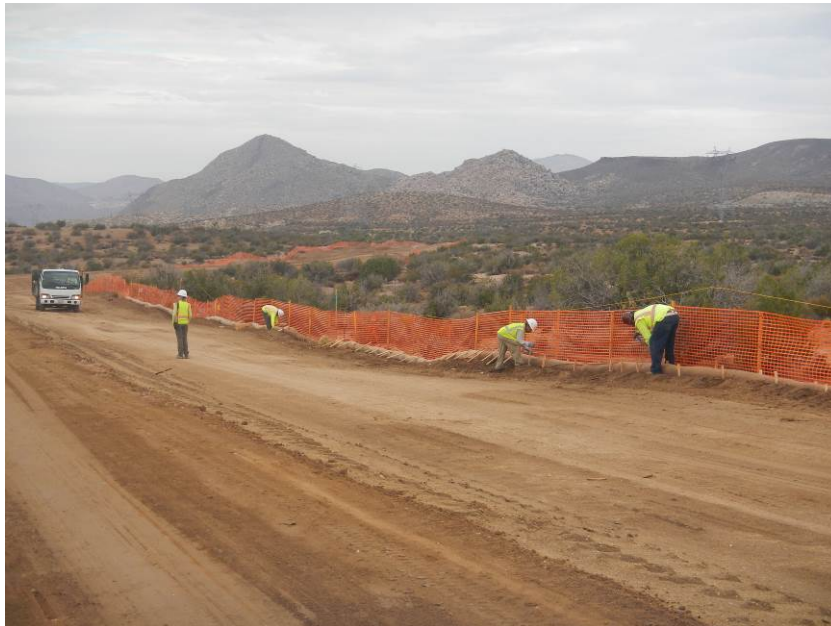
In accordance with the approved Minor Project Refinement Request 003, SDG&E began to clear and grub Carrizo Gorge Fly Yards 1 and 2. Construction activities observed during this reporting period consisted of clearing vegetation. Fencing was also installed along the perimeter of Carrizo Gorge Construction Yards 1 and 2 to prevent unauthorized access. Native American and Archeological monitors were on site during all fencing activities as is required by Mitigation Measure CUL-1D (see Photo 7 – Attachment A). BMP's consisting of straw wattles and silt fencing was installed at the Carrizon Gorge Fly Yard in accordance with Mitigation Measure HYD-4 (see Photo 8- Attachment A).

Photo 8: BMP's consisting of straw wattles and silt fencing are installed along the Southern Access Road in accordance with the SWPPP and Mitigation Measure HYD-4.
