<p>California Public Utilities Commission <i>Mitigation Monitoring, Compliance, and Reporting Program</i></p>
	<p>South Bay Substation Relocation Project</p> <p>Compliance Status Report: 015</p> <p>September 30, 2015</p>

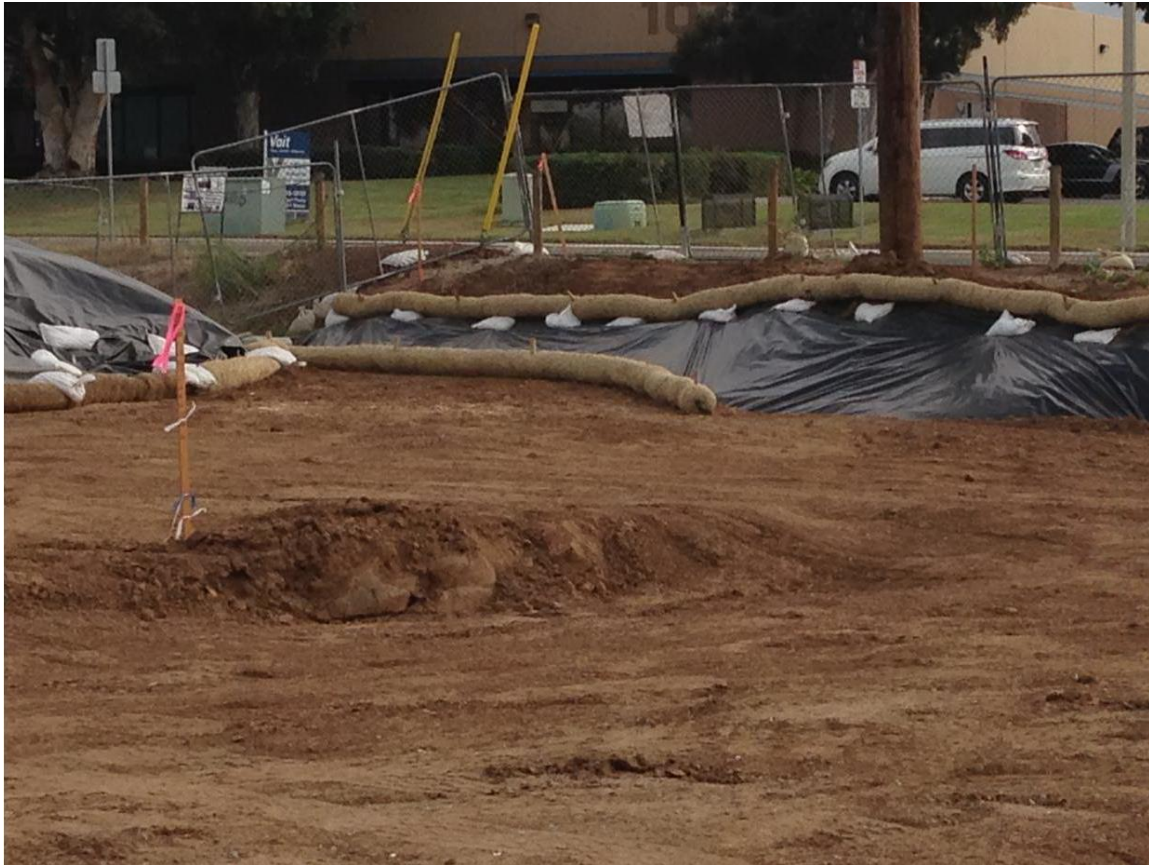
- Installing and maintaining Storm Water Pollution Prevention Plan (SWPPP) Best Management Practices (BMPs) (See Photo 1—Attachment A)
- General grading and compaction activities
- Delivery of a transformer and placement of the 230 kilovolt (kV) transformers onto transformer pads

Photo 1: Prior to an anticipated rain event, visqueen secured by gravel bags and straw wattles were observed along the Bay Boulevard Substation box culvert/southern driveway in accordance with the SWPPP. Stockpiles were also secured with visqueen, gravel bags, and straw wattles prior to the event, and runoff was not reported.

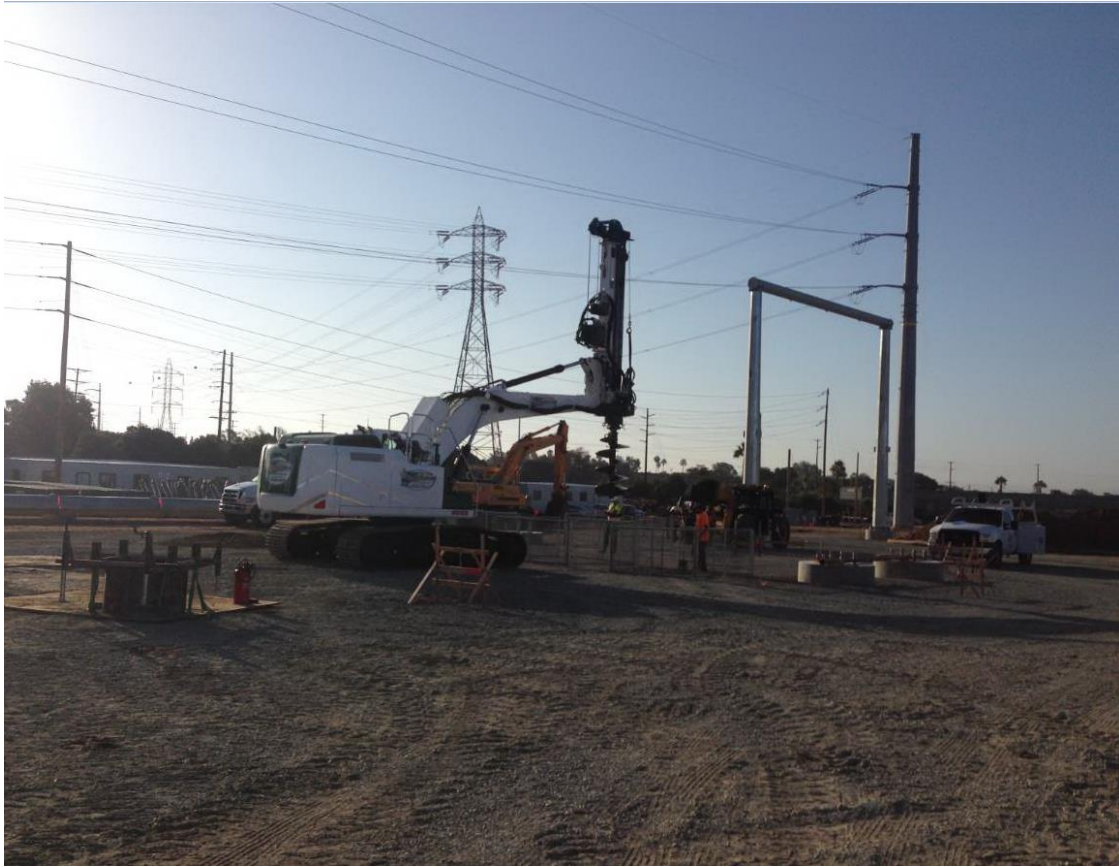
- Drilling for and setting foundations, setting rebar cages, and pouring concrete (See Photo 2—Attachment A)
- Bioswale: Grading and backfilling activities for the swale and slopes

Photo 2: Drilling for tower foundations at the Bay Boulevard Substation 230kV pad.

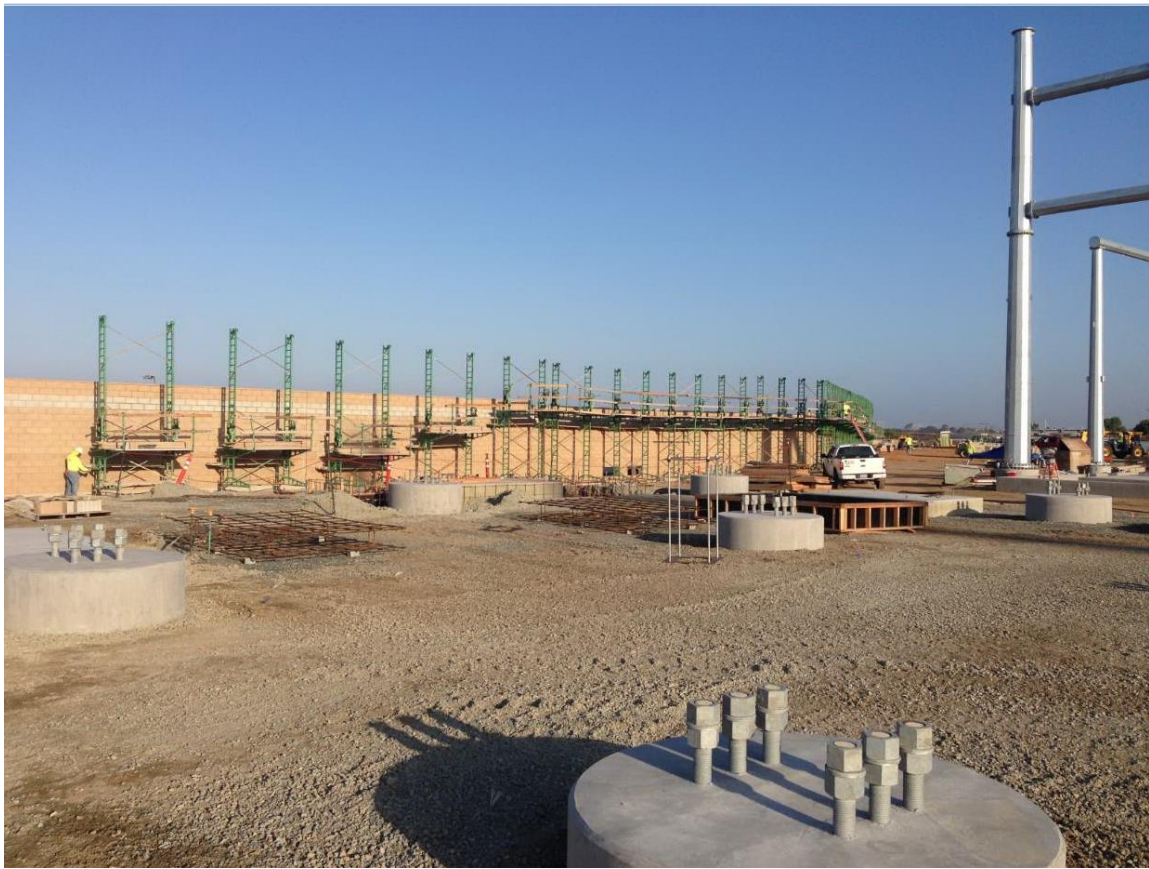
- Bioretention Basin: Installing perforated drain pipe and gravel
- Screen Wall and Control Shelter: Excavating, placing forms and rebar, and pouring concrete for the screen wall footing and conducting masonry work (See Photo 3—Attachment A)

- Erecting steel structures (See Photo 3—Attachment A)
- Duct Banks: Installing the duct bank adjacent to the southern screen wall footing; installing the duct bank adjacent to the southern driveway; trenching for and installing the duct bank near the northern driveway

Photo 3: Masonry work on the construction screening wall (above) and control shelter continued this reporting period. Vertical components of the Bay Boulevard Substation (structural steel, above, right) was observed being erected by equipment.

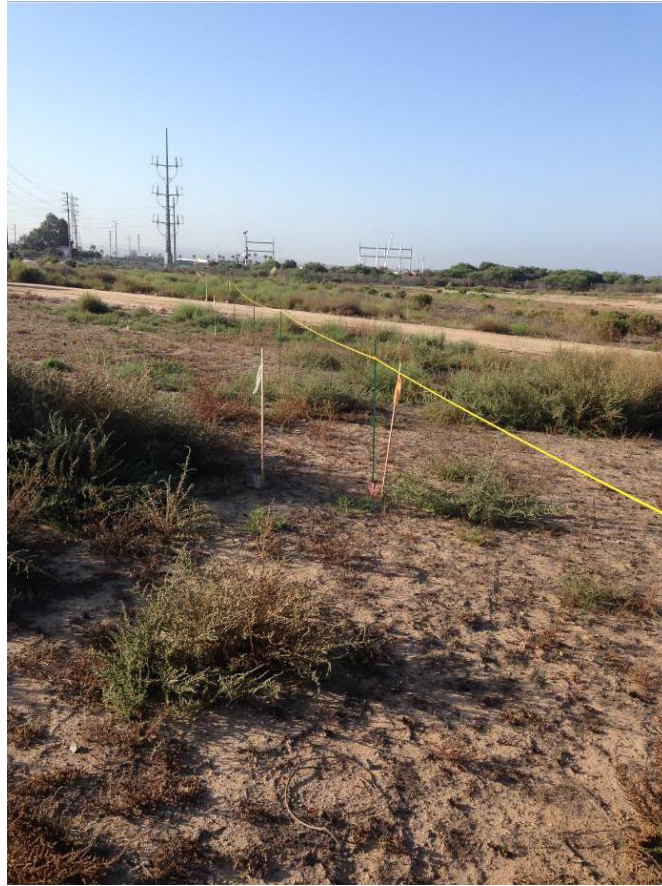
Initial activities along the transmission line alignment included delineating approved limits of disturbance/work limits (See Photo 4—Attachment A). Upon completion of delineating work limits, SWPPP BMPs such as fiber rolls/straw wattles and silt fencing were observed installed along the alignment. A stabilized entrance to the transmission line alignment, consisting of a rock apron and rattle

Photo 4: Prior work occurring along the transmission line alignment, work limits were delineated on the ground.

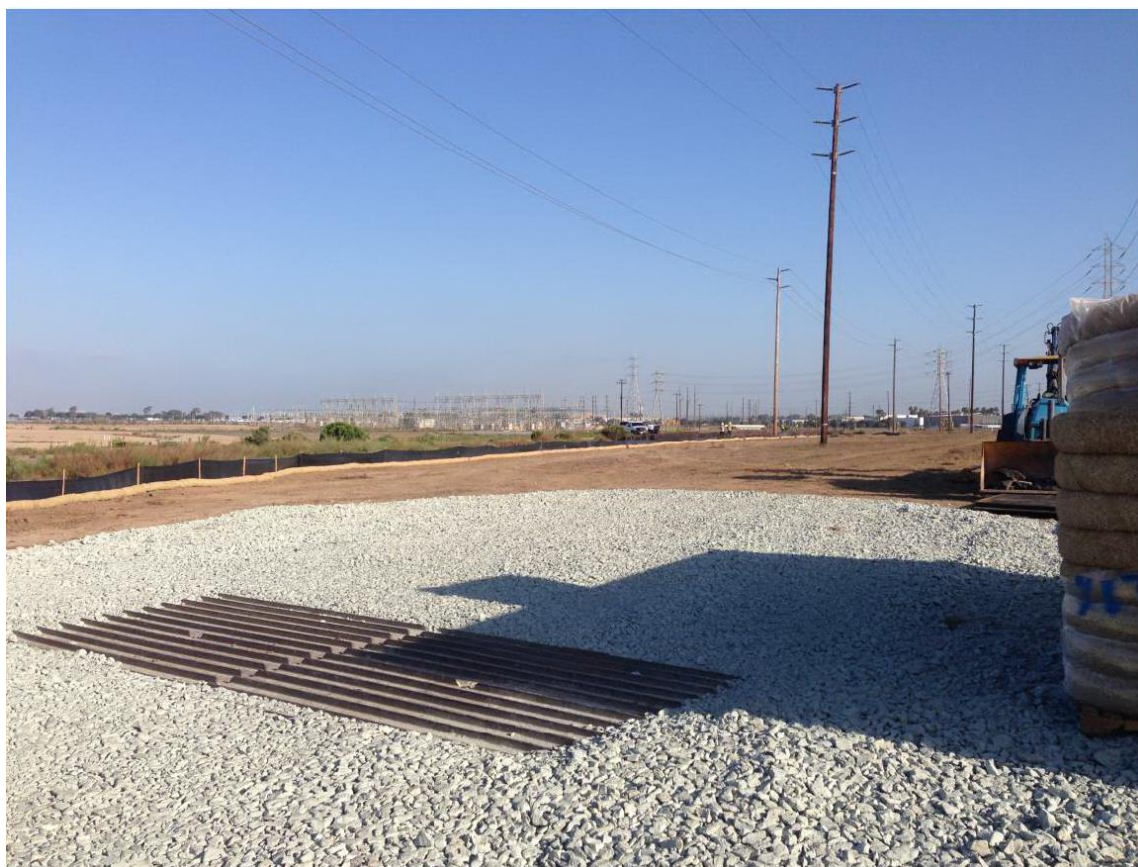
plates, was observed installed in order to minimize sediment track out onto Bay Boulevard in accordance with the SWPPP (See Photo 5—Attachment A).

Photo 5: After work limits were delineated along the transmission alignment, SWPPP BMPs were installed, including silt fencing, straw wattles, and a stabilized construction entrance consisting of a rock apron and rattle plates.

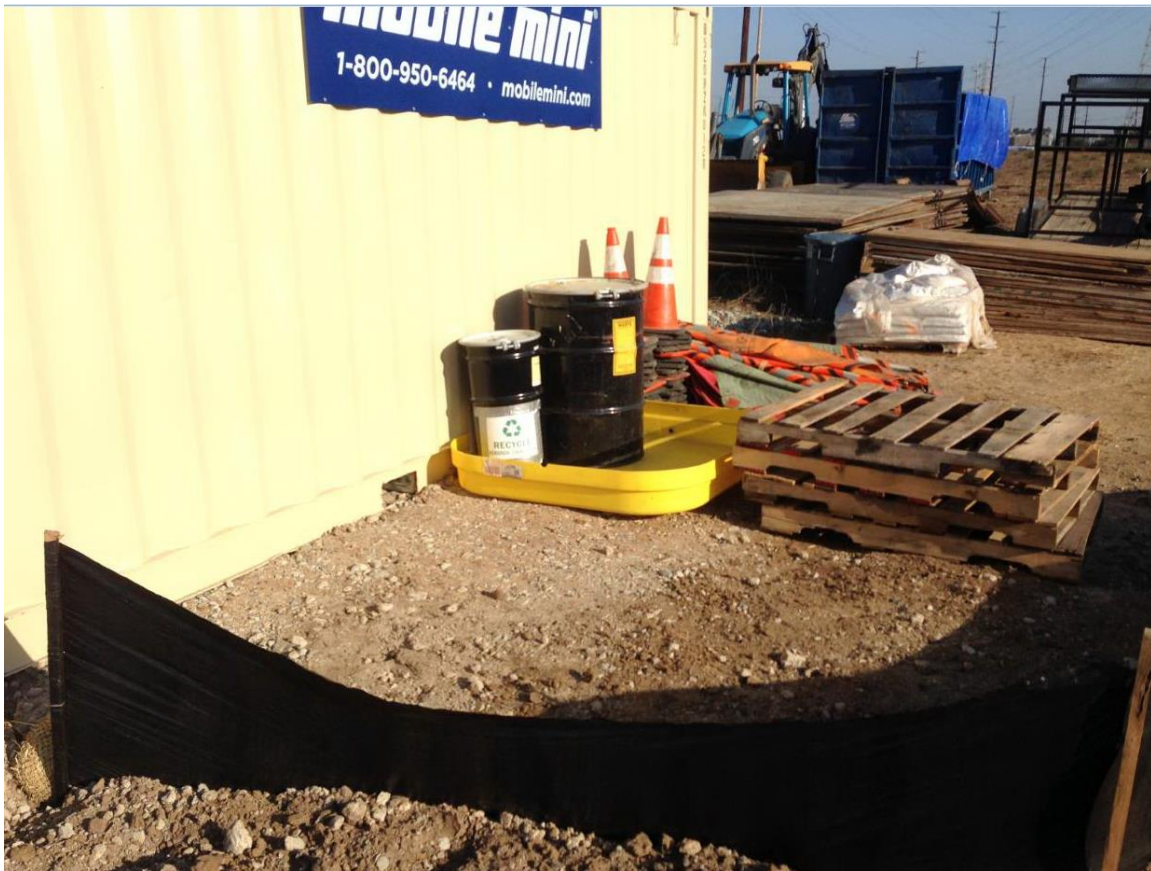
Crews were observed mobilizing and staging materials and equipment within the transmission alignment, including heavy vehicular equipment, dumpsters, silt fencing and fiber rolls/straw wattles, and poles. Absorbent materials were observed under staged heavy equipment in order to prevent potential equipment leaks from penetrating soil, and waste bins were contained in accordance with the SWPPP and APM-HAZ-01. Dumpsters were observed secured and covered in order to prevent attracting wildlife or causing litter within the work area (See Photo 6—Attachment A).

Photo 6: Equipment including dumpsters, heavy vehicular equipment, building materials, etc. was staged along the transmission line alignment. Silt fencing was installed around staging areas, waste bins were observed contained, absorbent material was observed under staged vehicular equipment, and dumpsters were observed covered and secured to prevent attracting wildlife.
