<p>California Public Utilities Commission <i>Mitigation Monitoring, Compliance, and Reporting Program</i></p>
	<p>South Bay Substation Relocation Project</p> <p>Compliance Status Report: 003</p> <p>March 15, 2015</p>

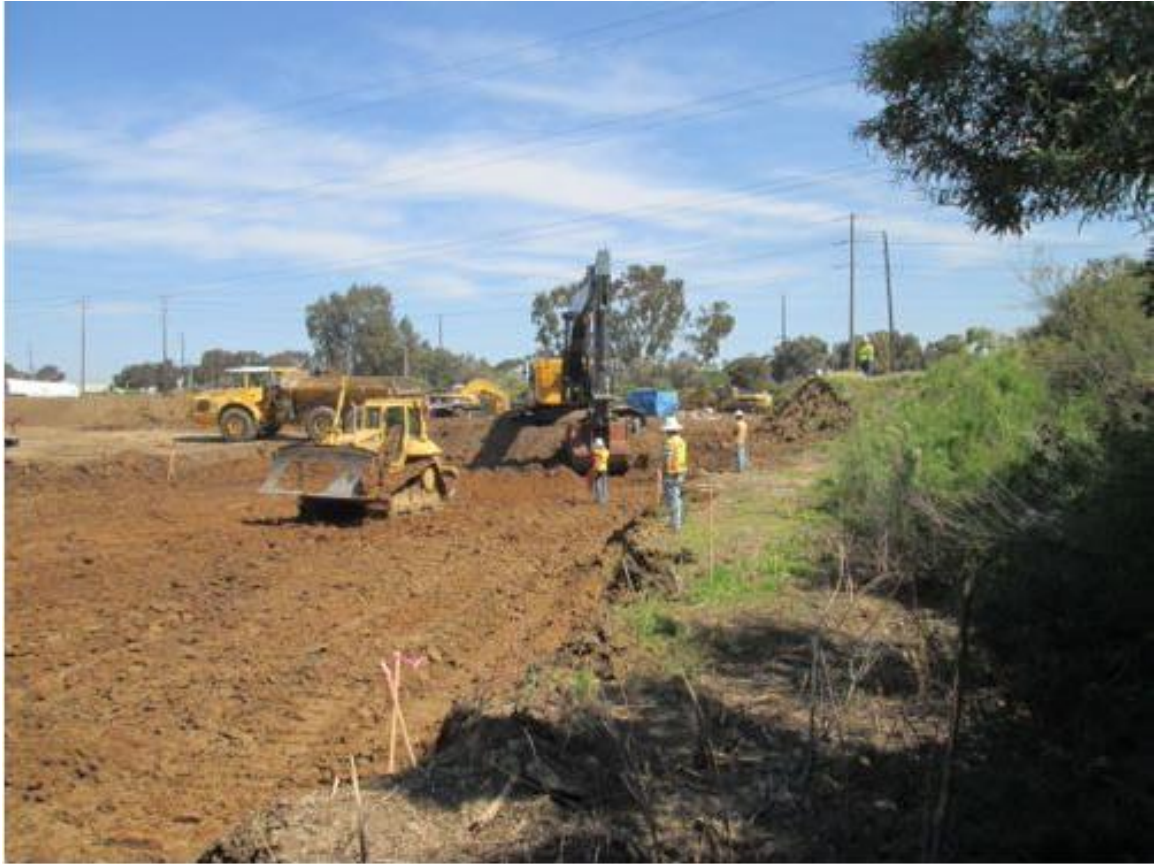
Photo 1: Archaeological, Native American, and paleontological monitors were observed on site monitoring initial excavation and earthwork activities in accordance with MM CUL-1 and APM CUL-05.

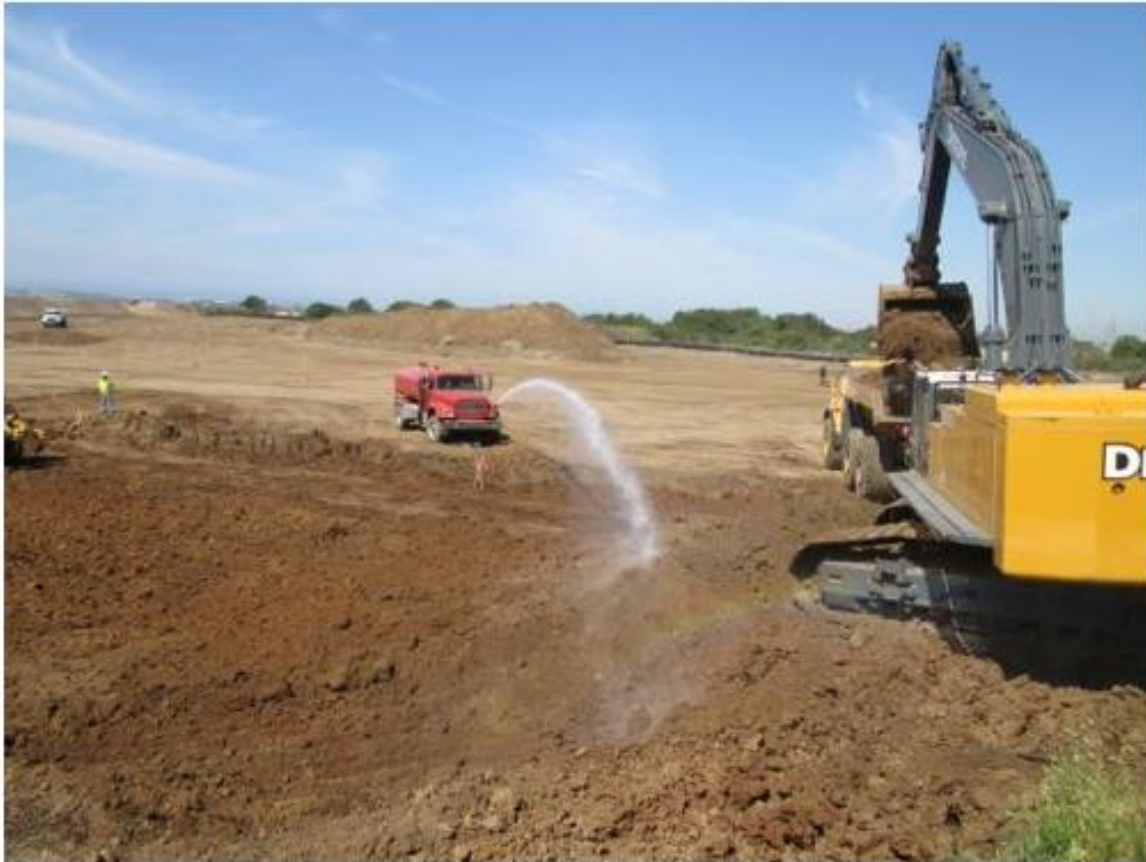
Photo 2: A water truck was observed being utilized to water excavation areas in order to minimize dust emissions in accordance with APM AIR-01.

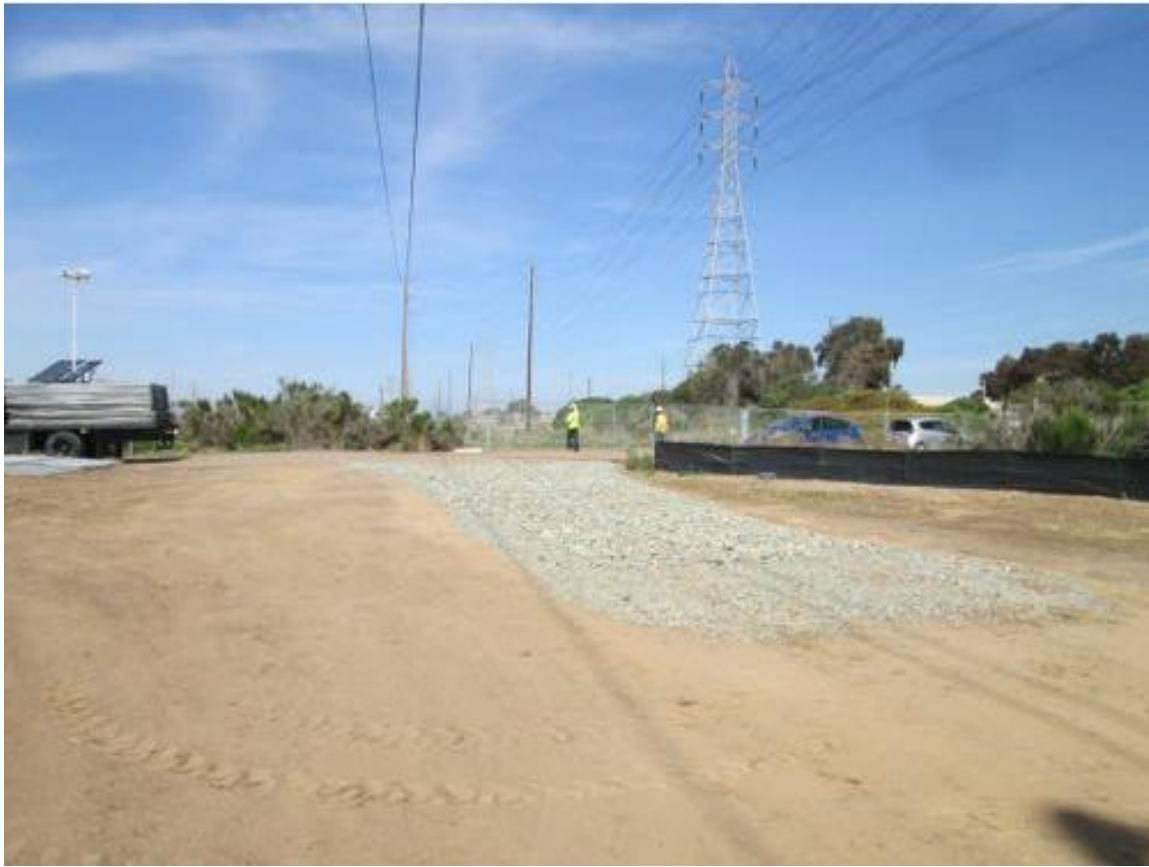
Photo 4: Installed rock aprons at the point of ingress and egress to minimize dirt/mud tracking from the site onto paved roads were observed in good condition in accordance with MM HYDRO-1.

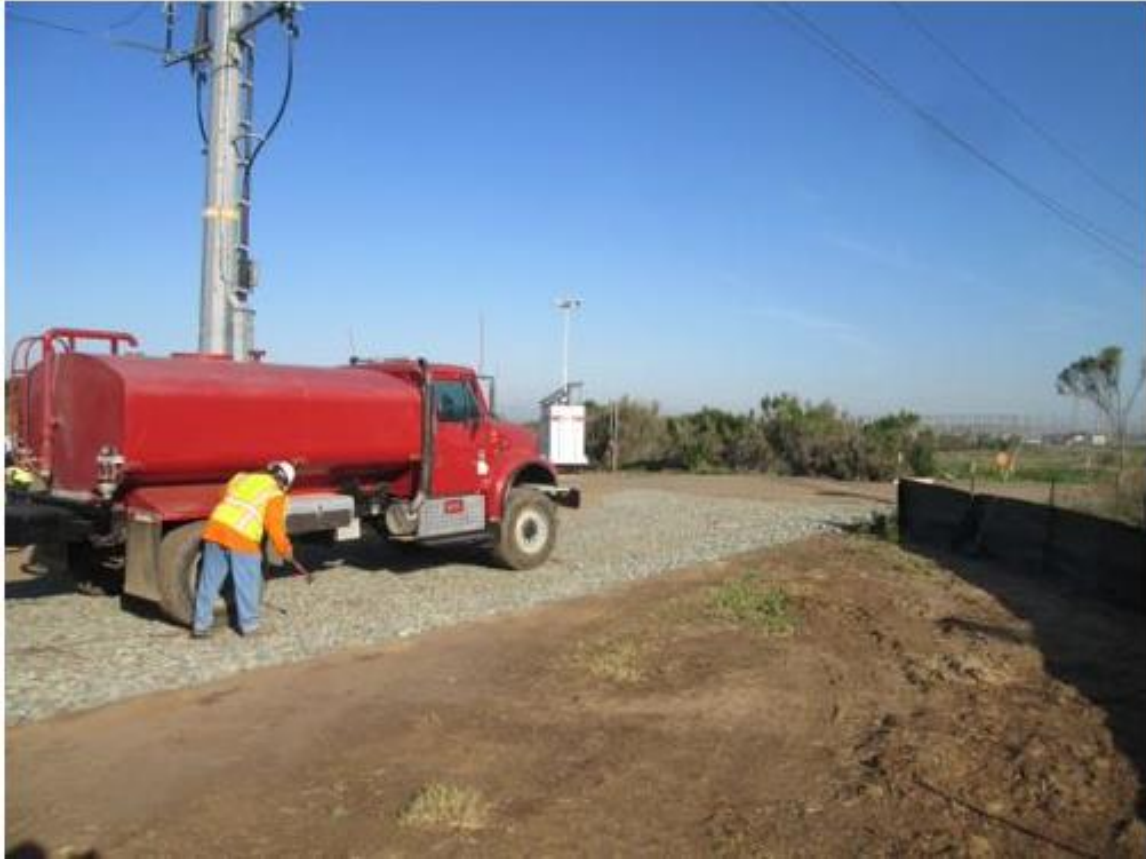
Crews were observed installing the perimeter chain-link fencing near the site entrance and installing best management practices (BMPs), including straw wattles and silt fencing, around the perimeter of the graded areas in accordance with the project Storm Water Pollution Prevention Plan (SWPPP). The sediment control BMPs, including the rock apron installed at the site ingress/egress were observed in good condition in accordance with MM HYDRO-1 (see Photo 4—Attachment A). A water truck driver was observed manually removing dirt/mud from the water truck tire tread before exiting the site to prevent sediment track-out in accordance with MM HYDRO-1 and MM BIO-5 (see Photo 5—Attachment A).

Photo 5: A water truck driver manually removing dirt/mud from the water truck tire tread before exiting the site to prevent sediment track-out in accordance with MM HYDRO-1 and MM BIO-5.

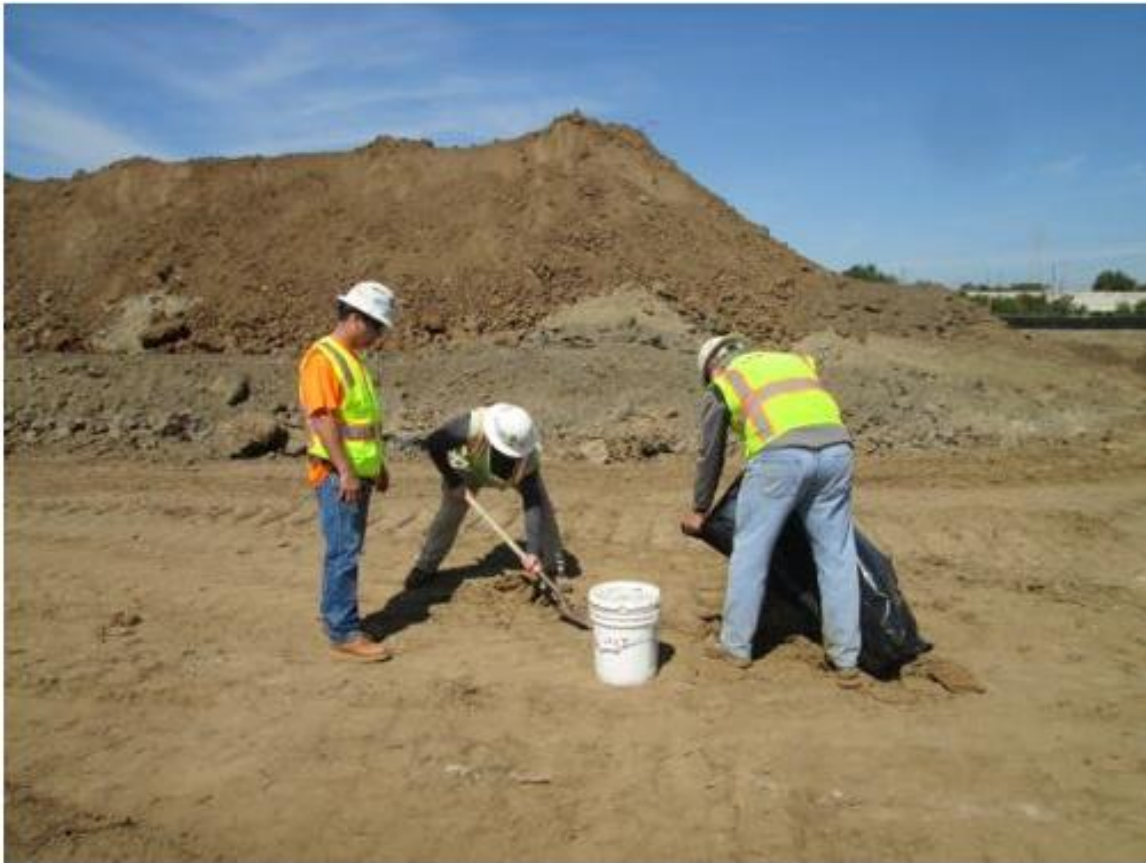
Spill prevention measures observed included containment bins placed beneath hazardous materials stored onsite, spill kits staged on site, drip pans placed beneath sanitary facilities, and absorbent material was observed beneath staged equipment in accordance with APM HAZ-01. On March 10, 2015, a CPUC third-party monitor observed minor grease drip marks on the ground in an equipment staging area, which was communicated to the Lead Environmental Inspector (LEI) on site. The LEI subsequently informed the contractor of the grease drip marks and the drips were observed being cleaned in accordance with APM HAZ-01 (see Photo 6—Attachment A).

Photo 6: Crews were observed cleaning and containing stained soils on the project site in accordance with APM HAZ-01.
