<p><b>California Public Utilities Commission</b> <b><i>Mitigation Monitoring, Compliance, and Reporting Program</i></b></p>
	<p><b>South Bay Substation Relocation Project</b></p> <p><b>Compliance Status Report: 006</b></p> <p><b>April 26, 2015</b></p>

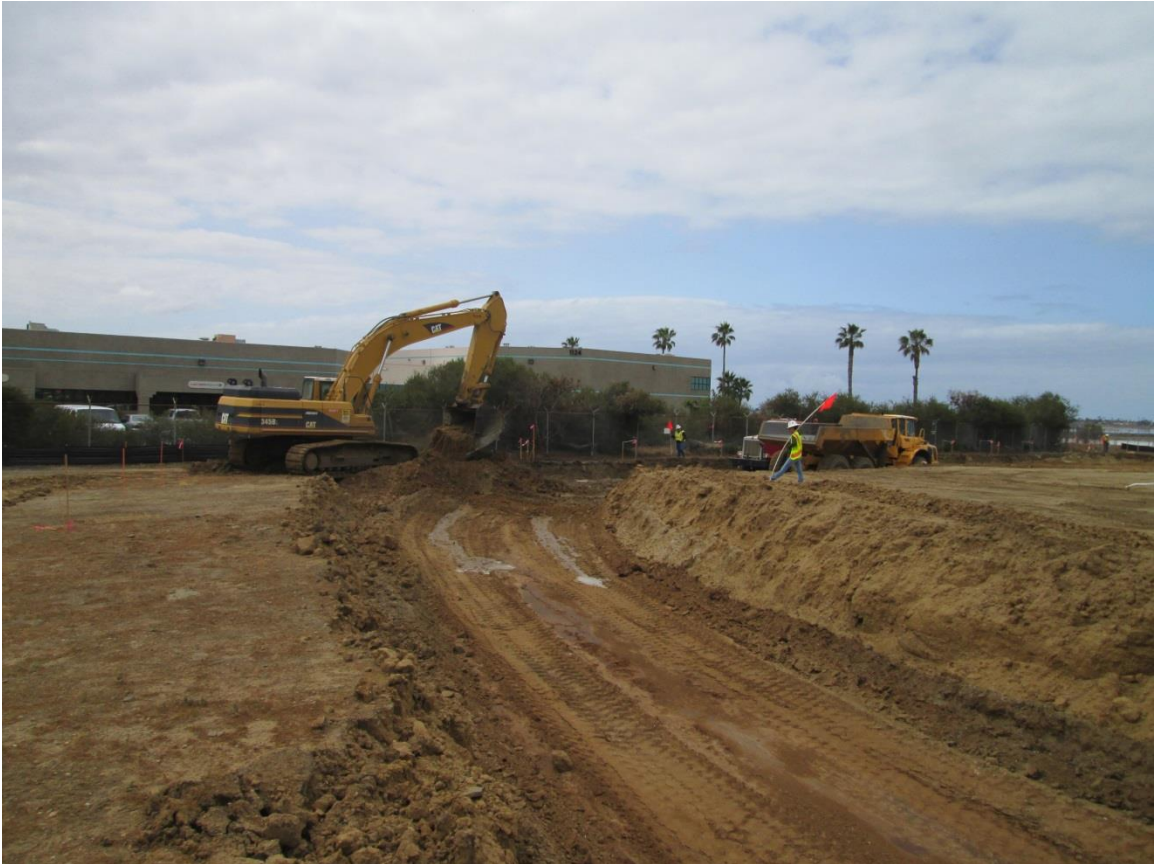
Archeological and Native American monitors were present to monitor earthwork and excavations in accordance with MM CUL-1 and a paleontological monitor was observed on site to monitor activities

occurring within the Bay Point Formation in accordance with APM CUL-05 (see Photo 1—Attachment A).

**Photo 1:** A cultural and paleontological monitor observing excavation and re-compaction activities in accordance with MM CUL-1 and APM CUL-05.

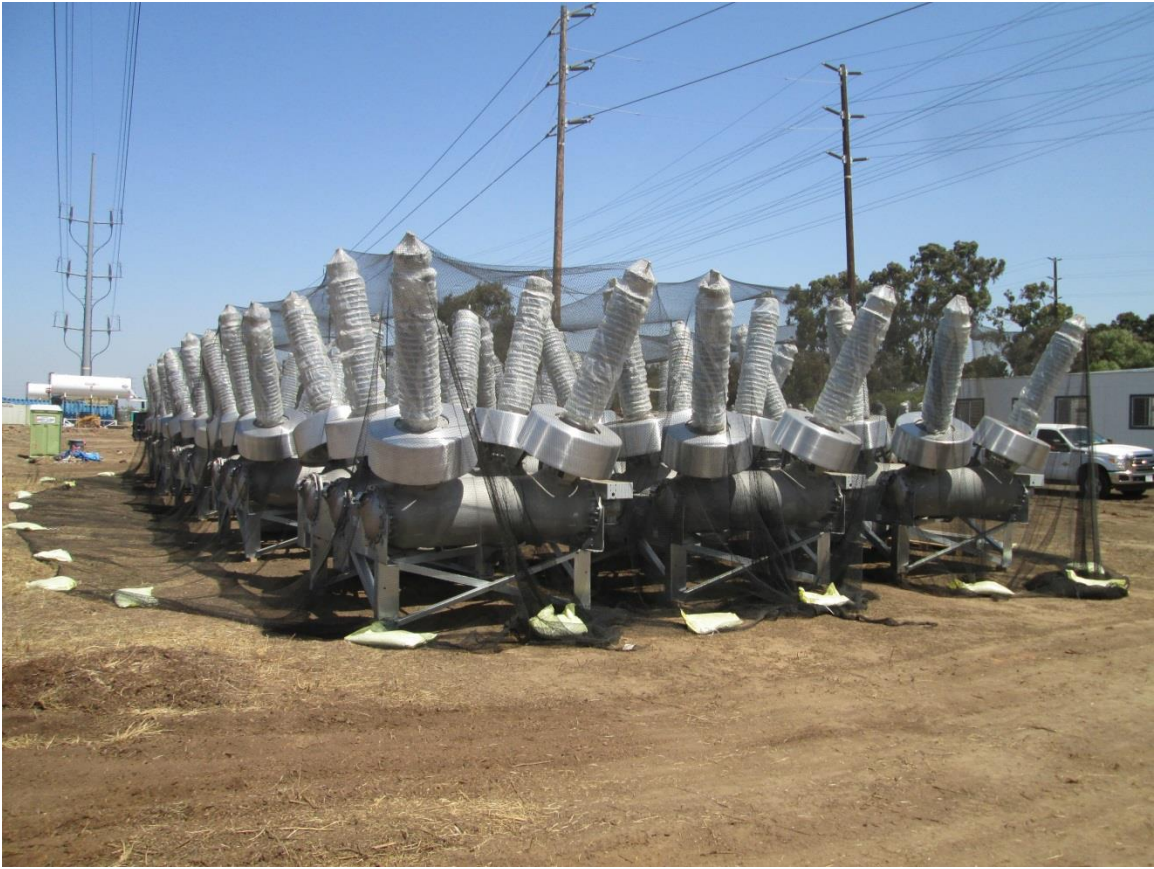
Biological monitors were observed on site during construction activities. Staged equipment, such as transformers and circuit breakers were covered with netting to minimize the potential for birds nesting within them (see Photo 2—Attachment A).

**Photo 2:** Netting material were placed over staged project equipment, such as circuit breakers and transformers, to deter birds from nesting in equipment.

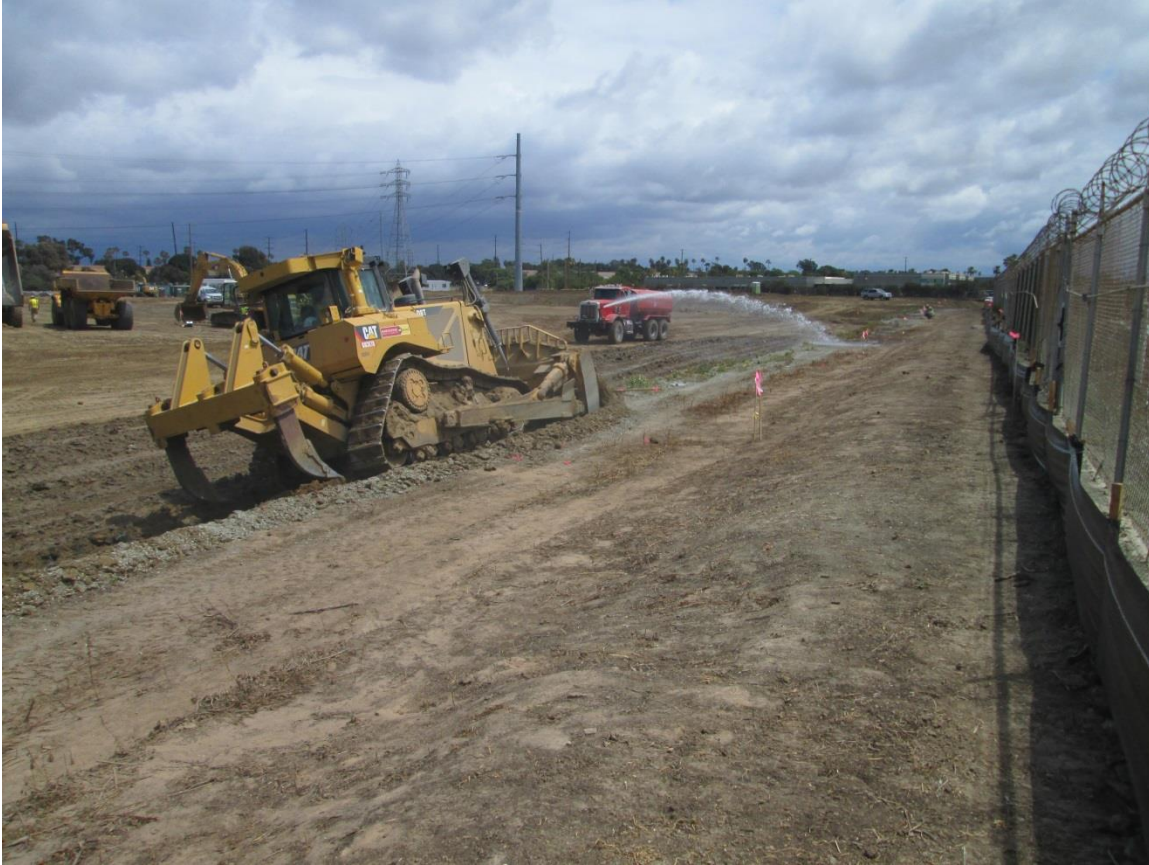
Crews were observed trenching and installing conductor cable to support the temporary office trailers. During initial trenching, water was applied in areas of exposed soils, to prevent fugitive dust emissions in accordance with MM-BIO-5. Water trucks were observed on site during earthwork and excavation activities and applying water to reduce potential for fugitive dust in accordance with APM AIR-01 and MM BIO-5 (see Photo 3—Attachment A). Baker tanks are being utilized to store reclaimed construction water for dust suppression and soil compaction.

**Photo 3:** Water trucks were observed being utilized to water grading areas in order to minimize dust emissions in accordance with APM AIR-01. Monitors were observed present during these activities.

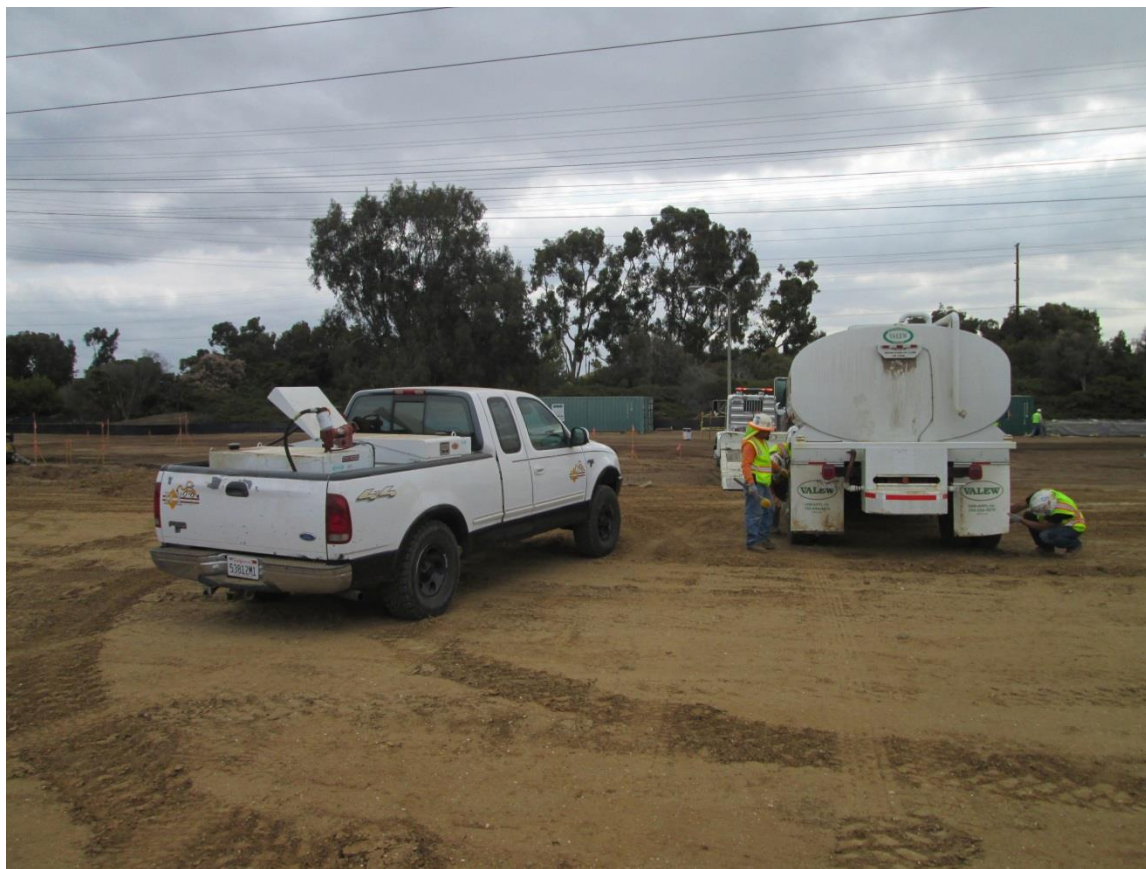
Installed SWPPP BMPs, including straw wattles and silt fencing around the perimeter of the graded areas, as well as the rock apron installed at the site ingress/egress were observed in good working condition. The gravel bag dam and silt fence at the southwest corner of the site, designed to prohibit off-site sedimentation or storm water discharge was observed intact and functional. Crews were observed cleaning mud from construction equipment prior to hauling offsite to reduce potential sediment track-out in accordance with the SWPPP (MM-HYDRO-1) and to reduce potential for offsite transport of weedy material in accordance with MM-BIO-4 (see Photo 4—Attachment A).

**Photo 4:** Crews were observed cleaning mud from a water truck prior to hauling offsite to prevent sediment track-out from the project in accordance with the project SWPPP and to reduce potential for offsite transport of weedy material in accordance with MM BIO-4.

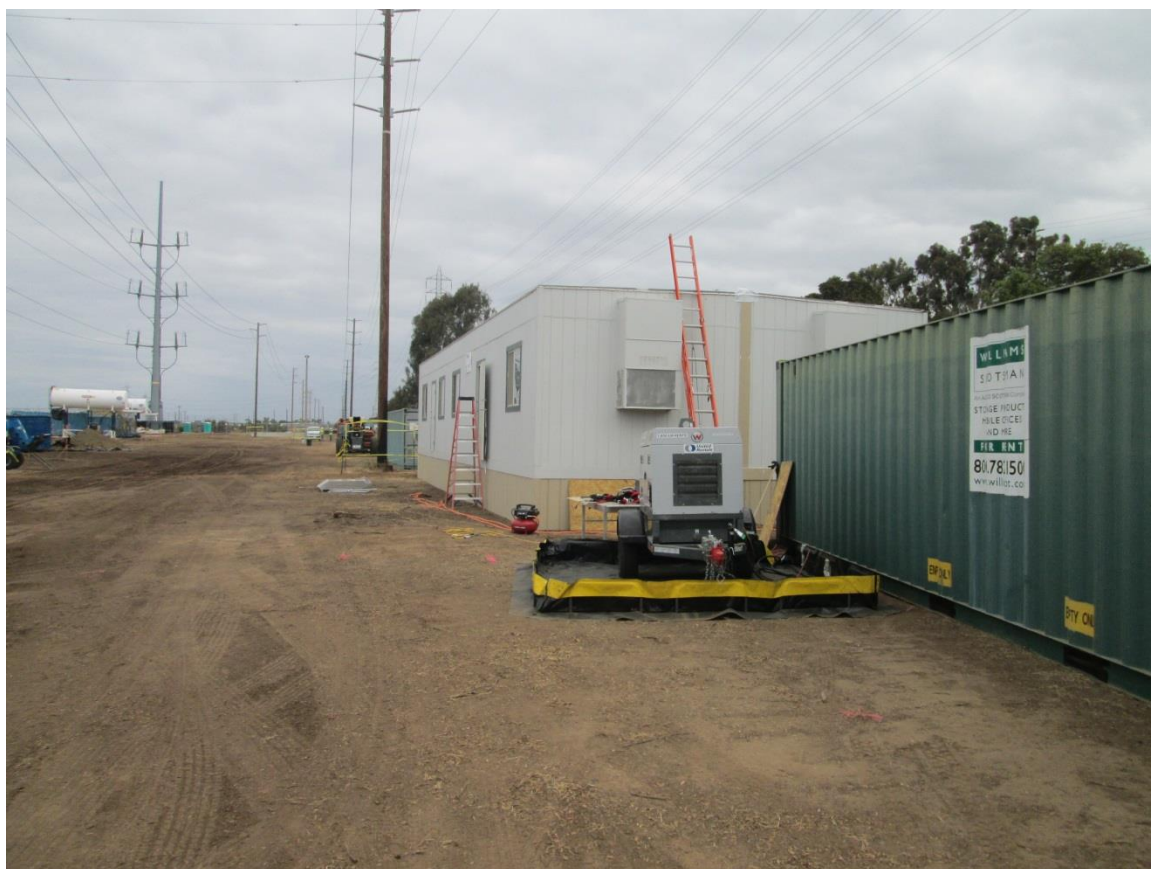
Spill prevention measures observed included containment bins placed beneath hazardous materials stored onsite, spill kits staged on site, drip pans placed beneath sanitary facilities, and absorbent material was observed beneath staged equipment in accordance with APM HAZ-01 (see Photo 5—Attachment A). Excavated soil containing buried trash was observed temporarily stockpiled on visqueen for future disposal in accordance with APM-BIO-01 (see Photo 6—Attachment A).

**Photo 5:** Spill containment was observed under equipment such as the generator used to service the temporary construction trailer in accordance with APM HAZ-1.

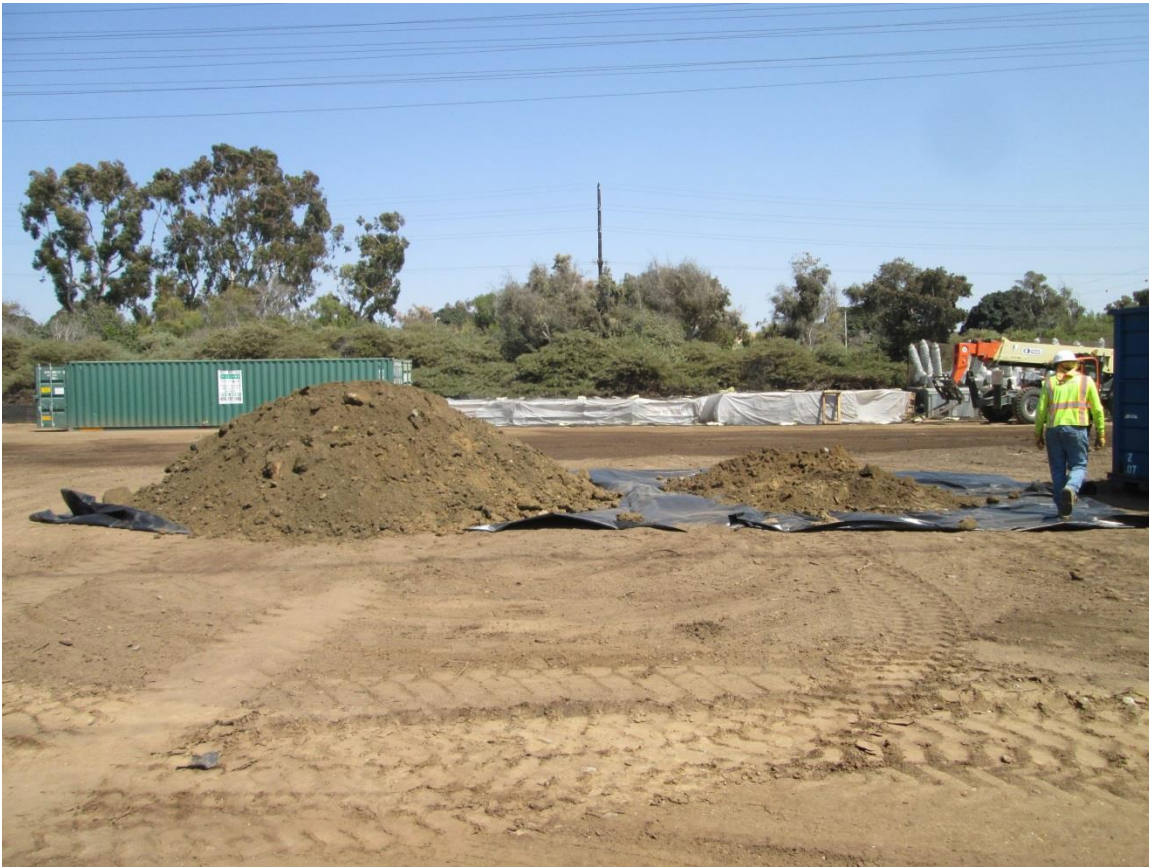
**Photo 6:** Excavated soil containing buried trash was observed temporarily stockpiled on visqueen for future disposal in accordance with APM BIO-01.
