**Re: Monthly Report Summary #11 for Aliso Canyon Turbine Replacement Project**

## Aliso Canyon Turbine Replacement Project CPUC Site Inspection Form

Project:	Aliso Canyon Turbine Replacement	Date:	February 6, 2015
Project Proponent:	Southern California Gas Company and Southern California Edison	Report #:	VS043
Lead Agency:	California Public Utilities Commission	Project Phase/NTP:	Guard House and Road Widening (NTP-1). The New Admin/IM Building (NTP-2) and Central Compressor Site (NTP-3). P-41 Fill Site (NTP-2). PS-42 Fill Site and the PS-42 Rock Site and Temporary Fill Site. P-32 Fill Site (NTP-3) and the Natural Substation (NTP-3, NTP-A). TSP-45 and 49, and the San Fernando Substation (NTP-A). Oak Tree Mitigation.
CPUC PM:	Andrew Barnsdale, Energy Division	AM/PM Weather:	Clear, calm, mild (64 degrees F). Later in the day a slight breeze picked up with an increase in temperature to 69. A chance of rain is predicted for tonight.
E & E CM:	Lara Rachowicz	Start/End time:	0930 hrs at the San Fernando Substation. 1015-1330 hrs at the Aliso gas field

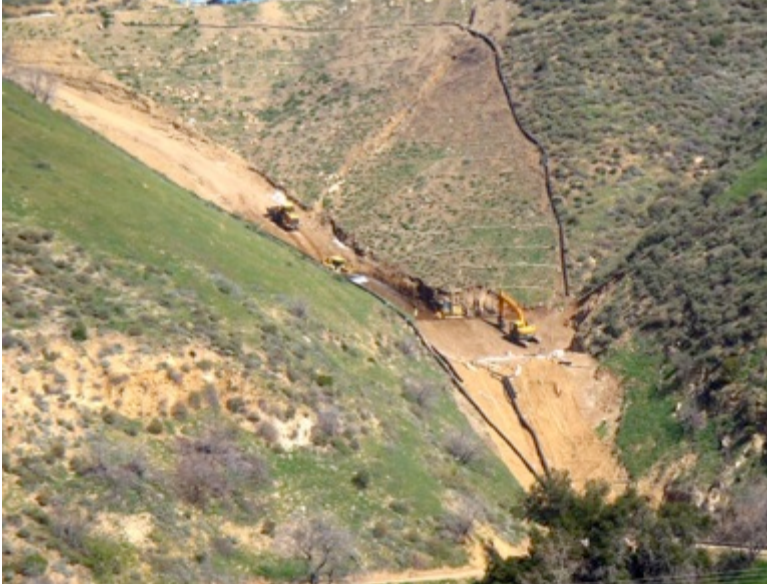
Date	Location	Photo	Description
02/06/15	PS-42 Fill Site

Soil has been brought into the PS-42 fill site and a crew is working on compacting that dirt – see photo. They will be reestablishing the BMPs later this afternoon in preparation for the storm. Bio monitor Juan Miranda (APM BR-1d and APM BR-6) was at the site along with the Paleo Monitor. Some work has been done on the diversion piping to more firmly anchor it to the slopes.

<p>Crews are working on compaction of the soil coming from the Natural Substation. They are also upgrading the diversion piping and will be reinstalling the BMPs later in the day in preparation for the incoming storm.</p>
02/06/15	Oak Mitigation Site.

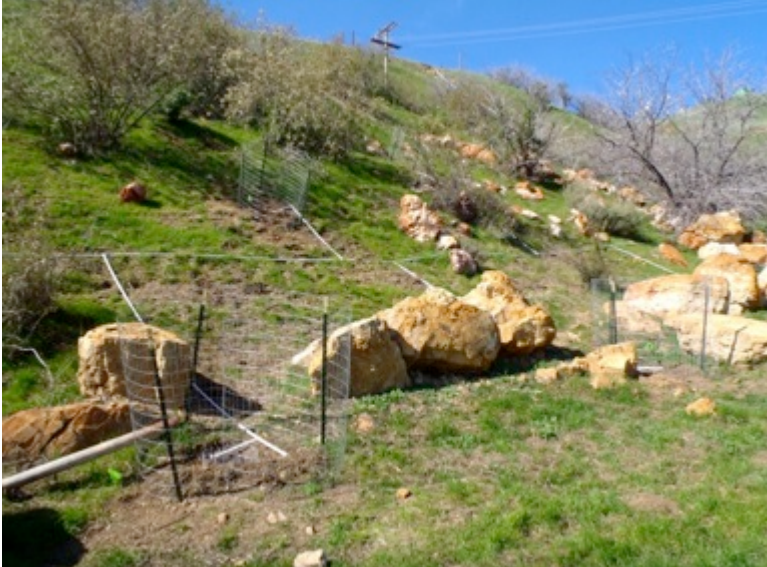
At the oak mitigation site a crew is installing the oak protection cages and the irrigation system – all looks good. See photo.

<p>A crew is installing the irrigation and protective wire for the as yet to be planted oaks.</p>
02/06/15	TSP 49

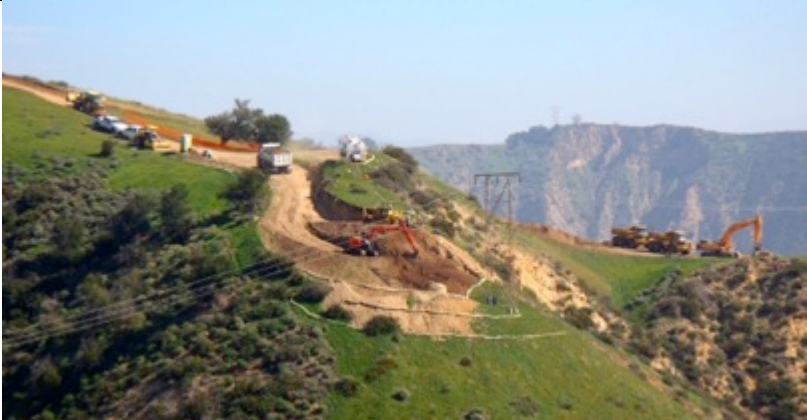
At TSP 49 a crew and heavy equipment were excavating soil and building a new crane pad – see photo. A Paleo monitor (MM CR-1, MM CR-3, MM CR-6 and MM CR-8) was onsite fulltime. Some of the soil is being stockpiled in a newly approved area just up the slope from the work near several oak trees – see photo. Straw wattle has been placed around the stockpiled soil. The work is being spot checked by Biological monitor C. J. Fotherington (APM BR-1d, APM BR-6). A water truck is onsite along with the fire crew (MM HZ-2).

<p>Crews are working on the crane pad – excavating and moving dirt up to the newly approved temporary stockpile area.</p>

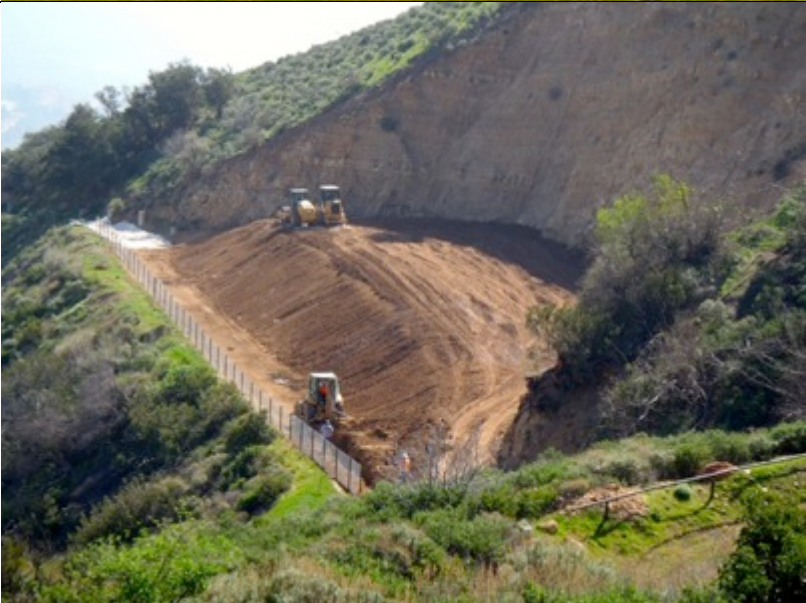
No soil is being brought in to P-41 as they continue to install a subdrain within the fill site – see photo.

Installation of a subdrain continues at the fill site.
02/06/15	Central Compressor Station

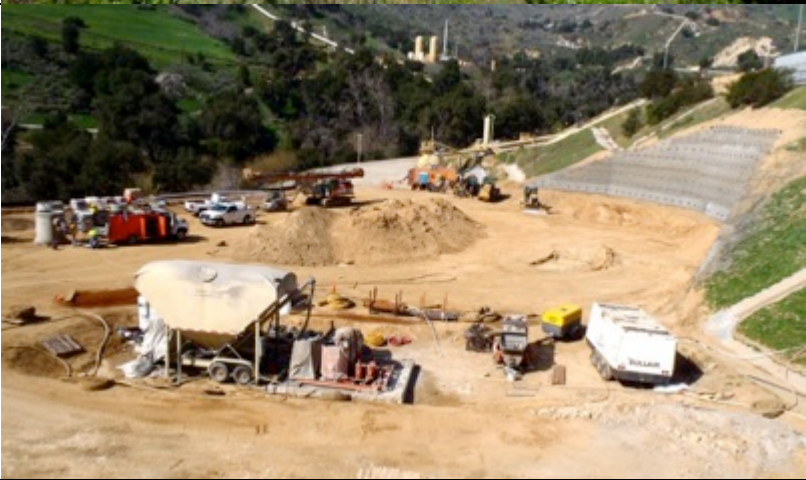
At the Central Compressor Station crews continue to excavate – see photo. A variety of other construction activities are ongoing within the CCS area – see photo. Soil is being taken to the P-32 fill site from the CCS.

A variety of work is ongoing within the CCS area.

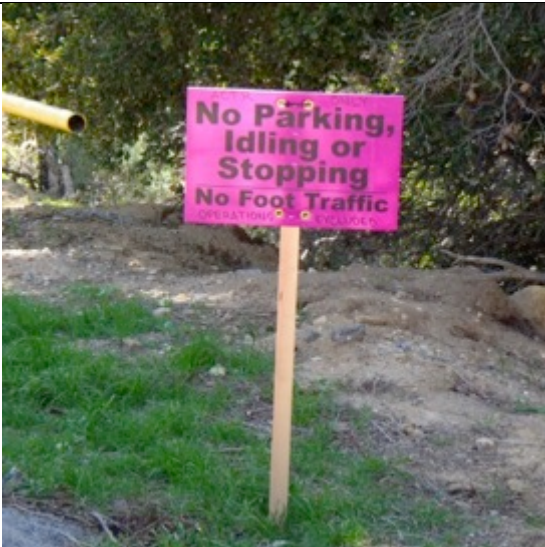
02/06/15	Limekiln Road

The red-tailed hawks are nesting again this year in the same sycamore tree along the main access road. Signs have been posted to keep people from disturbing the birds – see photo. It feels like spring is on its way as trees are beginning to leaf out, birds are starting to call, and I saw several lizards out foraging.

Signage for the nesting red-tailed hawks.
02/06/15	San Fernando Substation	 	Installation of the above ground structures is ongoing.

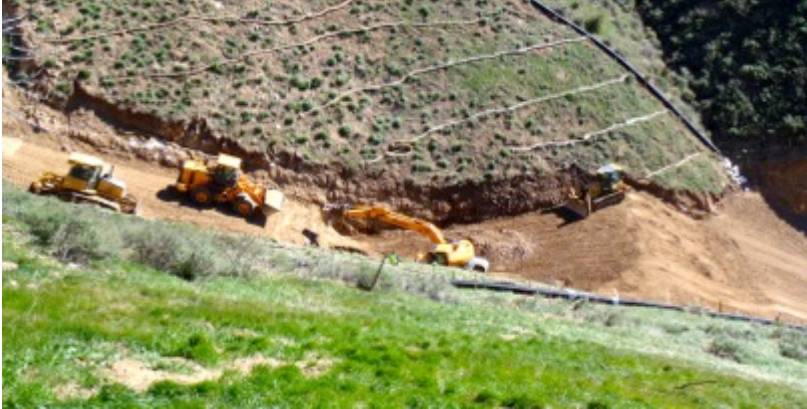
Date	Location	Photo	Description
2/12/15	PS-42 Fill Site

Dirt has been coming to the fill site but at the time of the site visit the crews were working on the installation of a sub-drain.
2/12/15	Oak Mitigation Site.

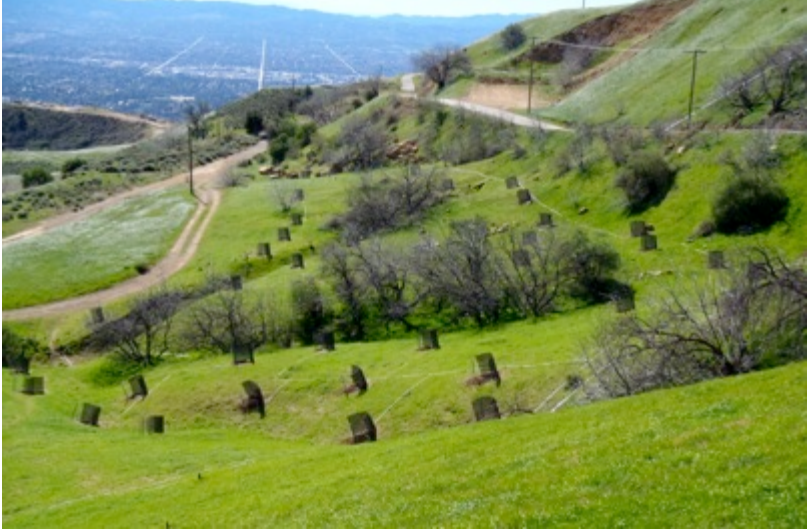
Shade cloth has been added to the oak protective cages.
2/12/15	TSP 49

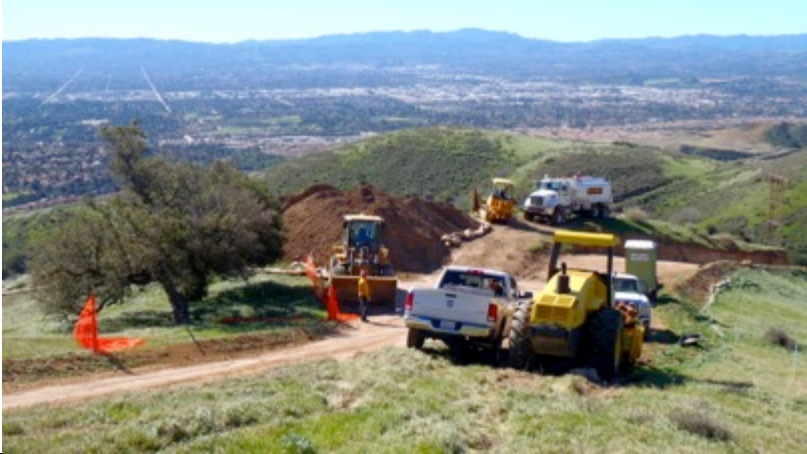
Crews and equipment at the TSP 49 site.

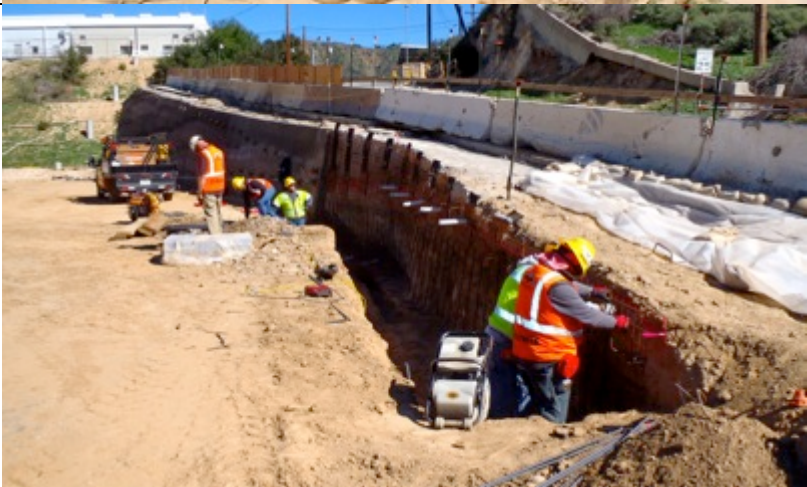
More bank stabilization.
2/12/15	P-32 Fill Site	 	Soil from the CCS is being spread and compacted within the P-32 fill site.

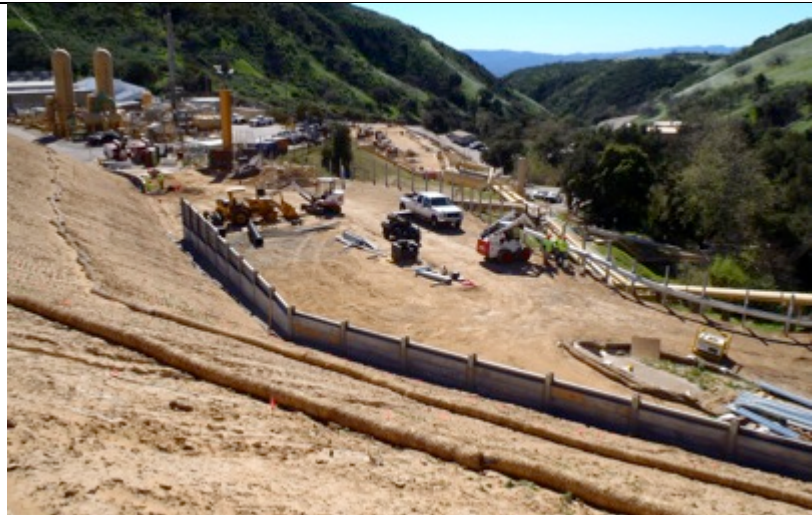
<p>Crews are working on slope stabilization, walls and railings.</p>
<p>2/12/15</p>	<p>New Admin/IM Building</p>

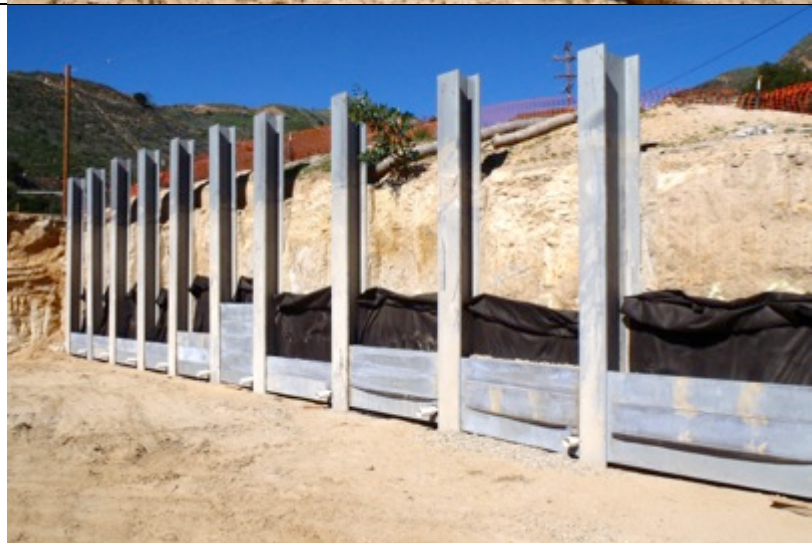
<p>Slope stabilization work.</p>
<p>2/12/15</p>	<p>TSP 46 access road</p>

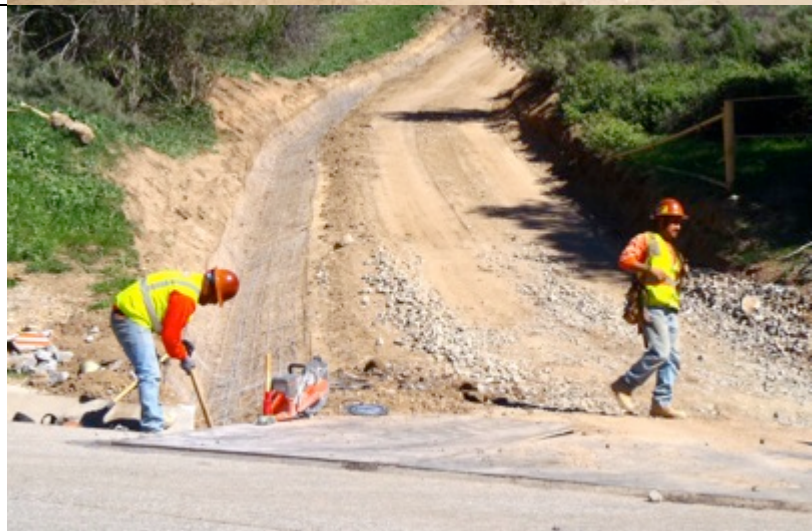
<p>Crews are working on a V-ditch along the TSP 46 access road.</p>

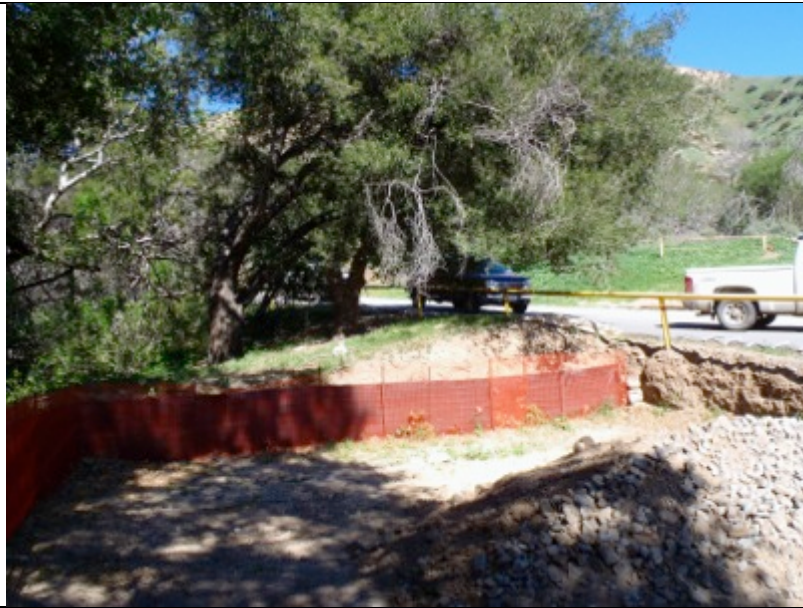
TSP 46  
staging area  
(previously  
used for  
guard house  
staging area)

I saw the red-tailed hawks on their nest. A bushtit nest was found near the TSP 46 staging area; a buffer distance had not been established yet and no buffer fencing had been installed while I was onsite – see photo.

The tree in the center  
of the photo, 15 feet  
outside of the  
exclusion fencing, has  
a bushtit nest in it.

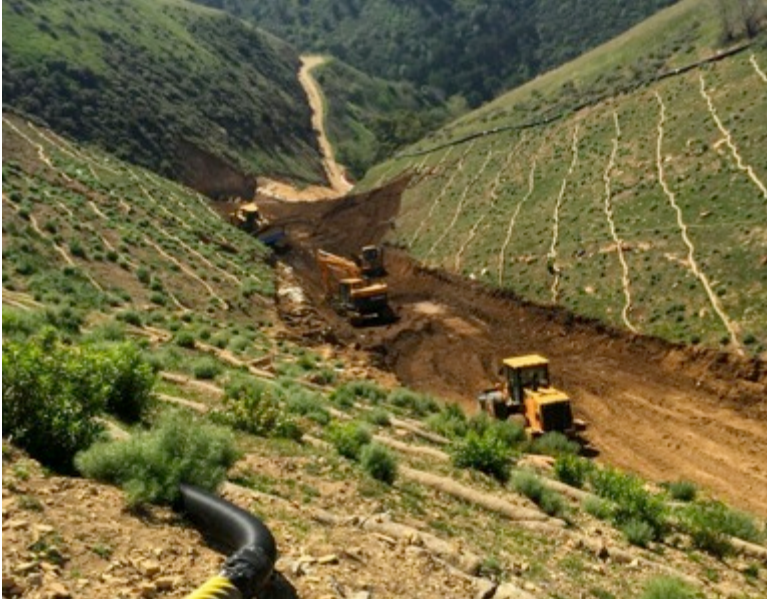
Date	Location	Photo	Description
2/19/15	PS-42 Fill Site

Existing dirt was being worked at the site.
2/19/15	PS-42 Fill Site

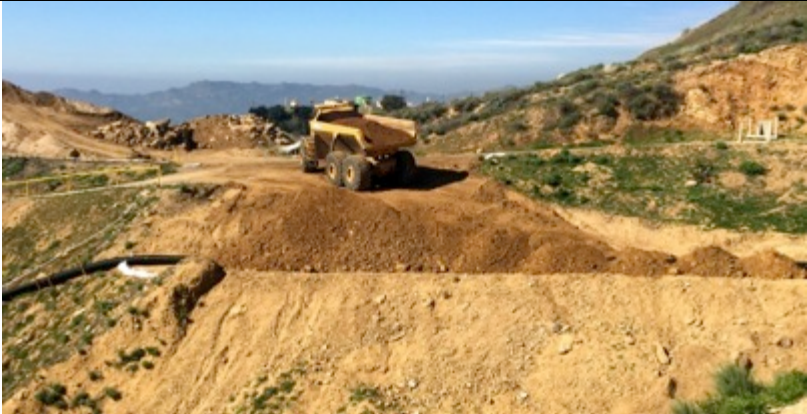
Some dirt from the Natural Substation access road is being dumped at the top of the PS-42 site to make a pad for trucks to dump dirt down into the fill site.
2/19/15	Oak Mitigation site.

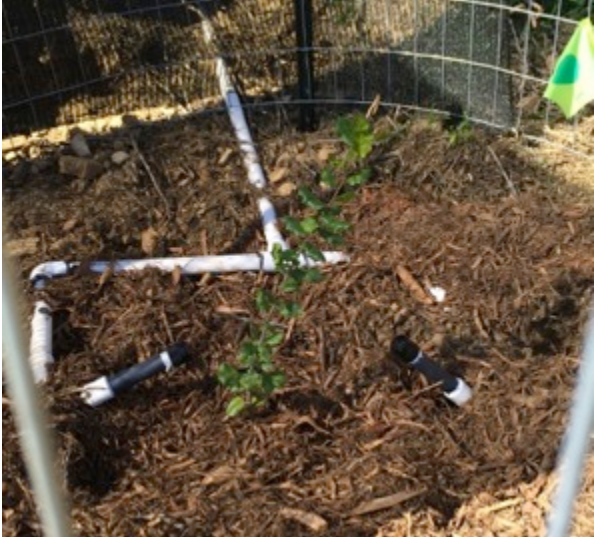
Oak seedlings have been planted and look good.

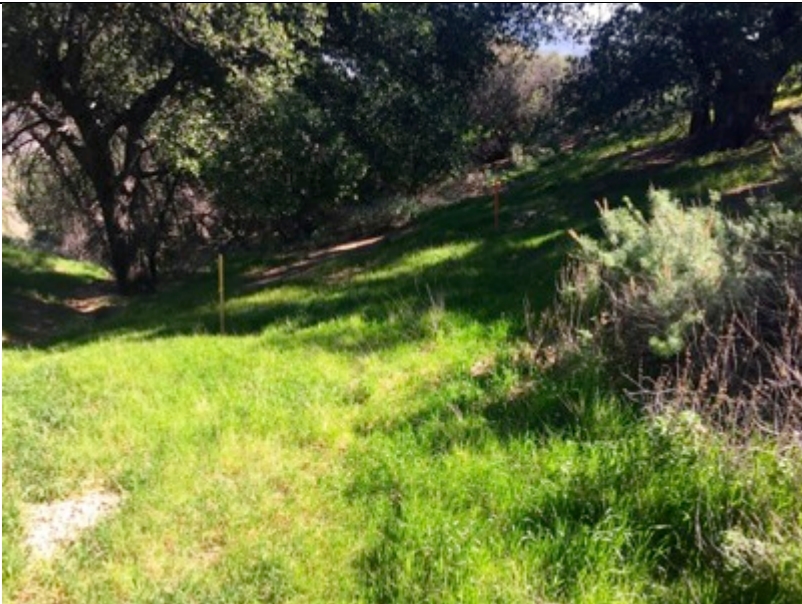
<p>2/19/15</p>	<p>MPR-6 subdrain and outfall location</p>

<p>Area to be excavated for the subdrain. Stakes indicate the furthest extent of the disturbance.</p>
<p>2/19/15</p>	<p>P-41 Fill Site</p>

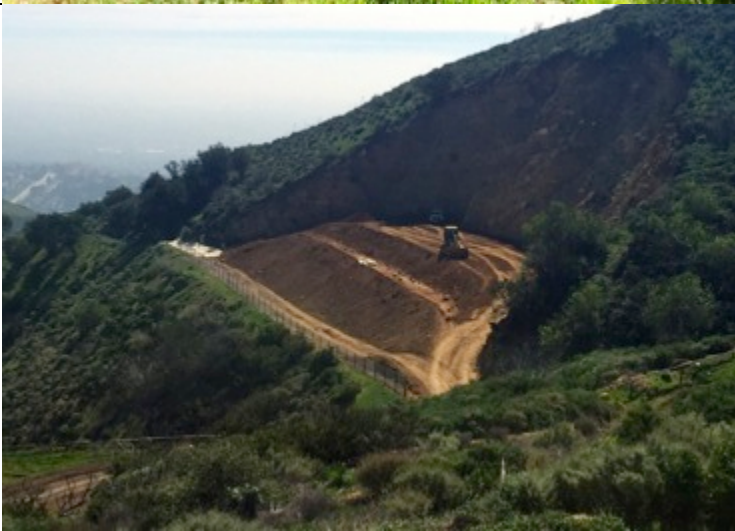
Soil is being brought in to P-41 from the Natural Substation access road excavation; all looks good – see photo. Mud has continued to build up on the paved roadway (APM AQ-7) but it does not appear to be a hazard.

<p>Soil is being brought to the fill site from the Natural Substation access road work.</p>
<p>2/19/15</p>	<p>Central Compressor Station</p>

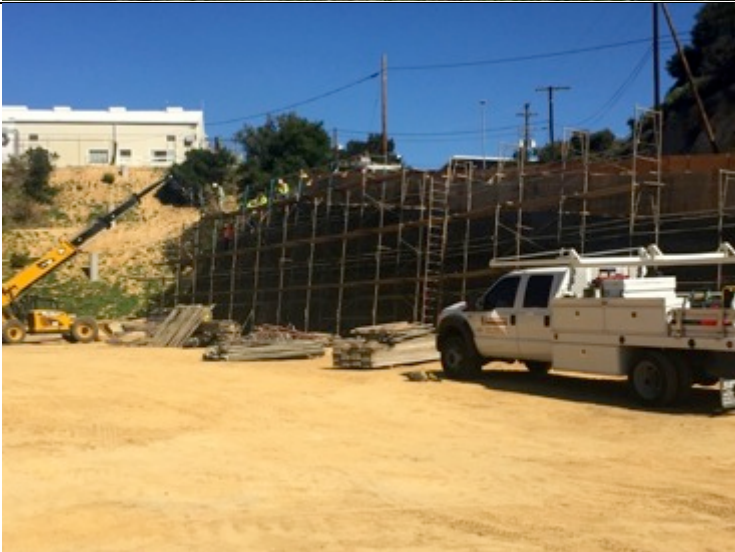
<p>Work continues on bank stabilization.</p>

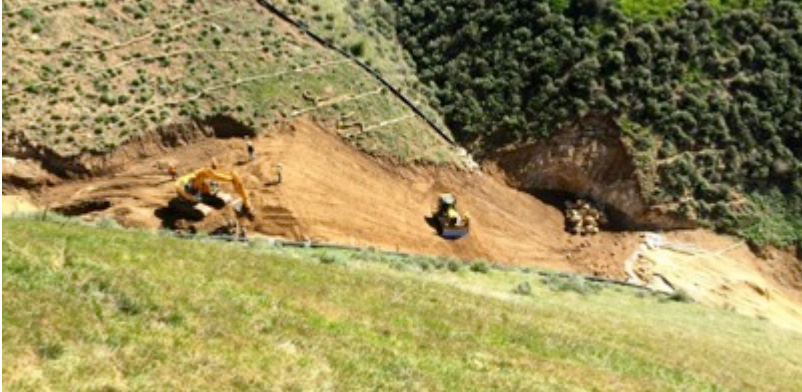
Date	Location	Photo	Description
2/24/15	PS-42 Fill Site

Fill dirt is being worked within the site.
2/24/15	PS-42 Fill Site

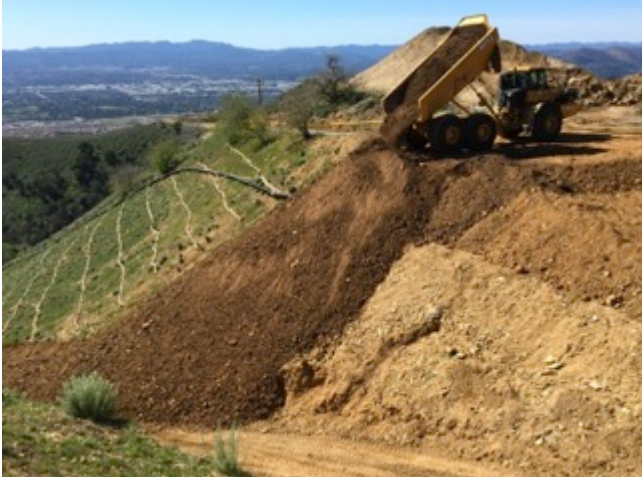
Dirt from the Natural Substation access road is being dumped into the PS-42 Fill Site.
2/24/15	PS-42 Fill Site

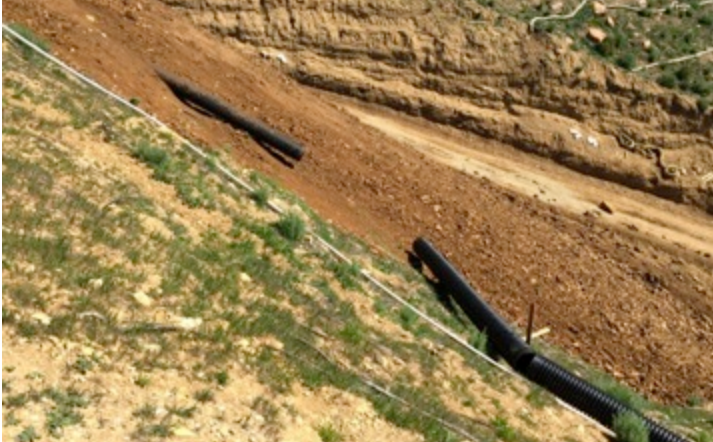
At the PS-42 fill site imported soil is being dumped into the site from the roadway at the top end of the site – see photo. As I was watching a dump truck drop its load the dirt disconnected the rainwater diversion piping – see photo. I checked with project personnel; they had witnessed the breakage and were going to fix the piping. Equipment was working the soil within the fill site – see photo. I asked Amandeep about the box culvert down at the base of the site but he said this was on hold as a possible raptor nest was found in the oak tree just below the rip rap. I checked the area and noted the nest in the oak but I did not see any birds. There were numerous birds calling in this area including Bewick's wren, oak titmouse, and rufous-crowned sparrow.

Soil being dumped into the fill site has pulled apart the diversion piping.
2/24/15	TSP 49

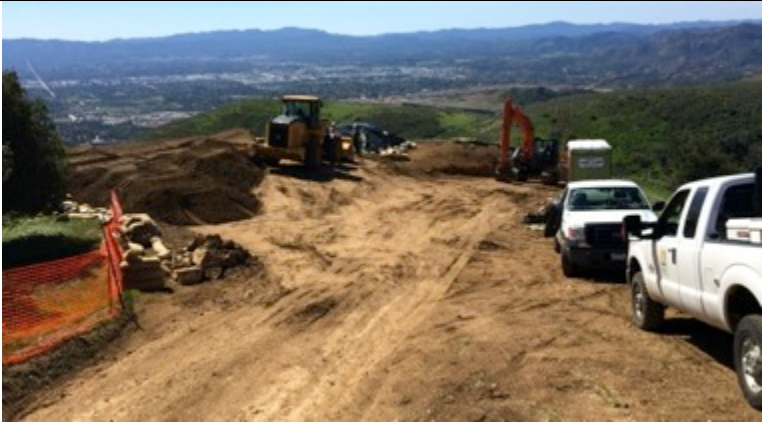
SCE crews continue to cut and backfill the area around TSP 49 site for the crane pad.

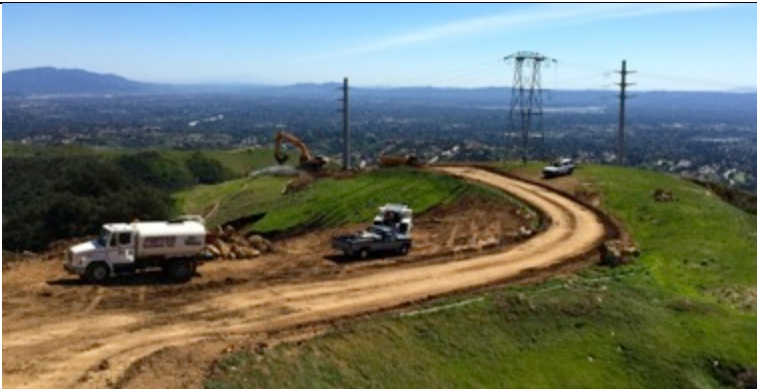
Excavation of the substation is now being done.
2/24/15	Natural Substation Access Road

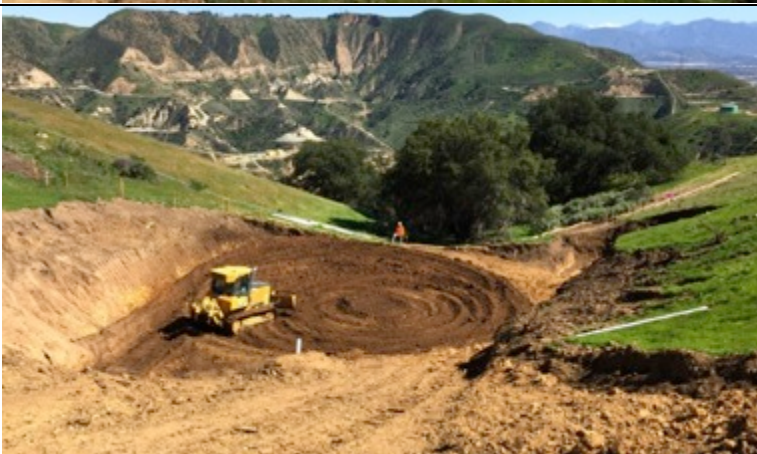
A portion of the access road is now being backfilled and compacted.
2/24/15	P-41 Fill Site

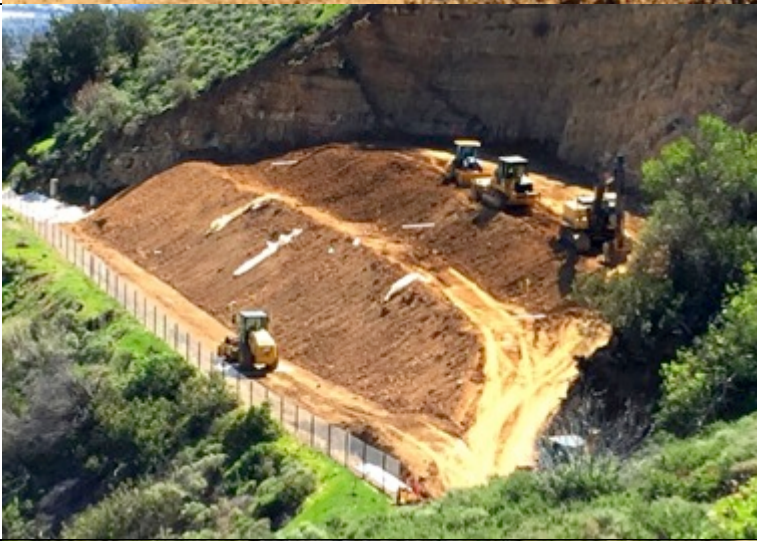
Soil is being brought to the fill site from the Natural Substation work.
2/24/15	Central Compressor Station

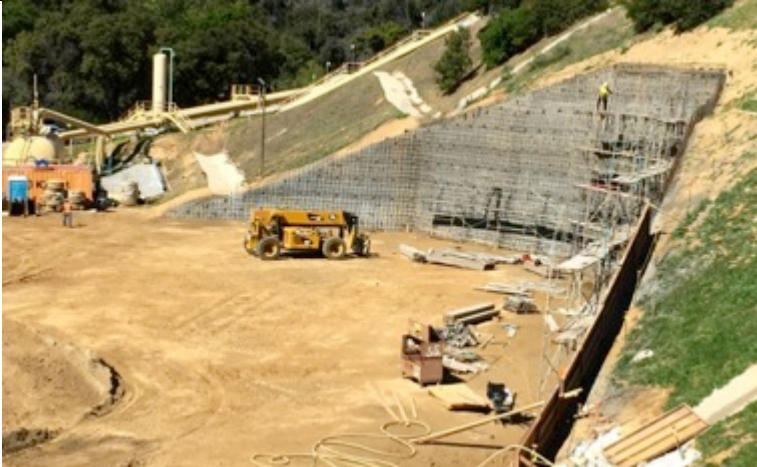
Work continues on bank stabilization.

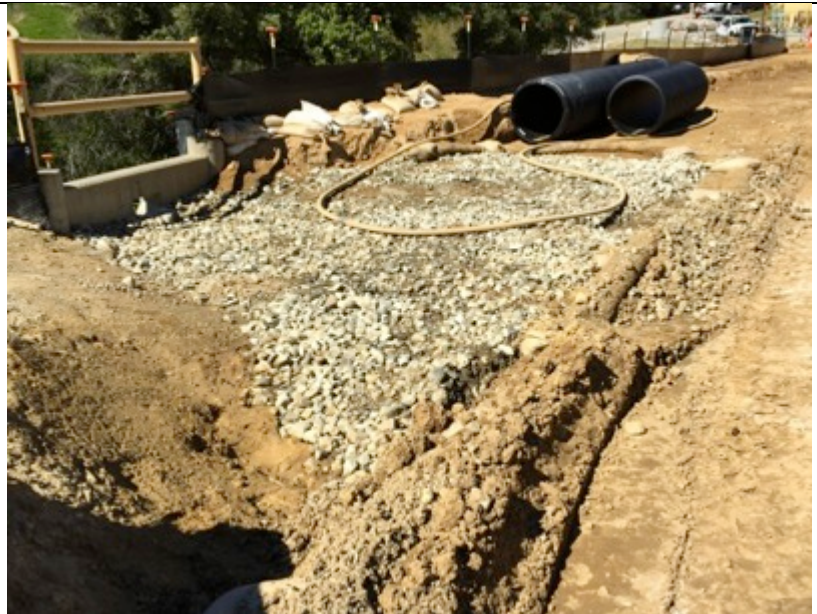
<p>2/24/15</p>	<p>Central Compressor Station</p>

<p>Main exit drain from the CCS area. The BMPs at this spot need some maintenance.</p>
<p>2/24/15</p>	<p>New Admin/IM Building</p>

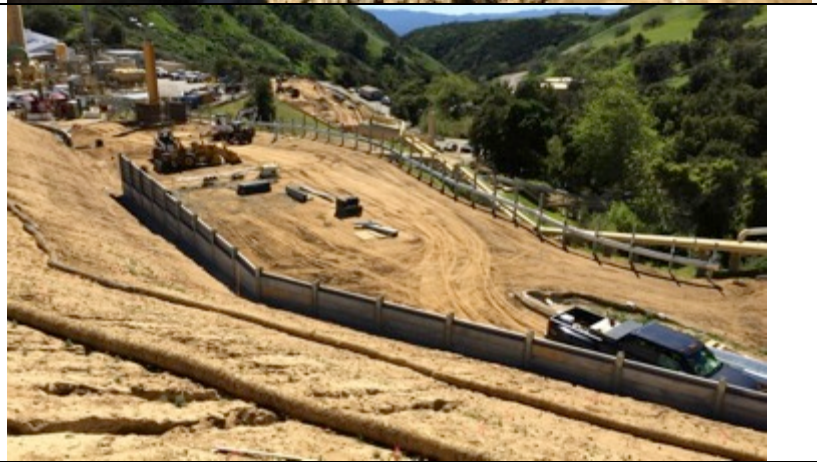
<p>Crews continue to work on walls and railings. Some of the BMPs could use some maintenance; note the riles going under the wattles.</p>
<p>2/24/15</p>	<p>New Admin/IM Building</p>

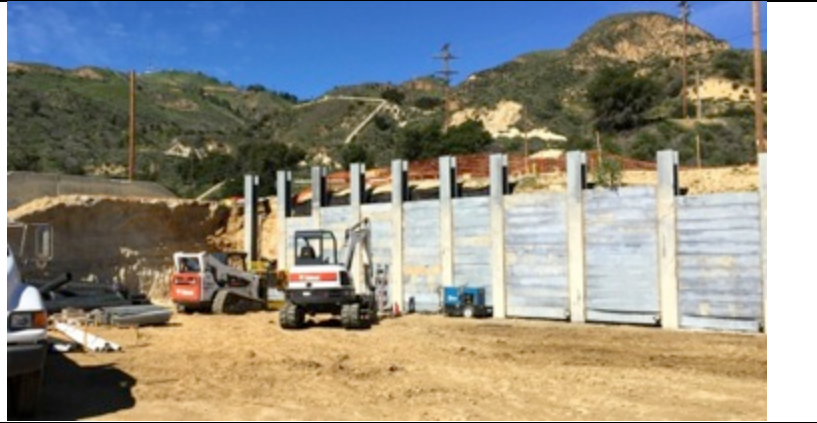
<p>Crews working on slope stabilization walls.</p>

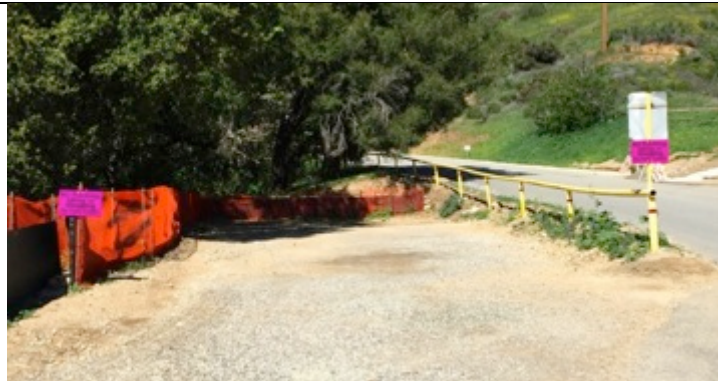
2/24/15	Guard House staging area with bushtit nest

No construction activity at the guard house. Bird nesting signs have been placed at the guard house staging area but there is no barrier fence or tape at the edge of the nesting buffer to stop people from using the part of the staging area within the nest buffer (APM BR-1c). A motorgrader was working on the TSP 46 access road just across the street from the staging area. This work was not associated with the Aliso Canyon Turbine Replacement Project, but was instead O & M work.

Nest protection signs are up in the proper locations but there is no barrier fence in place.
2/24/15	San Fernando Substation

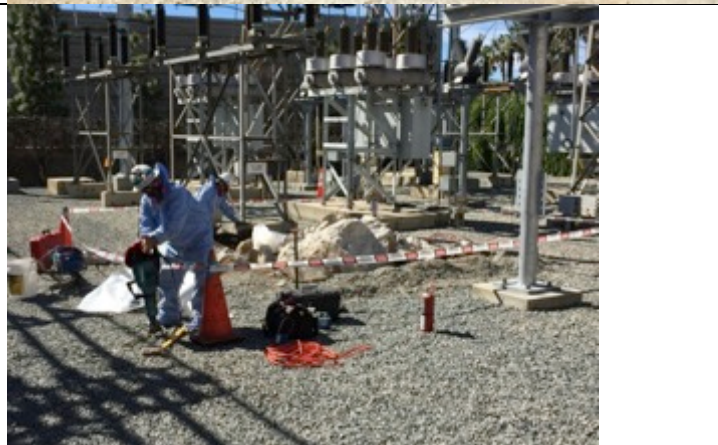
Crews are removing an old foundation.
2/24/15	San Fernando Substation

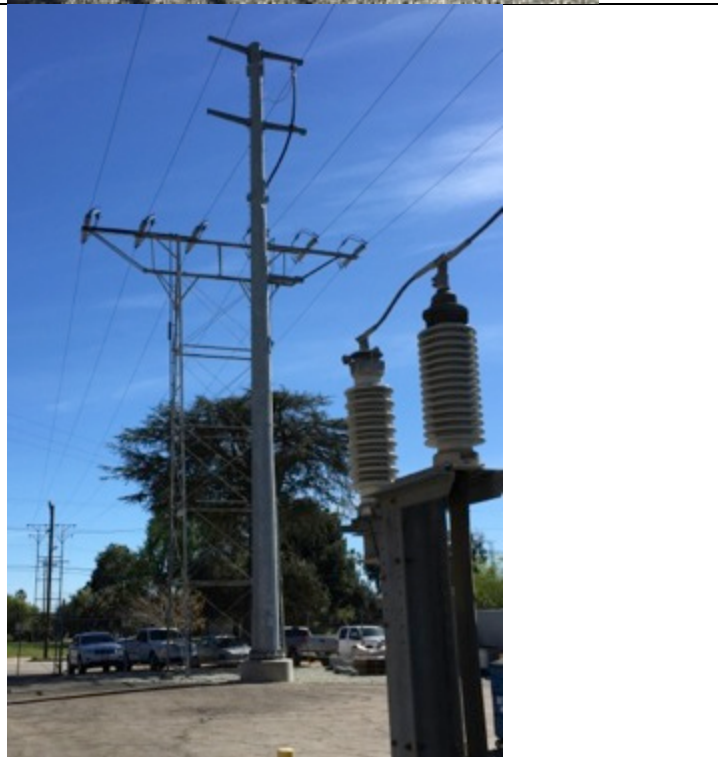
At the San Fernando Substation a crew continues to work inside the MEER, and another crew is working on excavating one of the old foundations. Paleo/Arch monitor Cecilio Garcia is onsite (MM CR-1, MM CR-3, MM CR-6 and MM CR-8) – see photo. They have installed the upper portion of the large TSP – see photo.

The upper portion of the TSP has been installed.

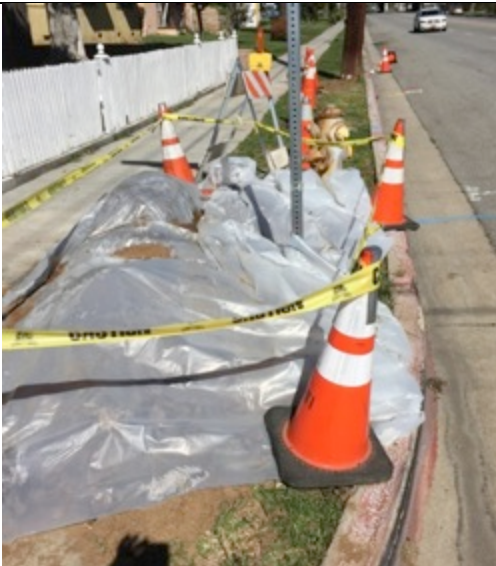
<p>Covered splice pit.</p>
<p>2/24/15</p>	<p>Sharp Ave. and San Fernando Mission Road (part of San Fernando Substation Tap)</p>

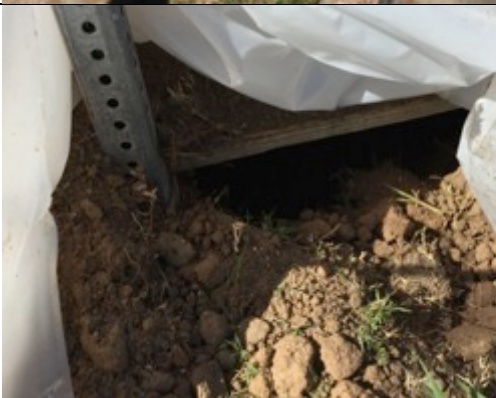
temporary San Fernando Substation Tap. Construction is on hold here; the two box holes had been covered with plywood, dirt and plastic, with caution tape and cones placed around the work site – see photo. I looked under one area of plastic and noted that a good sized hole (6 inches) was open between the plywood and the excavation – see photo. This should be covered up as per condition MM BIO-11.

<p>Opening into the splice box pit that needs to be covered.</p>
<p>2/24/15</p>	<p>TSP 7 site in Wiley Canyon</p>

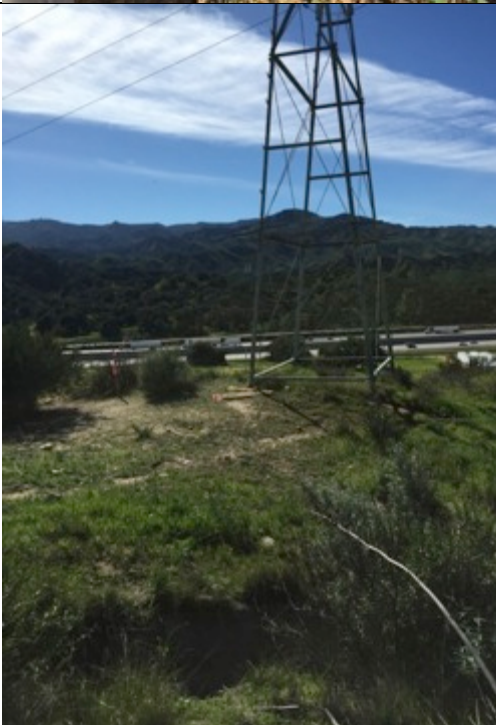
<p>Nesting bird surveys have been done and the access road was staked as crews are preparing to move into this area.</p>
