Re: Monthly Report Summary #12 for Aliso Canyon Turbine Replacement Project

Aliso Canyon Turbine Replacement Project CPUC Site Inspection Form

Project:	Aliso Canyon Turbine Replacement	Date:	March 5, 2015
Project Proponent:	Southern California Gas Company and Southern California Edison	Report #:	VS047
Lead Agency:	California Public Utilities Commission	Project Phase/NTP:	Guard House and Road Widening (NTP-1). The New Admin/IM Building (NTP-2) and Central Compressor Site (NTP-3). P-41 Fill site (NTP-2), PS-42 Fill Site, P-32 Fill site (NTP-3) and the Natural Substation (NTP-3, NTP-A). TSP-45 and 49, and the San Fernando Substation (NTP-A). Oak Tree Mitigation Area.
CPUC PM:	Andrew Barnsdale, Energy Division	AM/PM Weather:	Sunny, cool (60 degrees) and breezy (winds gusting up to 15 mph) at Aliso. Sunny and warmer (73 degrees) at San Fernando Substation and in Wiley Cyn.
E & E CM:	Lara Rachowicz	Start/End time:	0900-1245 hrs at the Aliso gas field. 1330 hrs at San Fernando and 1415 hrs at TSP 7 and 11 in Wiley Cyn.
Monitor(s):	Vince Semonsen

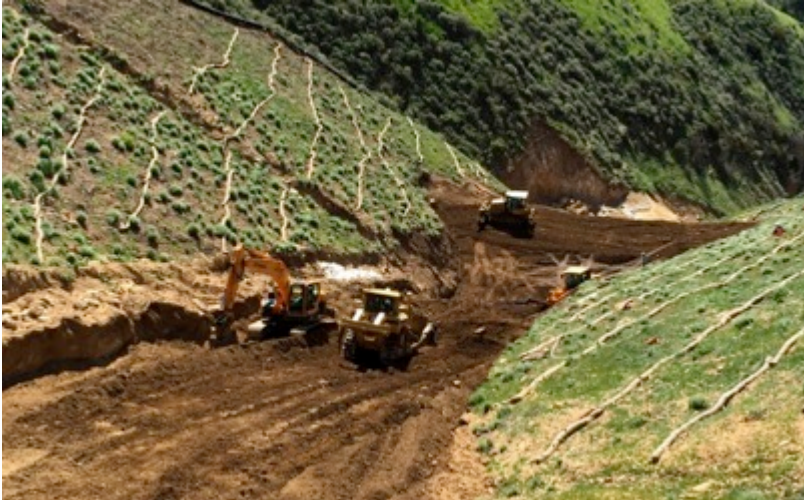
Date	Location	Photo	Description
3/05/15	PS-42 Fill Site

Equipment continues to work the dirt coming in from the Natural Substation.
3/05/15	PS-42 Temporary Rock Fill site	 	Stockpiled dirt has been covered with jute netting.
3/05/15	Guard House staging area	 	Some traffic cones have been placed at the boundary of the nest buffer.

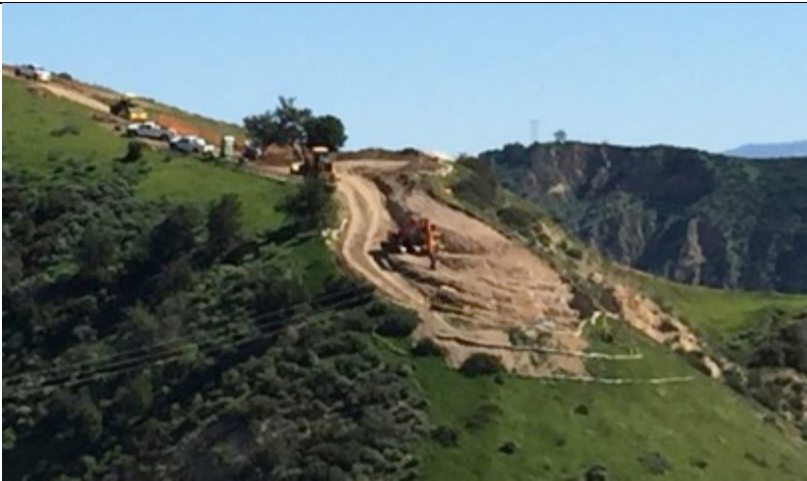
TSP 49

Work on the crane pad is ongoing.

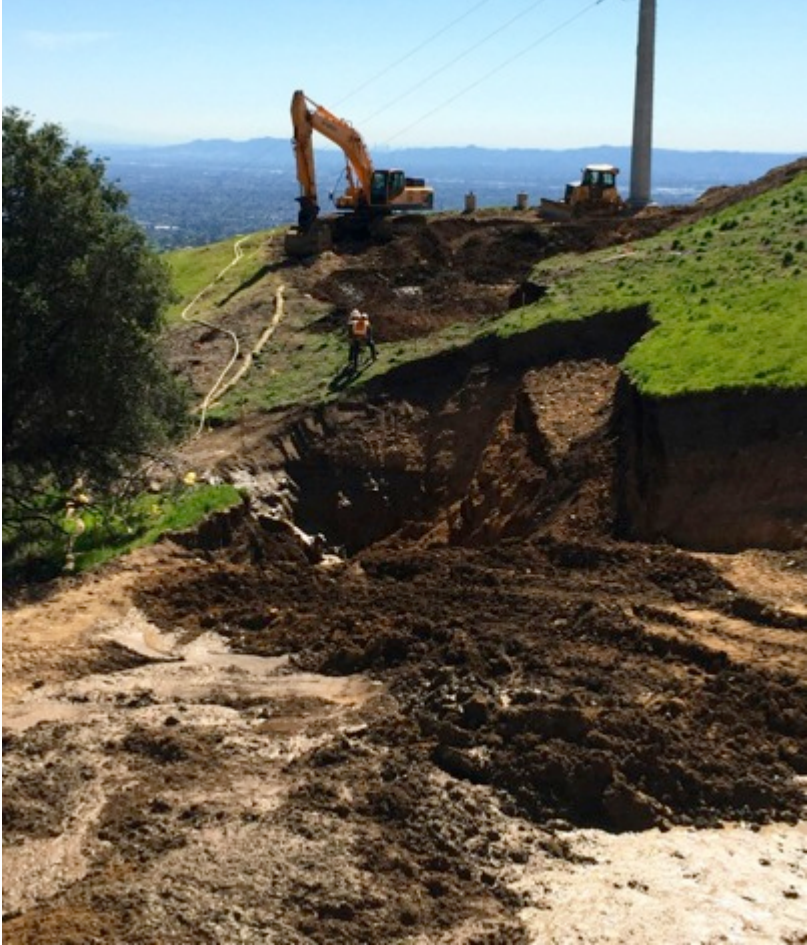
Natural Substation

Excavation of the substation access road is being done with an excavator. Note the mud in the foreground.

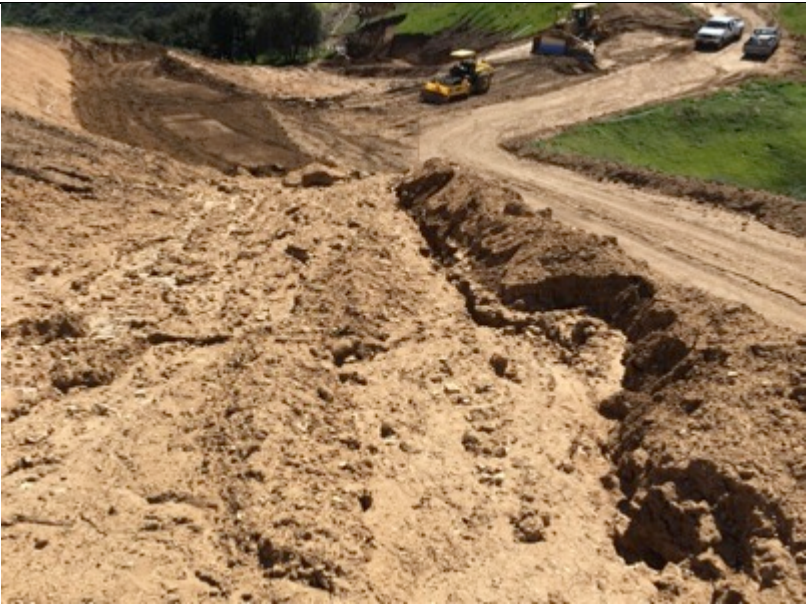
On the following Thursday, March 5, the CPUC's Compliance Monitor noticed a lack of BMPs on steep slopes under active construction and evidence of erosion and sedimentation at the Natural Substation and Access Road work site (Natural Substation). It appeared that water moved uninhibited down steep slopes of exposed soil, sediment-laden water overtopped the BMPs that were installed around the perimeter of the work site, and sedimentation occurred in a small oak tree grove below the Natural Substation. In accordance with SCG's National Pollutant Discharge Elimination System General Permit and APM GE-2, proper BMPs (e.g., silt fencing, fiber rolls on steep slopes) should have been installed to prevent erosion and, in particular, to protect the oak trees from sediment deposition. Photos from the inspection show erosion rills down the middle of the access road that was being constructed, an overflowed excavation/containment area at the base of the access road, missing and degraded BMPs, and evidence of erosion and sediment deposition under the oak tree canopy below the Natural Substation (see Attachment 1). Additionally, no exclusionary fencing to protect the oak trees had been installed, as required by APM BR-1b, APM BR-2, and APM BR-5.

Rainwater runoff from the latest storm system came down the access road causing some significant riling.
3/05/15	Natural Substation Access Road

- Install fiber rolls on slopes under active construction when the weather forecast indicates a 50 percent or greater chance of rain;
- Include the use of sediment traps (incorporated into SWPPP Amendment 5);
- Submit a weekly account of BMP maintenance;

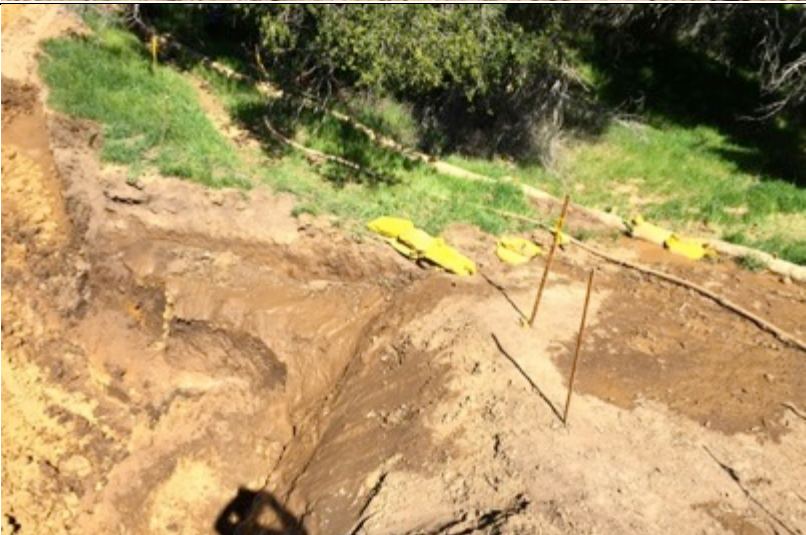
During the March reporting period a significant compliance incident occurred at the Aliso Canyon Natural Gas Storage Field; erosion of exposed soil and sedimentation into an oak tree grove occurred during a heavy storm due to a lack of proper Best Management Practices (BMPs) by SCG. On Saturday night February 28, 2015 a forecasted storm began to drop rain and continued through Sunday before turning to intermittent showers on Monday March 2. Prior to the storm event, when the forecast reached a 50% chance of rain and as outlined in the Storm Water Pollution Prevention Program (SWPPP), SCG completed a Rain Event Action Plan. The storm was predicted to drop 0.46 inches of rain, but over the course of the storm a total of 2 inches of rain fell.

Muddy water coming down the access road filled the hole near the oak swale with water, then overtopped the hole and ran down through the oaks.
3/05/15	P-32 Fill Site

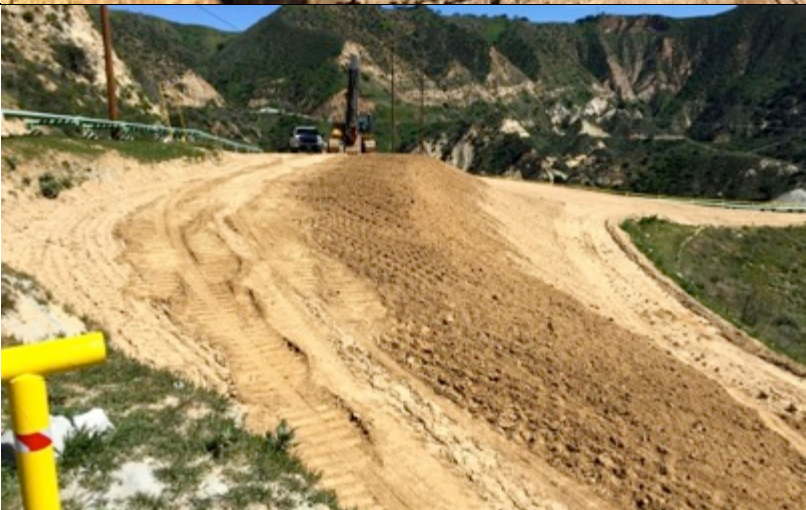
Soil is being brought to the fill site; then it is spread and compacted.

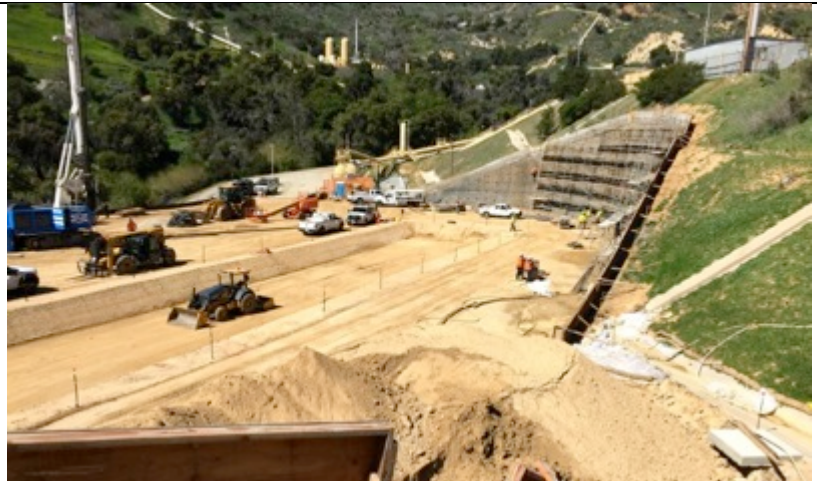
<p>3/05/15</p>	<p>Central Compressor Station</p>

<p>Work continues on bank stabilization in addition to some excavation work.</p>
<p>3/05/15</p>	<p>San Fernando Substation</p>

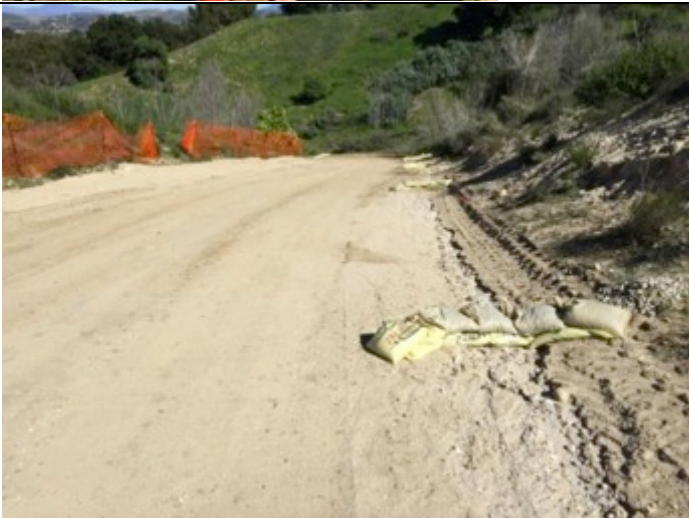
At TSP #7 the existing access road has been repaired with some temp BMPs installed – see photo. The additional access road has been cleared and graded with nest buffer stakes installed – see photos. A crew is digging a trench for a drainage culvert with the excavation being overseen by Paleo/Arch monitor Cecilio Garcia (MM CR-1, MM CR-3, MM CR-6 and MM CR-8). Biological monitor C. J. Fotherington (APM BR-1d, APM BR-6) is also onsite.

<p>The access road had been regraded with some temporary erosion control measures installed.</p>
<p>3/05/15</p>	<p>TSP #7</p>

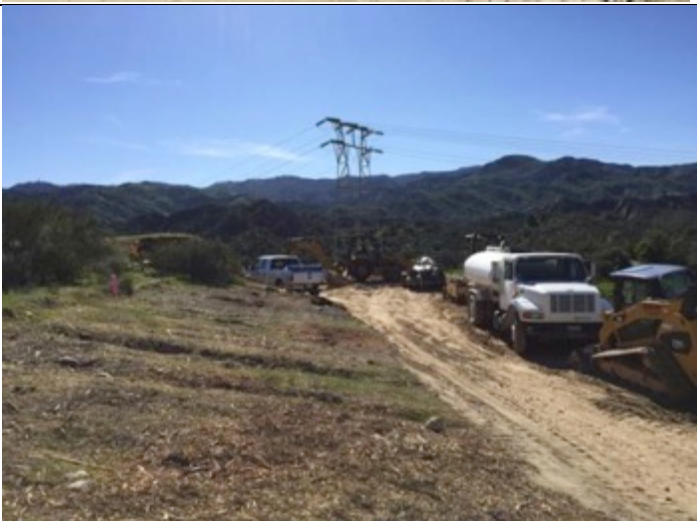
<p>Crews have cleared and cut the final stretch of the access road. Some nest barrier signage is in place on the upper side of the roadway.</p>

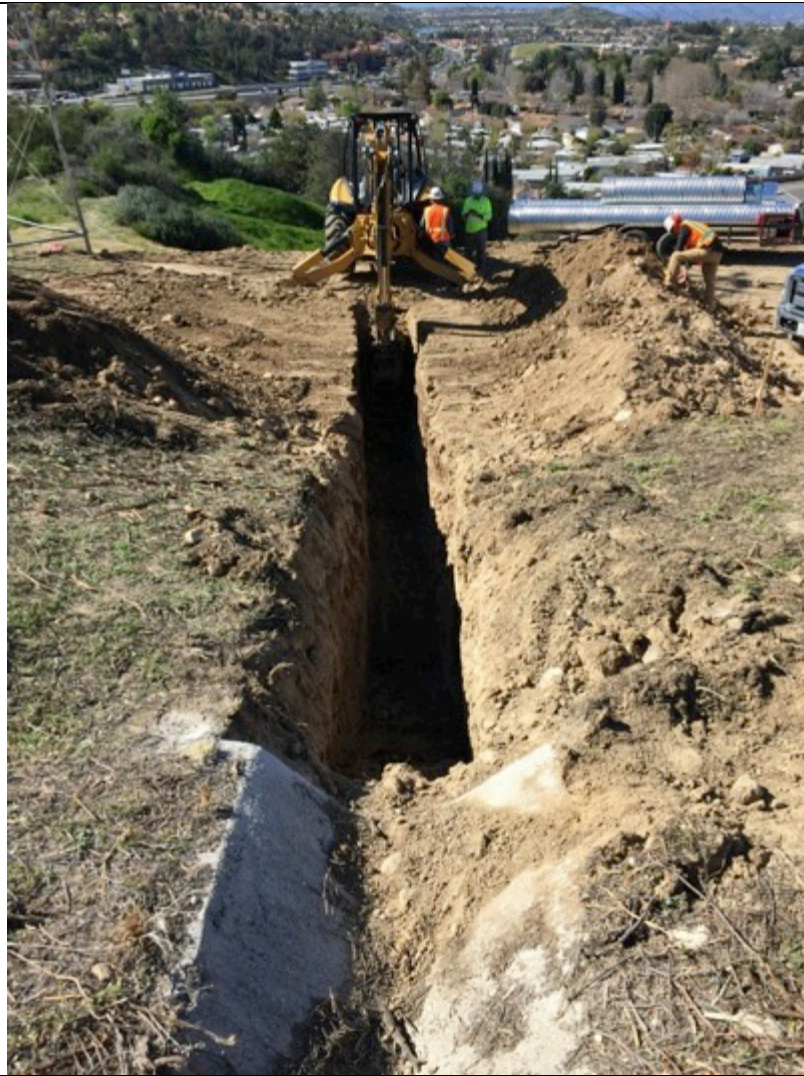
TSP #7

Crew is digging a trench for a drainage culvert.

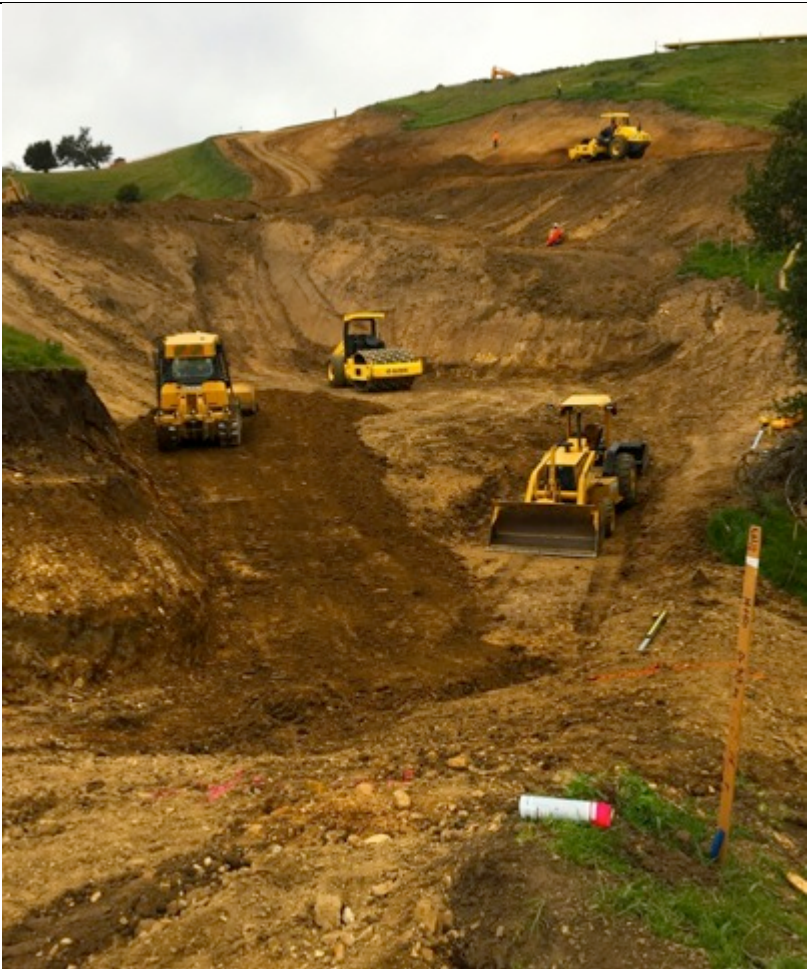
Natural
Substation
Access road

Crews are excavating the upper road and recompacting the access road down by the oak swale and the subdrain.

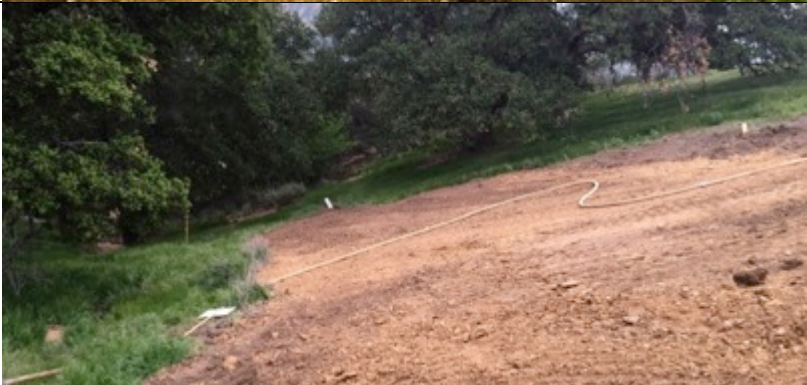
Natural
Substation
Access road

The subdrain outfall pipe has been installed and backfilled. The work was monitored by an arborist.

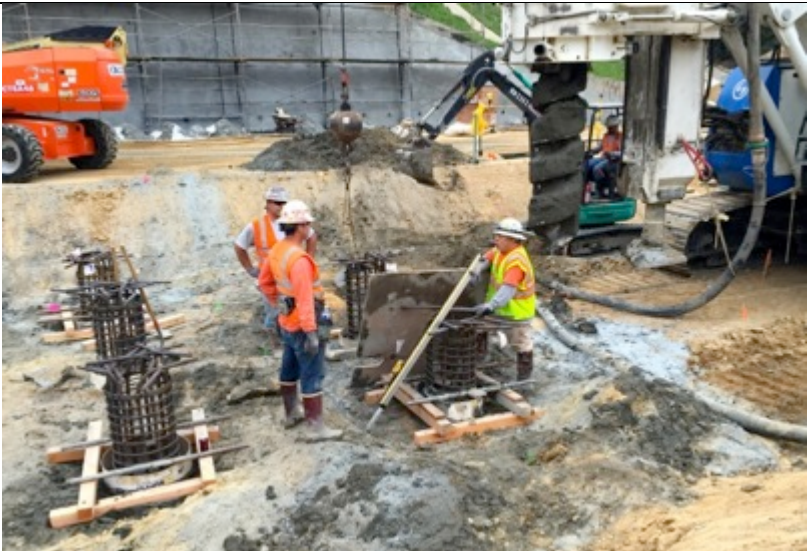
At the Central Compressor Station crews continue to work on the slope stabilization and are drilling and installing the compressor foundations – see photos. I asked Amandeep about the discolored soil noted from the drilling work and he said it “is excess concrete from drilling and pouring operation”. Concrete trucks are onsite and the proper concrete washout containment was in place. BMPs have been maintained and upgraded in and around the CCS – see photo.

A photograph showing construction workers in orange safety vests and hard hats working on a site. They are pouring concrete into rebar cages that are supported by wooden forms. In the background, there is a large piece of machinery, possibly a concrete pump or mixer, and a concrete mixer truck. The ground is dirt and concrete.	Drilling compressor foundation holes, followed by setting and pouring the cages.
3/11/15	Central Compressor Station	  A photograph showing a circular structure made of sandbags, likely a Best Management Practice (BMP) for erosion control. The structure is surrounded by a wooden railing. In the background, there are trees and a building.	Upgraded BMPs at the main site drain location.

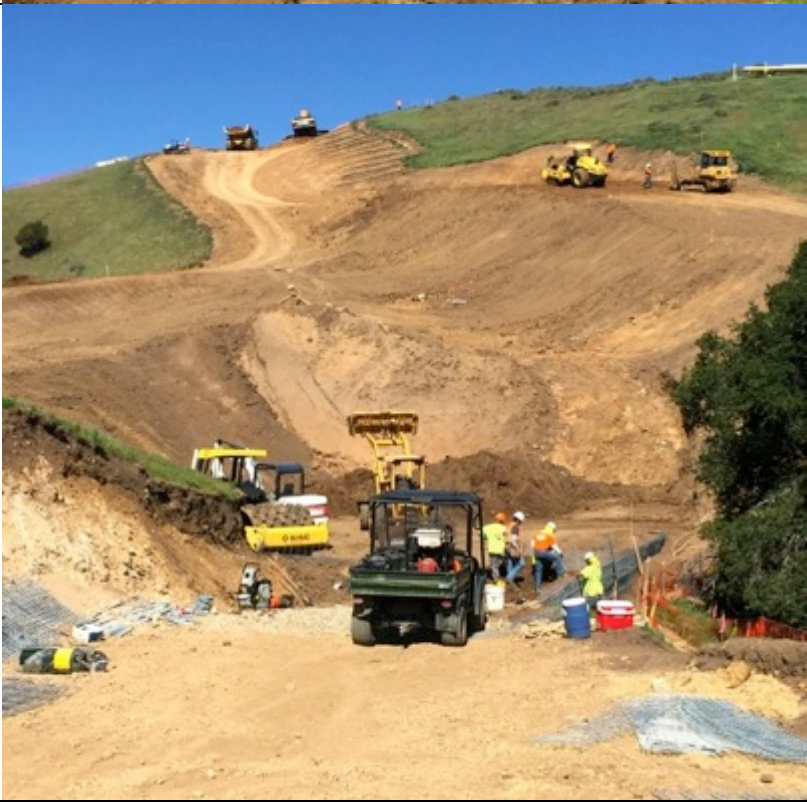
3/19/15 Natural Substation Access Rd.

Lots of earthwork – some temporary erosion control measures (straw wattles) have been installed on portions of the access road.

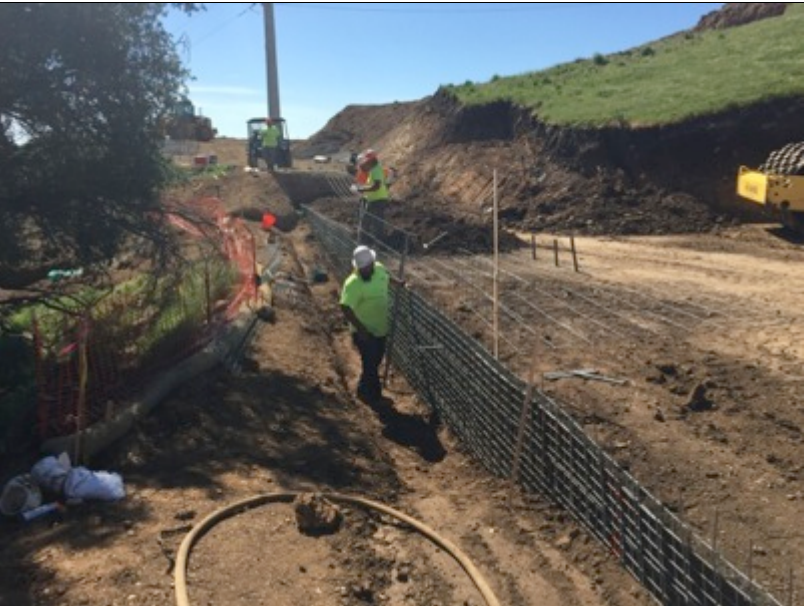
<p>Crews are working on a retaining wall near the oak swale. Exclusion fencing has been installed along with some BMPs.</p>
3/19/15	Natural Substation Access Rd.

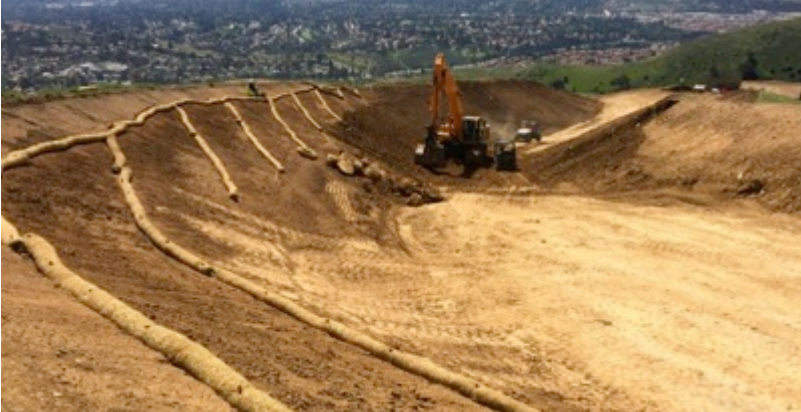
<p>Excavation of the access road continues with full-time Paleo monitoring. Temporary BMPs are installed on the finished slopes.</p>
3/23/15	Natural Substation

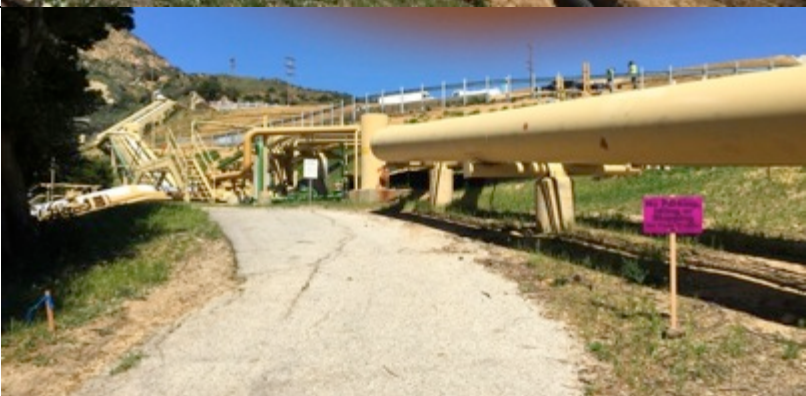
At the Central Compressor Station the retaining walls have been finished, crews continue to drill and install the compressor foundations, and are working on installing some drainage systems and silt fencing – see photos. A house finch nest listed as HOFI-04 was found within some piping and barrier signs have been installed. However, Seth said no barrier fencing has been installed because O&M personnel need access to this area.

<p>A house finch nest was found in the piping (HOFI-04) – signs have been installed but there is no barrier fence due to O&M access.</p>

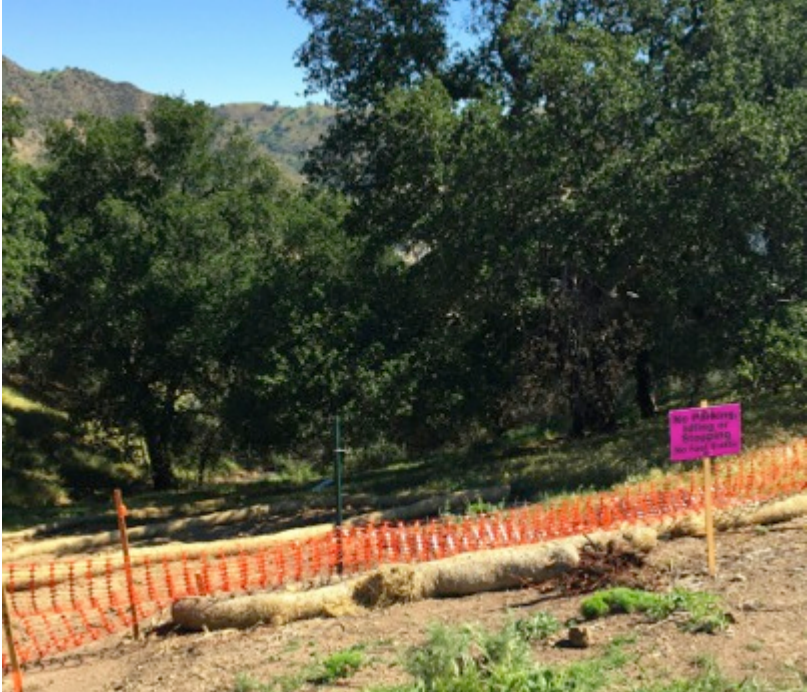
Natural Substation Access Rd.

An oak titmouse nest is in the oak just down from the access road.
