Re: Monthly Report Summary #19 for Aliso Canyon Turbine Replacement Project

Aliso Canyon Turbine Replacement Project CPUC Site Inspection Form

Project:	Aliso Canyon Turbine Replacement	Date:	October 8, 2015
Project Proponent:	Southern California Gas Company and Southern California Edison	Report #:	VS074
Lead Agency:	California Public Utilities Commission	Monitor(s):	Vince Semonsen
CPUC PM:	Andrew Barnsdale, Energy Division	AM/PM Weather:	Partly cloudy, mild temperatures, and calm. Becoming clear and hot with a slight breeze.
E & E CM:	Lara Rachowicz	Start/End time:	0800 to 0945 at TSPs 6 through 32. 1015 to 1330 at the Aliso Storage Field.
Project NTP(s):	Guard House and Road Widening (NTP-1). The new Admin/IM Building (NTP-2) and Central Compressor Station (CCS) (NTP-3). P-41 Fill Site (NTP-2), PS-42 Fill Site, P-32 Fill Site (NTP-3), and the Natural Substation (NTP-A, NTP-D). TSPs 2 through 42 (NTPs A, C, and D) and the SCE 210 Freeway Yard.

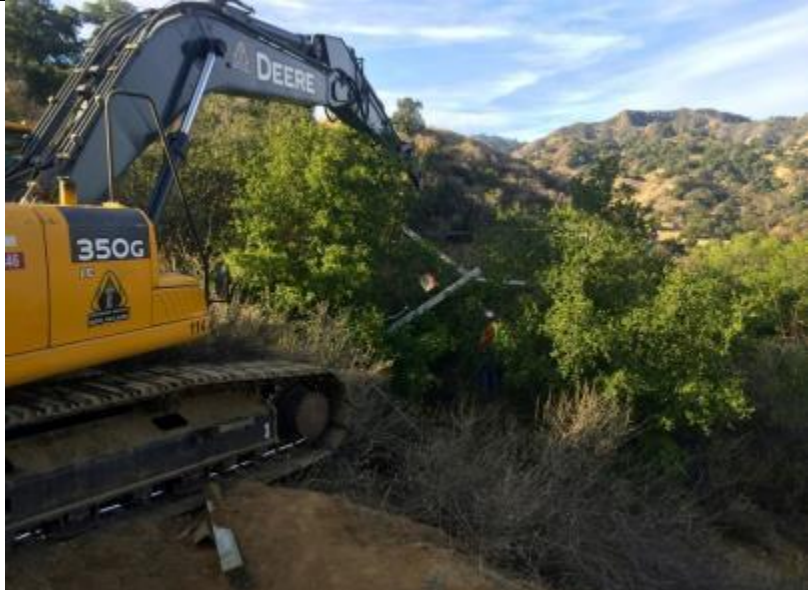
<p>The photograph shows a yellow Deere 350G excavator with a lattice boom, pulling a large, dark metal lattice tower structure through a wooded area. The excavator is positioned on a dirt path, and the background shows rolling hills and trees under a clear sky.</p>	Excavator pulling out the old latticework tower, with minimal impacts to the existing oak trees.

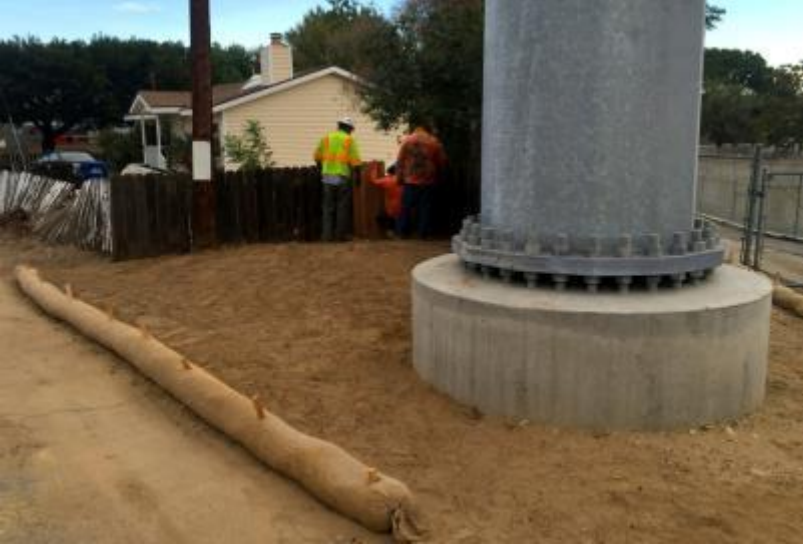
REPRESENTATIVE SITE PHOTOGRAPHS			
Date	Location	Photo	Description
10/08/15	TSP 6

During this site visit, I met with Todd White (Arcadis) at 0800 near the Mobile Estates. We drove to TSP 6 where a crew was removing the old foundations – see photo. The crew was also repairing fencing on some of the landowners' property. Biological monitor Shannon Dye was onsite with this crew (APM BR-1d and APM BR-6). The crew was in the process of completing work at TSP 6 and would be moving to TSPs 8 and 9.

Crews are taking out the old tower foundations and repairing a fence near TSP 6.
10/08/15	TSP 24/25 access road

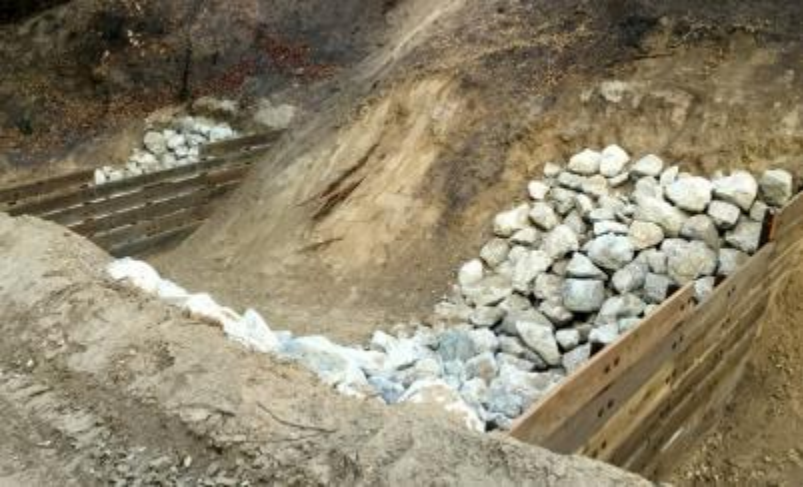
We drove along the TSP 24/25 access road and noted that the drainage work done by the Los Angeles County Department of Public Works (LADPW) crews had been completed – see photo. A crew was stringing wire at TSP 25; therefore, we did not go to that site. We were able to view the jurisdictional drainage between TSPs 24 and 25 – see photo; however, no work was being conducted. According to Todd White, the crew will finish the drainage work once the stringing crews have completed the work at TSP 25.

Debris barriers installed by the LADPW.
10/08/15	TSP 24/25 access road	 	No work within the jurisdictional drainage while crews are at TSP 25 stringing wire.

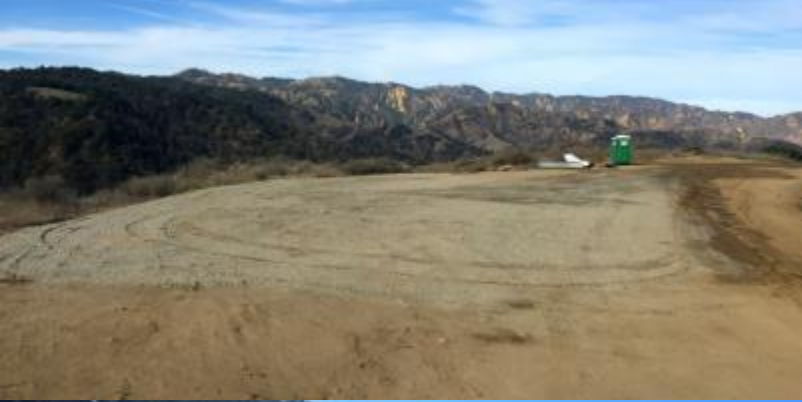
REPRESENTATIVE SITE PHOTOGRAPHS			
Date	Location	Photo	Description
10/08/15	Helicopter pad near TSP 30

The recently completed helicopter pad.
10/08/15	CCS

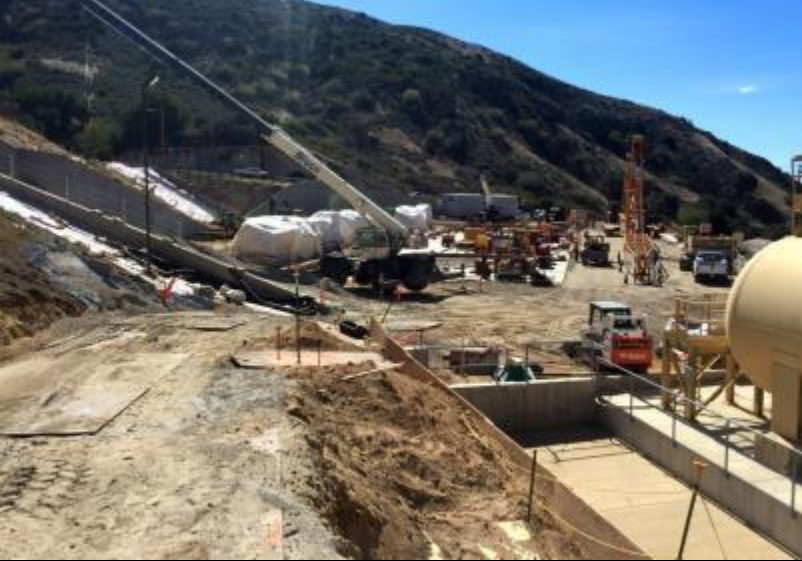
Ongoing construction work.
10/08/15	CCS

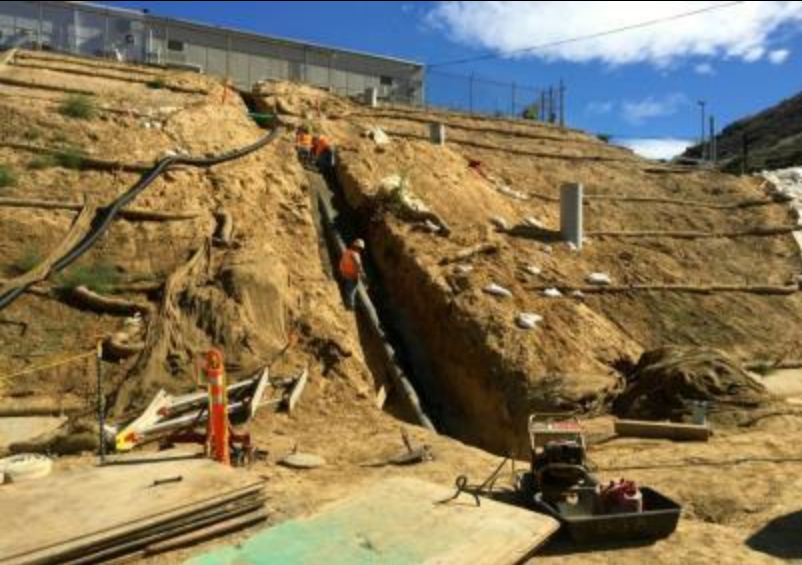
Backfilling the trench – note the gas can in the foreground is in a containment vessel, but not the generator.

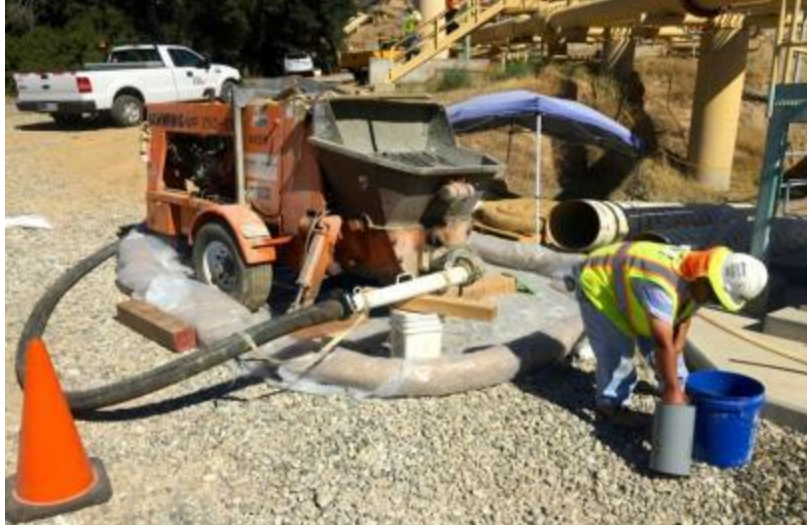
REPRESENTATIVE SITE PHOTOGRAPHS			
Date	Location	Photo	Description
10/08/15	CCS

Concrete pumper truck with containment.
10/08/15	CCS

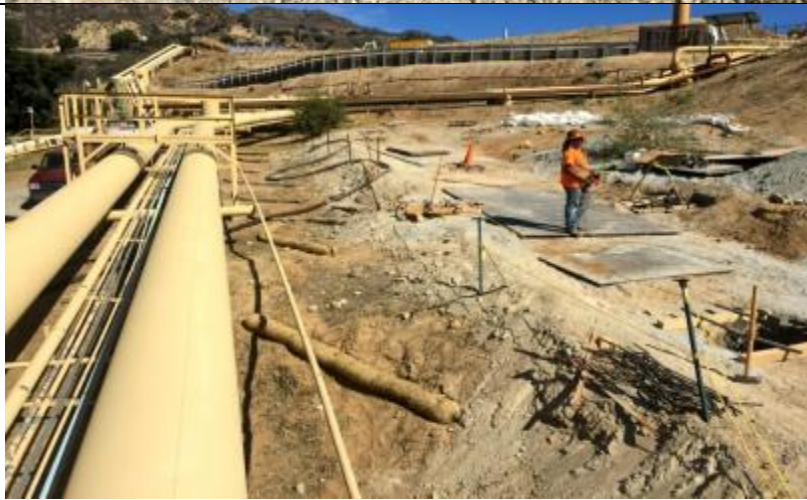
Drilling and pouring foundations continues – note the lack of exclusion fencing here.
10/08/15	CCS

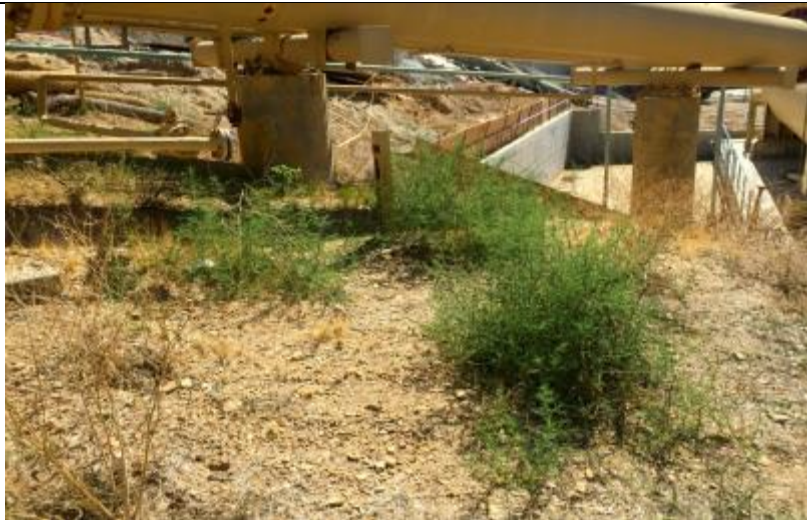
At the CCS, construction activities included excavation work, pouring concrete, and backfilling trenches – see photos. Concrete washouts appeared to be in good condition, and some of the wattles on the slopes had been replaced. A generator being used in the area did not have any containment under it. I also noted that some of the exclusion fencing near the pipe rack, along the creek corridor, had been removed (APM BR-1b) and replaced with wattles. Later in the day, I asked Amandeep Singh and SCG representative B.J. Lukins about the fencing. We discussed whether fencing was needed, and they agreed to look into the matter. A crop of invasive Russian thistle is coming up under the pipe rack – see photo.

Russian thistle growing under the pipe rack.

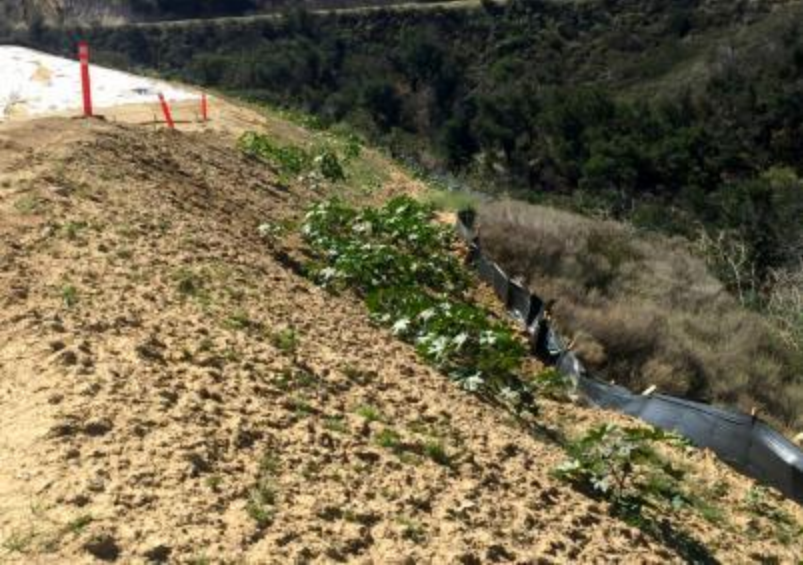
REPRESENTATIVE SITE PHOTOGRAPHS			
Date	Location	Photo	Description
10/08/15	P-32 Fill Site

Castor bean growing on the slopes of the P-32 Fill Site.
10/08/15	P-32 Fill Site

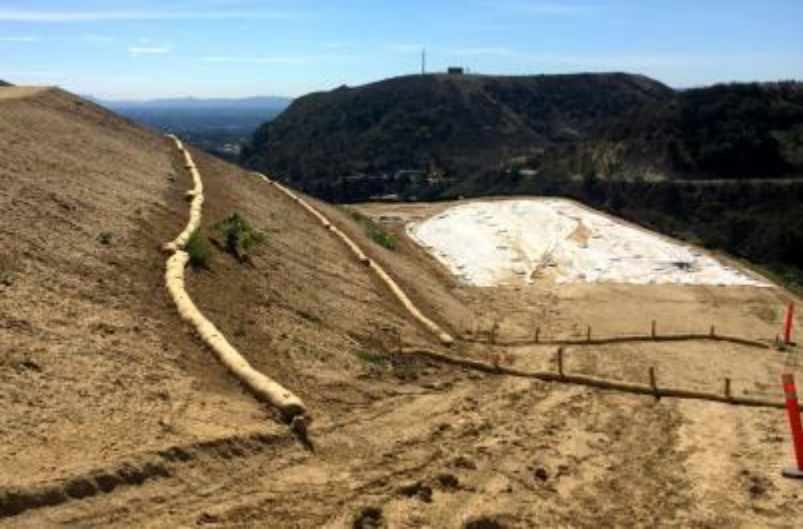
Wattles installed on the P-32 Fill Site slopes.
10/08/15	P-43 Fill Site

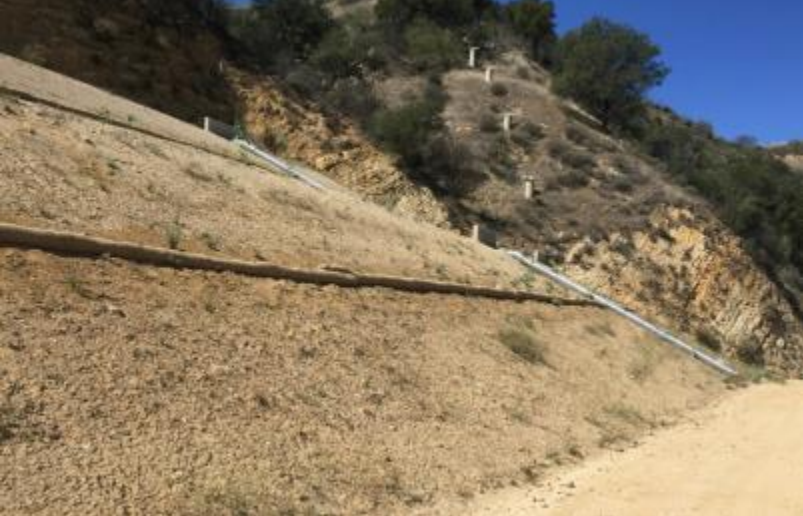
I looked at the P-41 and P-43 fill sites, where wattles were being installed – see photo. The P-41 Fill Site slopes were well vegetated with grasses. The access road to the P-43 Fill Site was rutted/rilled; upon further investigation, I found that all of the runoff from the P-43 and P-41 fill sites travels down the P-43 Fill Site access road. This could become an issue during the winter.

Wattles installed on the P-43 Fill Site slopes.

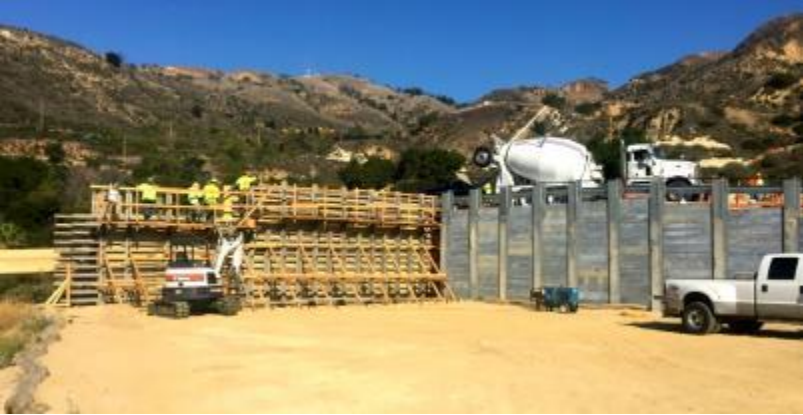
REPRESENTATIVE SITE PHOTOGRAPHS			
Date	Location	Photo	Description
10/13/15	New Admin/IM Building

Work on the walls continues.
10/13/15	New Admin/IM Building

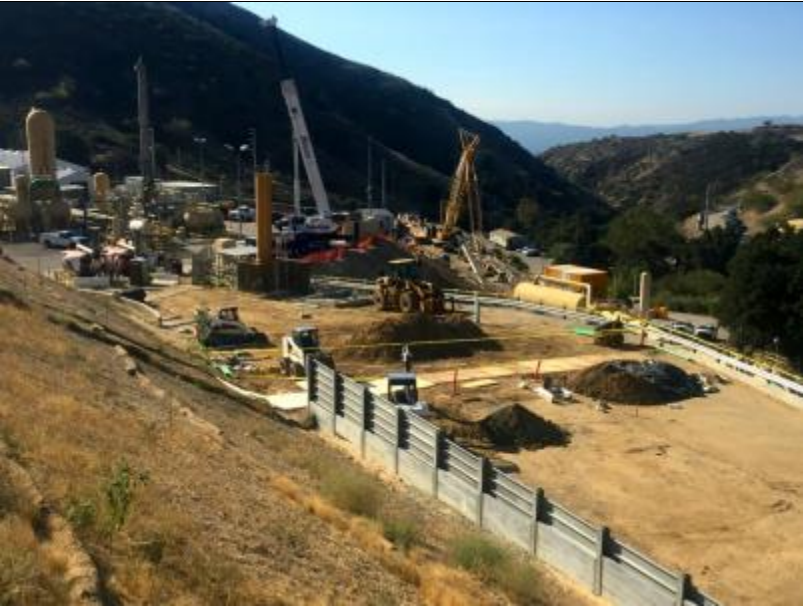
Some trenching is taking place on the lower new Admin/IM Building area.
10/13/15	CCS

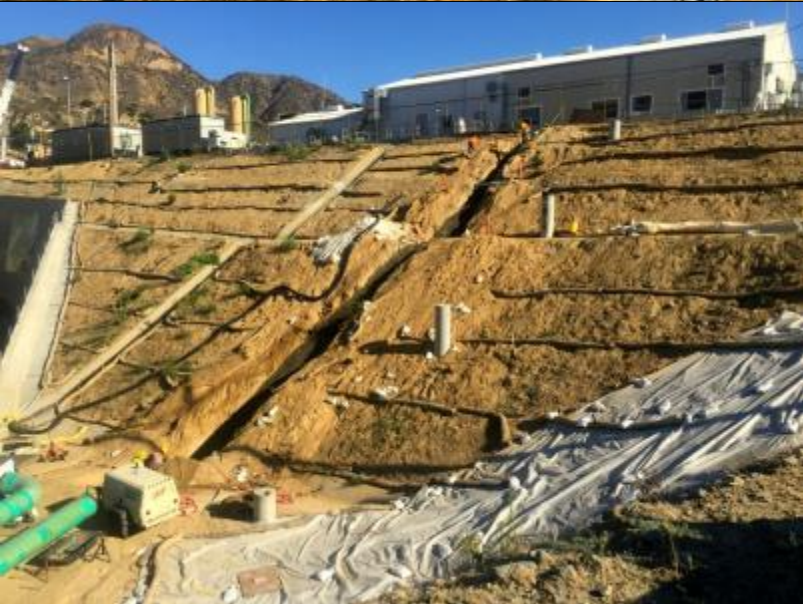
Backfilling the trench continues.

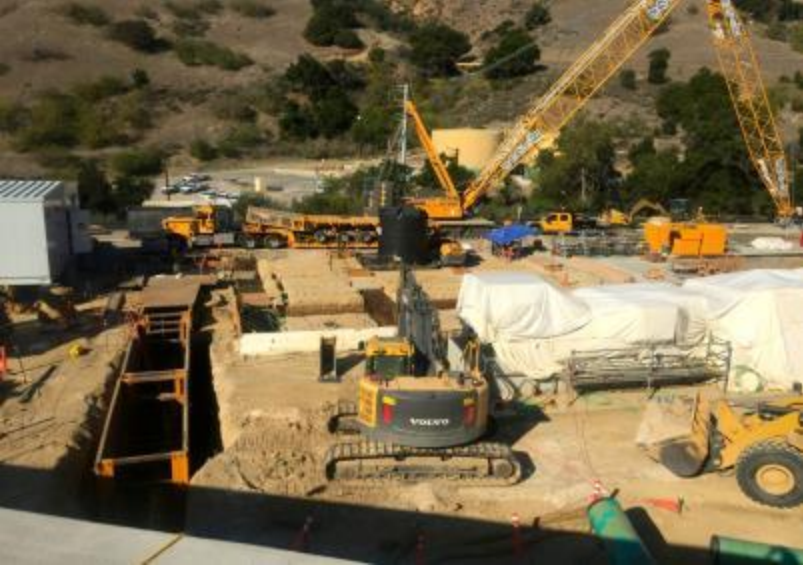
REPRESENTATIVE SITE PHOTOGRAPHS			
Date	Location	Photo	Description
10/13/15	CCS

A large crane has been set up onsite.
10/13/15	PS-42 Fill Site

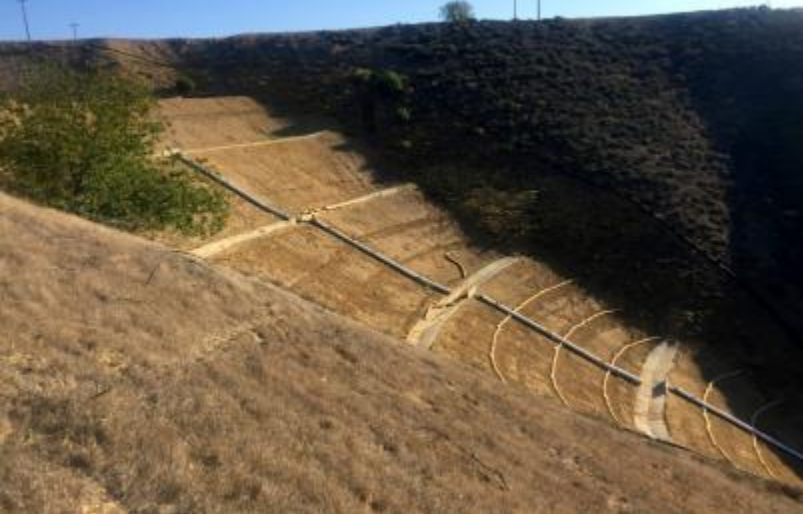
New BMP materials are being installed on the fill slope.
10/13/15	Natural Substation

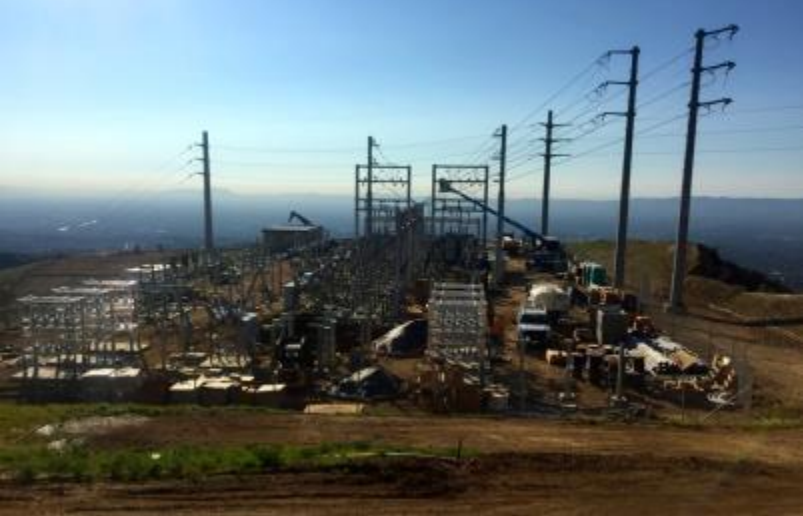
Site overview.

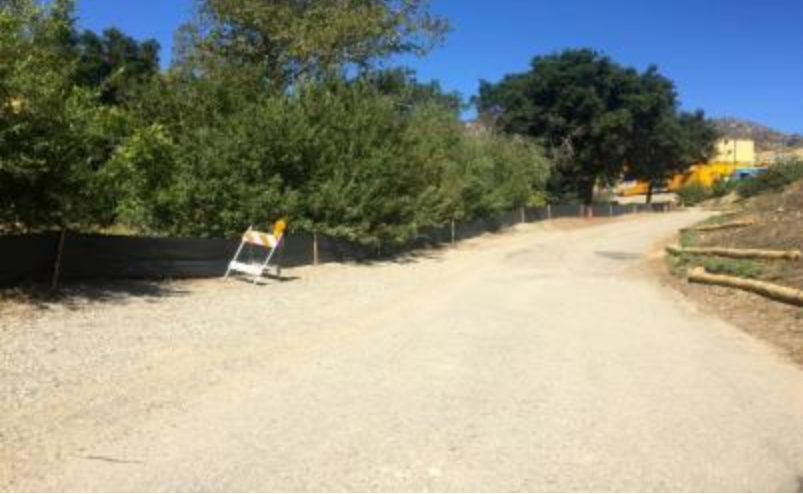
REPRESENTATIVE SITE PHOTOGRAPHS			
Date	Location	Photo	Description
10/22/15	CCS

I walked through the CCS area looking at the construction activities and the exclusion fence installation – see photos. The fencing was extended along the riparian corridor with both K-rail and silt fencing; the fencing now runs along most of the riparian corridor next to the CCS area (APM BR-1b). Ongoing construction activities include trenching and forming and pouring of foundations within the CCS – see photos.

Exclusion fencing along the riparian corridor.
10/22/15	CCS

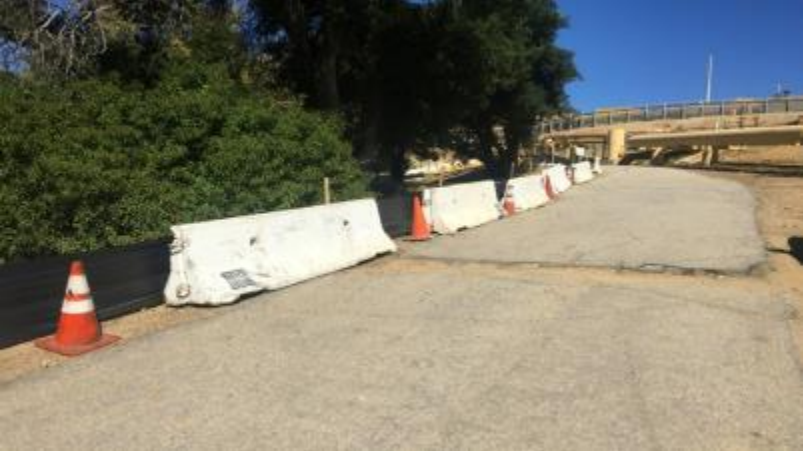
Exclusion fencing with concrete barriers (K-rails).
10/22/15	CCS

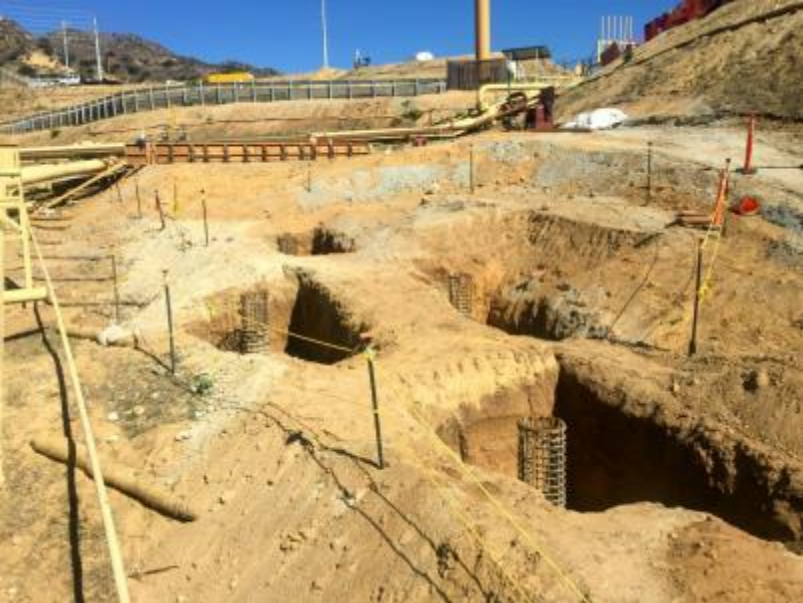
Installed cages.

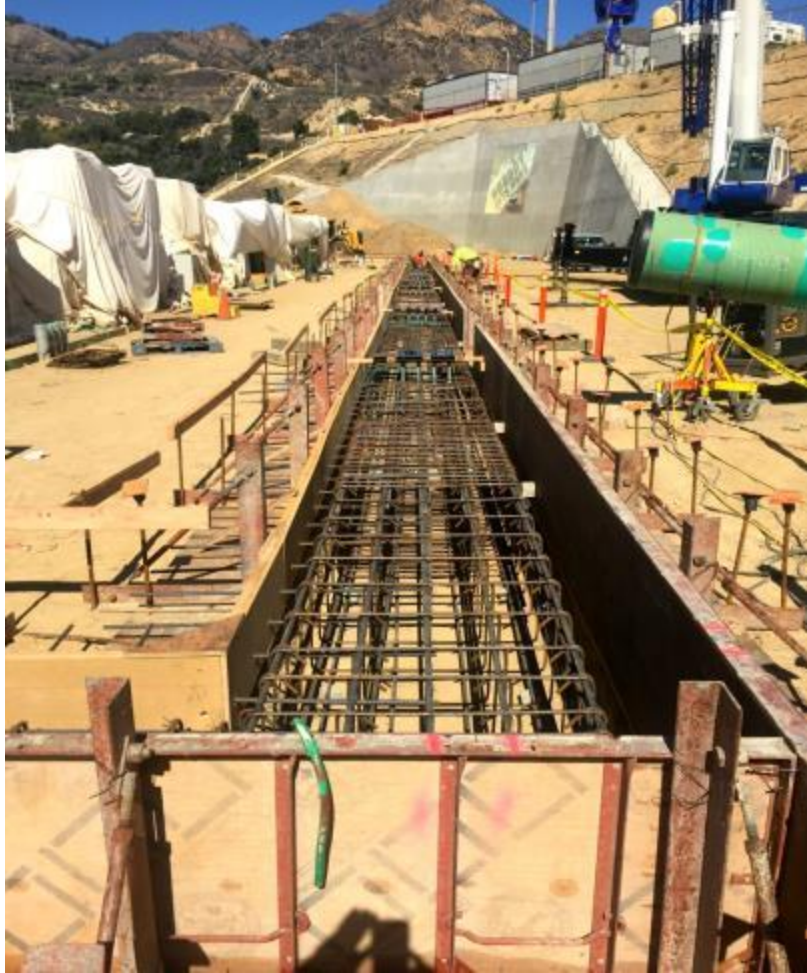
REPRESENTATIVE SITE PHOTOGRAPHS			
Date	Location	Photo	Description
10/22/15	CCS

Open trenches with rebar – ready to be poured.
10/22/15	PS-42 Fill Site

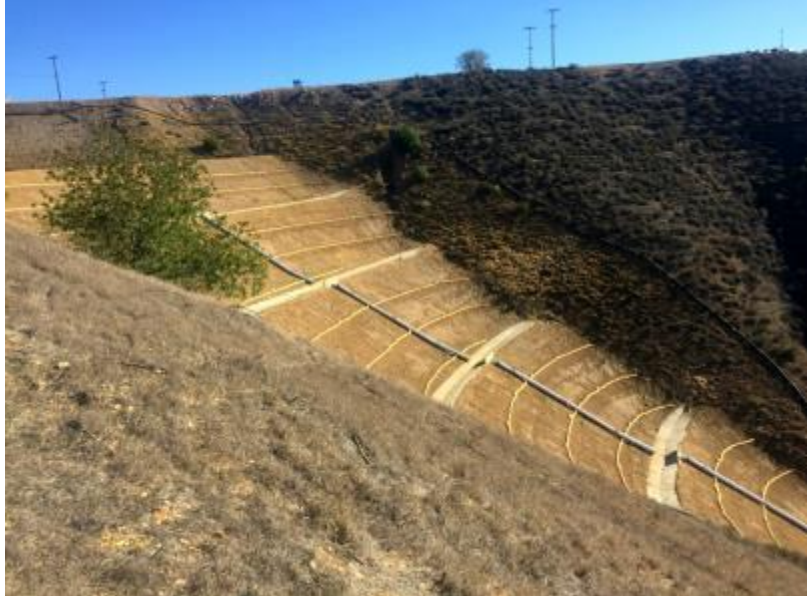
BMP materials have been installed on the fill slope – next is hydroseeding.

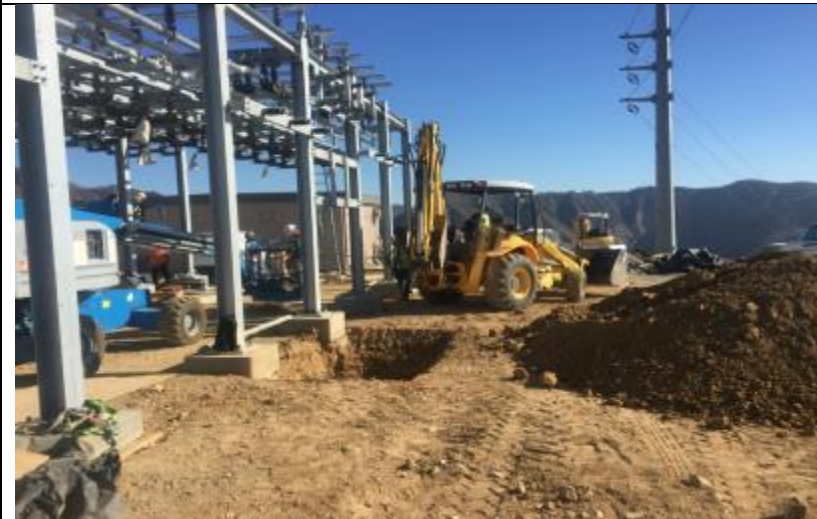
Date	Location	Photo	Description
10/22/15	Natural Substation

Excavation continues at the Natural Substation – also foundation pouring and equipment installation.
10/22/15	P-32 Fill Site

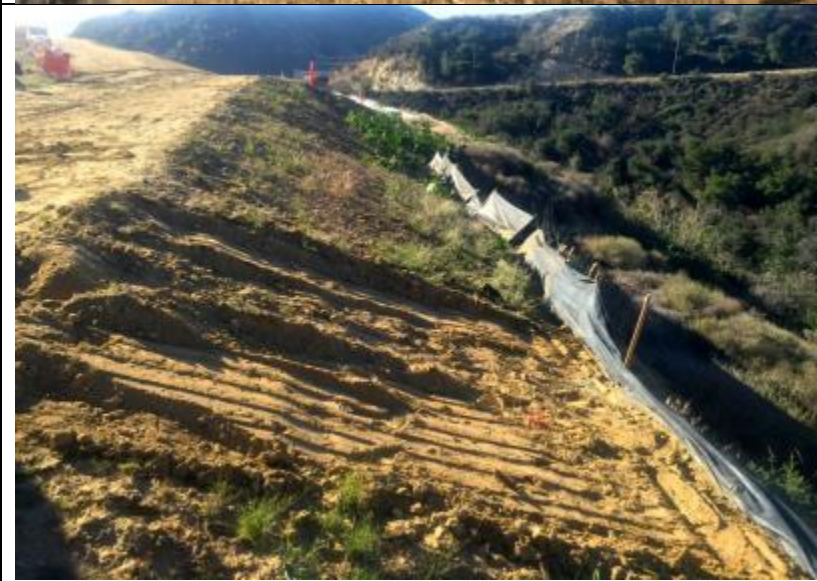
BMP crew is preparing to replace the silt fencing with straw wattle.
10/22/15	TSP 42

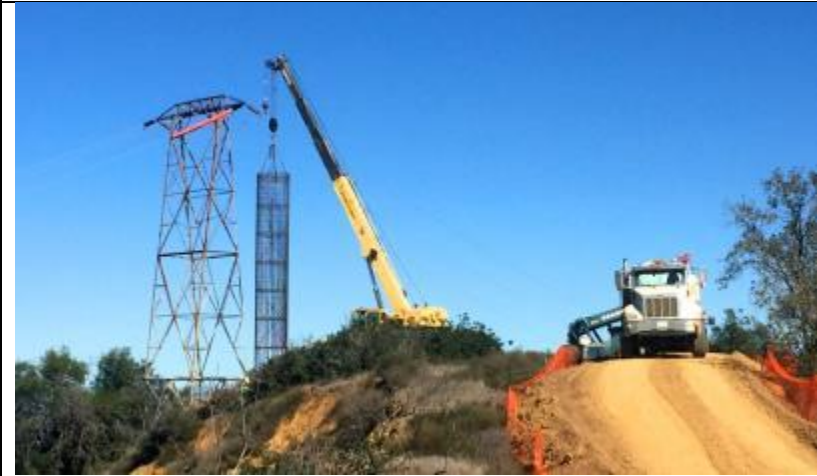
Cage installation prior to pouring the tower foundation.

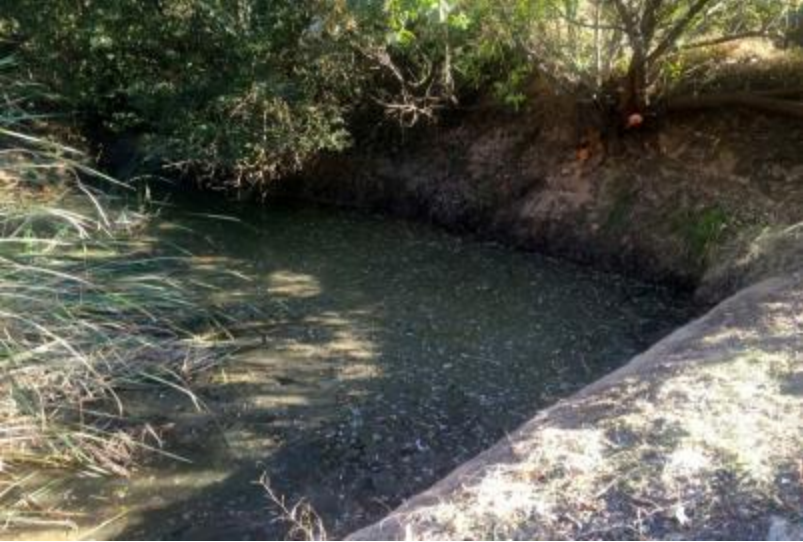
REPRESENTATIVE SITE PHOTOGRAPHS			
Date	Location	Photo	Description
10/29/15	Limekiln Creek

Weeper dam and catch basin near the CCS. Note the pruned willow.
10/29/15	Limekiln Creek

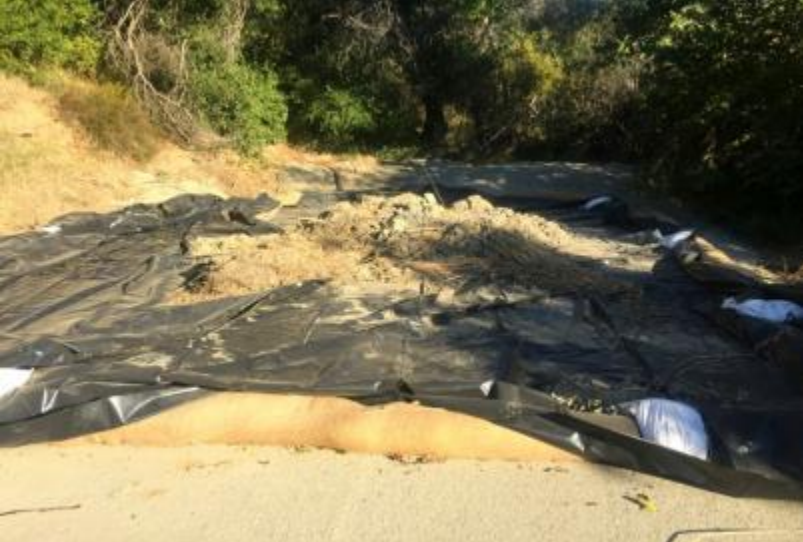
Mud and cattails excavated from the catch basin near the CCS.
10/29/15	Telecom route

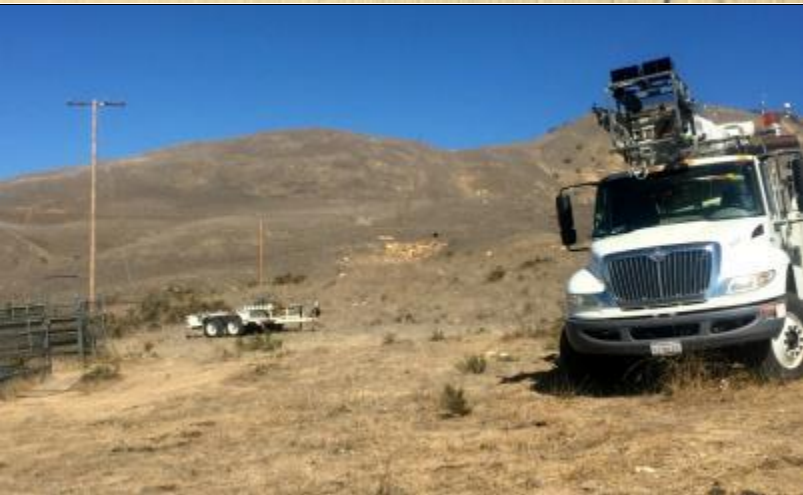
The telecom line will be hung on the poles shown in the photo. The photo was taken looking north up toward Oat Mountain.
