Re: Monthly Report Summary #25 for Aliso Canyon Turbine Replacement Project

Aliso Canyon Turbine Replacement Project CPUC Site Inspection Form

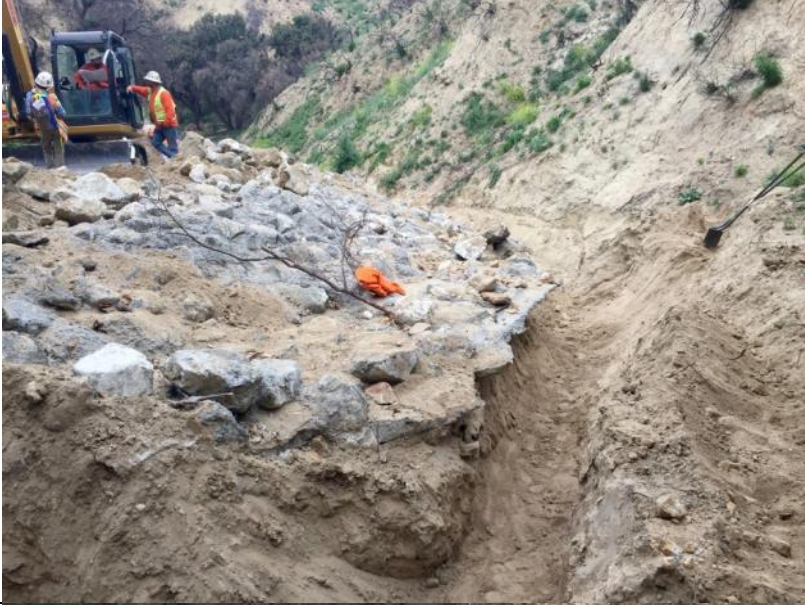
Crew onsite fixing the erosion rill along the riprap.
4/07/16	Drainage #4 along the TSP 24/25 access road

Check erosion repairs at Drainage #4 along the TSP 24/25 access road, and at TSP 7.
Check on nesting bird buffers throughout the Aliso Storage Field and secure the stored bird netting.

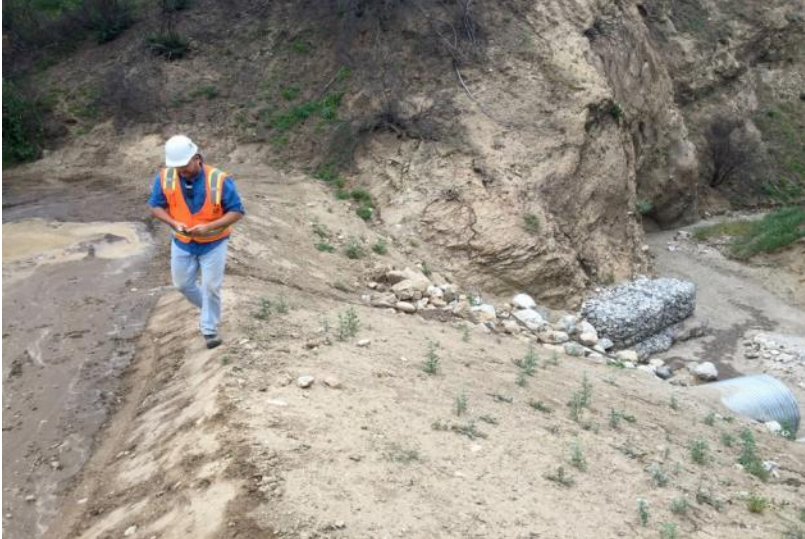
Rainwater runoff ponds on the road and then cuts through the road berm, draining into the jurisdictional drainage.
4/07/16	TSP 30

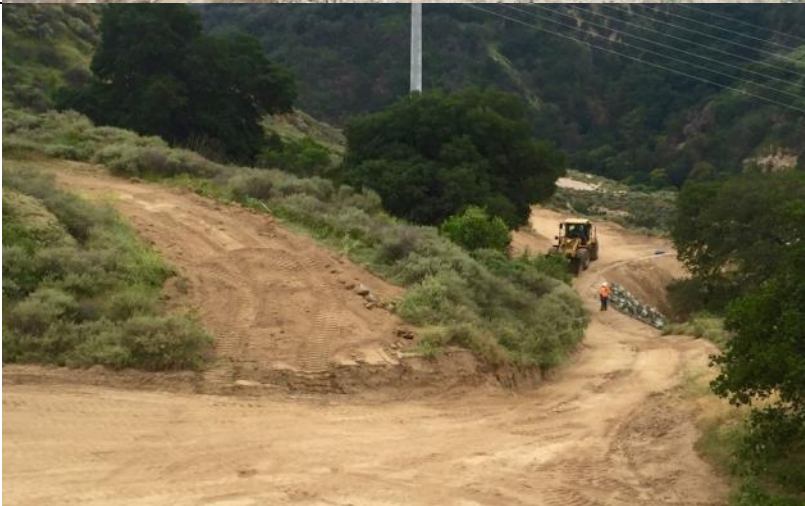
Stockpiled topsoil is being restored at a number of locations around TSP 30.

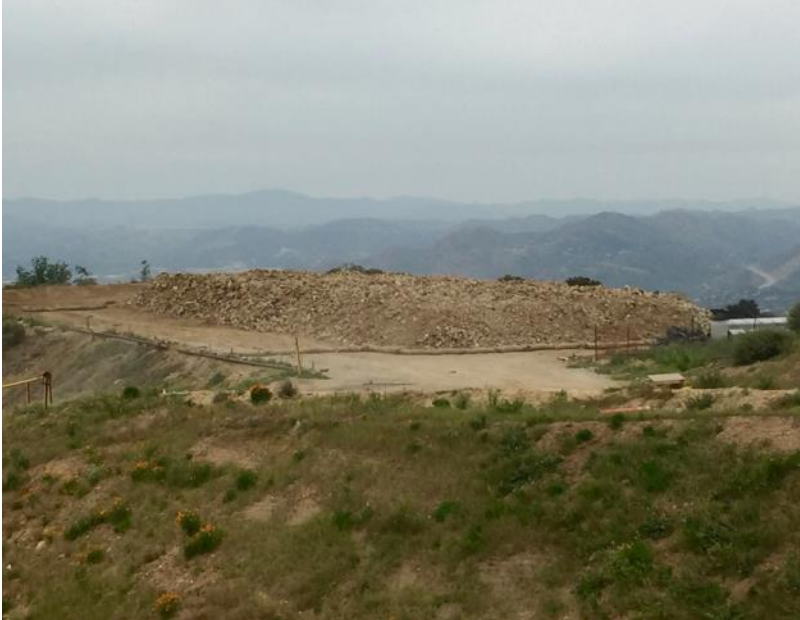
No work was taking place at the PS-42 rock staging area, and it appears that work in this area is complete – see photo. I noted some loose pieces of bird netting on the PS-42 well pad, which I collected and disposed of – see photo.

Work at PS-42 Fill Site appears to be nearly complete.
4/07/16	New Admin/IM Building

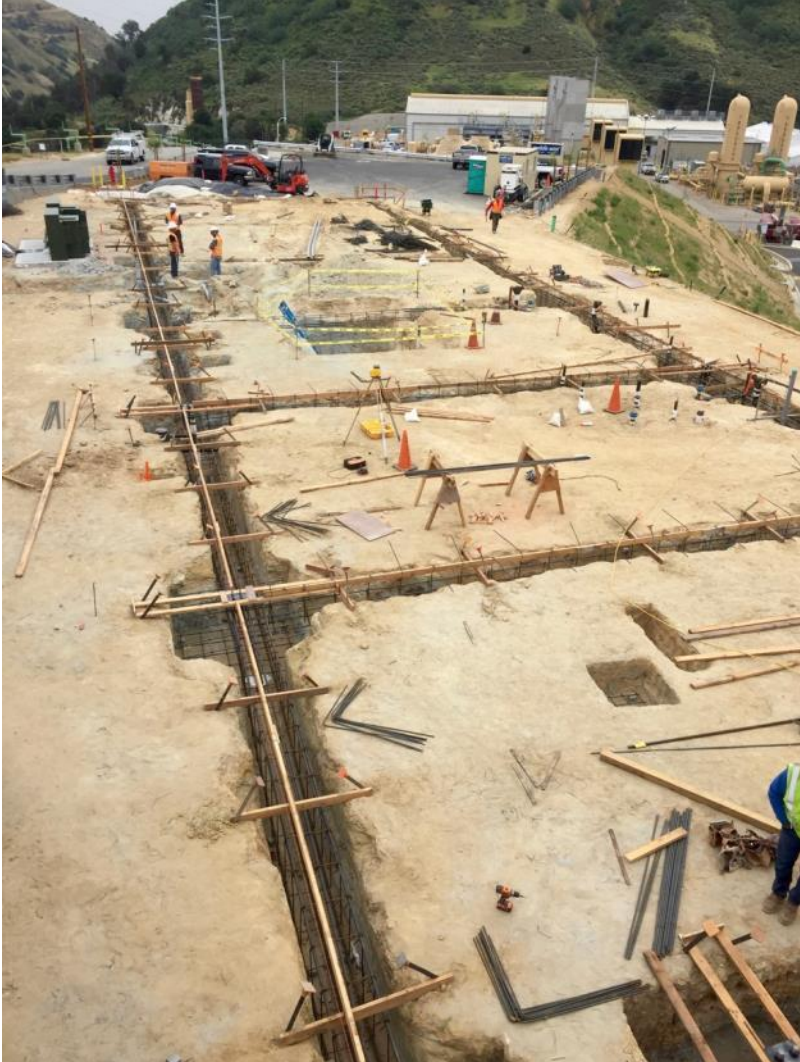
At the new Admin/IM Building, trenching was being conducted at several locations, and foundation work was ongoing – see photos.

Foundation work continues at the new Admin/IM Building.

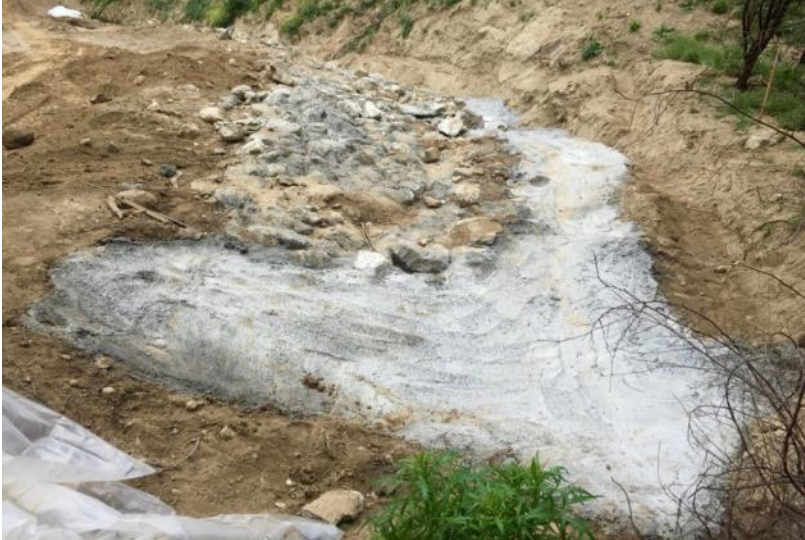
Erosion along the TSP 24/25 access road has been filled with slurry.
4/11/16	Drainage #4 along the TSP 24/25 access road

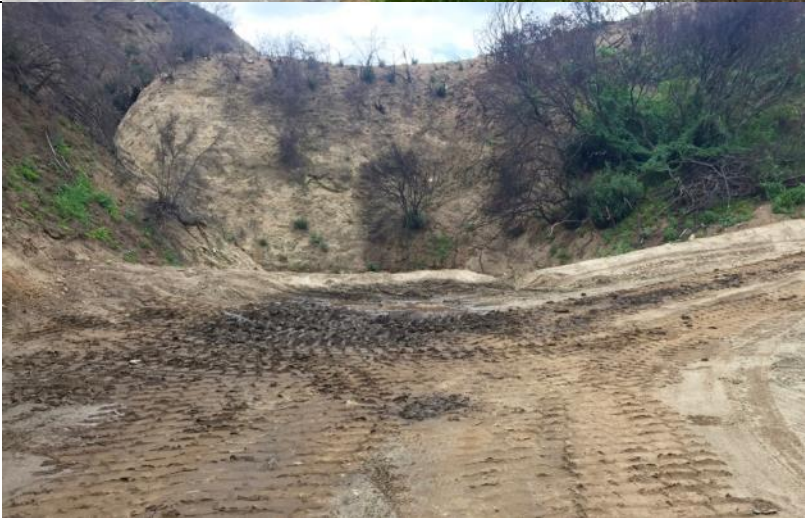
Rainwater runoff ponds on the road and then cuts through the road berm, draining into the jurisdictional drainage.
4/11/16	Drainage #4

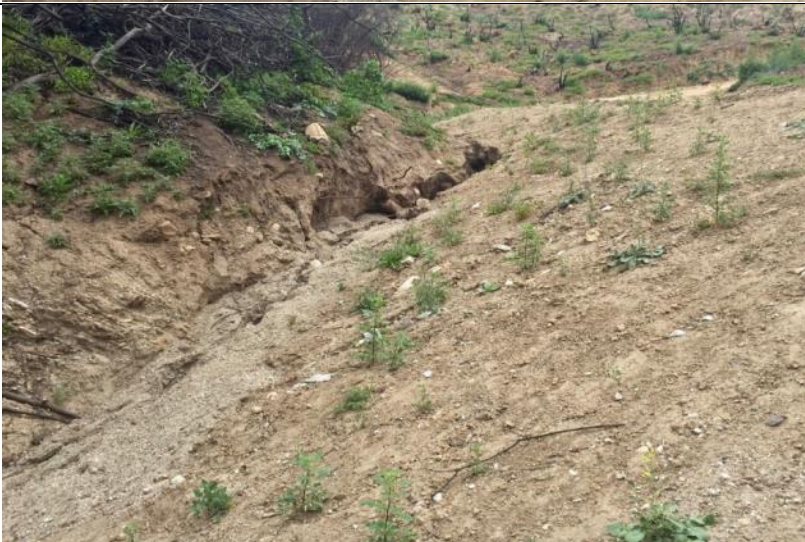
Erosion rill along the outside of the access road that ends up in the drainage.

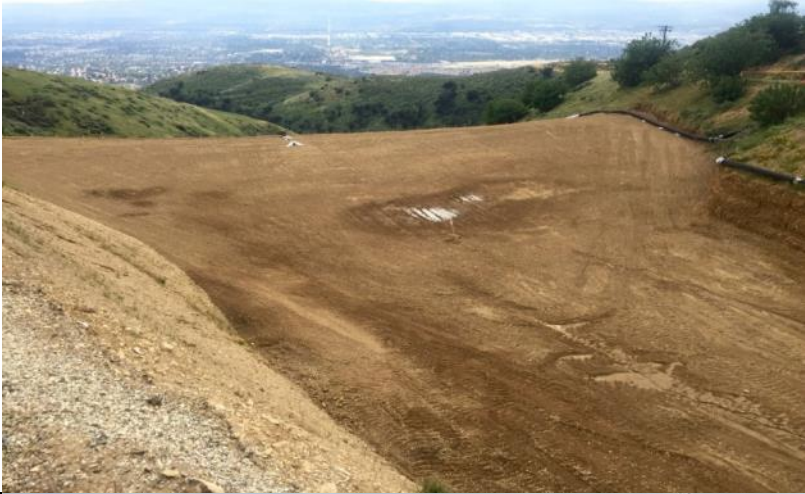
I observed ponded water on the PS-42 Well Pad, but the PS-42 Fill Site was nearly dry, with only a small wet area in the center of the site – see photos.

Only a small puddle remains on the PS-42 Fill Site after the weekend rains.
4/11/16	Natural Substation access road

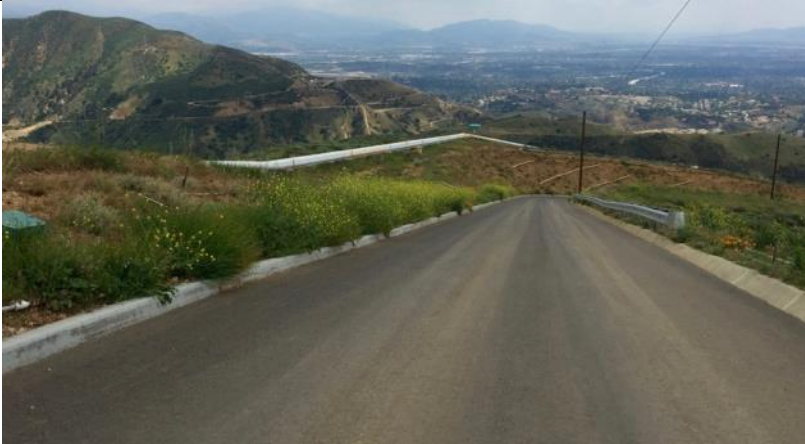
An invasive mustard species is getting big along the access road.
4/11/16	Natural Substation access road – oak swale

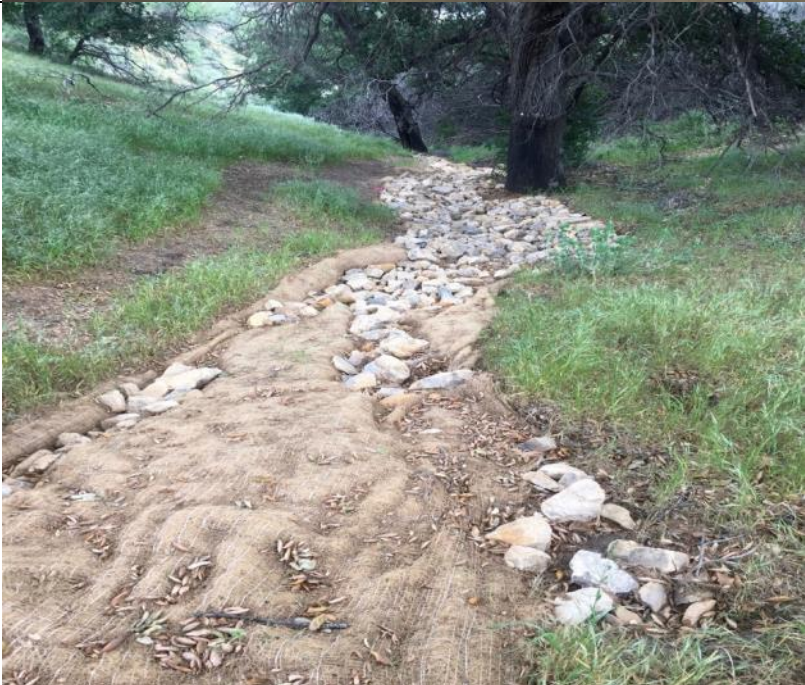
Erosion stabilization within the oak swale.

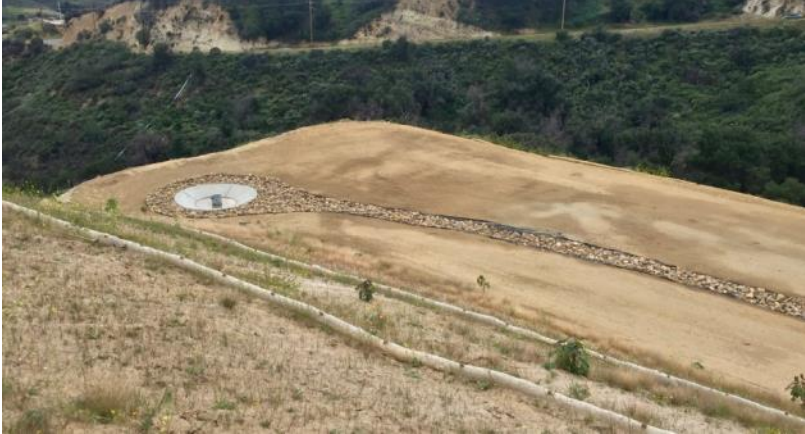
Final BMPs at the P-32 Fill Site.
4/11/16	P-32 Fill Site

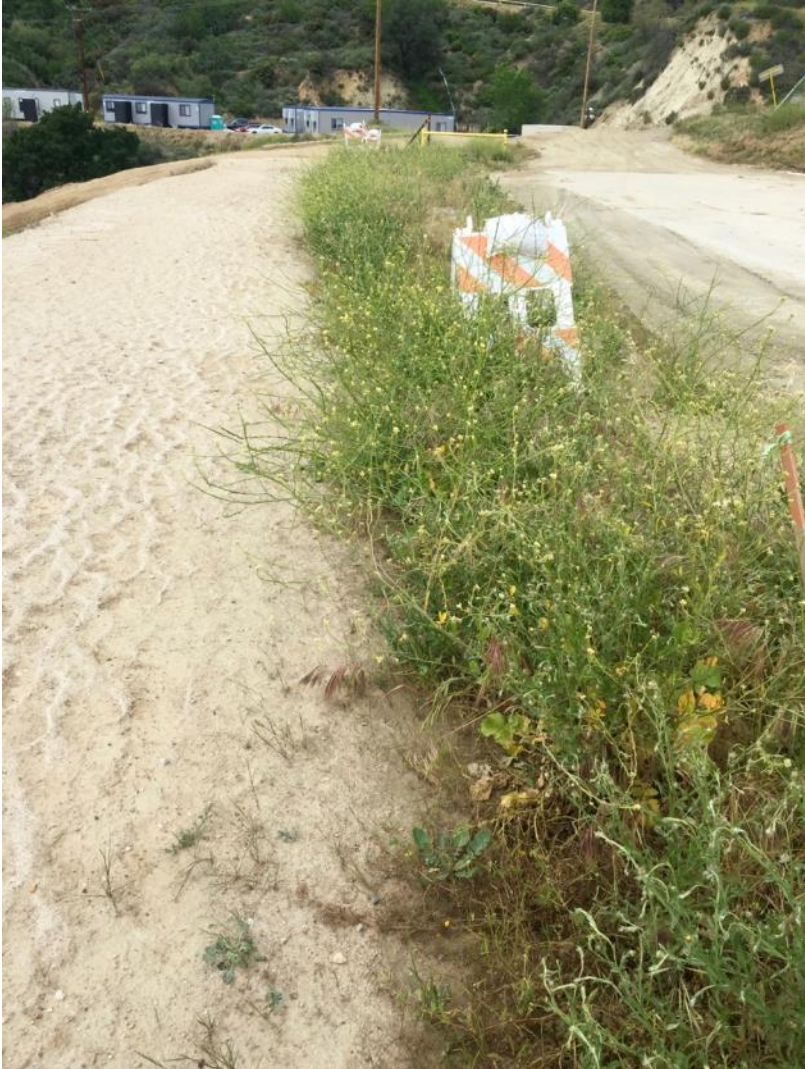
At the P-32 Fill Site, the final BMPs have been installed – see photo. I noted piles of old straw wattles and gravel bags on the well pad above the P-32 Fill Site. In addition, invasive mustard and starthistle are growing in this location – see photo.

Invasive weeds growing on the staging area above the P-32 Fill Site.

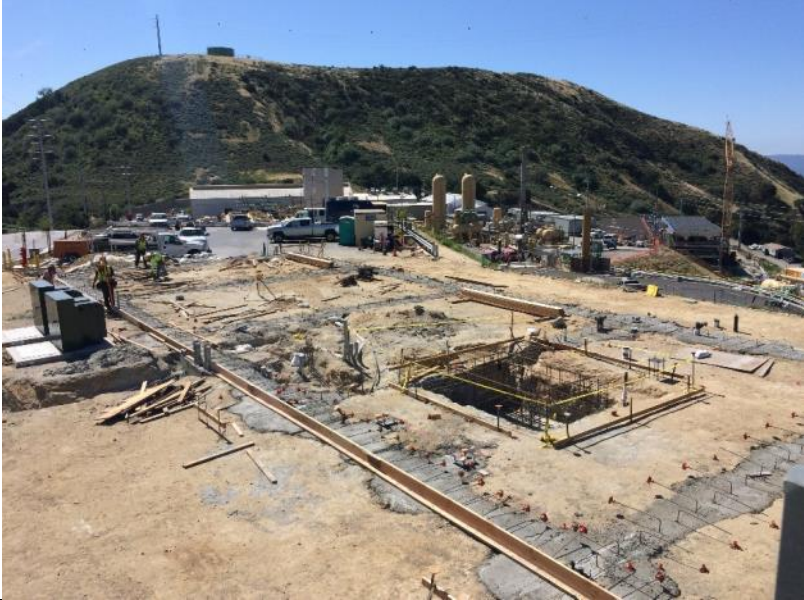
Construction continues at the New Admin/IM Building. Note the completed parking lot in the background.
4/18/16	New Admin/IM Building and CCS Slopes

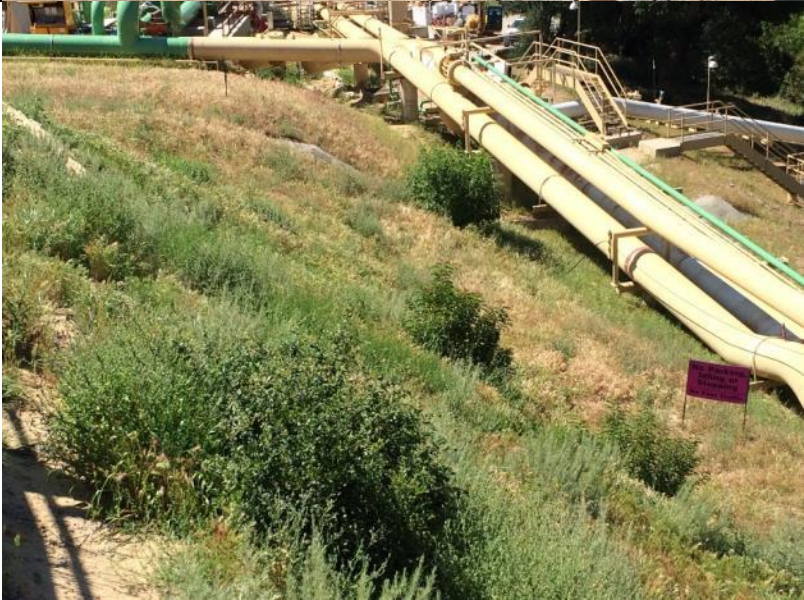
While at this location, Vince Semonsen pointed out invasive weed growth on the surrounding slopes. The slope at the Admin/IM Building had a few patches of an invasive starthistle, but was mostly native. Invasive weeds on the slope below the new Admin/IM Building leading to the piperack east of the CCS consisted of several starthistle patches, mustard, and large quantities of red brome. The group discussed the starthistle and its emergence this year; this species was not observed on site during previous years – see photo. Discussion of invasive weed management focused on understanding which areas would be prone to regular disturbance (required by fuel modification), which areas would be landscaped, and what the baseline conditions were. The E & E/CPUC team is in the process of reviewing SCG's proposed invasive weed management plan and will consider the noted discussion during the review of the plan.

An invasive starthistle and red brome are prevalent on these slopes.

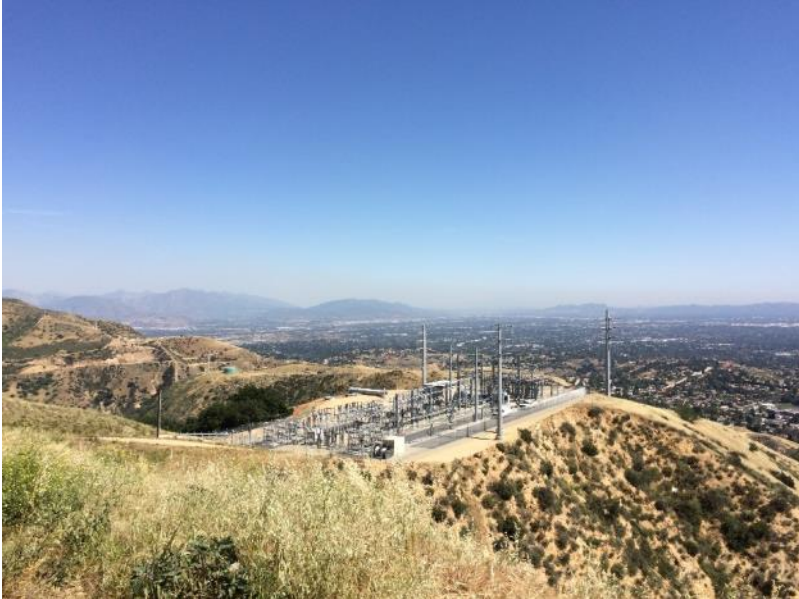
Overview of the completed Natural Substation.
4/18/16	TSP 49

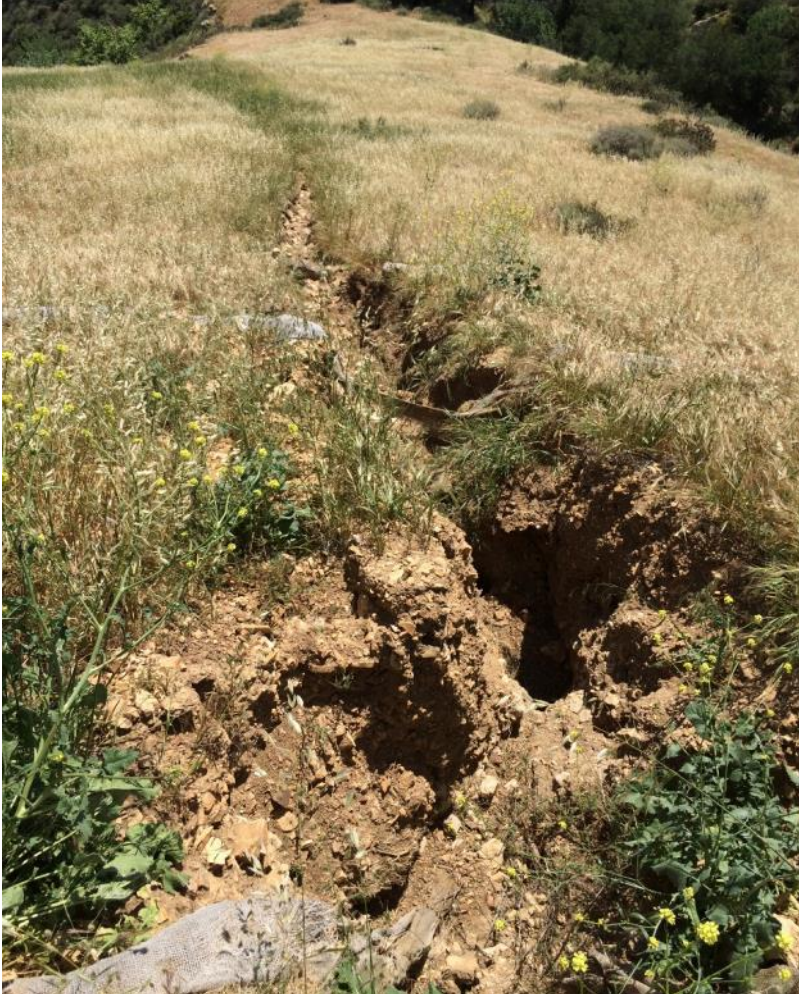
The group traveled to the TSP 49 access road and observed the newly marked disturbance limits, which decreased the previous limits. A soil stockpile was seen outside of the new limits, which Todd White and Vince Semonsen had not previously noticed. It was noted this soil could possibly be spread out in place, but that an email approval from the CPUC team would be necessary since the new disturbance limits approved as part of MPR-H were now restricted. Further down the road was the TSP; a very long erosion gully was seen going down the slope behind the TSP – see photo. Most of the gully was outside of the disturbance limits. The area would need better permanent storm water management, perhaps a McCarthy drain, and a berm to redirect water away from the existing erosion gully.

Erosion gully leading from TSP 49.

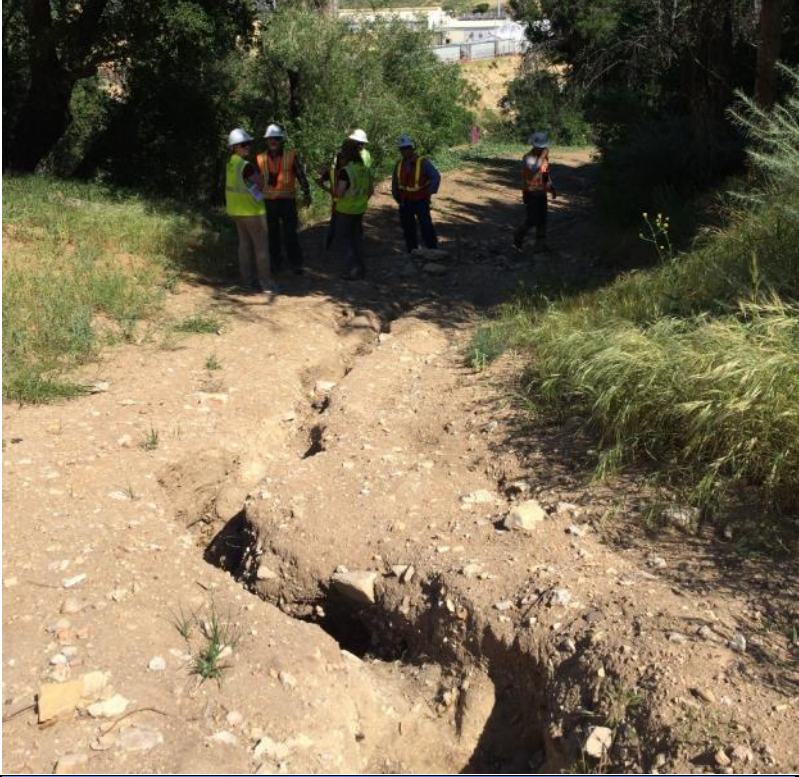
The group stopped at the 12-kV Plant Power Line access road, which leads to the proposed middle pole (Pole A2). Work along this area was approved on 4/15/16 as part of MPR-9. SCG's avian biologist Rob Conohan was onsite and had observed three new bird nests in the area. Two of the bird nests were in oak trees that were going to be affected by grading of the access road (trees 164 and 211). Submittals for nest buffer reductions were planned. Buffer signs were currently posted. SCG also anticipated that in the field adjustments could be made to eliminate the need for a drill rig pad on the lower portion of the access road. This would reduce the overall extent of impacts to oak trees. Amandeep Singh explained that crews would start at the access road entrance and a biologist would monitor nests; if signs of disturbance were to occur, work would not proceed. SCG anticipates fewer oak tree impacts than what was assumed in MPR-9. When asked about the proposed need to use helicopters for stringing, it was explained by SCG that pull sites have to be directly in line with the direction of the wire and, since the wire direction makes a hard turn at Pole A2 and the slope behind the pole is steep, a helicopter would be necessary. Pulling through a turn/corner is not possible. The use of helicopters would enable this stringing to take place. It is anticipated that the helicopter may be in the area for approximately three hours making multiple flights and landing when needed at the Aliso Storage Field. The area where the oak swale drainage encounters the western bend of the access road was observed. Steep terrain and multiple erosional gullies were observed upslope from the road. Some work to stabilize these slopes or redirect the water away from the road would likely prevent erosion and sedimentation in the future – see photo.

Erosion leading to the 12-kV PPL access road.
4/19/16	TSP 40/41

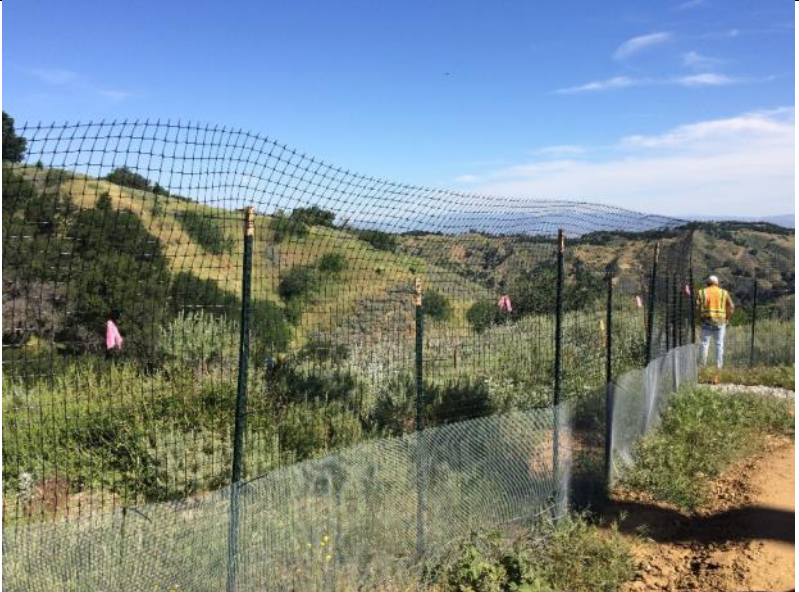
Fenced VCSS area with planted Mariposa lilies.

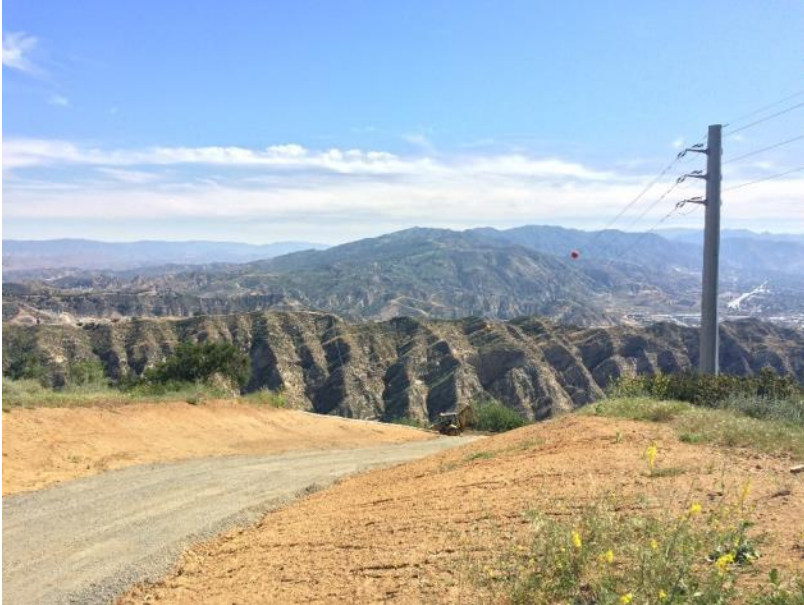
From an area near TSP 40, the group looked across the canyon to see the approximate location of the peregrine falcon nest and the proposed flight path for helicopter work – see photo. This work was planned for 4/19 but was pushed back to later in the week. Vince will try to attend to monitor the activity. The group drove to TSP 42 and observed the new access road (the SCG pipeline was under this road) and an area where numerous Mariposa lilies were planted – see photo. A crew was working on removing the existing steel lattice tower at this location.

Planned restoration areas with TSP 40 visible. The peregrine falcon nest is in the cliffs in the background.
4/19/16	TSP 42

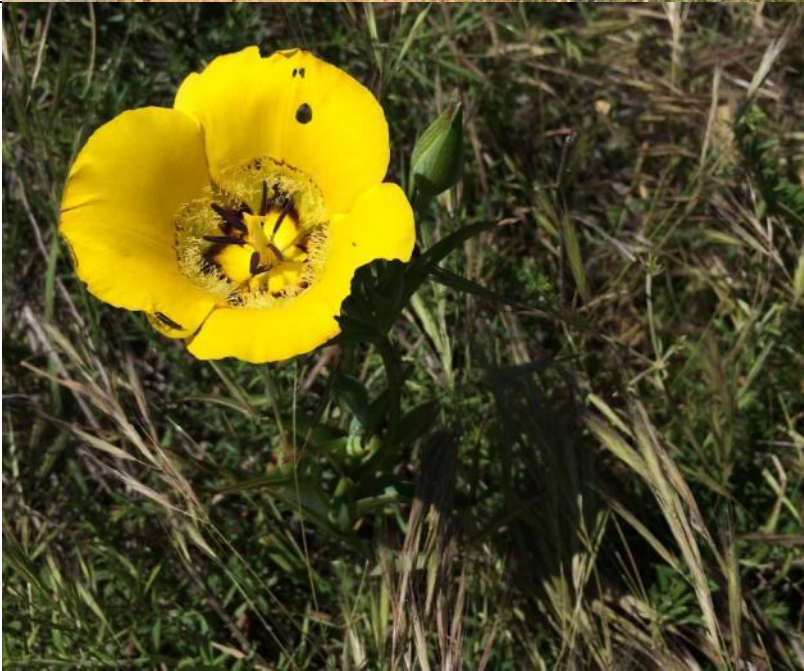
Mariposa lily bloom adjacent to the access road.

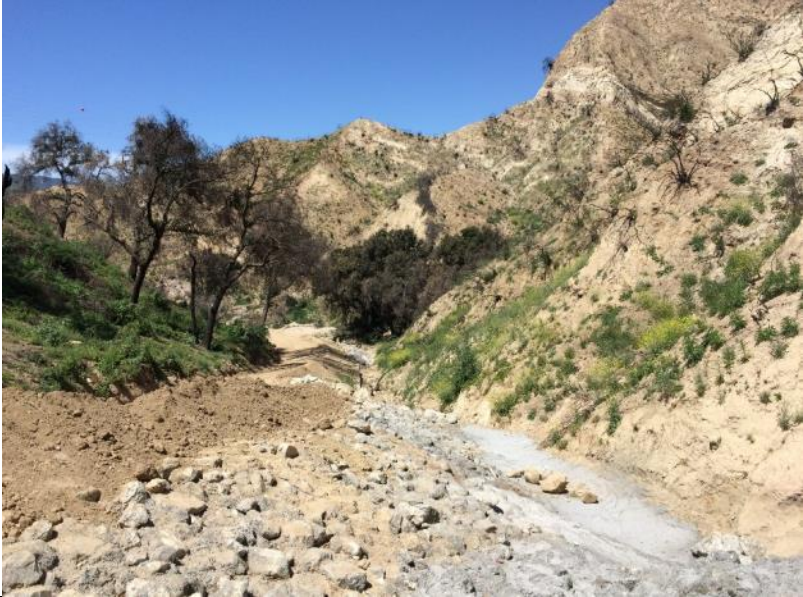
Riprap grouted in place within Drainage #4.

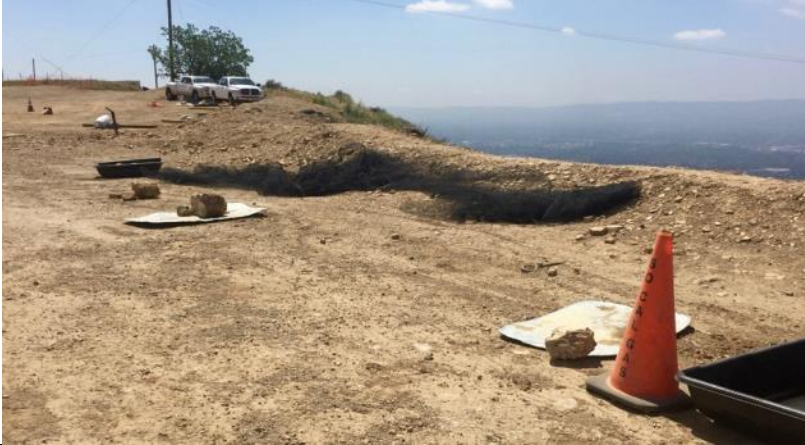
At the PS-42 Well Pad, there were several piles of bird netting; some had been anchored down and some were loose – see photo. It appeared that the netting was covering several sections of 12-kV poles. This material can trap lizards and snakes, and could continue to do so if it blows away. I mentioned this to SCG's biological monitor Juan Miranda and heard later from Seth Rosenberg that they had addressed the issue.

Bird netting on the ground after it is taken off the equipment.
4/22/16	TSP 49

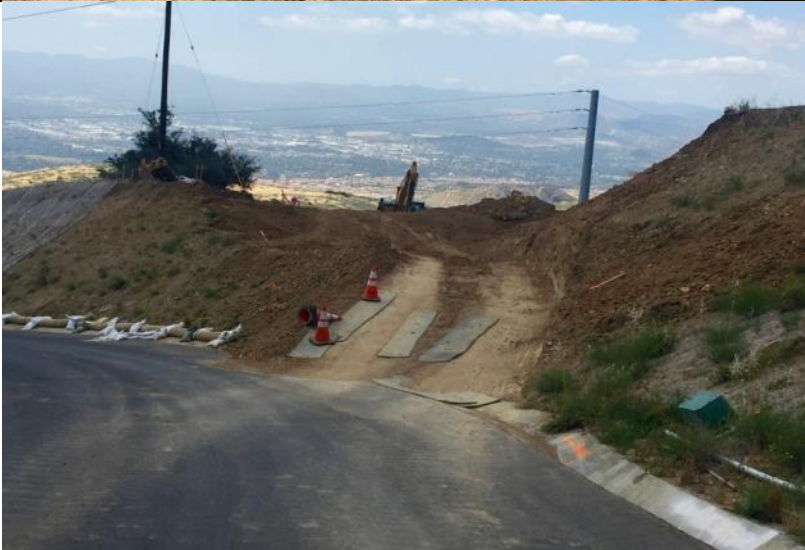
The access road to TSP 49 had been partially dug, with work shutting down after a bird nest was found very close to the work area – see photo. According to Juan Miranda, the nest can be seen from the Natural Substation access road and it has several chicks in it. It is a lark sparrow nest, and the avian biologists expect the chicks to fledge within a week. The soil from the access road work was being delivered to the PS-42 Fill Site, and equipment was compacting it into the Fill Site – see photo.

Excavation of the access road to TSP 49 off of the Natural Substation road.
4/22/16	Natural Substation

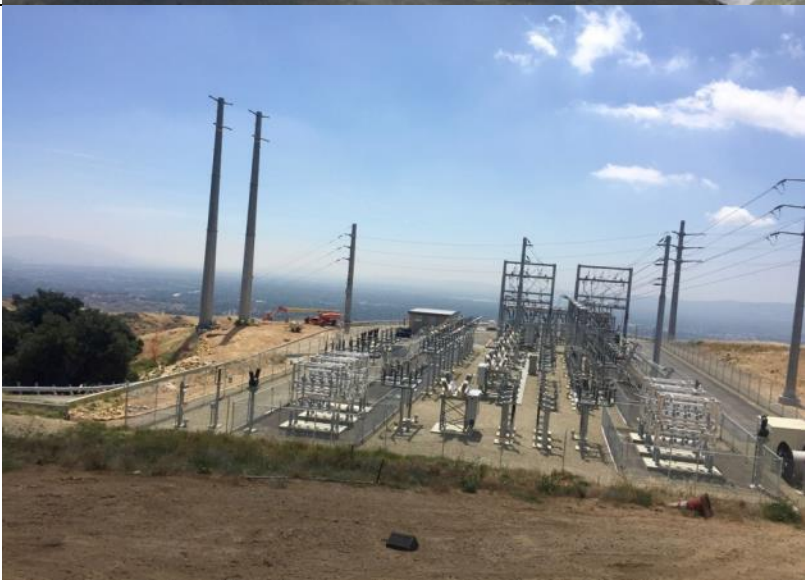
The two 12-kV TSPs have been installed (on left of photo).
