Re: Monthly Report Summary #33 for Aliso Canyon Turbine Replacement Project

CPUC Site Inspection Reports
December 1, 6 & 7, and 29, 2016

Aliso Canyon Turbine Replacement Project CPUC Site Inspection Form

Project:	Aliso Canyon Turbine Replacement	Date:	December 1, 2016
Project Proponent:	Southern California Gas Company and Southern California Edison	Report #:	VS125
Lead Agency:	California Public Utilities Commission	Monitor(s):	Vince Semonsen
CPUC PM:	Andrew Barnsdale, Energy Division	AM/PM Weather:	Clear and cold with gusting winds
E & E CM:	Lara Rachowicz	Start/End time:	0830 to 0900 at SCE components 0900 to 1130 at the Aliso Canyon Natural Gas Storage Field (Aliso Storage Field)
Project NTP(s):	The new Admin/IM Building (NTP-2), Central Compressor Station (CCS) (NTP-3), 12-kV power line (NTP-3), and PS-42 Fill Site. Tubular Steel Poles (TSPs) 2 through 42 (NTPs A, C, and D).

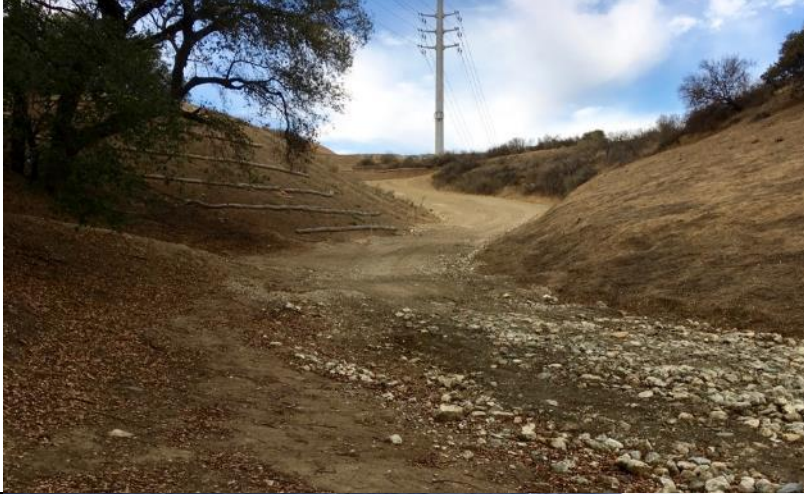
REPRESENTATIVE SITE PHOTOGRAPHS			
Date	Location	Photo	Description
12/01/16	TSP-22 Access Road

I drove by the SCE access roads at TSP-26 and at TSPs 12-22 (Photo 1) to check if best management practices (BMPs) had been added to the roadways. I did not observe any new BMPs at either location.

Photo 1 – No additional BMPs have been added to the access road.
12/01/16	P-37 Well Pad.

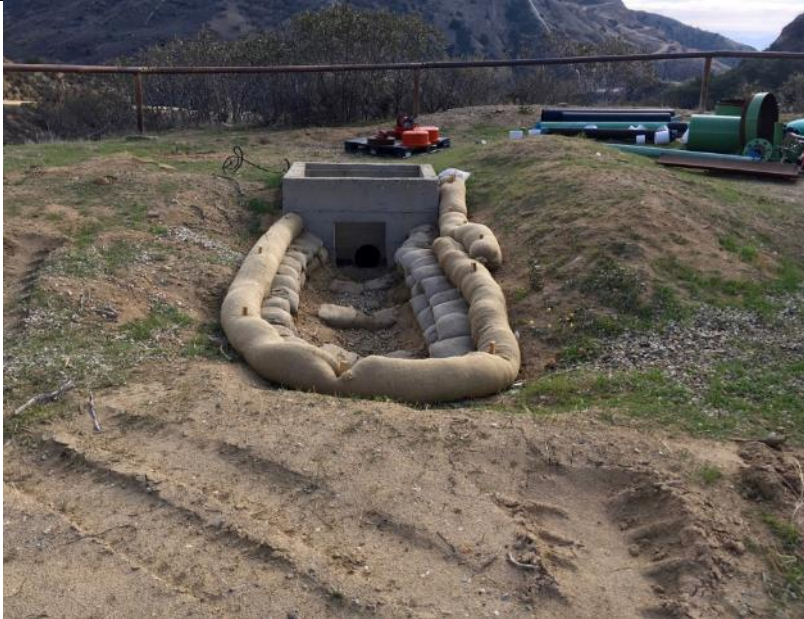
I arrived onsite at the Aliso Storage Field at 0900, stopping first at the P-37 staging area. The drilling rig had been removed, and most of the Kiewit materials had also been removed. Sediment control at the well pad drain inlet had been addressed with straw wattles added around the opening (Photo 2).

Photo 2 – New BMPs have been installed around the drain inlets.
12/01/16	Oak Tree Mitigation Site

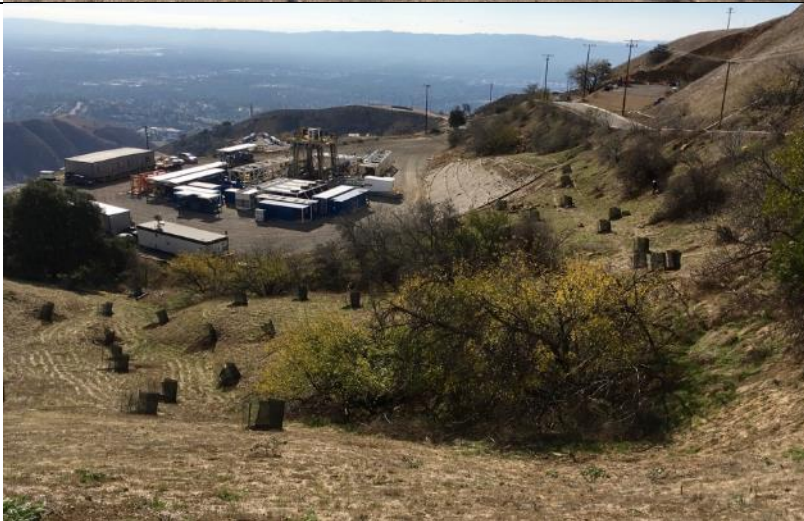
Photo 3 – Crews were onsite conducting maintenance work on the oak tree cages.

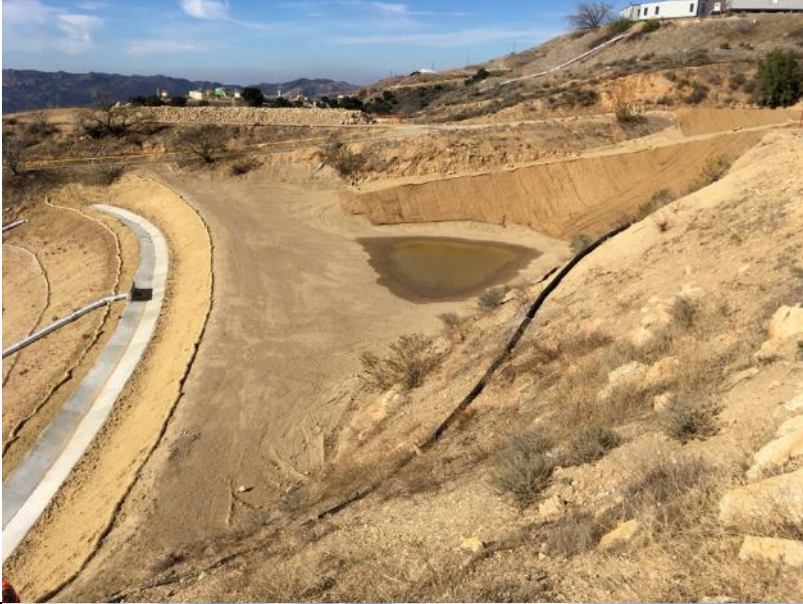
REPRESENTATIVE SITE PHOTOGRAPHS			
Date	Location	Photo	Description
12/01/16	PS-42 Fill Site

At the PS-42 Fill Site, I noted ponded water from the recent rain events (Photo 4). Ray Romero (AECOM) stated that 1.25 inches of rain accumulated during a storm about two weeks prior to my site visit, and an additional 0.25 inch was calculated during the recent rain event. A survey crew was working within the PS-42 Fill Site, and it looked like the crew was evaluating the best location for replacing the last of the plastic drainpipe going around the site.

Photo 4 – Some water has ponded within the PS-42 Fill Site after the recent rains.
12/01/16	12-kV Poles near the Natural Substation

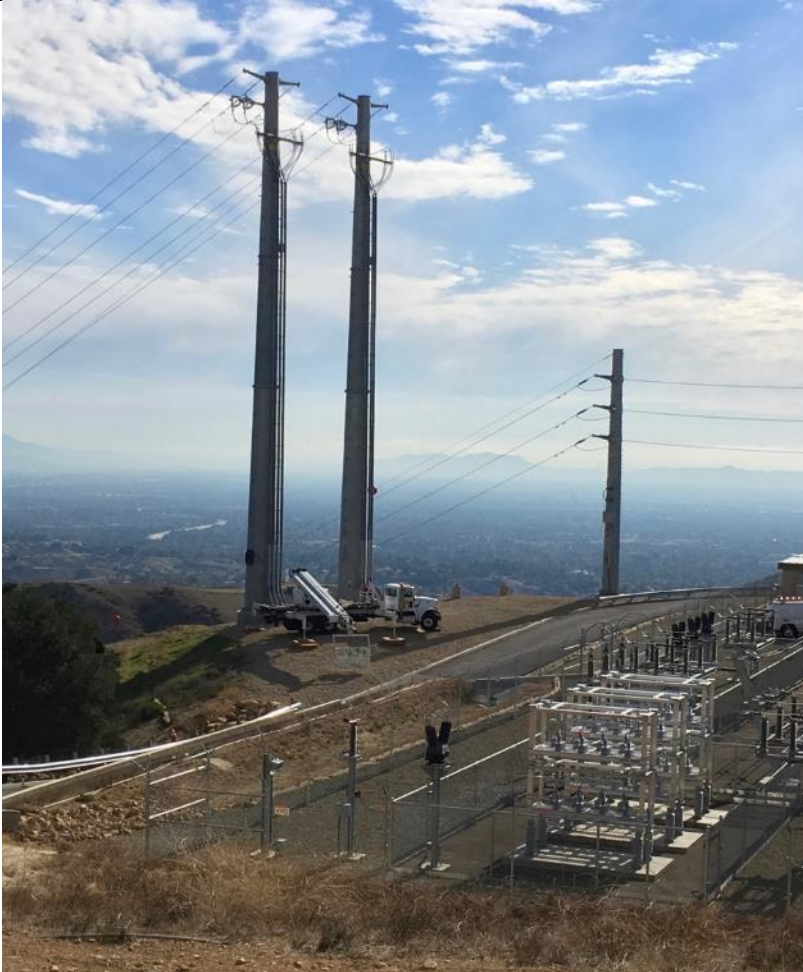
Photo 5 – Some work continues on the 12-kV poles.

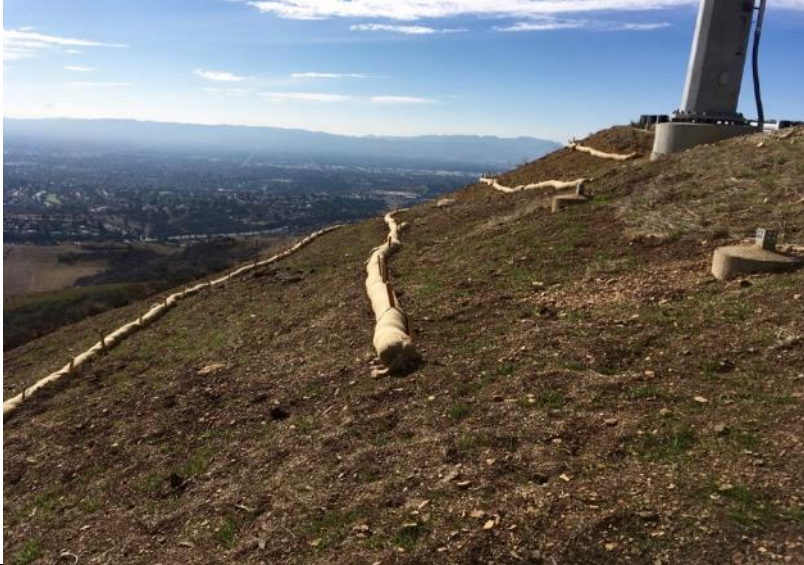
REPRESENTATIVE SITE PHOTOGRAPHS			
Date	Location	Photo	Description
12/01/16	Natural Substation

The burned straw wattles on the slope below the Natural Substation had been replaced (Photo 6).

Photo 6 – BMPs replaced on the south facing slope below the substation
12/01/16	CCS

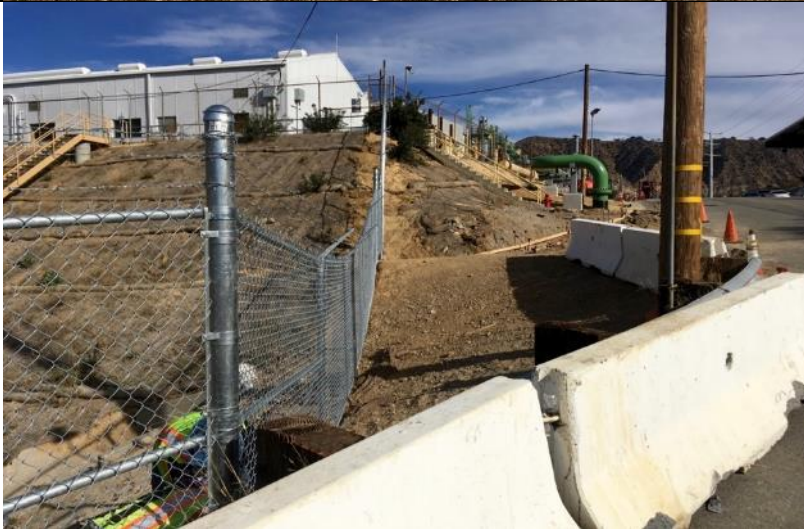
Photo 7 – The blowdown line has been backfilled and the perimeter fence has been installed.
12/01/16	CCS

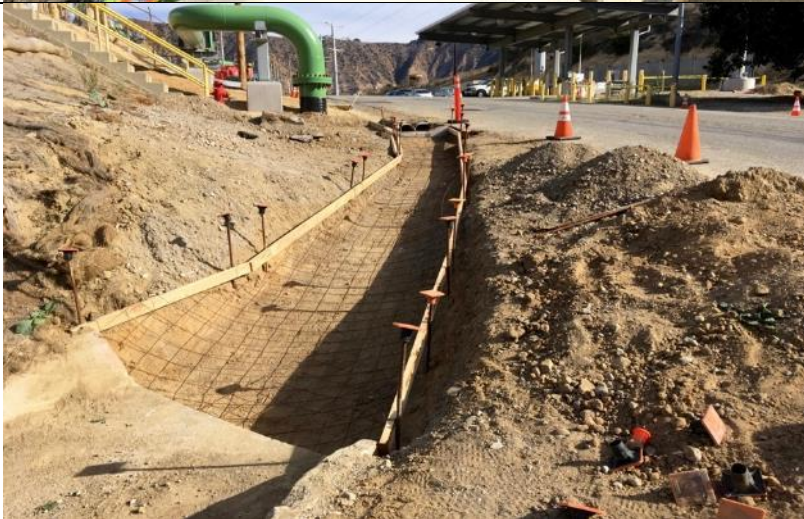
Photo 8 – Forms for connecting a drainage ditch over the blowdown line.

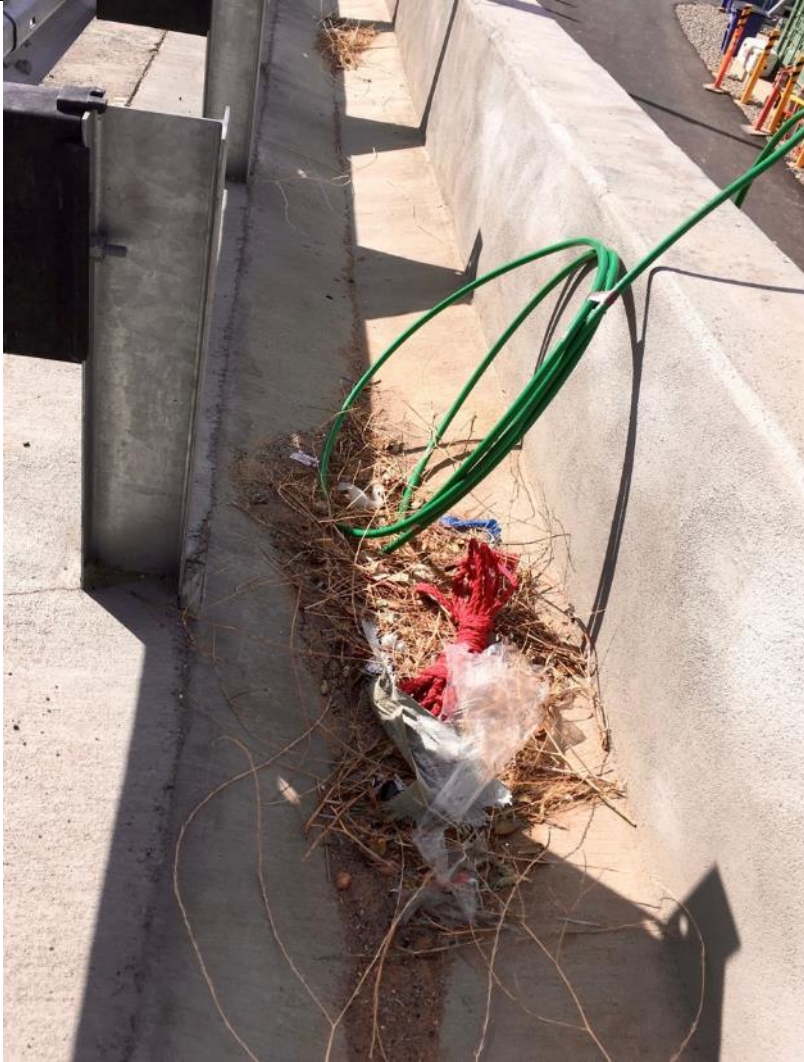
Photo 10 – Drainage ditch along the main access road next to the CCS.

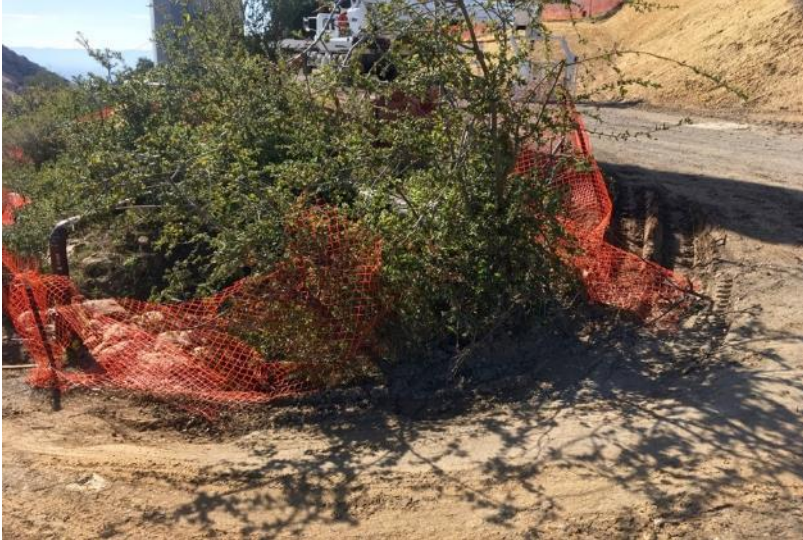
REPRESENTATIVE SITE PHOTOGRAPHS			
Date	Location	Photo	Description
12/01/16	12-kV A2 Pole

Photo 13 – Oak sapling slightly damaged by the ongoing work.
12/01/16	CCS

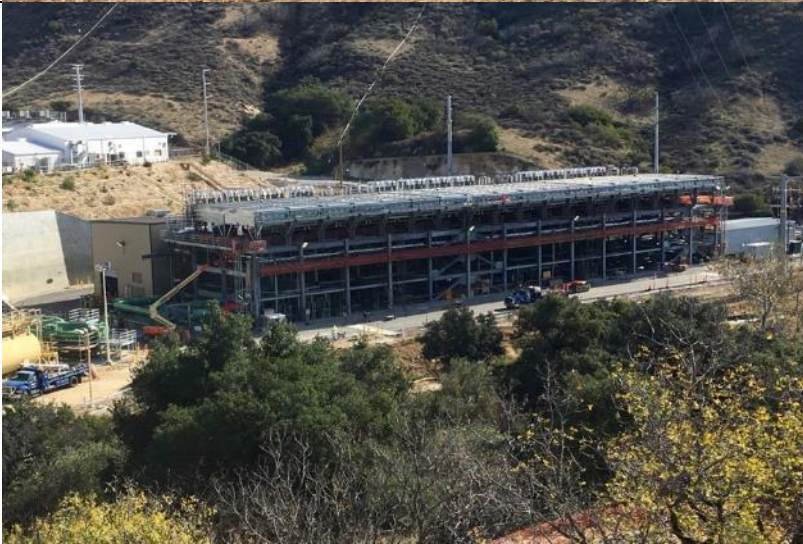
Photos 14 and 15 are overview shots of the CCS and new Admin/IM Building showing the extent of the construction activity.

Photo 14 – Overview of the CCS from across Limekiln Creek.
12/01/16	New Admin/IM Building

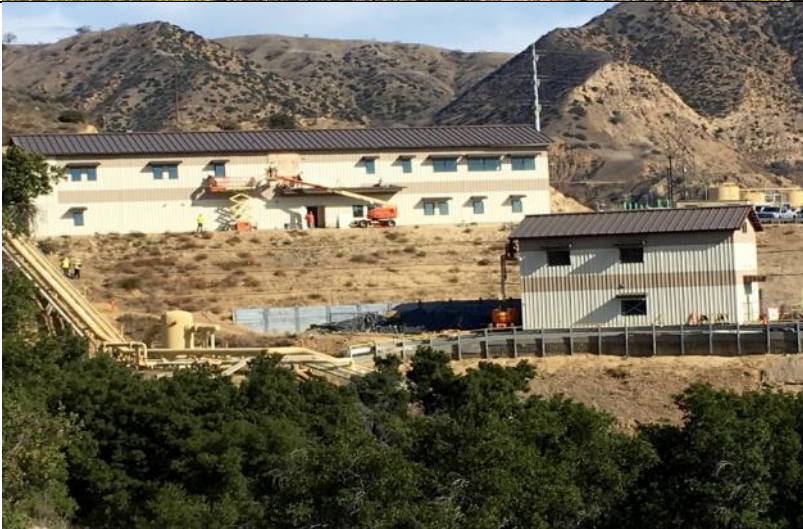
Photo 15 – Overview of the new Admin/IM Building from across Limekiln Creek.

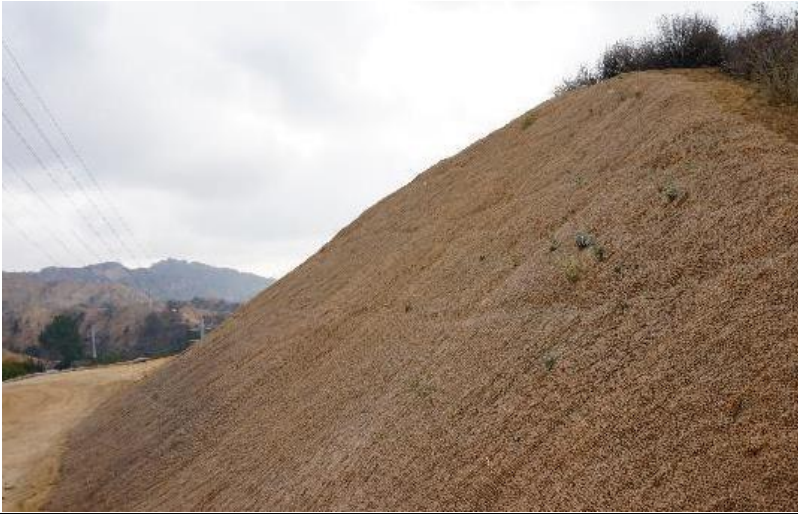
REPRESENTATIVE SITE PHOTOGRAPHS			
Date	Location	Photo	Description
12/6/2016	TSP 21

Photo 1 – Slopes adjacent to TSP 21 showing signs of native plant growth
12/6/2016	TSP 21

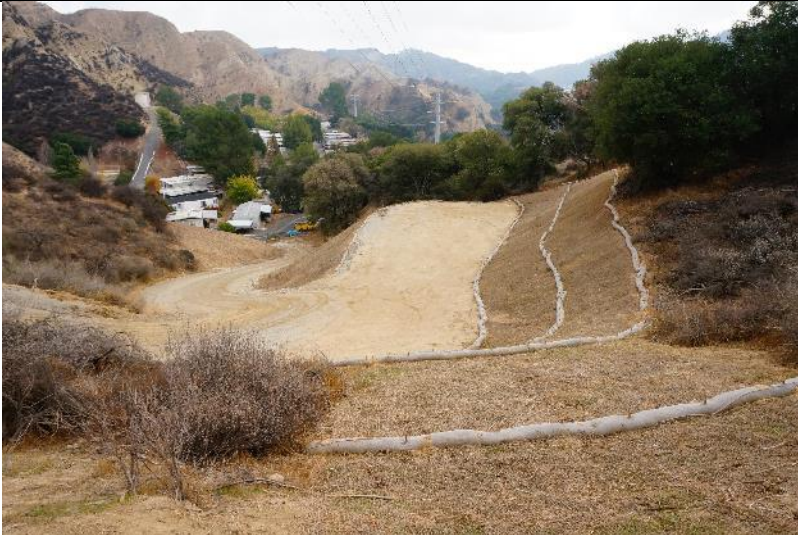
Photo 2 – Stabilized slopes and access road below TSP 21.
12/6/2016	Drainage 4 along TSP 24/25 Access Road

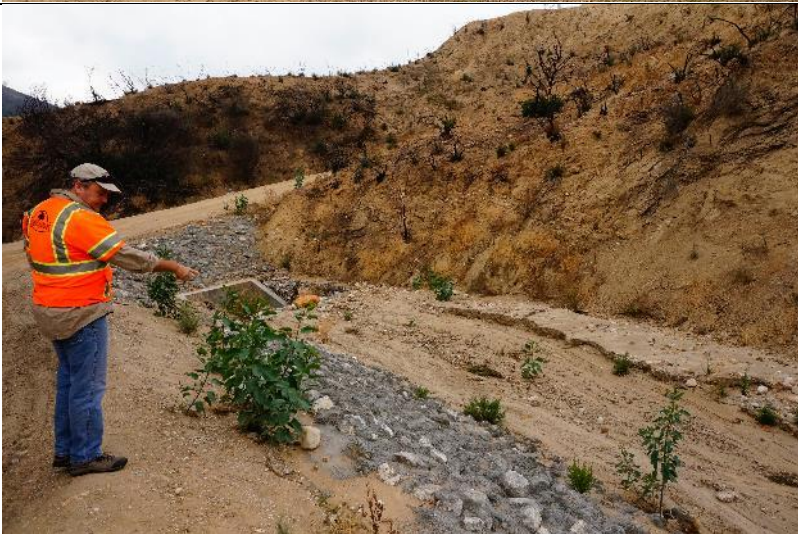
We visited Drainage #4, located between TSPs 24 and 25. Rills were present on the steep access road and likely formed during the recent rain events. Tree tobacco, an invasive species, was growing in several locations along the drainage (Photo 3). Todd White (Jericho) informed the group that the plants we observed were not present 6 weeks ago when SCE conducted invasive weed removal. SCE said that restoration of the area has been completed according to their water board permit, but they plan to conduct weed removal in January 2017. Vince Semonsen (CPUC) was concerned about a patch of soil between the access road and the culverts. The road has been graded so that water runoff will be directed away from this patch; however, Vince Semonsen was concerned that there was no netting or hydroseeding completed in this area; therefore, if water were to wash into this area, the soil could runoff into the drainage. Lucy Cortez (CASC) and Klaus Wojak (SCE) agreed that it is best to not disturb the area because some vegetation already has been growing (Photo 4).

Photo 3 – Tree tobacco growing in/around the drainage.

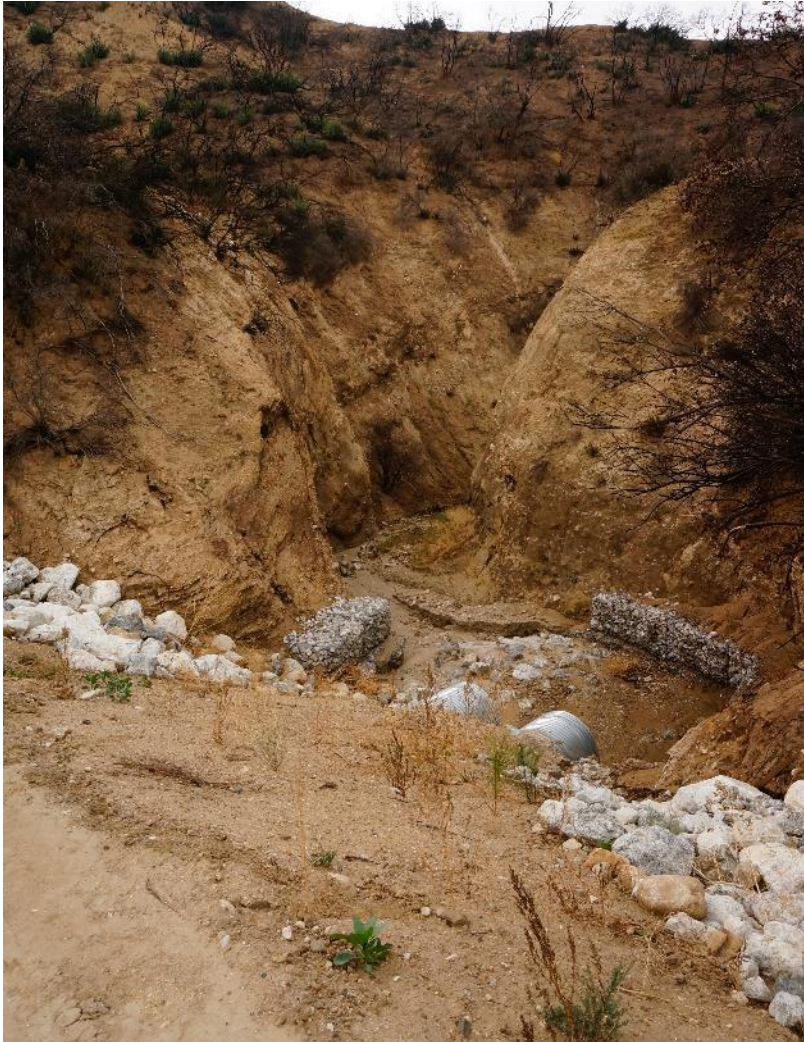
REPRESENTATIVE SITE PHOTOGRAPHS			
Date	Location	Photo	Description
12/6/2016	Drainage 4 along TSP 24/25 Access Road

Photo 4 – Slope leading into the drainage above the culvert, with some vegetation growing.
12/6/2016	TSP 40 Access Road

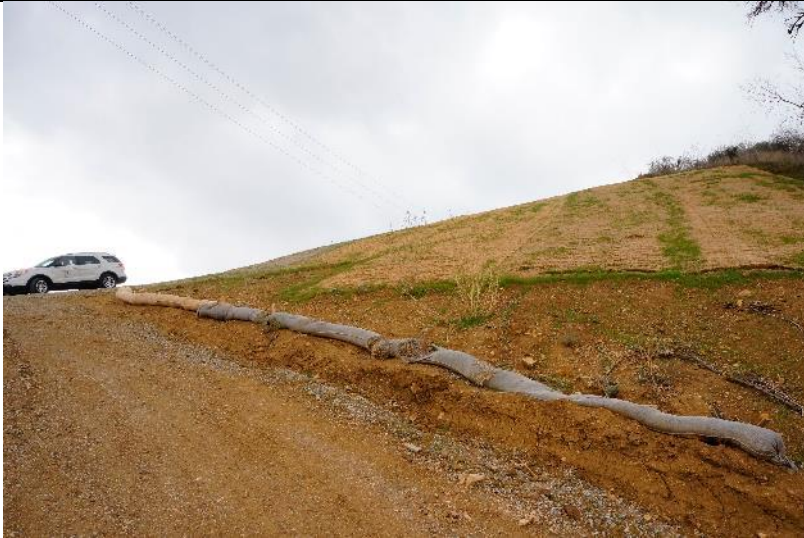
Photo 5 – Stabilized slope with biodegradable BMPs in place.

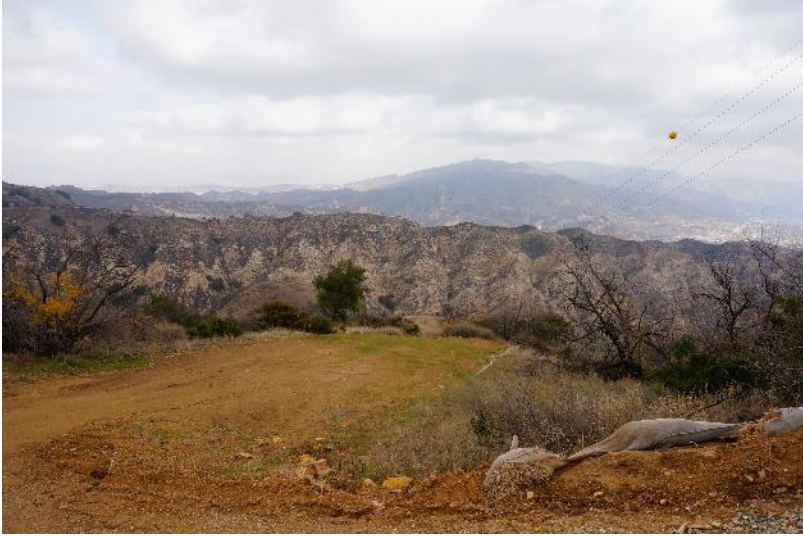
REPRESENTATIVE SITE PHOTOGRAPHS			
Date	Location	Photo	Description
12/6/2016	TSP 40 Access Road

Photo 6 – Un-restored access road, degraded straw wattles, and slopes below TSP 41.
12/6/2016	TSP 42

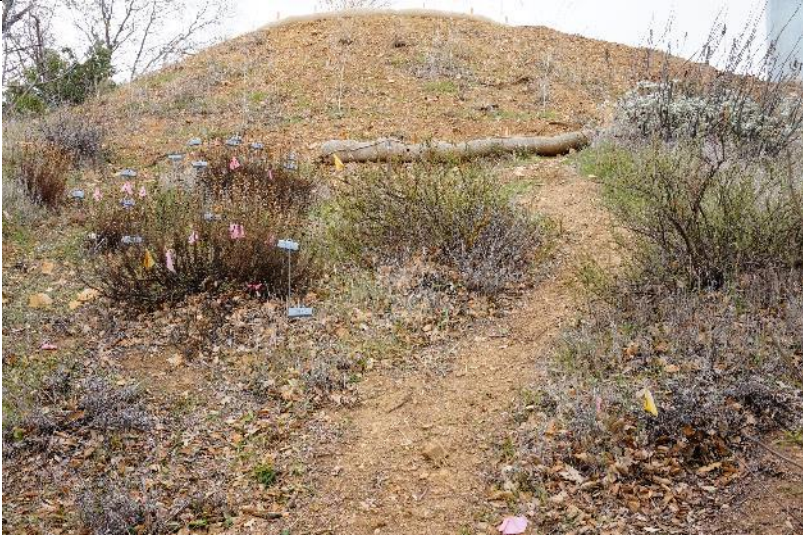
We drove through the Aliso Canyon Storage Field (Aliso Storage Field) to access TSPs 40, 41, and 42. Derek Rodgers (SCG Environmental Coordinator) joined the group to view these components. We drove to TSP 40 and looked at the final BMPs. The jute netting had a good amount of vegetation regrowth (Photo 5). Vince Semonsen (CPUC) asked what the plan was for the area below TSP 40, because the area has become revegetated but was not part of the restoration plan. An erosion rill and degraded straw wattles were visible on this portion of the road (Photo 6). Lucy Cortez (CASC) informed the group that the area was listed as a road and is not part of the ACTR Project's SWPPP or revegetation plan. There was no plan to restore the area because O&M may use the area as a turn-around. We walked to the TSP 42 Well Pad to look at the permanent BMPs in place. This area has pin flags marking Mariposa lily areas (Photo 7).

Photo 7 – Flagged locations of Mariposa lily plantings and BMPs.
12/6/2016	TSP 30

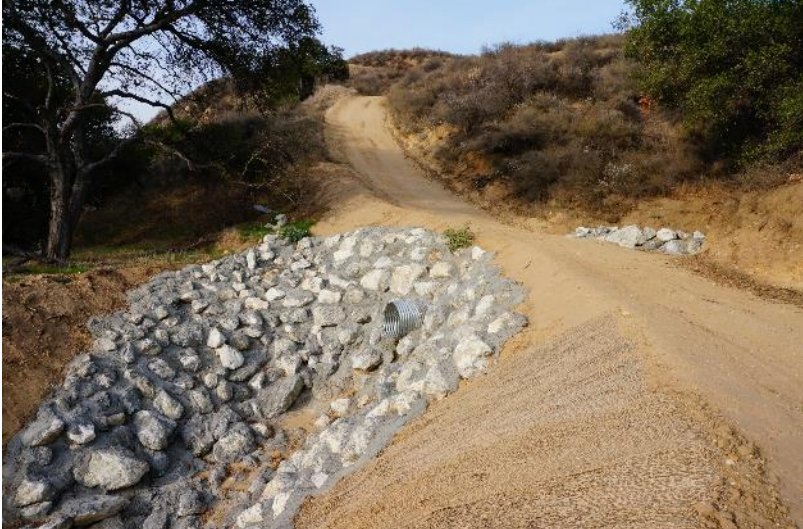
Photo 8 – New culvert and armored drainage along access road.

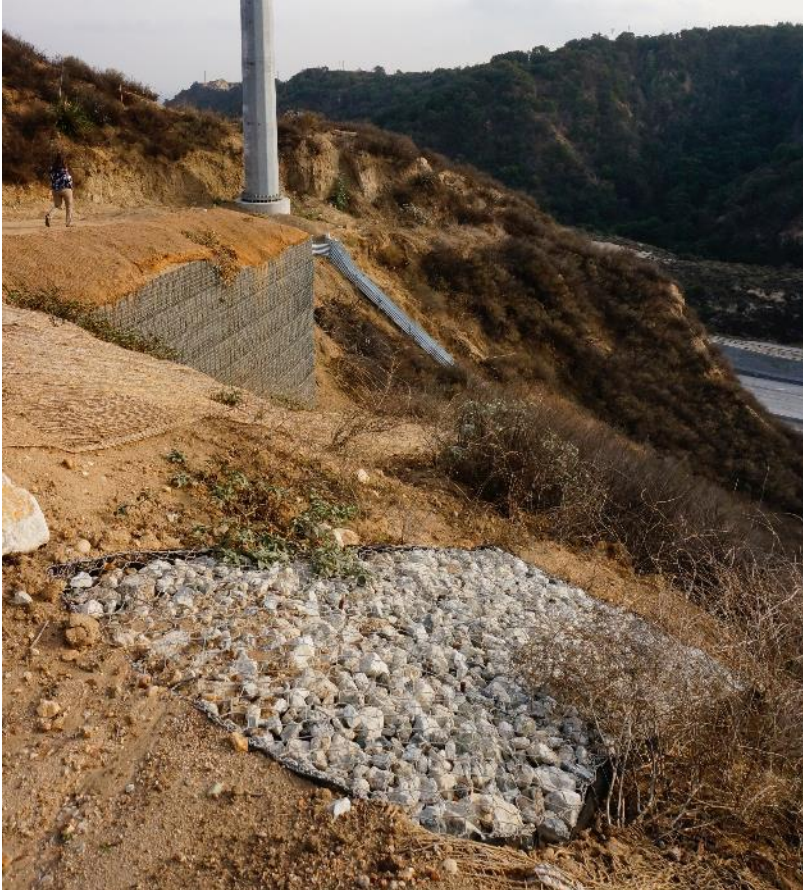
REPRESENTATIVE SITE PHOTOGRAPHS			
Date	Location	Photo	Description
12/6/2016	TSP 30

Photo 9 – Hilfiker wall, McCarthy drain, and gabion mattress installed at TSP 30.
12/7/2016	Natural Substation Access Road

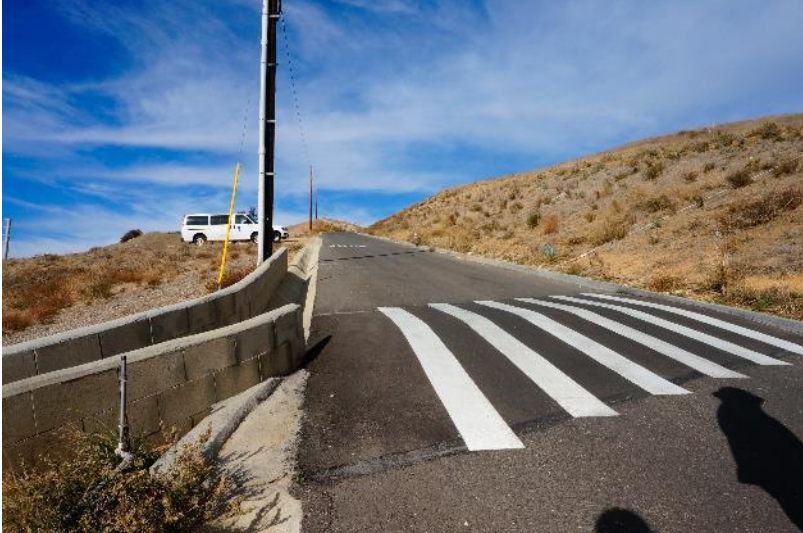
Photo 10 – Water bar installed along the Natural Substation Access Road.

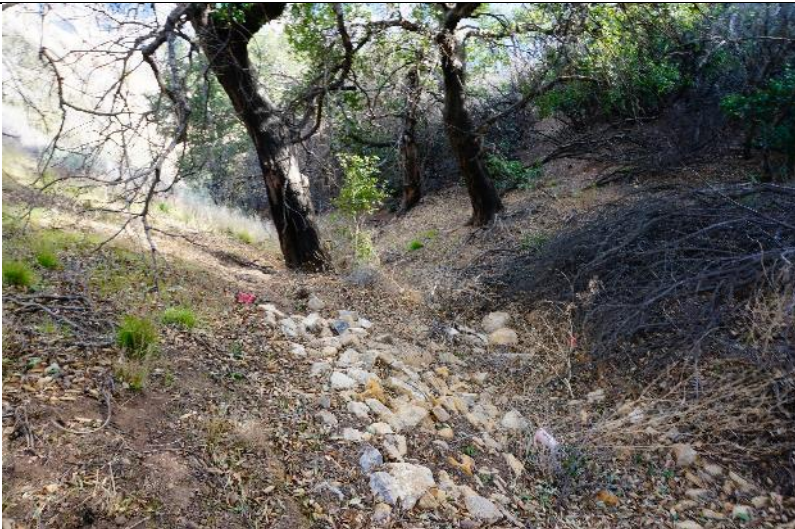
REPRESENTATIVE SITE PHOTOGRAPHS			
Date	Location	Photo	Description
12/7/2016	Oak Swale below Natural Substation

Photo 11 – Leaf litter and debris in reinforced oak swale.
12/7/2016	Oak Swale below Natural Substation

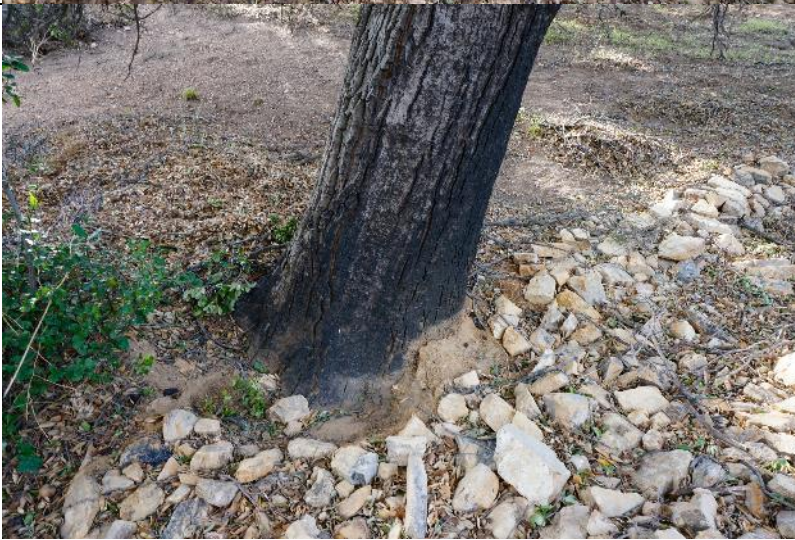
Photo 12 – Base of oak tree in reinforced oak swale, with no scour or damage evident.
12/7/2016	PS-42 Fill Site

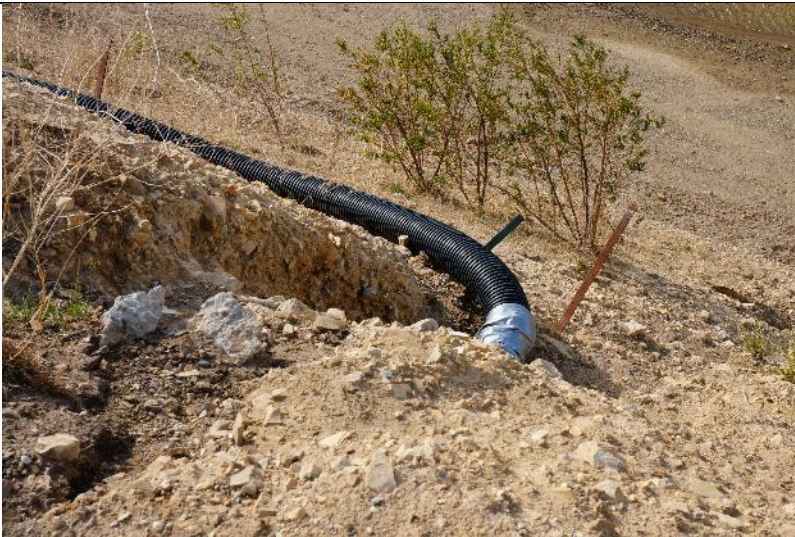
The group then drove to PS-42 Fill Site. No construction activity was taking place at this location. Minimal imports were expected for the duration of the ACTR Project. Once the ACTR Project is completed with imports, the PS-42 Fill Site will be turned over to O&M. SCG will stabilize the slopes before closing out the SWPPP and turning over to O&M. BMPs were in place along the access road and, overall, the permanent BMPs were in good condition. The plastic bypass drain was firmly in place on the PS-42 Fill Site slopes. Questions were asked regarding drainage under the PS-42 Well Pad; Photo 14 shows the inlet that connects to the PS-42 Fill Site bypass drain (Photo 13).

Photo 13 – Drain bypass pipe with evidence of erosion upslope.

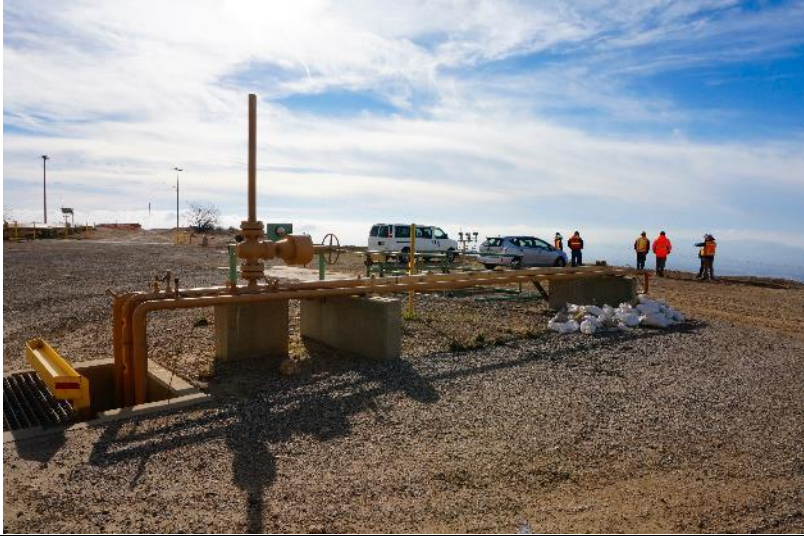
REPRESENTATIVE SITE PHOTOGRAPHS			
Date	Location	Photo	Description
12/7/2016	PS-42 Well Pad

Photo 14 – Underground vault with drain inlet that leads to the bypass pipe adjacent to PS-42 Fill Site (see photo above).
12/7/2016	TSP A2 Access Road

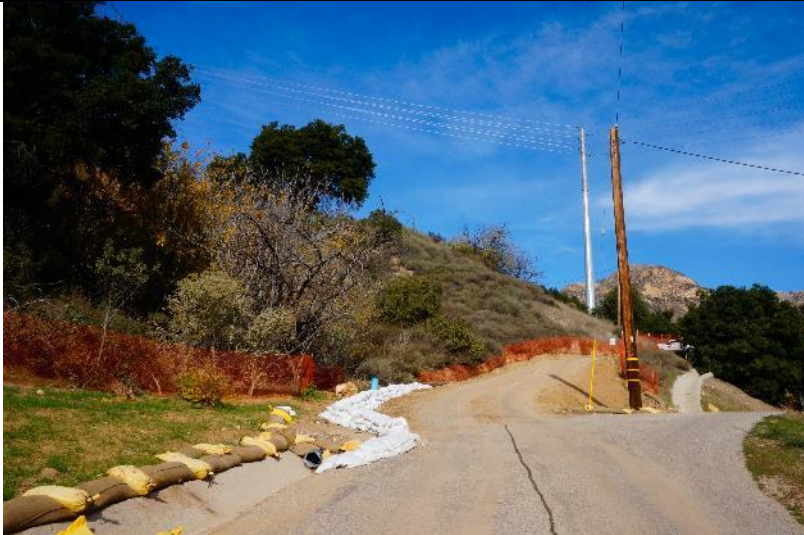
We parked near the TSP-A2 access road (Photo 15). We were unable to walk up and inspect the area because Henkels and McCoy were stringing the fiber optic cable after removing the lashing. We were able to look up the slope to see the new pole that was installed for the ADSS cable (Photo 16). The foot path the workers used to access the area was clearly marked, BMPs were in place, and sensitive resources were fenced off. SCG informed us that the drainage that runs from the oak swale to the TSP-A2 access road will be repaired by the Pipeline Integrity group. They have committed to fixing the area, and money has already been allocated. SCG was unsure of the timeframe; however, it will occur after Henkels and McCoy has completed their work in the area.

Photo 15 – BMPs placed near the V-ditch; orange fencing properly installed along the access road.
12/7/2016	12-kV Power Line

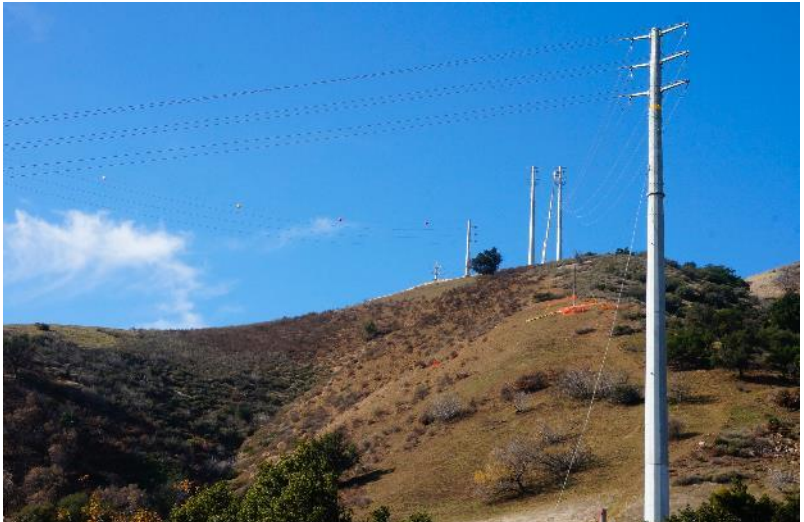
Photo 16 – Orange fencing installed around the new middle pole and cleared walking path.

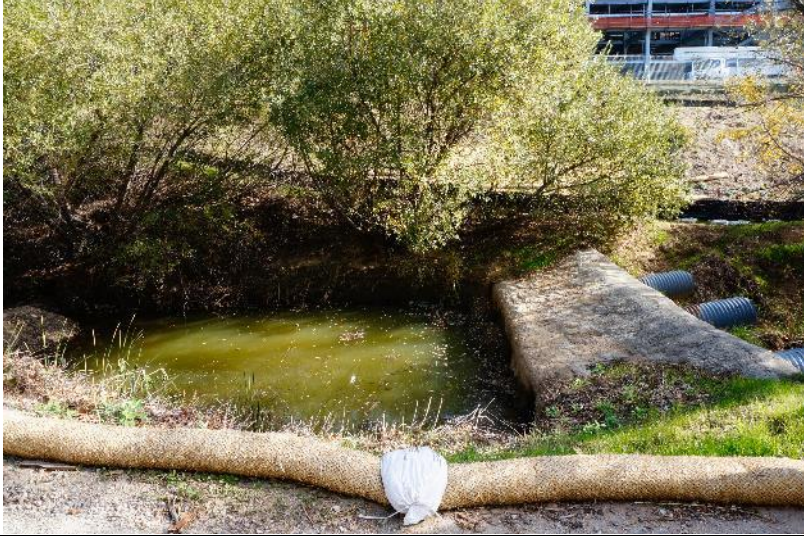
REPRESENTATIVE SITE PHOTOGRAPHS			
Date	Location	Photo	Description
12/7/2016	Retention Pond South of the CCS

We walked to the upper sedimentation basin and observed newly installed straw wattles with black netting placed adjacent to the basin (Photo 17). A V-ditch needed maintenance, and degraded gravel bags were noted on slopes south of the CCS (Photo 18). We then walked around the new Admin/IM Building, noting a few BMP deficiencies (trench without escape ramps, uncovered stock pile, gaps around a covered excavation, and straw wattles that needed to be replaced) (Photos 19, 20, and 21). The biofiltration system was finished near the new Admin/IM Building, and plants were growing well. Crews were working inside the building. We walked around the CCS area and discussed the drainage system. All impervious surfaces have been directed toward the biofiltration systems (one at the new Admin/IM Building and one at the CCS). The surrounding mountains have historically drained under the new CCS area, and water runoff was still directed in that direction. SCG stated that, by diverting water from the impervious surfaces through biofiltration systems, there was actually less runoff directed through the historical drainage. Final landscaping of the CCS should provide solid stabilization of slopes below the CCS. The nitrogen leak testing truck was onsite with proper secondary containment (Photo 22). Fencing was being installed (Photo 23). The group then had a tour through the CCS.

Photo 17 – Upper sedimentation basin/newt pond with older black plastic mesh wattles installed.
12/7/2016	Drain Outflow Below the CCS

BMP deficiencies need attention at the CCS, including an escape ramp in the trench around new Admin/IM Building, the stock pile cover, and gaps around the excavation cover.
 Clean up the V-ditch abutting southern slopes at the CCS. Replace straw wattles that have black plastic netting with biodegradable straw wattles.

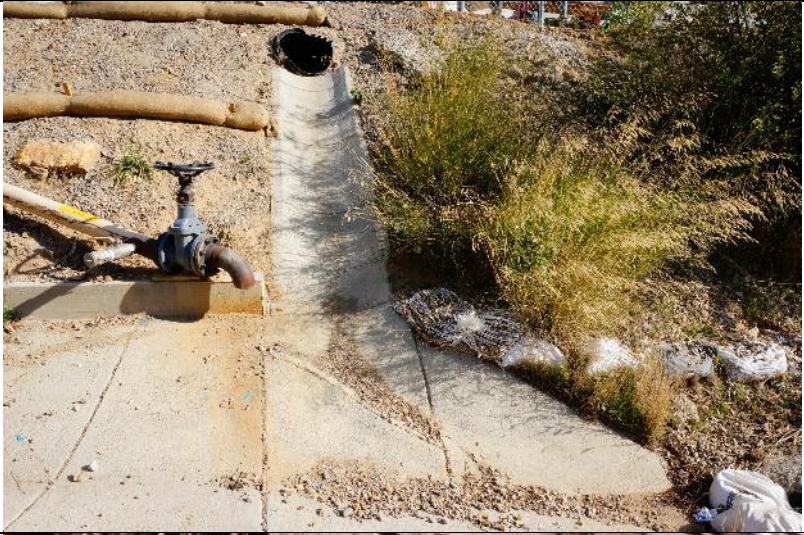
Photo 18 – Degrading gravel bags, and dirt/gravel in the V-ditch.
12/7/2016	Slopes Between the New Admin/IM Building and the CCS

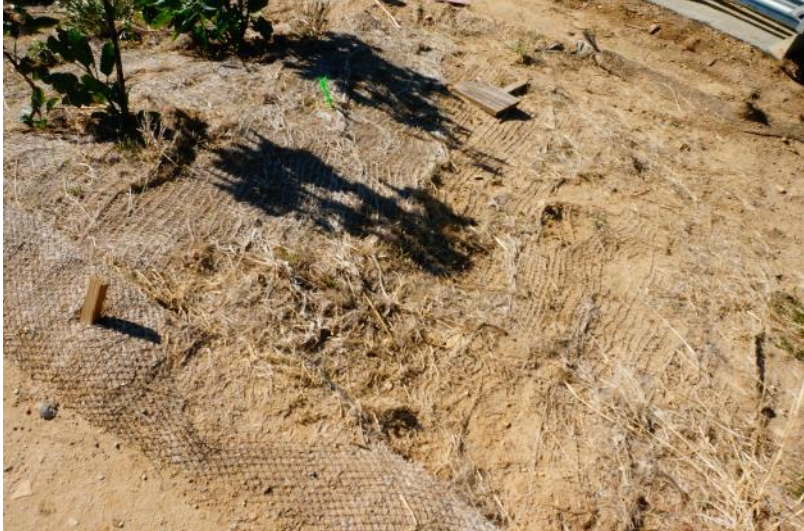
Photo 19 – Degrading straw wattle with black plastic netting along the walking path.

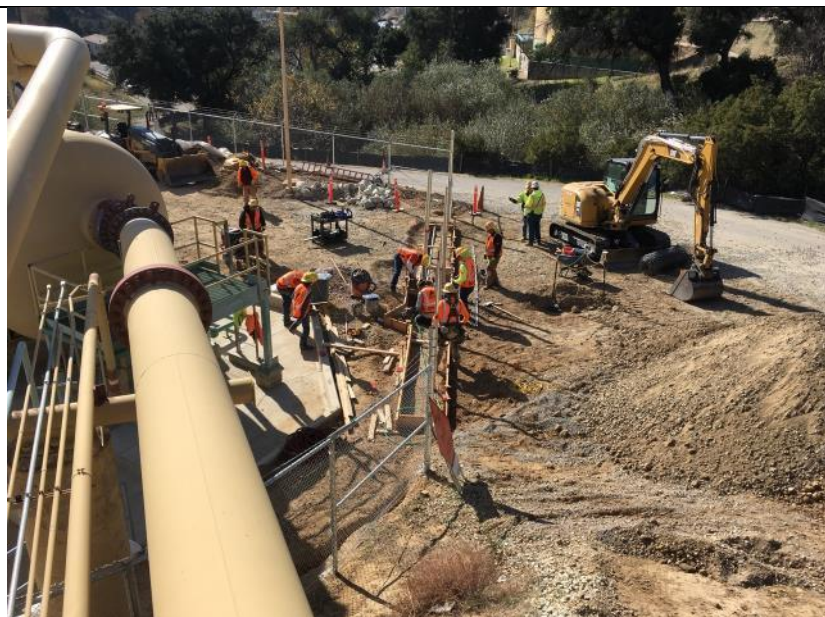
Date	Location	Photo	Description
12/7/16	CCS

Photo 23 – Crews installing a fence around the CCS, which requires digging and pouring concrete.

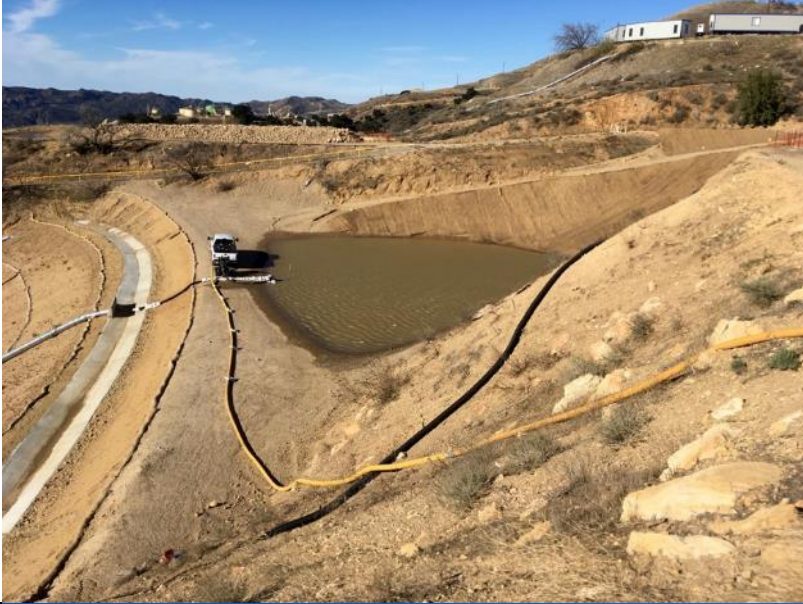
REPRESENTATIVE SITE PHOTOGRAPHS			
Date	Location	Photo	Description
12/29/16	PS-42 Fill Site

Photo 1 – Water is being pumped out of the PS-42 Fill Site.
12/29/16	PS-42 Well Pad

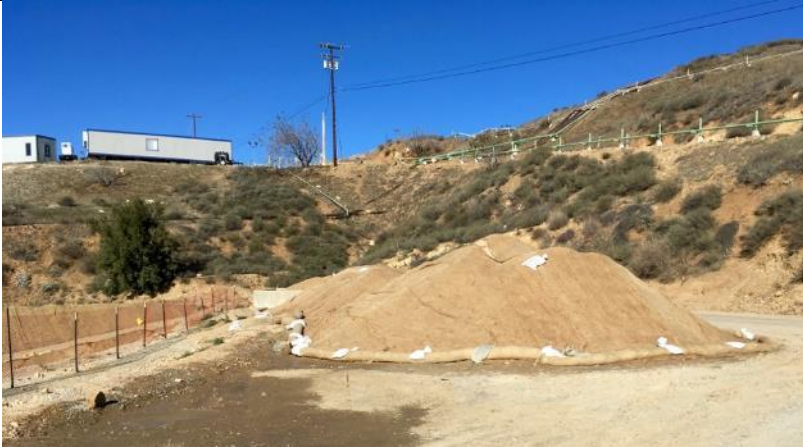
Photo 2 – Covered soil stockpiles that are waiting to be placed in the PS-42 Fill Site.
12/29/16	Parking Area below the 12-kV/A2 Access Road

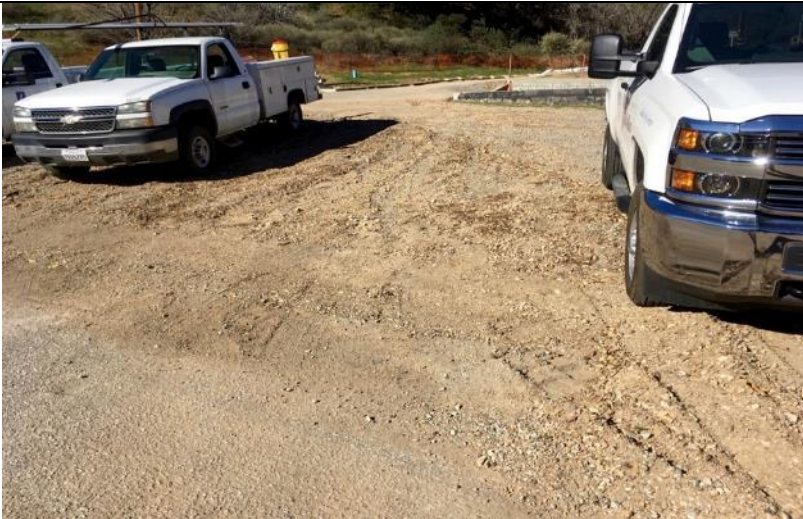
I walked up the A2 access road and noted the amount of rock, sediment, and leaves that had been deposited on the parking area just below the access road (Photo 3). The A2 access road was severely eroded with deep rills (>2 feet) all the way up the road and into the oak swale area. It appeared that a lot of water flowed down the oak swale (Photos 4 and 5). Crews were in the process of adding additional best management practices (BMPs) to the access road.

Photo 3 – Remaining mud and debris below the A2 access road.

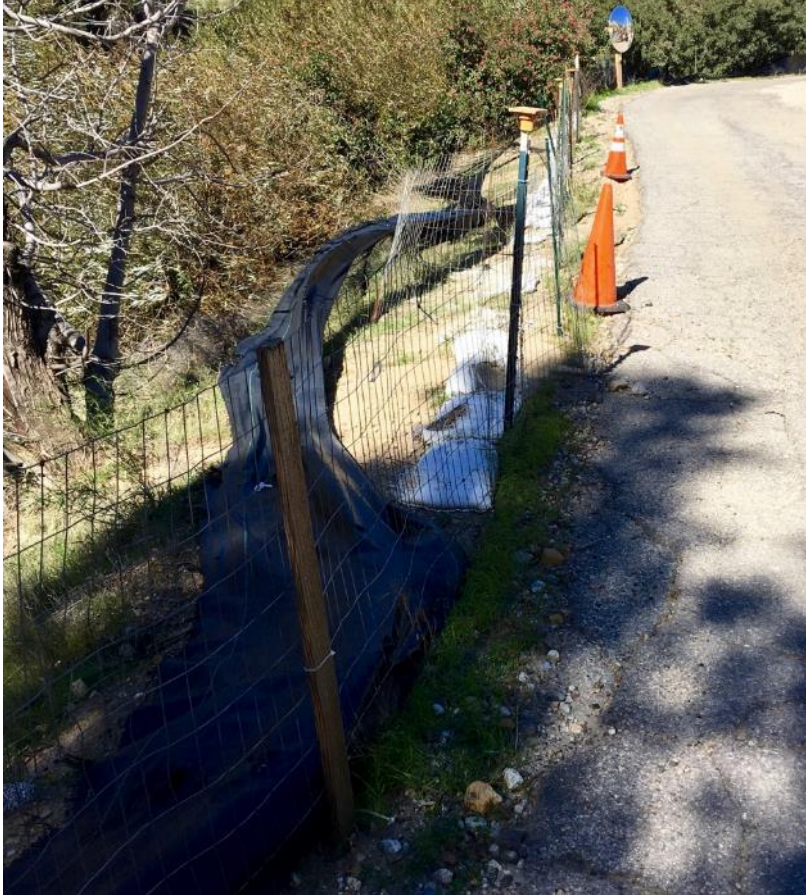
REPRESENTATIVE SITE PHOTOGRAPHS			
Date	Location	Photo	Description
12/29/16	Paved Road along Limekiln Creek and below the CCS

I walked up the paved roadway along Limekiln Creek and noted that the silt fencing installed to prevent newts from leaving the creek and traveling toward the CCS needed to be repaired (Photo 9).

Photo 9 – Newt barrier (silt fencing) in need of repair or replacement along Limekiln Creek.
12/29/16	New Admin/IM Building

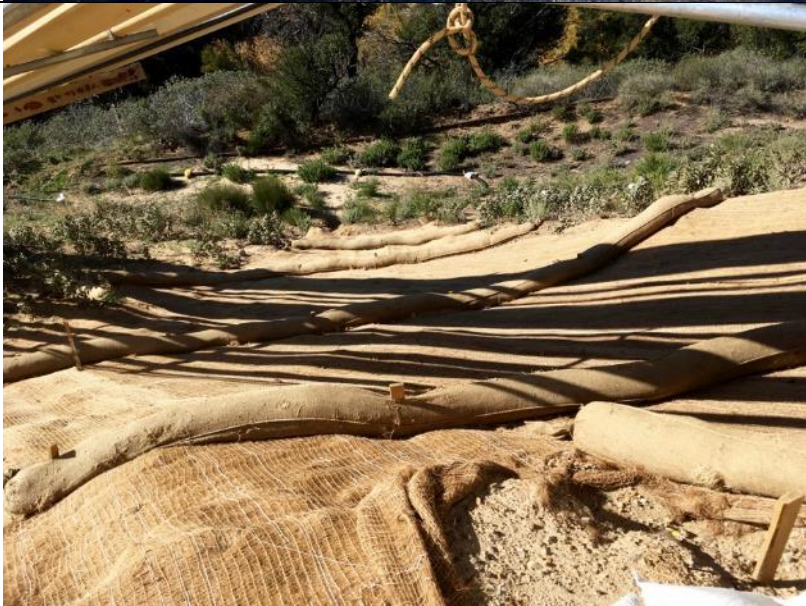
Photo 10 – BMPs have been upgraded below the new office buildings.

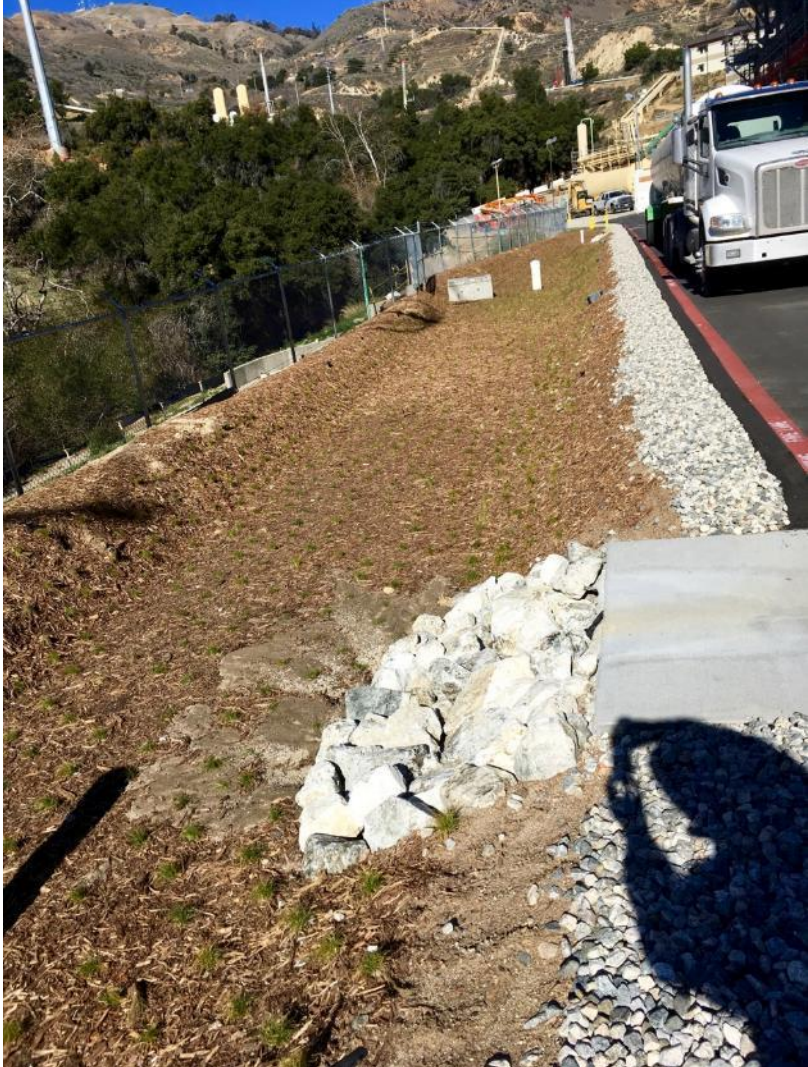
Date	Location	Photo	Description
12/29/16	CCS

The bioswale in the CCS was in good condition, with only a small amount of sediment noted at both of the inlets (Photo 14).

Photo 14 – Bioswale.
