Re: Monthly Report Summary #34 for Aliso Canyon Turbine Replacement Project

CPUC Site Inspection Reports
January 10, 19, and 23, 2017

Aliso Canyon Turbine Replacement Project CPUC Site Inspection Form

Project:	Aliso Canyon Turbine Replacement	Date:	January 10, 2017
Project Proponent:	Southern California Gas Company and Southern California Edison	Report #:	VS127
Lead Agency:	California Public Utilities Commission	Monitor(s):	Vince Semonsen
CPUC PM:	Andrew Barnsdale, Energy Division	AM/PM Weather:	Overcast and foggy with some light drizzle and cold temperatures.
E & E CM:	Lara Rachowicz	Start/End time:	0900 to 0930 at SCE components 1000 to 1100 at SCG
Project NTP(s):	The new Admin/IM Building (NTP-2), Central Compressor Station (CCS) (NTP-3), 12 kV power line (NTP-3), and PS-42 Fill Site. Tubular Steel Poles (TSPs) 2 through 42 (NTPs A, C, and D).

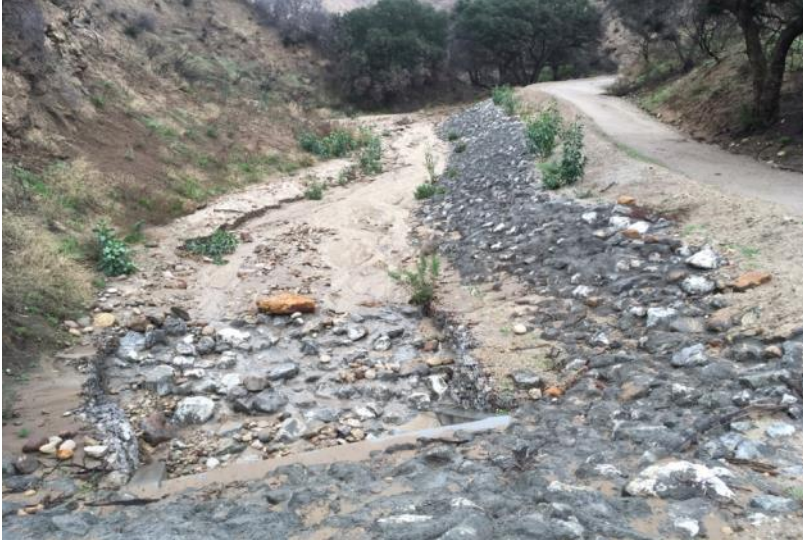
I hiked into the drainage between TSPs 24 and 25 to check the creek, the access road, and the new creek culverts. These areas appeared to be in good condition following the rainfall events, with very little erosion and stable creek banks, access roads, and fill slopes. Photo 1 shows the creek channel (note the invasive tree tobacco) and Photo 2 shows the new fill slope/road shoulder above the creek culverts. The entrance to the TSP 24/25 access road appeared stable, with no noticeable erosion or mud flowing into the Crescent Valley Mobile Estates (Mobile Estates).

Photo 1 – The creek channel and banks look stable; there are numerous areas of tree tobacco (invasive species) in and along the creek.
1/10/17	Drainage between TSPs 24 and 25

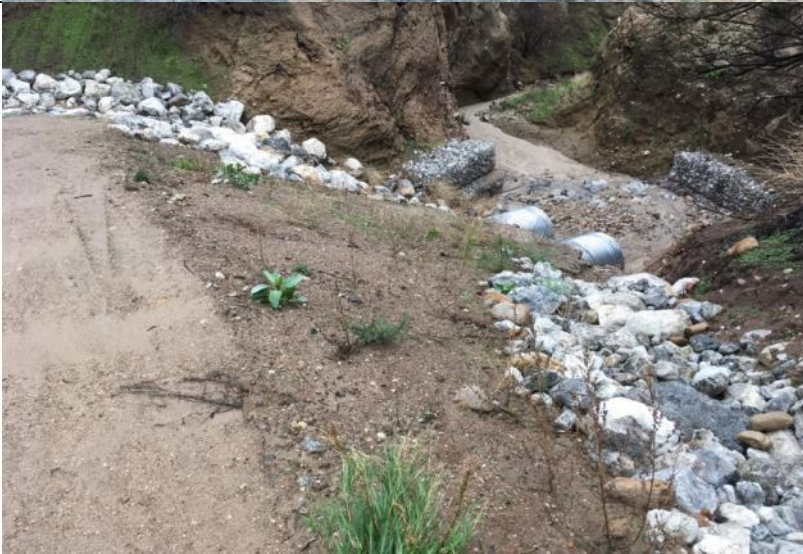
Photo 2 – The fill slope above the culvert outfall is in good condition with no erosion issues.
1/10/17	Entrance to the TSP 12-22 Access Road

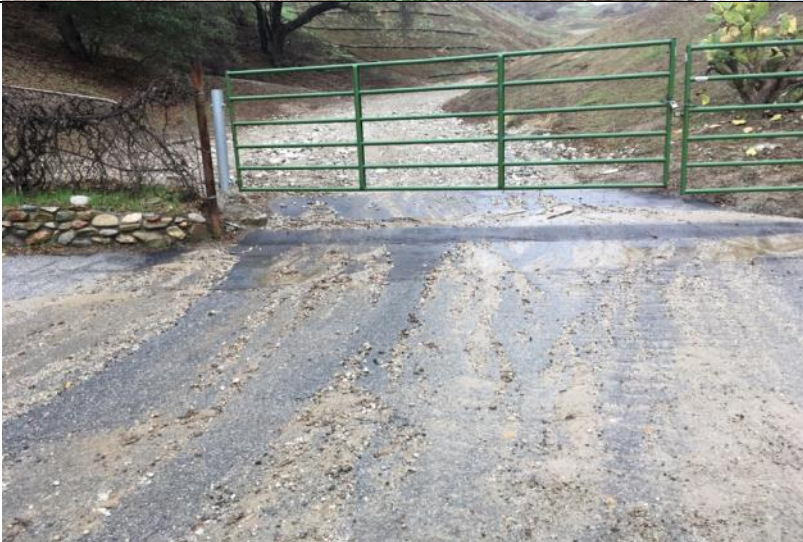
Sediment had traveled onto the paved access road at the entrance to TSPs 12-22 (Photo 3). I did not walk up the access road, but it appeared that the sediment was coming from the access road (noted in previous reports) and not from any of the Aliso Canyon Turbine Replacement (ACTR) Project sites.

Photo 3 – Mud and rock traveled down the access road and flowed out onto the paved road in the Crescent Valley Mobile Estates.

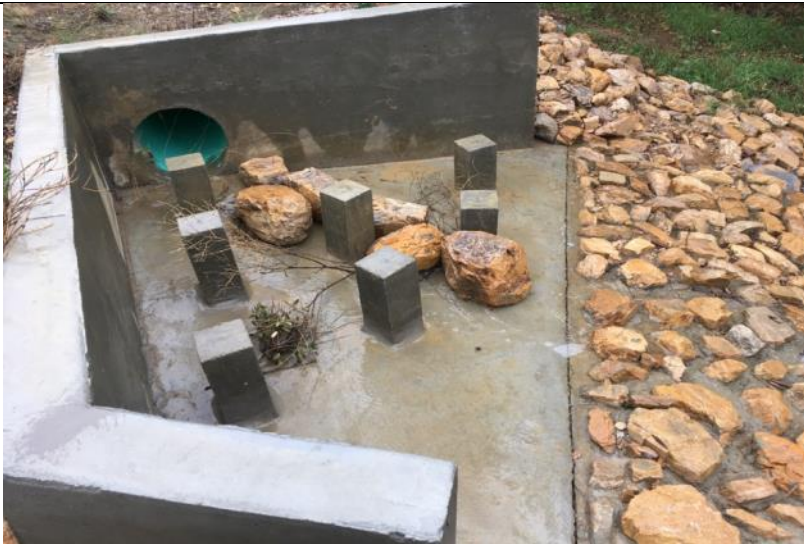
I drove to the Aliso Canyon facility and arrived at around 1000. I stopped at the ACTR Project trailer, but did not see any of the environmental personnel. I checked the Natural Substation area where I observed water flowing down the access road and entering the biofiltration unit, with clear water being discharged from the exit culvert (Photo 4). These ACTR Project components appeared to be functioning properly.

Photo 4 – Outflow culvert from the Natural Substation biofiltration unit, with energy dissipation structures.
1/10/17	PS-42 Fill Site

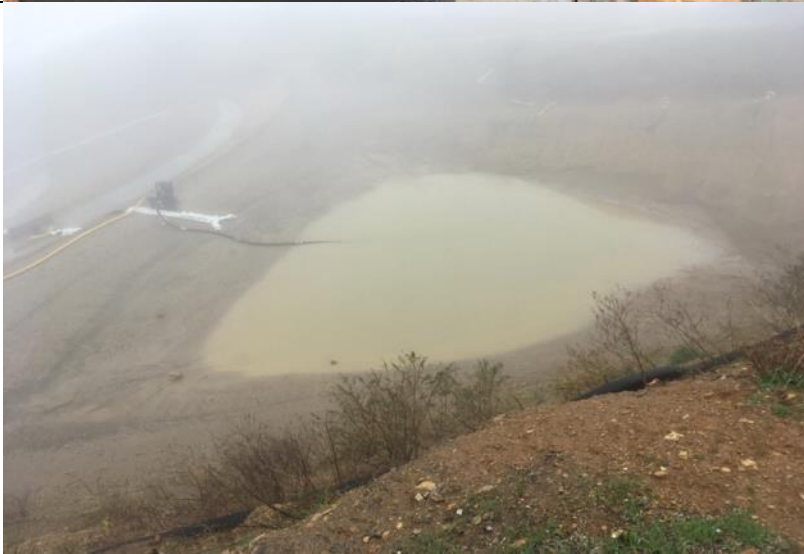
Approximately half of the flat upper portion of the PS-42 Fill Site was holding water (Photo 5). No crews were onsite, but the pumps, hoses, and baker tanks were in place for pumping out the water. The PS-42 Well Pad was submerged in water, and it appeared that some additional gravel bags had been installed around the PS-42 Well Pad to keep the water from entering the PS-42 Fill Site (Photo 6).

Photo 5 – Water that had ponded at the PS-42 Fill Site; water was not being pumped from the PS-42 Fill Site during my visit.
1/10/17	PS-42 Well Pad

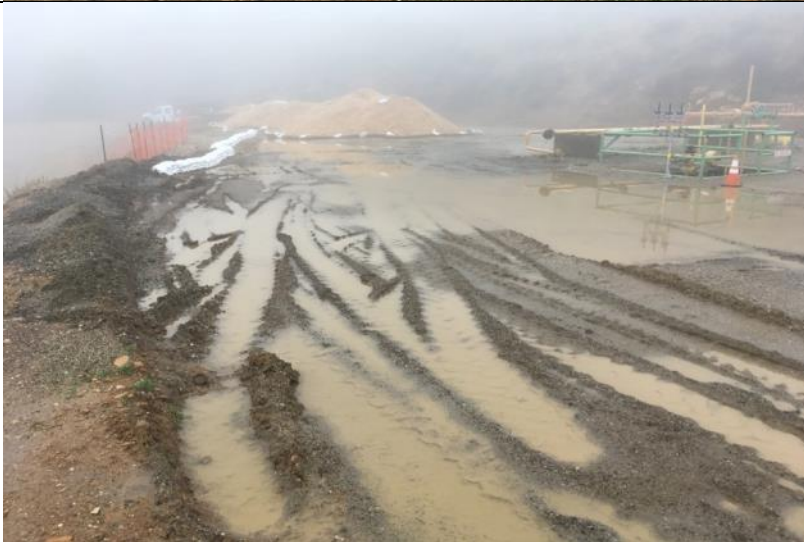
Photo 6 – Water on the PS-42 Well Pad; gravel bags had been added to keep water from entering the PS-42 Fill Site.

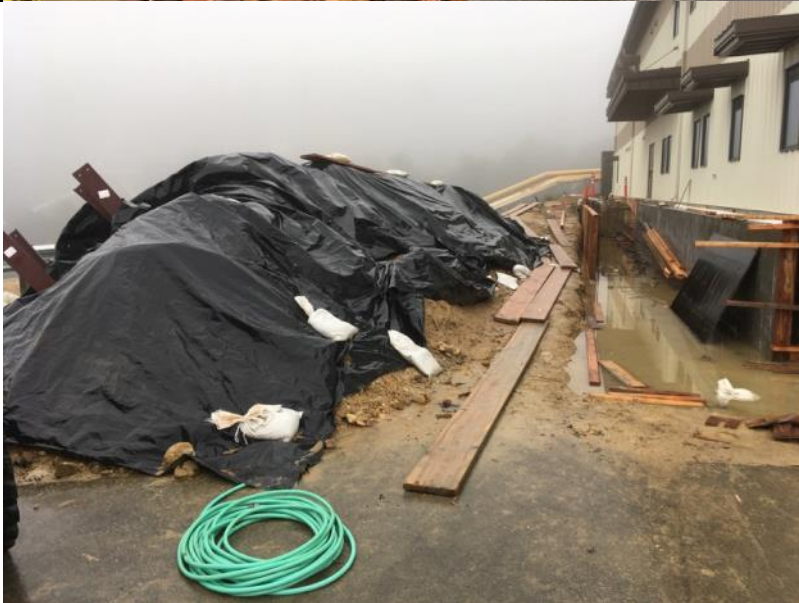
Crews continued to work at the new Admin/IM Building and were preparing to do some final concrete work (Photo 9). The stockpile of soil had been adequately covered with plastic (Photo 10).

A photograph showing a large pile of soil or earth covered with a black plastic tarp. The tarp is secured with white bags. In the foreground, there is a coiled green hose. The background shows the exterior of a building under construction.	Photo 10 – The soil stockpile has been adequately covered.

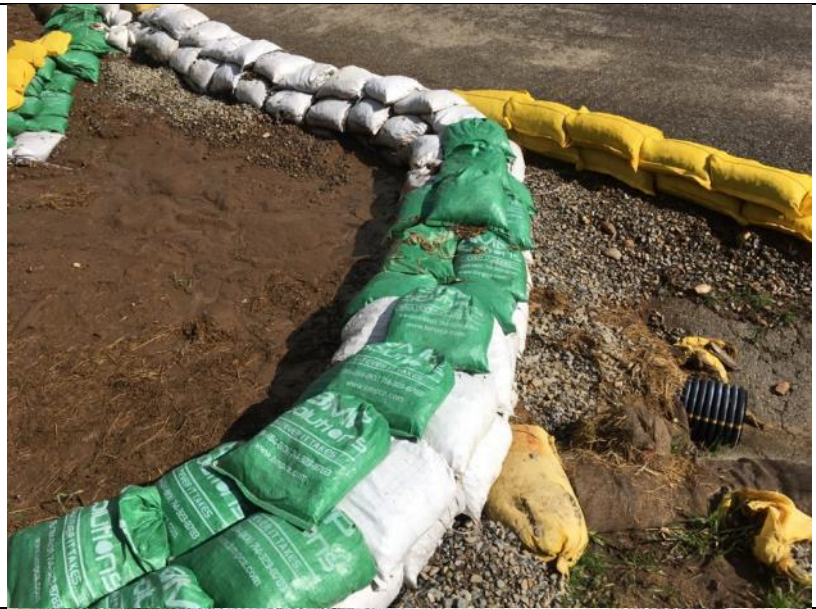
Since my last site visit, SCG had crews upgrade the best management practices (BMPs) along the access road, adding straw wattles and gravel bag containment basins along the road (Photo 1). Crews had also added a silt fence diversion structure where the oak swale drainage flowed onto the TSP A2 access road (Photo 3). The silt fence had been stabilized with metal "T" posts, gravel bags, and rock riprap to withstand the flow of rainwater runoff coming down the drainage. This structure diverted runoff away from the TSP A2 access road and into the old oak swale drainage channel.

Photo 1 – Upgraded BMPs at the end of the TSP A2 access road.
1/19/17	Oak Swale Drainage

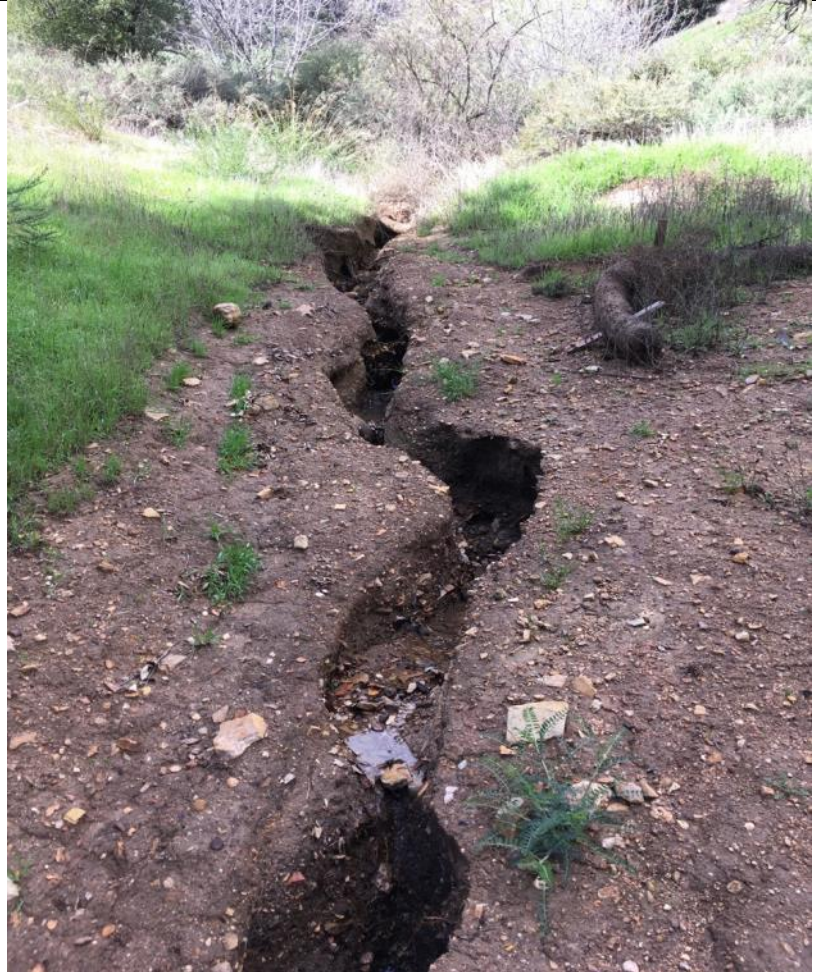
I had concerns that the diversion fencing would redirect the rainwater runoff traveling down the oak swale drainage into Limekiln Creek without the aid of any BMPs to trap mud and debris. However, upon examination of drainage above and below the silt fence diversion structure (Photos 2 and 4, respectively), it appeared that only small amounts of mud and debris were traveling into the drainage during the most recent storm. I only observed the flowlines from the runoff and some extra piles of oak leaves below the diversion structure (Photo 4). The erosion rill shown in Photo 2 has remained the same since the rains last year.

Photo 2 – Erosion rill at the base of the oak swale drainage channel.

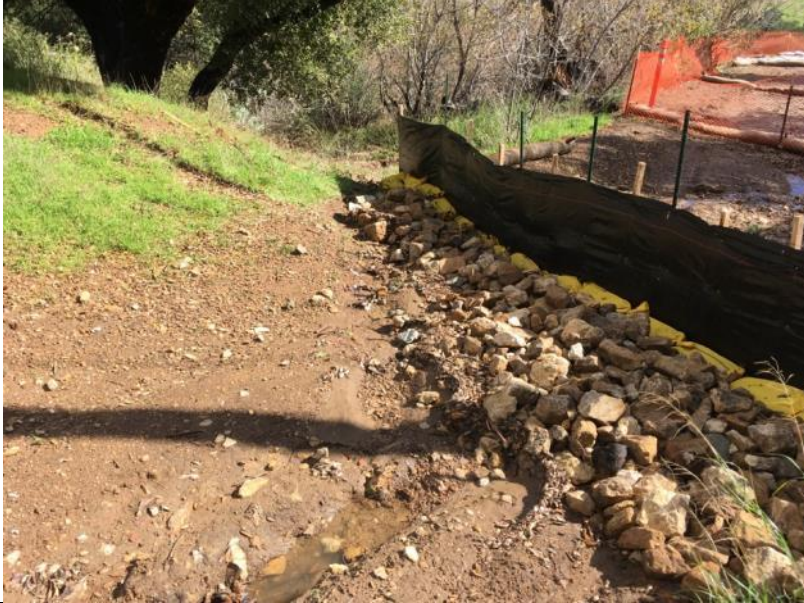
During the most recent rain storm, the combination of the additional BMPs and the silt fence diversion structure appeared to have been an adequate for reducing the flow of water onto the TSP A2 access road and capturing sediment before the water entered Limekiln Creek. However, it should be noted that one inch of rain over a 12-hour period is not considered a significant rain event; therefore, the area should be closely monitored for the adequacy of the diversion structure solution during larger rain events.

Photo 3 – Silt fence diversion structure installed to divert rainwater runoff into the old oak swale drainage and away from the TSP A2 access road.
1/19/17	Old Oak Swale Drainage

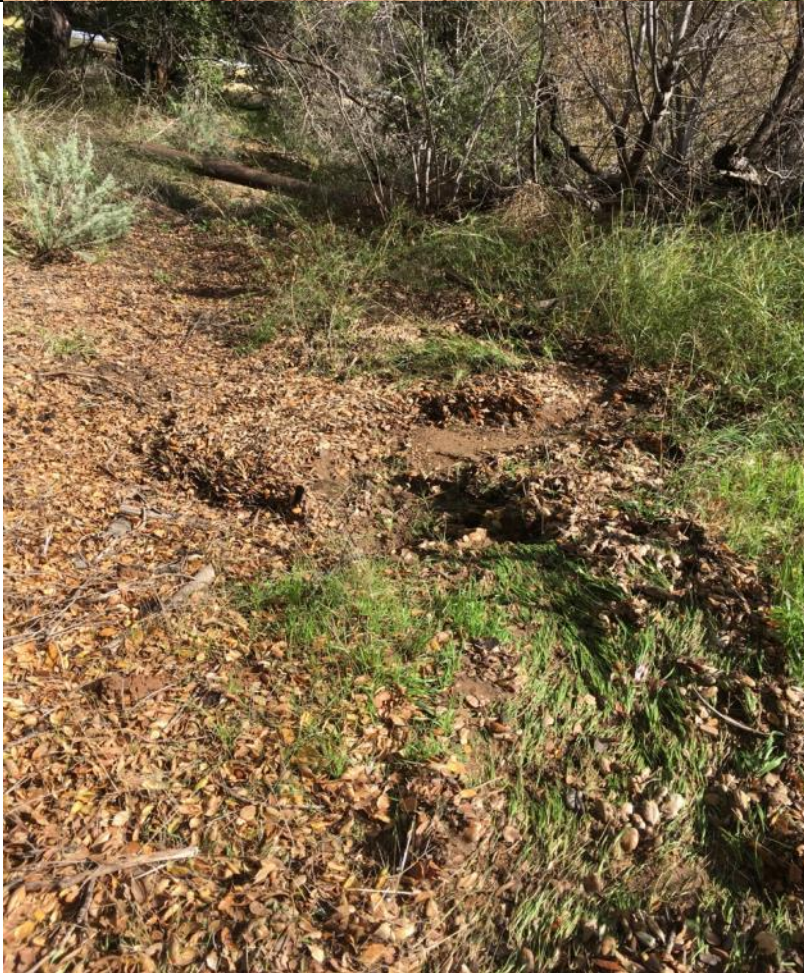
Photo 4 – Aftermath of the rainwater runoff diverted into the old oak swale drainage.

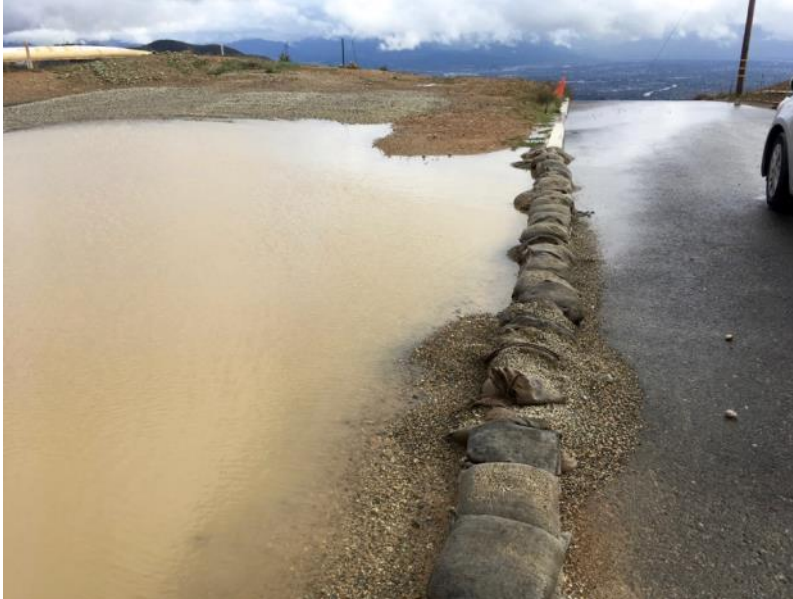
I arrived at 1100 and went to the Natural Substation to check the biofiltration unit. On the way, I noted a large area of ponded water at the Well Pad located at the top of the access road (Photo 1). Water from this Well Pad was flowing over the curb and down the Natural Substation access road. Since the amount of water traveling down the access road has been contributing to the oak swale erosion, I recommend that this water is directed away from the roadway.

Photo 1 – Ponded water on the Well Pad above the Natural Substation access road. This water was flowing over the curb and down the access road.
1/23/17	Bioswale at the Natural Substation	 	Photo 2 – Overview of the bioswale; note that the covers to the irrigation boxes washed down the access road.

Diversion of water away from the oak swale is recommended, especially for water from the Well Pad above the Natural Substation access road and water from the access road, itself.

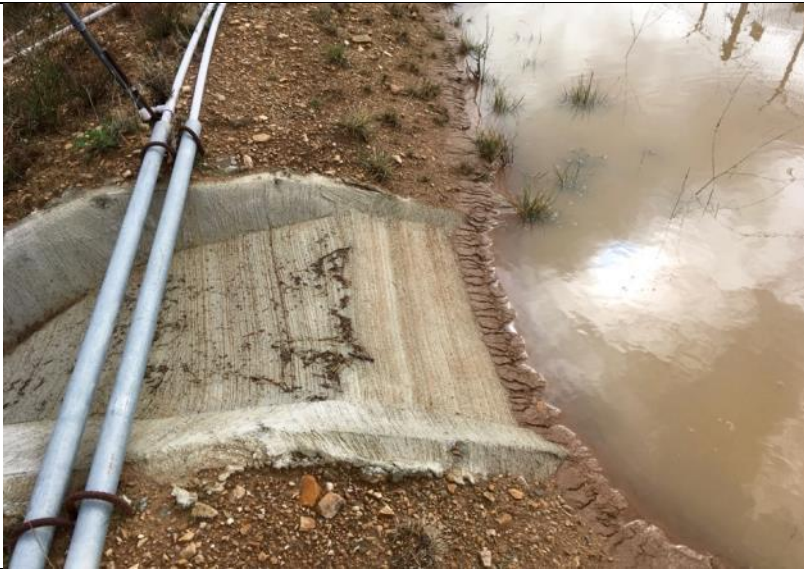
Photo 3 – Water filled the bio swale and drained out the concrete overflow ditch.
1/23/17	Natural Substation Bioswale

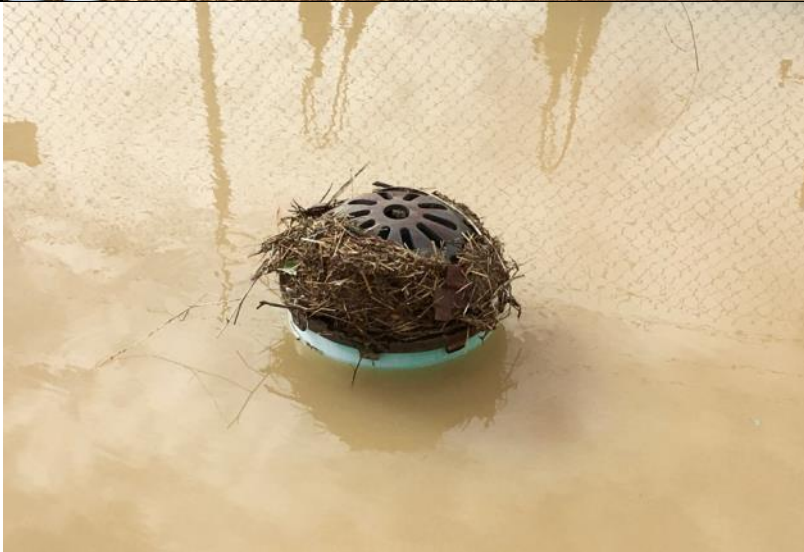
Photo 4 – Nearly clogged intake drains within the bioswale.
1/23/17	Natural Substation Access Road

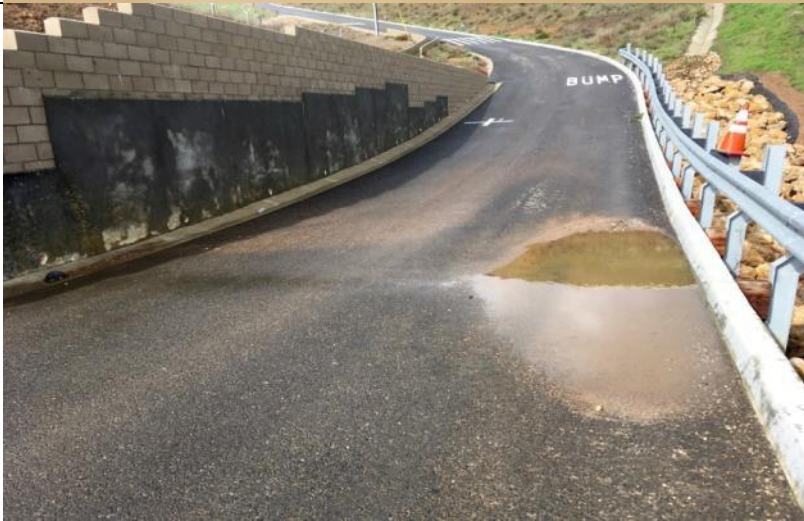
Photo 5 – Some ponded water in the access road.

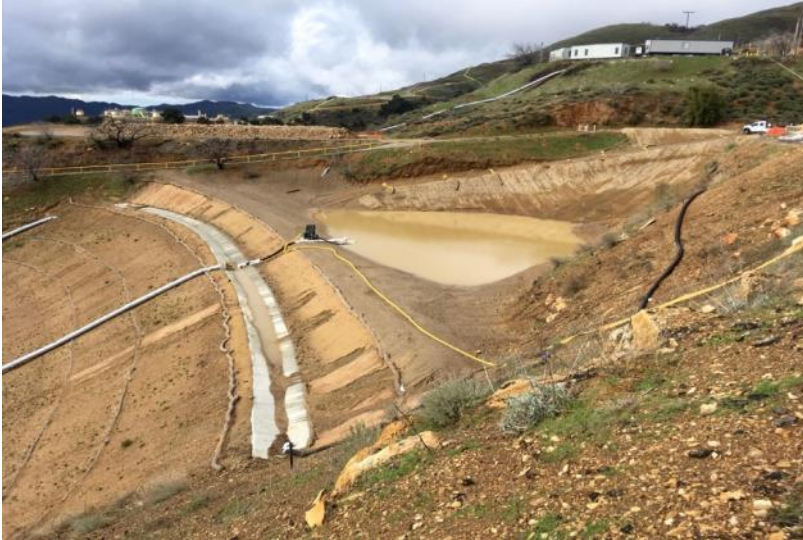
Photo 6 – Water filled the top of the PS-42 Fill Site. Pumping equipment remains onsite.
1/23/17	TSP A2 Access Road

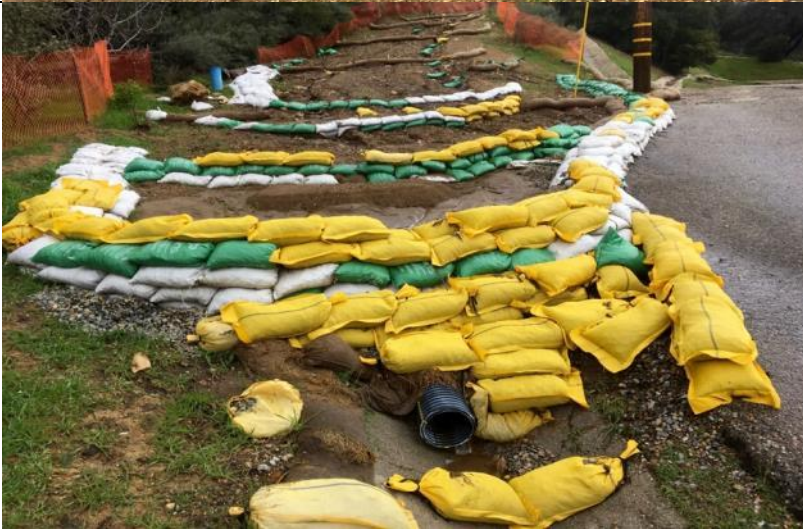
Photo 7 – BMPs at the entrance to the TSP A2 access road. Additional bags had been added since my previous site visit.
1/23/17	TSP A2 Access Road

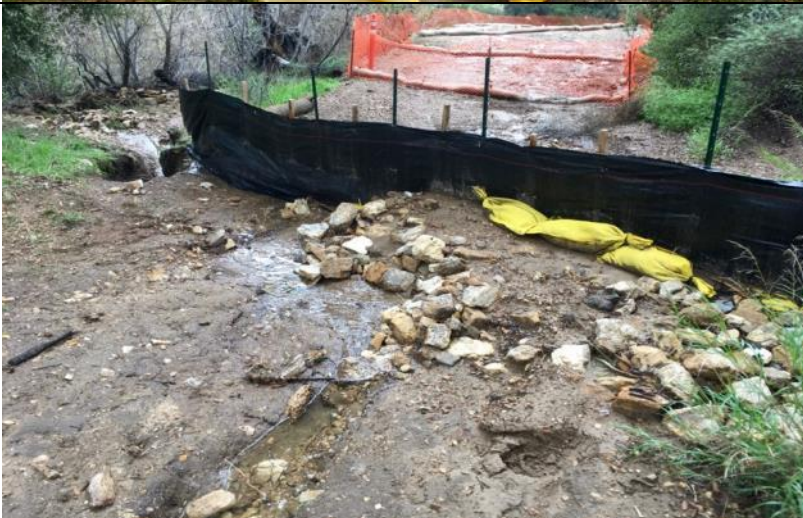
Photo 8 – Silt fencing used to divert water away from the TSP A2 access road. Much of the rock and gravel bags were washed away.

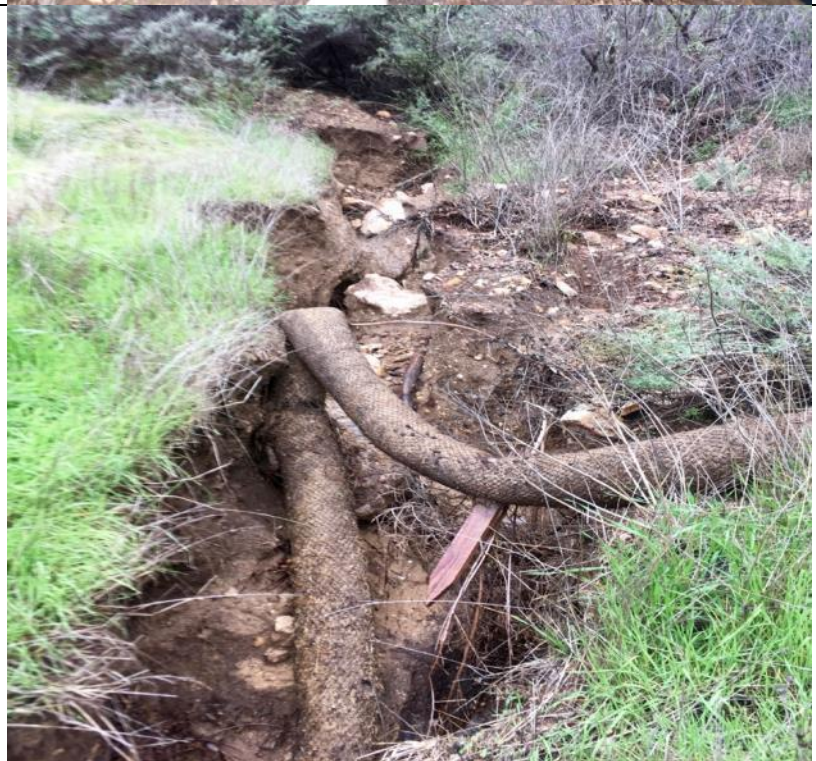
I noted increased erosion above the silt fencing compared to my last visit (Photo 10). The increased rainwater runoff from the recent storm and associated mud and debris appeared to have eroded portions of the old oak swale drainage channel, creating deep rills below the silt fence (Photo 9), and deposited mud, rock, and gravel bags along the channel (Photo 11) and into Limekiln Creek. Photo 12 shows the upper sedimentation basin/newt pond just downstream of the old oak swale drainage was full of mud, rock, and debris. Many mud slides were noted throughout Aliso Canyon; therefore, not all of the sediment and debris in the newt pond can be attributed to the oak swale runoff.

Photo 10 – New erosion within the oak swale above the silt fence.

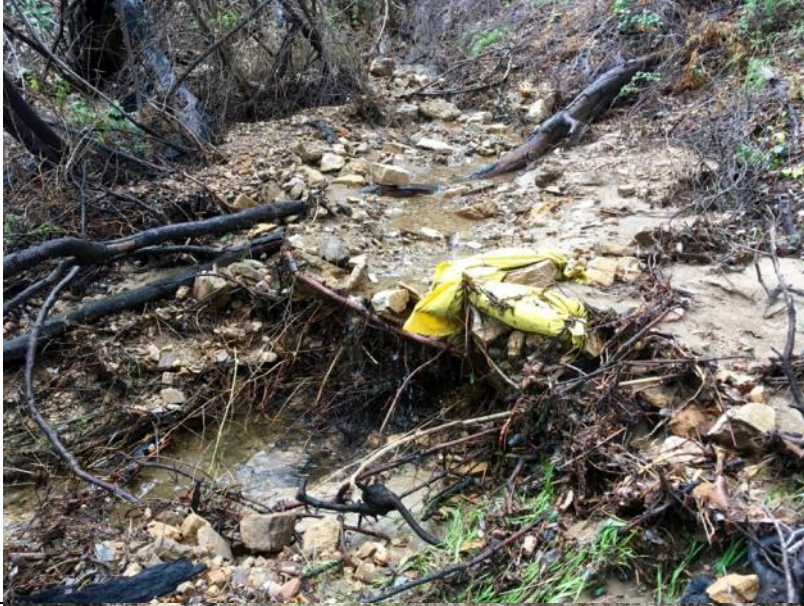
Photo 11 – Mud, debris, and gravel bags were deposited within the original oak swale drainage, approximately 50 feet below the silt fence diversion structure.
1/23/17	Limekiln Creek, Upper Sedimentation Basin/Newt Pond

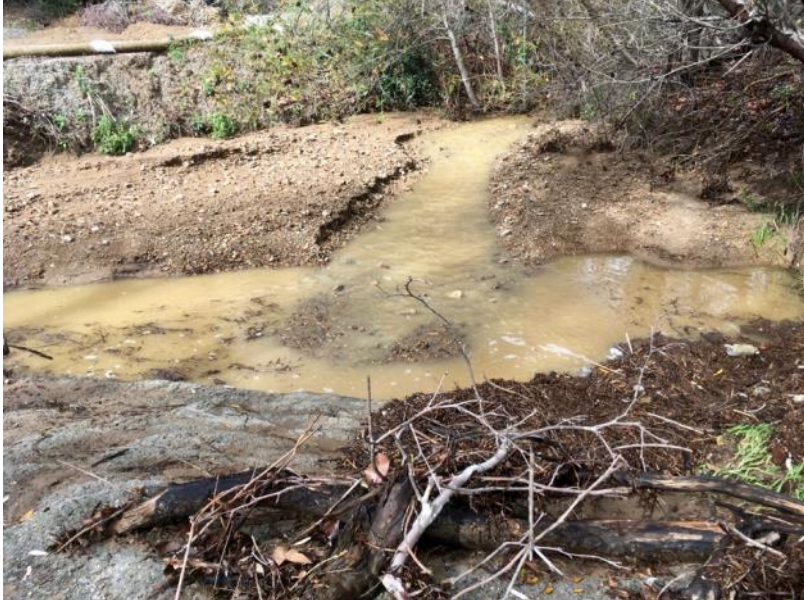
Photo 12 – The upper sedimentation basin/newt pond below the CCS was completely filled with sediment and debris.
