**Re: Monthly Report Summary #3 for Aliso Canyon Turbine Replacement Project**

## Aliso Canyon Turbine Replacement Project CPUC Site Inspection Form

<b>Project:</b>	Aliso Canyon Turbine Replacement	<b>Date:</b>	June 6, 2014
<b>Project Proponent:</b>	Southern California Gas Company and Southern California Edison	<b>Report #:</b>	VS010
<b>Lead Agency:</b>	California Public Utilities Commission	<b>Project Phase/NTP:</b>	Guard House and Road Widening (NTP #1)
<b>CPUC PM:</b>	Andrew Barnsdale, Energy Division	<b>AM/PM Weather:</b>	Sunny, clear morning with mild temperature and a slight breeze
<b>E &amp; E CM:</b>	Jennifer Siu	<b>Start/End time:</b>	0800 hrs to 1100 hrs
<b>Monitor(s):</b>	Vince Semonsen		
<b>Project Component(s):</b>	CPUC Oversight: Guard House and Geotechnical Investigations at PS-42

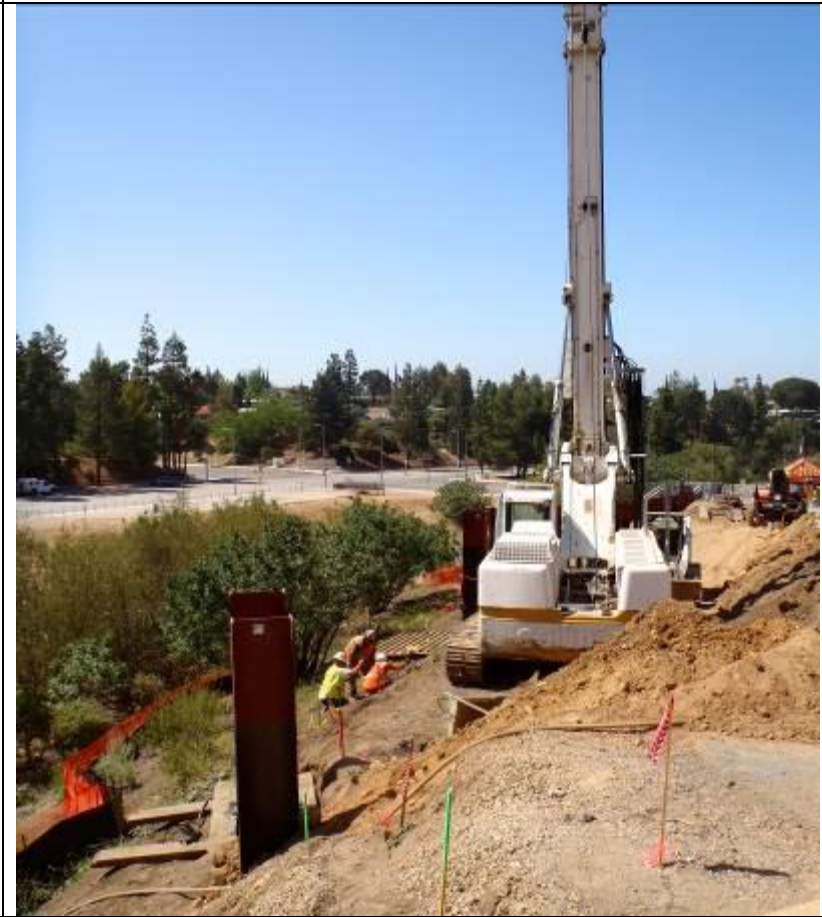
Date	Location	Photo	Description
6/6/14	Guard House

<p>Drilling rig and caissons along the Limekiln Creek access road.</p>
6/6/14	PS-43

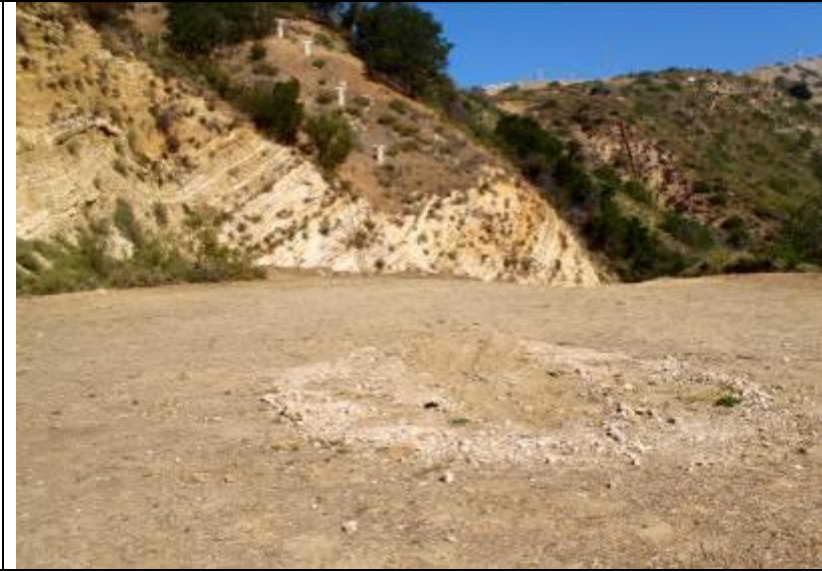
<p>At the PS-43 well pad a crew had come in and cleared some of the brush and grass at the site. The discolored soil denotes one of the geotechnical drilling locations.</p>

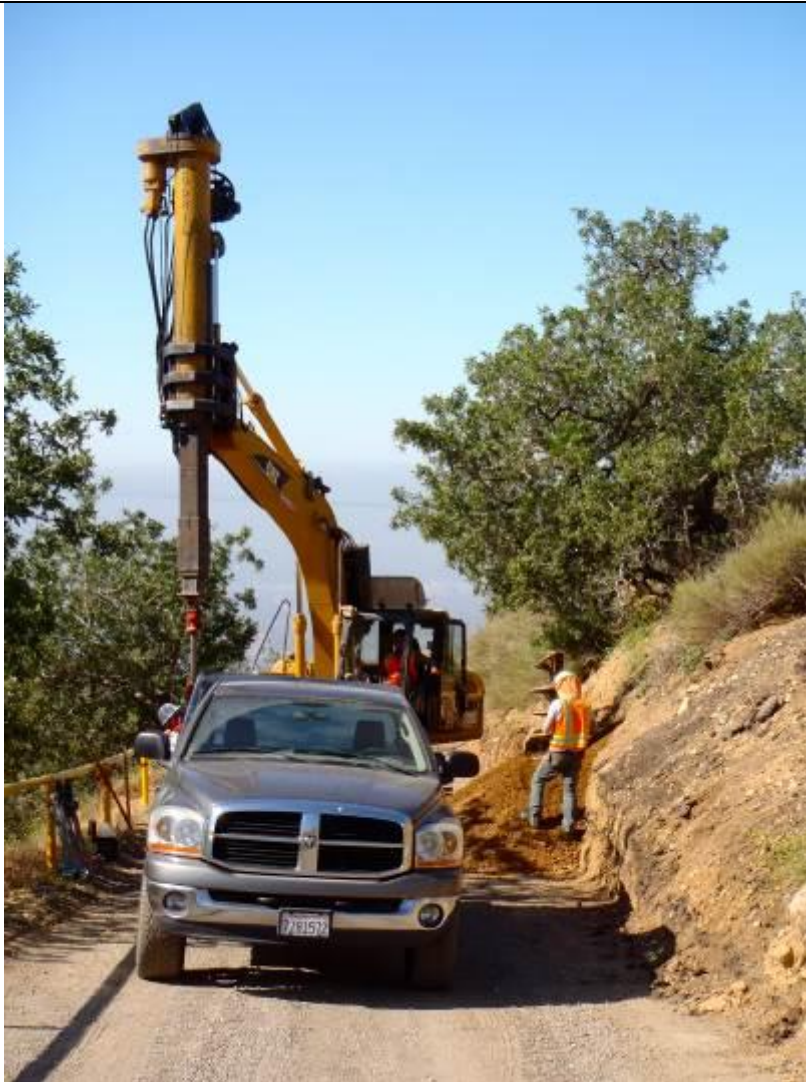
6/6/14 PS-42 site

A geotechnical drilling rig working on an existing access road around PS-42. Paleontological Monitor Joey Raum can be seen in the photo.

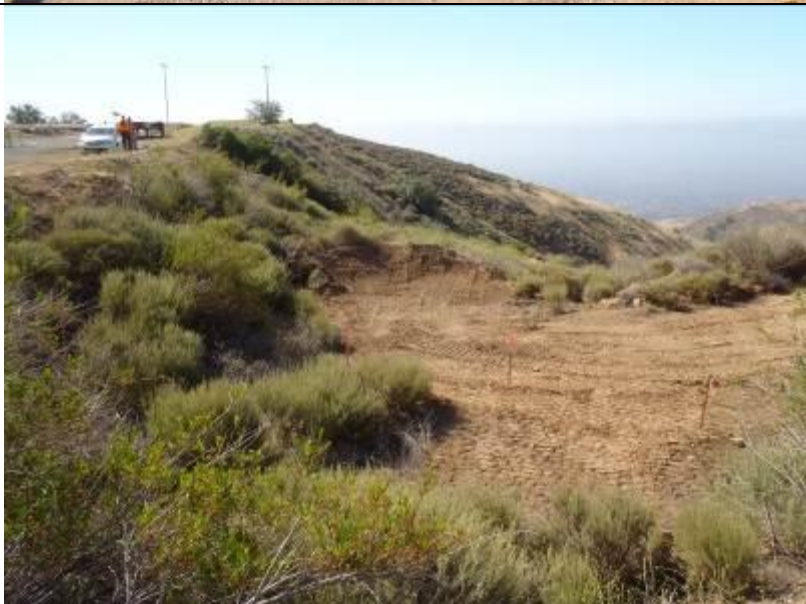
6/6/14 PS-42 site

A drilling location near the top of the PS-42 site. Some brush was cleared to allow the drilling rig access. A CA towhee nest was found nearby; the flagged lath stakes denote the do-not-enter buffer zone around the nest.

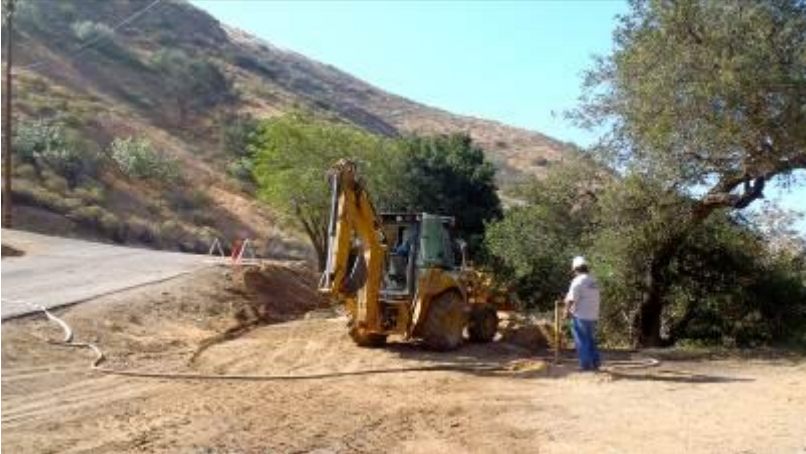
Upon arrival at the temporary trailer location, a small backhoe was observed building an earthen berm along the top-of-the-bank of the Limekiln Wash. The crew was also working under the dripline of the oak tree adjacent to the temporary trailer #1 location (MM BR-15). I notified Juan Miranda of the need for exclusion fencing along the edge of the riparian corridor and around the oak tree (APM BR-1b, APM BR-5). Amandeep Singh, SoCalGas' Consultant Compliance Manager, was notified and redirected the crew until a plan was formulated to install the proper fencing.

<p>Crews beginning the site preparation work at the Temporary Trailer #1 location. Note the lack of fencing along the bank and around the oak tree.</p>
<p>6/12/14</p>	<p>Temporary Trailer #1 Location</p>

Recommended follow-up: Check that the required fencing is installed along Limekiln Wash near temporary trailer #1 location and follow-up on the status of the nesting birds and the buffer zone there.

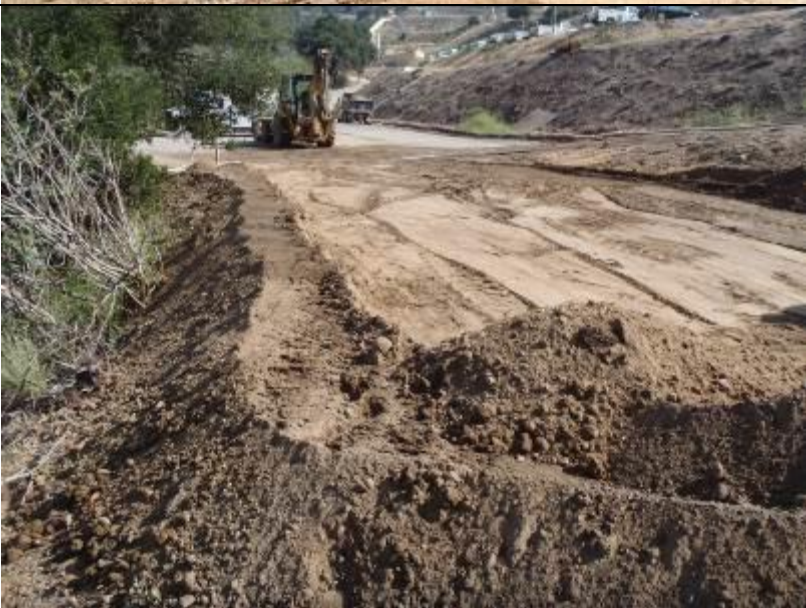
Date	Non-compliance issue and resolution	Relevant Mitigation Measure	NC Report #
6/12/14	A small backhoe was observed building an earthen berm along the top-of-the-bank of the Limekiln Wash. The crew was also working under the dripline of the oak tree adjacent to temporary trailer #1 location. I notified the biological monitor, Juan Miranda, of the need for exclusion fencing along the edge of the riparian corridor and around the oak tree. Amandeep Singh, the Consultant Compliance Manager, was notified, and he redirected the crew until a plan was formulated to install the proper fencing. I called the CPUC Compliance Manager to discuss the issue.	MM BR-15, APM BR-1b & APM BR-5

<p>Dirt moved to the edge of the creek bank without the required exclusion fencing.</p>
<p>6/12/14</p>	<p>Temporary Trailer #1 Location</p>

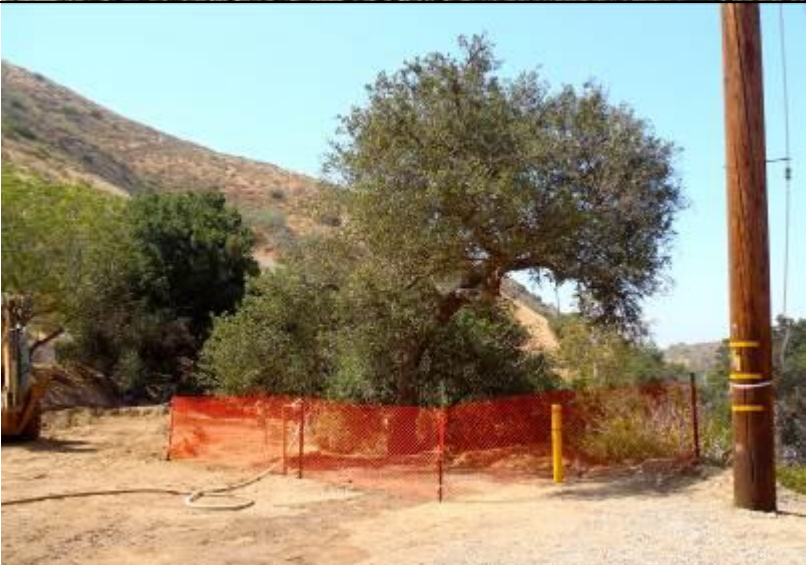
<p>Crews stopped work at the temporary trailer site, pulled the dirt back from the creek bank, and installed fencing around the dripline of the oak tree. A house wren was observed nesting in this oak; SoCalGas to prepare a nesting bird tracking report.</p>

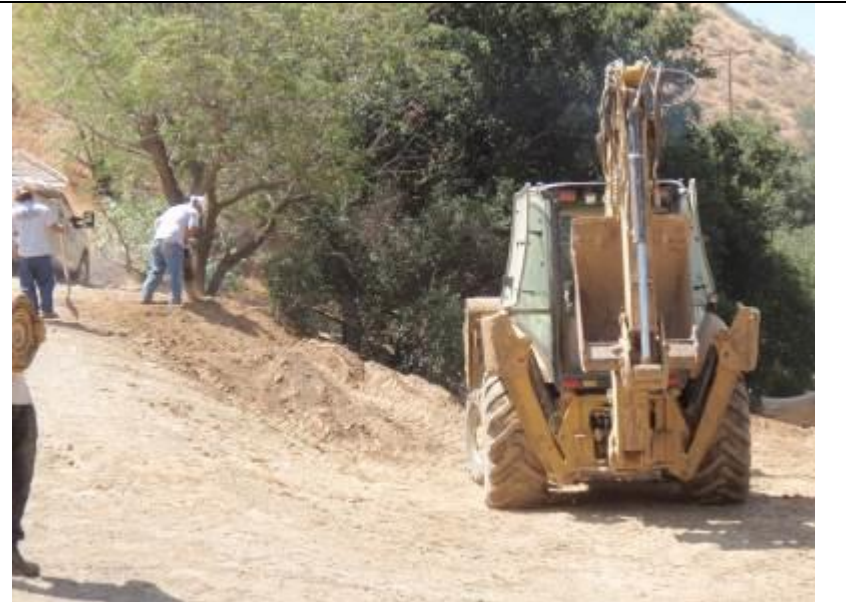
Workers using handheld compaction tool and backhoe to build soil berm.
6/18/14	Temporary Trailer Site #1	 	Biological monitor, Thomas Juhasz, in front of new exclusionary fencing around oak tree/ house wren nest.

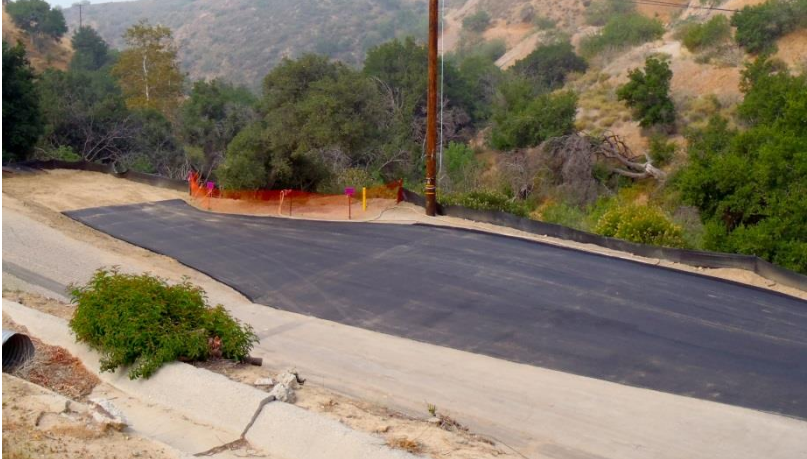
<p>Exclusion fencing is up around the temporary trailer area and paving is complete.</p>
<p>6/26/14</p> <p>Temporary Trailer #1 Location</p>

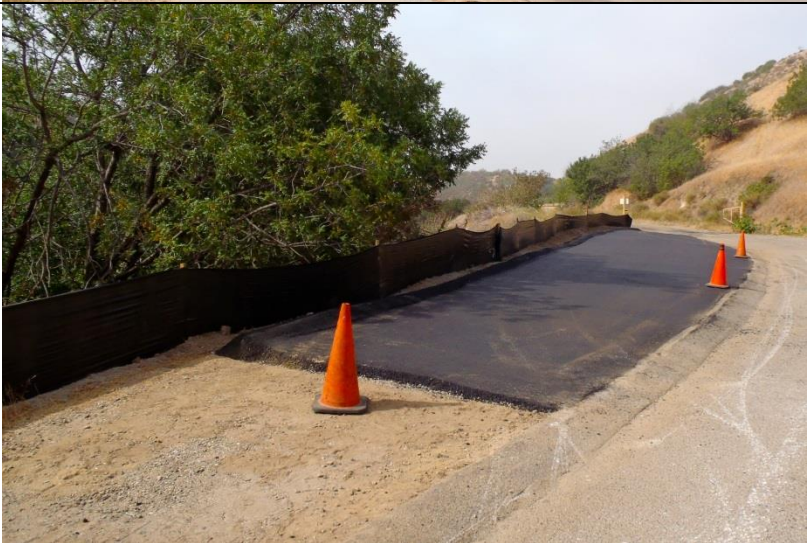
<p>Additional fencing and paving on the west side of the creek.</p>
<p>6/26/14</p> <p>New Storage Container Location</p>

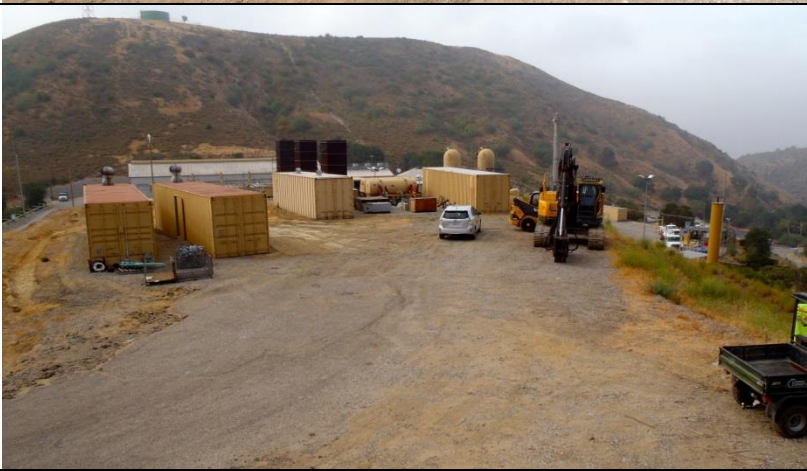
<p>Overview of the Storage Container location.</p>
