Re: Monthly Report Summary #9 for Aliso Canyon Turbine Replacement Project

Aliso Canyon Turbine Replacement Project CPUC Site Inspection Form

Project:	Aliso Canyon Turbine Replacement	Date:	December 3, 2014
Project Proponent:	Southern California Gas Company and Southern California Edison	Report #:	VS034
Lead Agency:	California Public Utilities Commission	Project Phase/NTP:	Guard House and Road Widening Component (NTP-1), the New Admin/IM Building (NTP-2), CCS Site (NTP-3). P-43 Fill Site (NTP-2), PS-42 Fill Site & the PS-42 rock site and temporary fill site. P-32 fill site (NTP-3). Natural Substation (NTP-3) and the San Fernando substation (NTP-A).
CPUC PM:	Andrew Barnsdale, Energy Division	AM/PM Weather:	Cool (60 degrees) with dense fog and drizzle. 2 inches of rain fell on the site over the last couple of days.
E & E CM:	Lara Rachowicz	Start/End time:	0945 hrs to 1230 at Aliso. 1300 hrs to 1345 hrs at the San Fernando Substation
Monitor(s):	Vince Semonsen		
Project Component(s):	CPUC Oversight: Guard House, New Admin/IM Building, P-41, PS-42, P-43 and P-32. CCS Site, Natural Substation, and San Fernando Substation

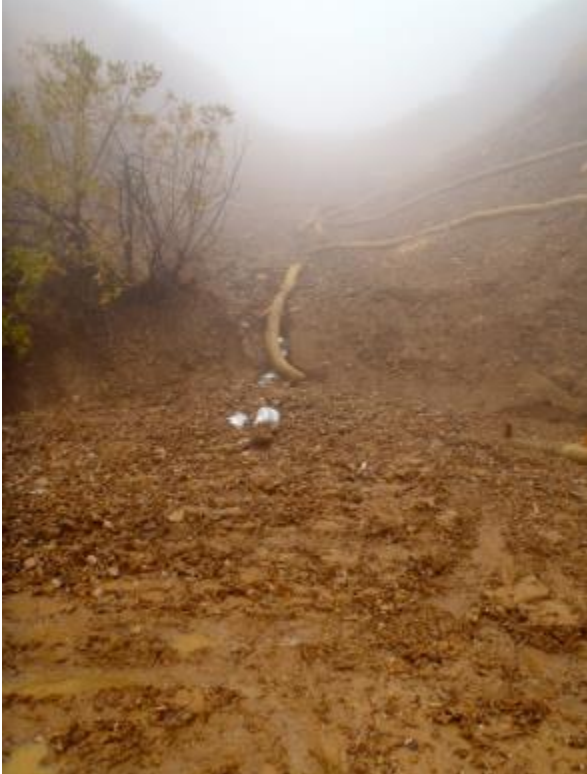
I did not visit every construction site due to restricted access and the fact that P-41 and P-43 were reportedly unimpacted by the storm, per discussions with Juan. At the PS-42 fill site, I observed significant erosion problems – see photos. The straw wattles above and below the fill key had failed due to the movement of water, mud and rock. Erosion gullies had formed down the middle of the slopes. The fill key was full of mud and rock, and water had overtopped the straw wattle along the rim of the fill key. Mud and rock washed down onto the lower access road and onto the road, which captured much of the loose material. However, water overtopped the gravel bags and straw wattles along the edge of the access road, sending muddy water down into the arroyo below the fill key, causing erosion downslope of the road. The rock riprap appeared unaffected by the runoff.

Looking up at the PS-42 fill key from the lower access road. Straw wattle has been “blown out” and mud and rock have been deposited on the access road.
12/03/14	PS-42 Fill Site – Lower access road

I met with Amandeep Singh and Dave Lohr at the PS-42 site and we discussed possible fixes to the BMPs below the fill key. Access was restricted because of the mud and loose rock, and work may need to be delayed until conditions improve. No more rain is predicted for at least a week.

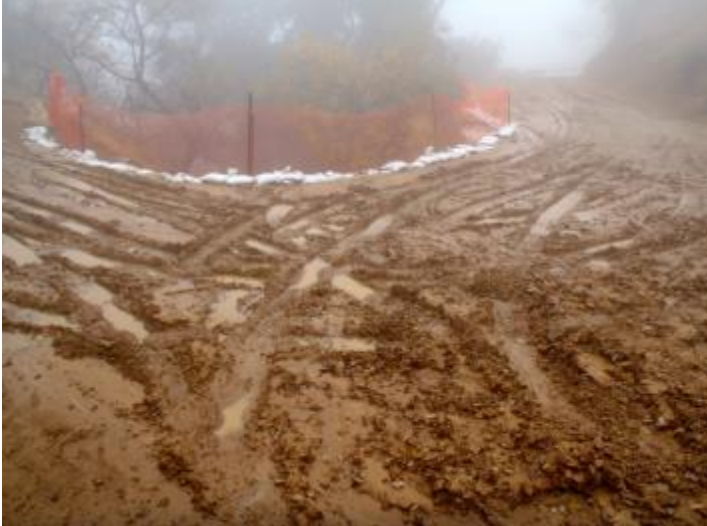
Lower access road looking across to the drainage gully. Gravel bags held back mud and rock but muddy water overtopped these BMPs.

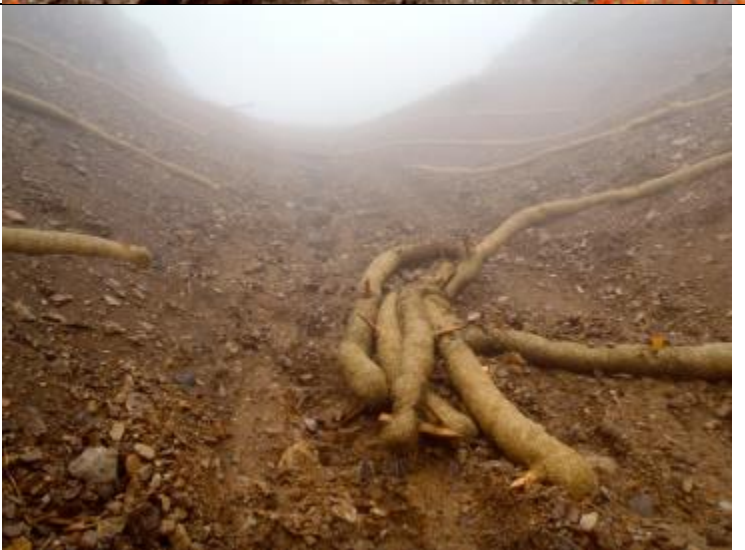
Looking up the steep slope toward the fill key from the lower access road. Note the blown out straw wattles and the erosion rills.
12/03/14	PS-42

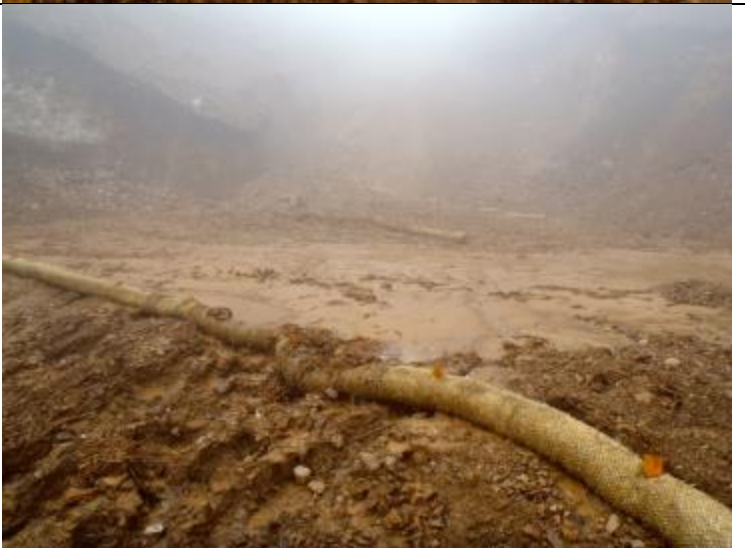
The fill key at PS-42 – note that it is full of mud and rock, and water had overtopped the straw wattle.

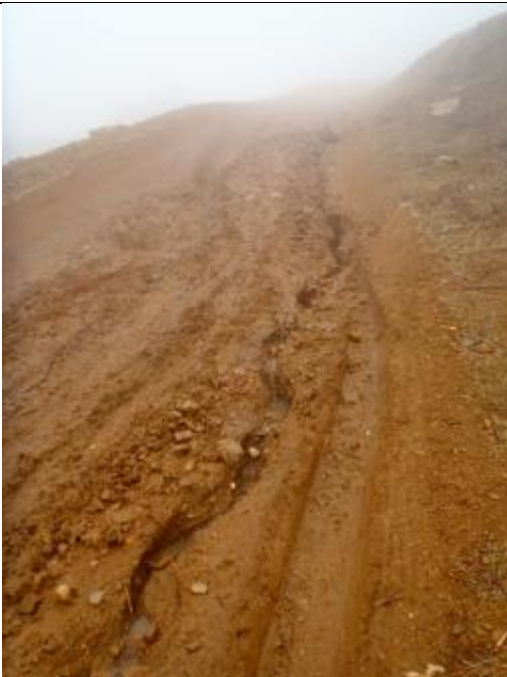
No one from SCE or their monitoring staff was onsite within the Aliso site. I walked down to the Natural Substation to check on the BMPs. I observed some erosion gullies on the access road to the substation and between TSPs 47 and 48 – see photos. Sediment had not migrated into any sensitive areas in either location, and other BMPs appeared to be intact and functioning. Some grading of the access road will be needed to allow traffic into the substation.

Steep portion of the access road with an erosion scar running down the inside edge of the roadway.
12/03/14	SCE Natural Substation

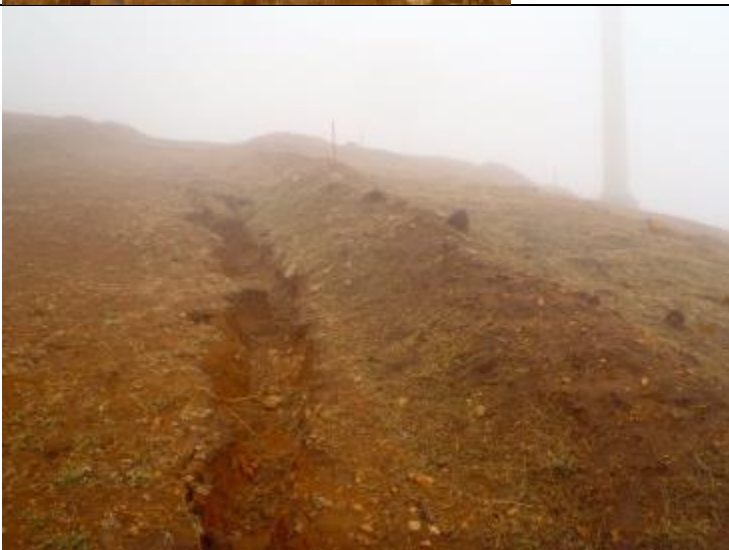
Erosion rill located between TSP 47 and 48.
12/03/14	Central Compresso r Station

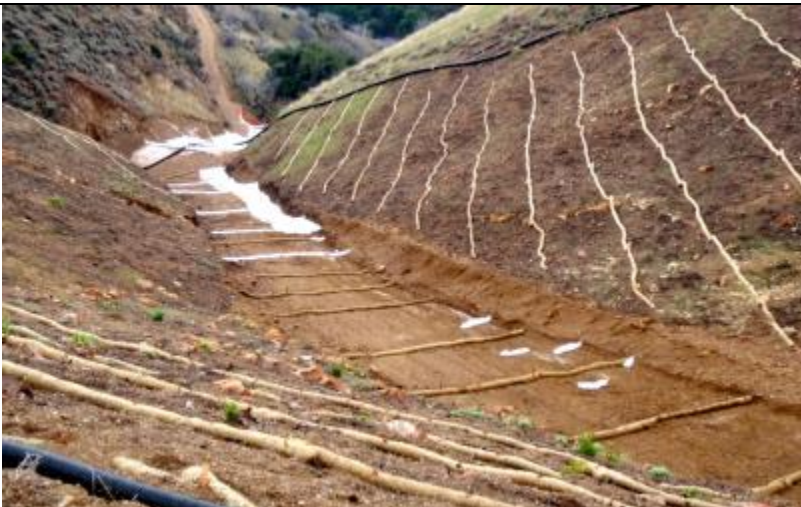
Additional temporary BMPs look to have held up well during the past storms, except for the few gravel bags that rolled down the slope.
12/16/14	PS-42 Fill Site – Looking up toward the fill key.

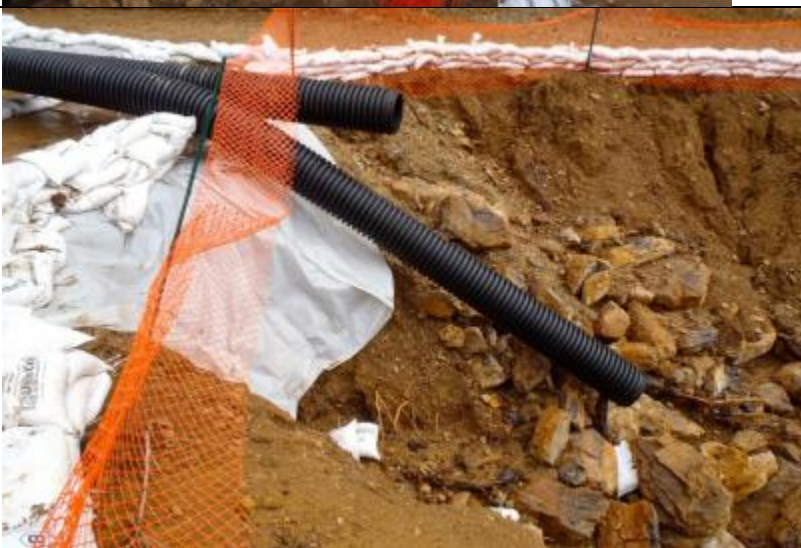
Diversion pipe outflow - some of the road bank next to the piping was eroded away dropping gravel bags into the drainage. Crews came through and added additional bags.

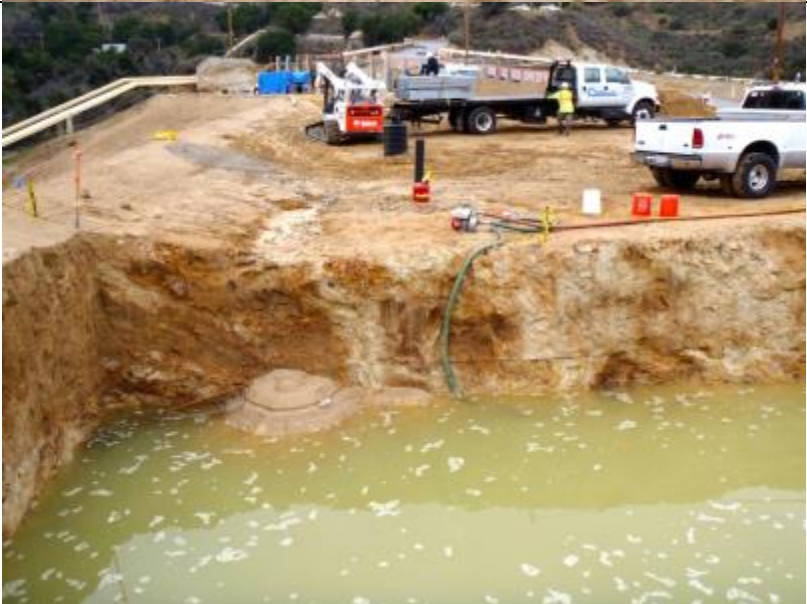
Pumping out the runoff rainwater that collected in the excavation – note there is no containment of the pump or the gas can.
12/16/14	New Admin/IM Building Site

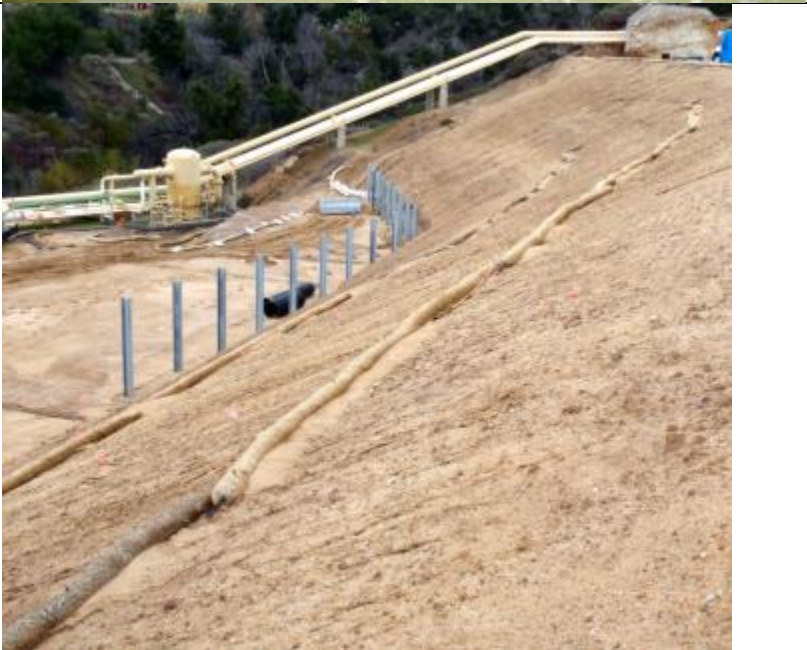
BMPs on the slopes needing maintenance.

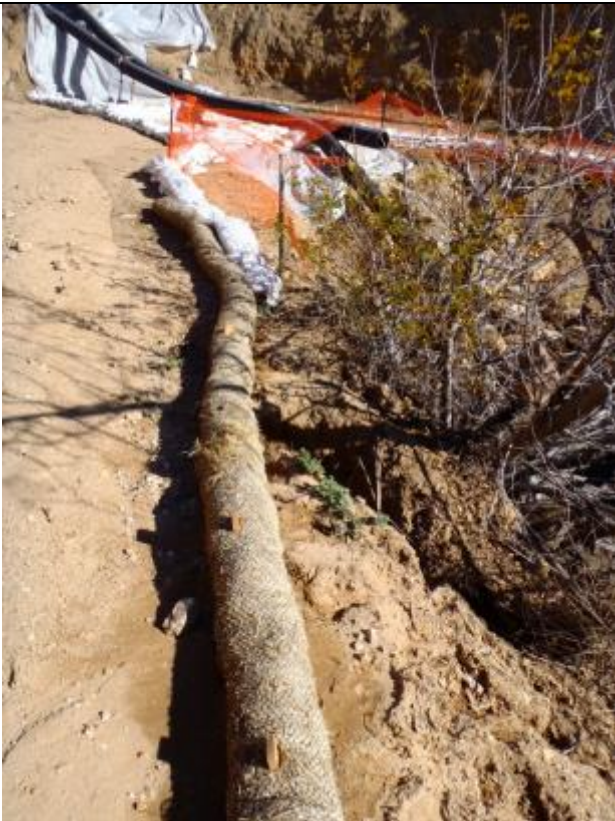
At PS-42, no work was being done. The BMPs needed some maintenance, including reestablishing the plastic sheeting below the fill key and some erosion prevention measures along the lower access road just before the diversion piping – see photos. The ends of the diversion piping have not been anchored yet. There are no storms predicted for the near future but crews should be ready to implement the needed repairs if rain is predicted.

<p>Some additional BMP work is needed along the access road below the PS-42 fill site. Water overtops the straw wattle seen in the photo and erodes the bank.</p>
12/23/14	PS-42 Fill Site – Diversion piping.

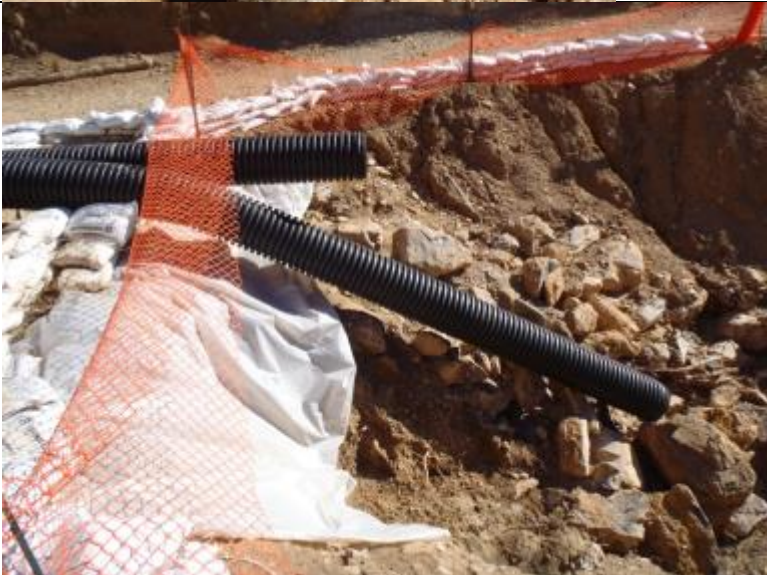
<p>Diversion piping has yet to be anchored.</p>

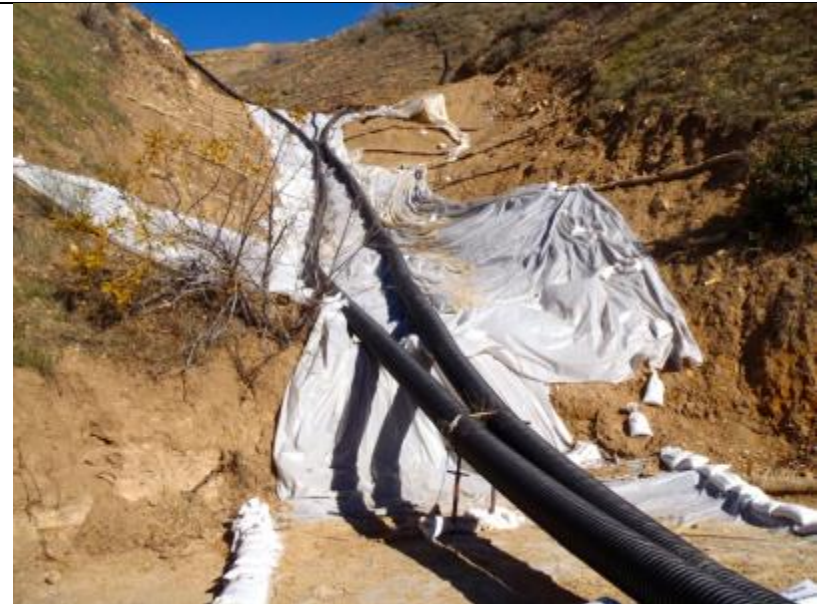
<p>Plastic sheeting installed below the fill key is in disrepair and needs some attention before the next storm system.</p>
<p>12/23/14</p>	<p>P-41 Fill Site</p>

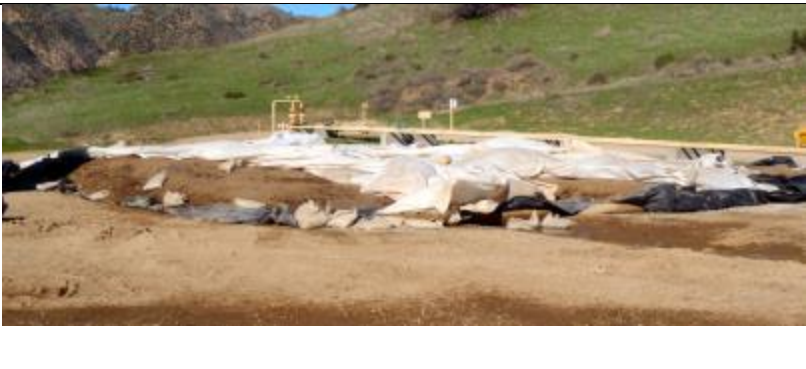
Topsoil stockpile near the TSP 45 site – note the plastic covering is coming off due to high winds.
