Re: Monthly Report Summary #9 for the Del Mar Reconfiguration (TL674A Reconfiguration and TL666D Removal) Project

CPUC Site Inspection Reports
September 9, 15, and 26, 2022

Del Mar Reconfiguration Project CPUC Site Inspection Form

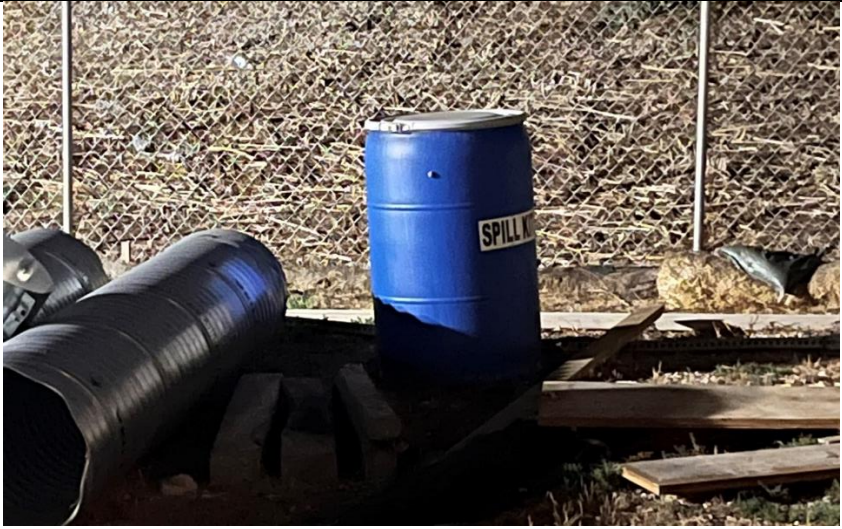
I arrived onsite at the Pumpkin Patch Yard at 2000 and met with the San Diego Gas and Electric (SDG&E) Environmental Inspector (EI). I attended the safety tailboard meetings and met with SDG&E Field Construction Advisor (FCA) to discuss the construction plans for the shift. I observed fully stocked spill kits within the Pumpkin Patch Yard (Photo 1) and observed drums with secondary containment in place, in compliance with on-site Storm Water Pollution Prevention Plan (SWPPP) (Photo 2).

Photo 1 – Fully stocked spill kit.
09/09/22	Pumpkin Patch Yard

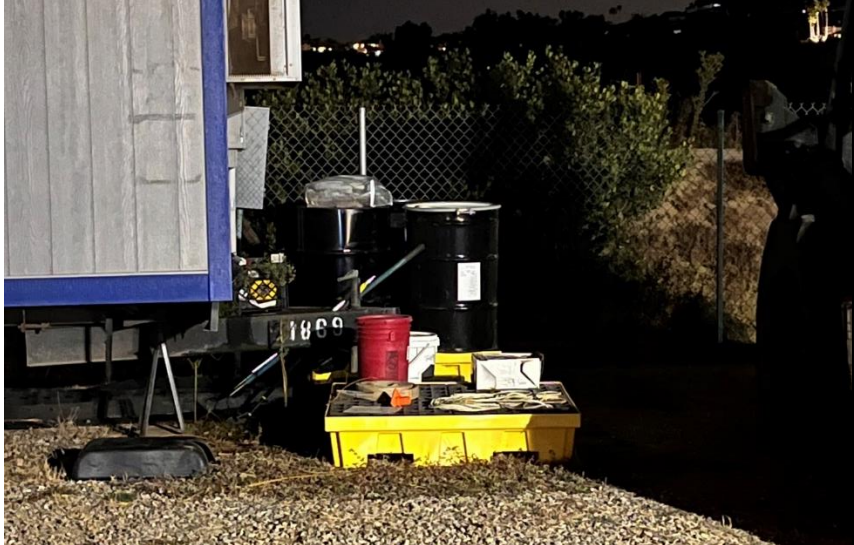
Photo 2 – Drums with secondary containment in place.

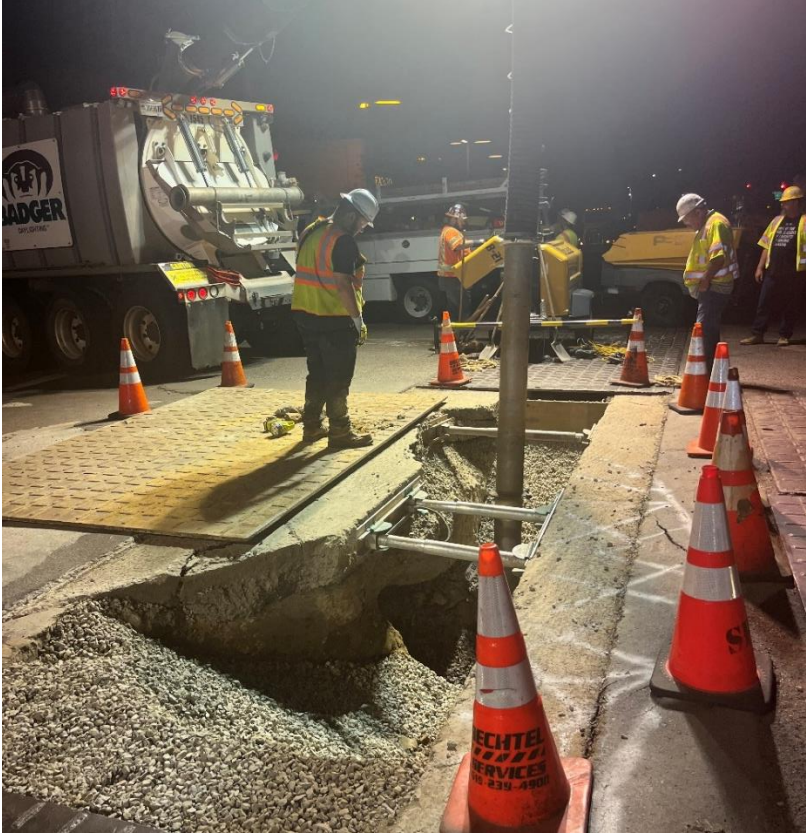
I drove to the work site along Via de la Valle near the intersection of Via de la Valle and Jimmy Durante Boulevard. Crews were cleaning out excavation using a vacuum truck to locate a sewer line (Photo 3).

Photo 3 – Clearing excavated material with a vacuum truck to locate a sewer line.

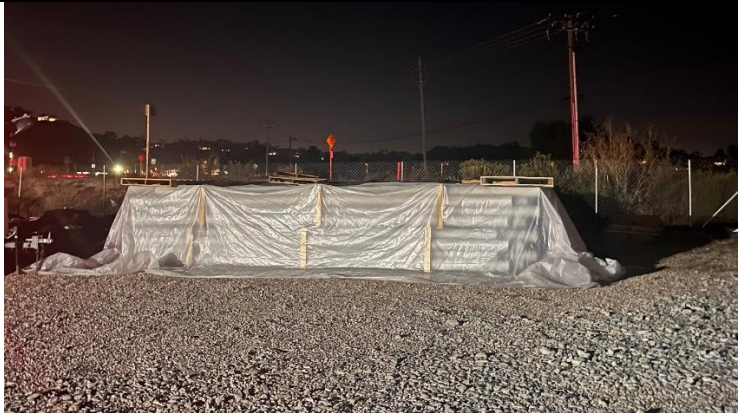
I arrived onsite at the Pumpkin Patch Yard at 2030 and met with San Diego Gas and Electric (SDG&E) Environmental Inspector (EI). I attended the safety tailboard meetings and met with SDG&E Field Construction Advisor (FCA) to discuss the construction plans for the shift. I observed organized conduit piping within the Pumpkin Patch Yard (Photo 1).

Photo 1 – Covered and organized piping in the Pumpkin Patch Yard.
09/15/22	TL6973 Reconfiguration – Via de la Valle

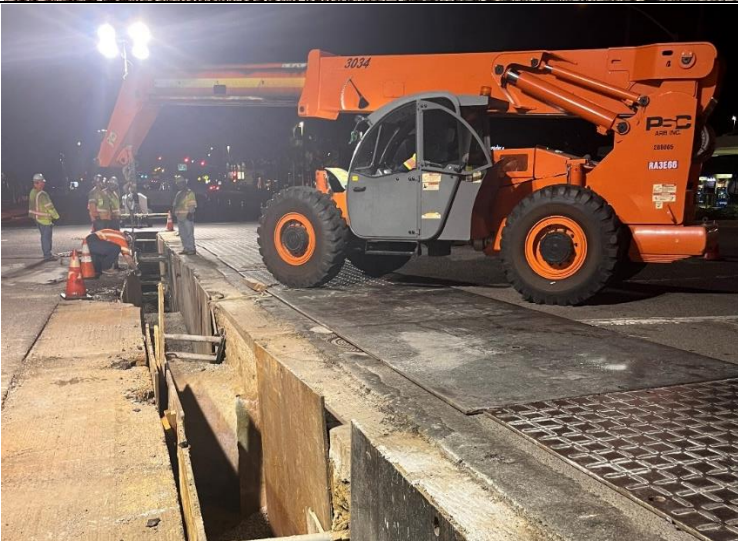
I drove to the work area along Via de la Valle near the intersection of Via de la Valle and Jimmy Durante Boulevard. Crews were installing shoring through loose material beneath the road (Photo 2). Another crew was hand digging to excavate around a known utility line (Photo 3). Traffic control was in place along Via de la Valle (Photo 4).

Photo 2 – Installation of shoring along Via de la Valle.
09/15/22	TL6973 Reconfiguration – Via de la Valle

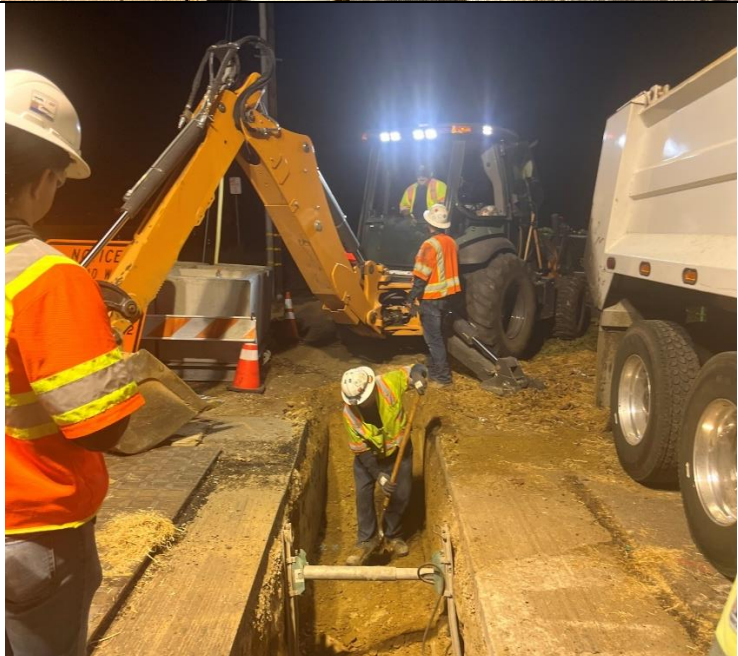
Photo 3 – Hand-digging excavation to clear an identified utility line.

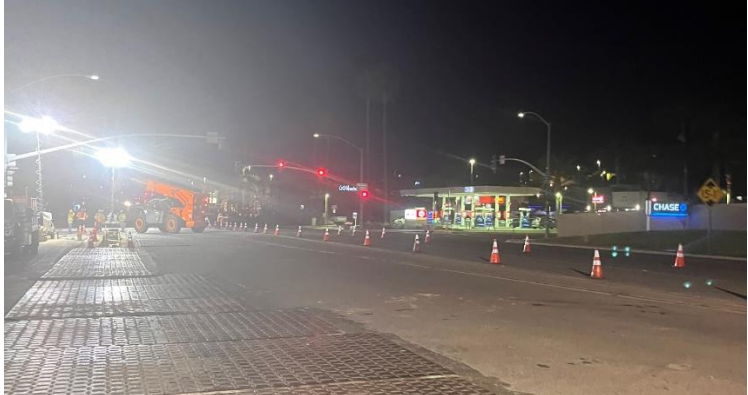
Photo 4 – Traffic control along Via de la Valle.

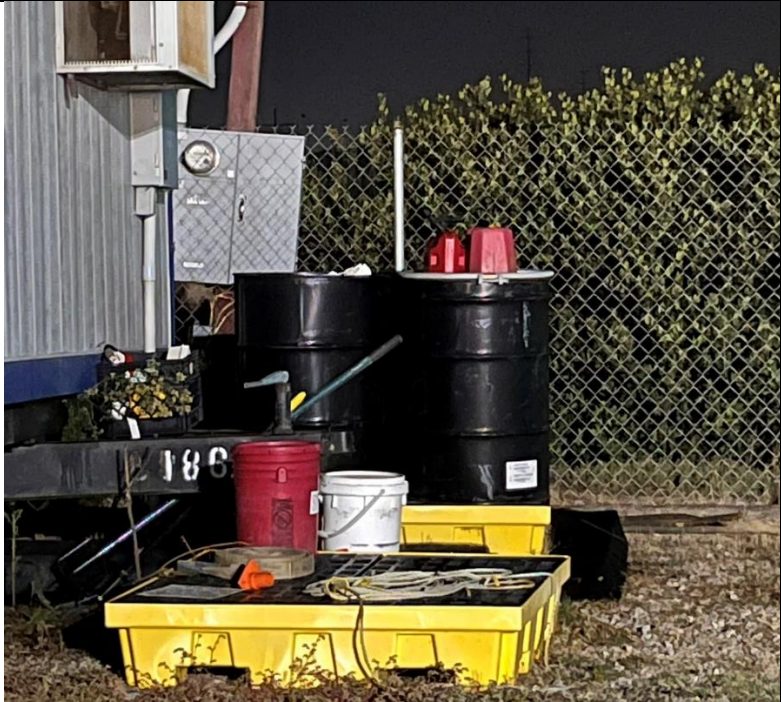
I arrived onsite at the project's Pumpkin Patch Yard at 2030 and met with San Diego Gas and Electric (SDG&E) Environmental Inspector (EI). I attended the safety tailboard meetings and met with the SDG&E Field Construction Advisor (FCA) to discuss the construction plans for the shift. I observed closed and labeled drums on spill pallets within the Pumpkin Patch Yard (Photo 1).

Photo 1 – Closed and labeled drums on spill pallets in the Pumpkin Patch Yard.
09/26/22	TL6973 Reconfiguration – Via de la Valle

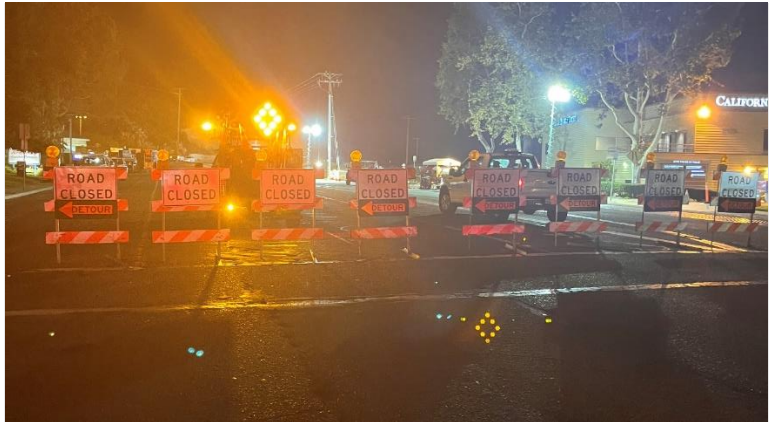
Photo 2 – Traffic control along Via de la Valle.

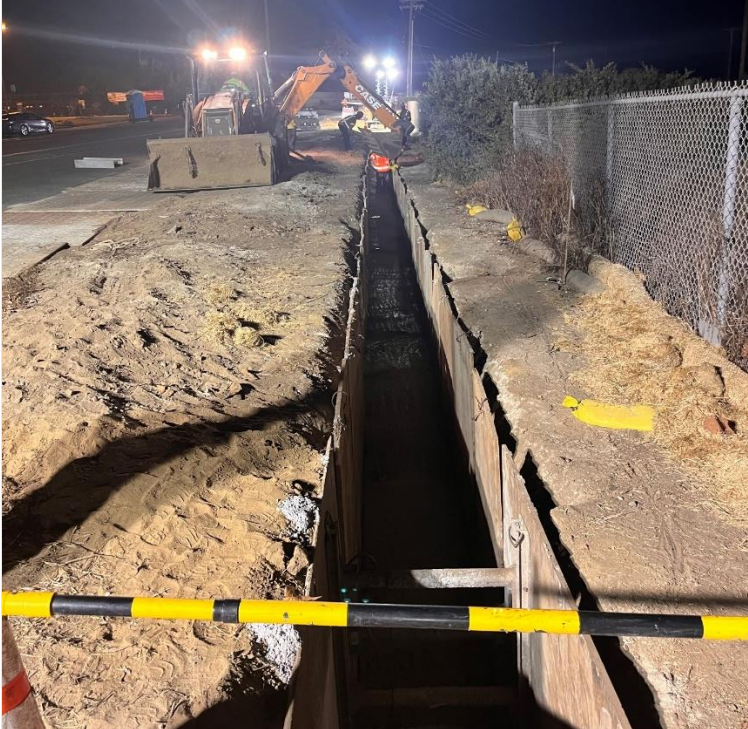
Photo 3 – Installation of shoring along Via de la Valle.
09/26/22	TL6973 Reconfiguration – Via de la Valle

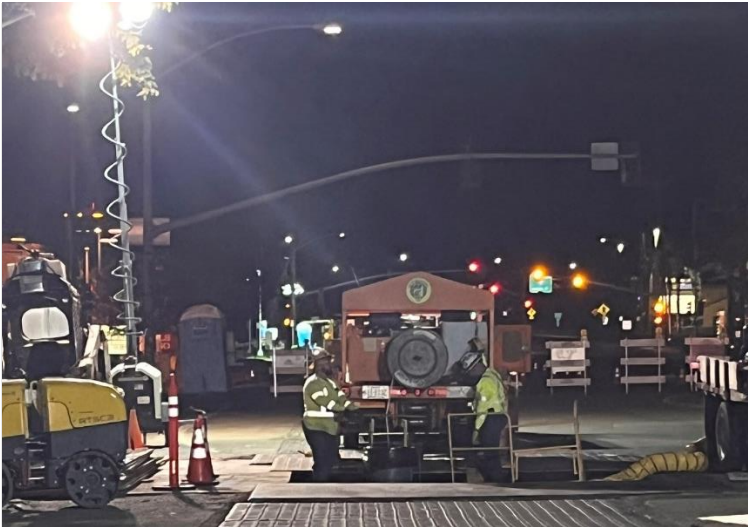
Photo 4 – Crews pulling wire through existing conduit and vault.
