Re: Monthly Report Summary #5 for the Del Mar Reconfiguration (TL674A Reconfiguration and TL666D Removal) Project

CPUC Site Inspection Reports
May 4, 11, 16, and 31, 2022

Del Mar Reconfiguration Project CPUC Site Inspection Form

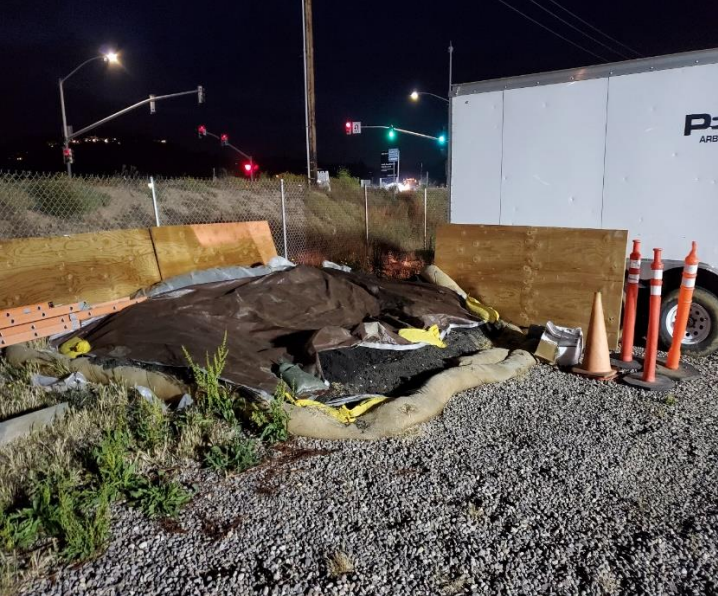
I arrived at the Pumpkin Patch Yard at 1600 and attended the safety tailboard meetings. I met with the San Diego Gas & Electric (SDG&E) Field Construction Advisor (FCA) and discussed the construction plans for the shift. I observed materials stored in the Pumpkin Patch Yard in compliance with the Spill Prevention, Control, and Countermeasure (SPCC) and Storm Water Pollution Prevention Plan (SWPPP) (Photo 1).

Photo 1 – Cold patch material stored in the Pumpkin Patch Yard with BMPs in place to prevent stormwater runoff.
05/04/22	TL674A Reconfiguration – Via de la Valle

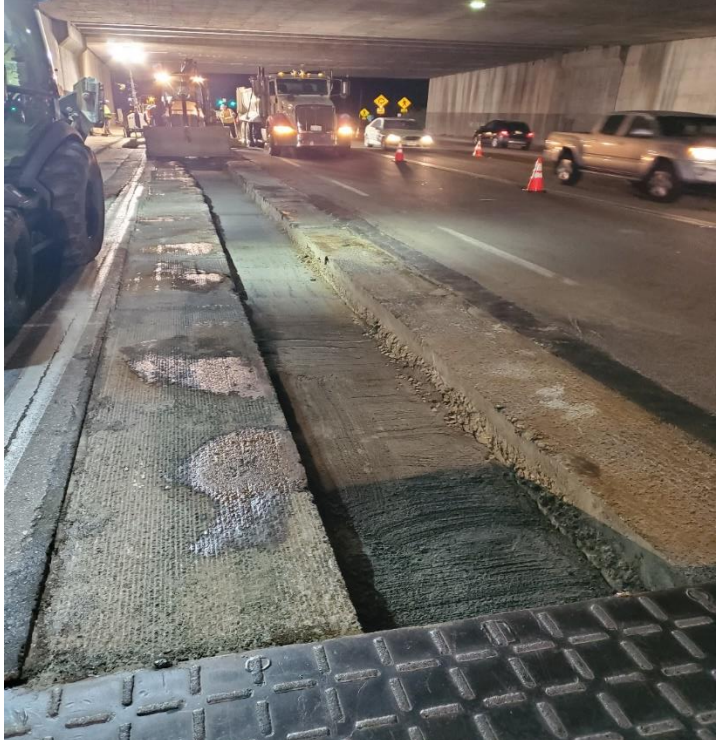
I observed crew removing steel plates from trenches that were then backfilled with concrete (Photo 2).

Photo 2 – Crews removed steel plates from the top of the trench and then backfilled with concrete. Photo facing west.

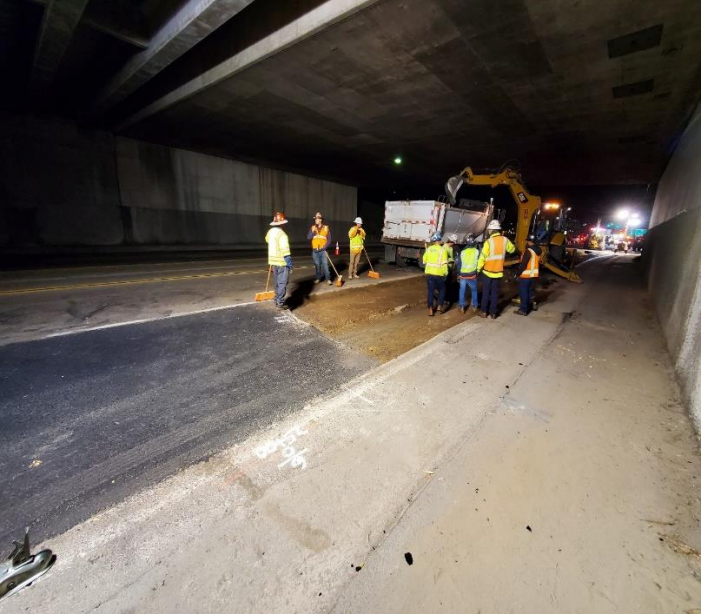
Crews were preparing the side of the trench for new asphalt pouring (Photo 3).

Photo 3 – Crews preparing to pour asphalt in the trench. Photo facing east.

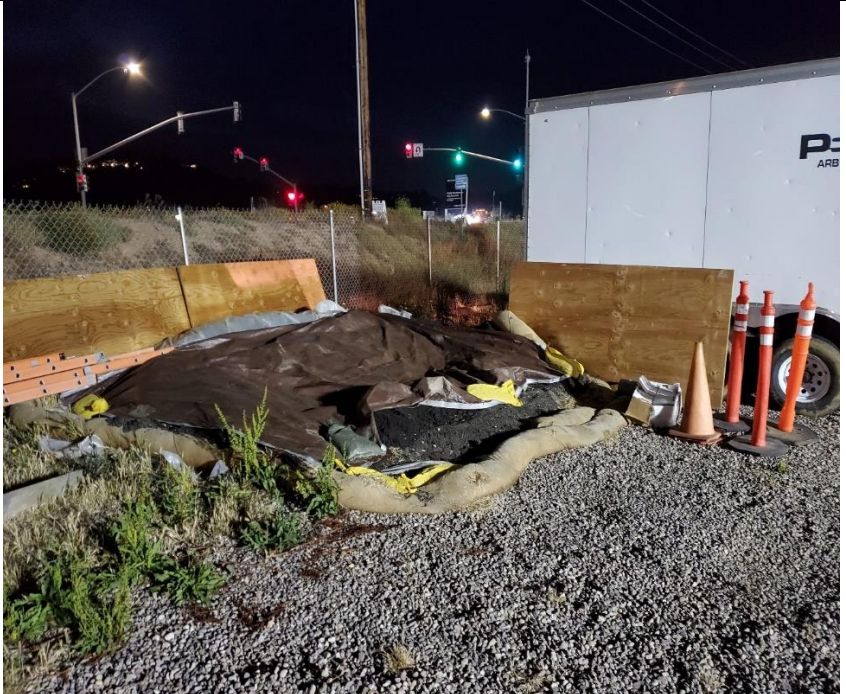
I arrived at the Pumpkin Patch Yard at 1600 and attended the safety tailboard meetings. I met with the San Diego Gas & Electric (SDG&E) Field Construction Advisor (FCA) and discussed the construction plans for the shift. I observed materials stored in the Pumpkin Patch Yard in compliance with Spill Prevention, Control, and Countermeasure (SPCC) and Storm Water Pollution Prevention Plan (SWPPP) (Photo 1).

Photo 1 – Cold patch material was stored in the Pumpkin Patch Yard with BMPs in place to prevent stormwater runoff.

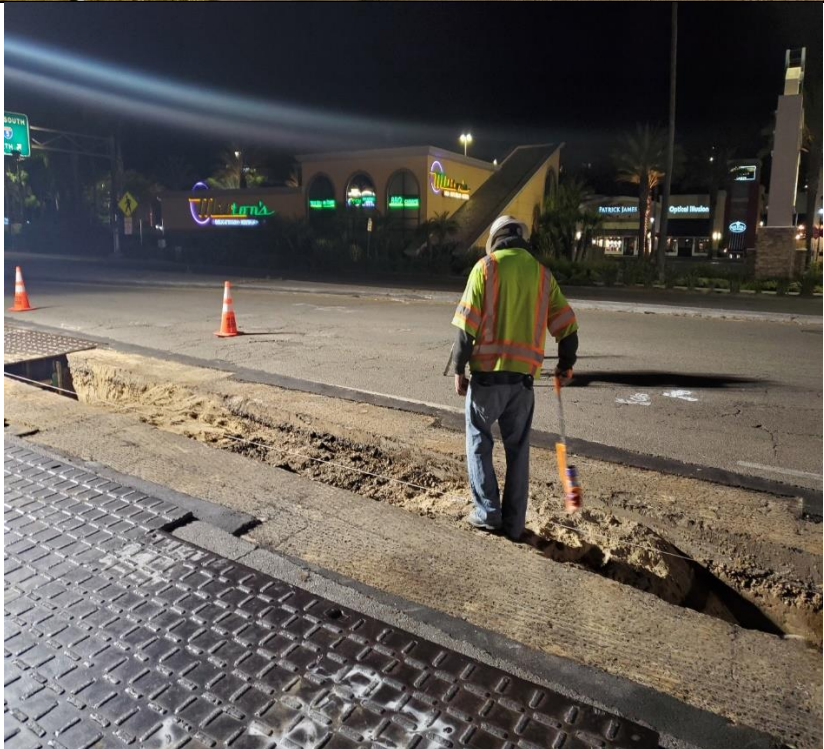
I observed crews removing steel plates from the tops of trenches (Photo 2). Crews found a telephone cable in the trench and prepared to relocate the trench about a foot north of Via de la Valle (Photo 3).

Photo 3 – Crews were marking the asphalt cut location where the new trench would be excavated. Photo facing north.

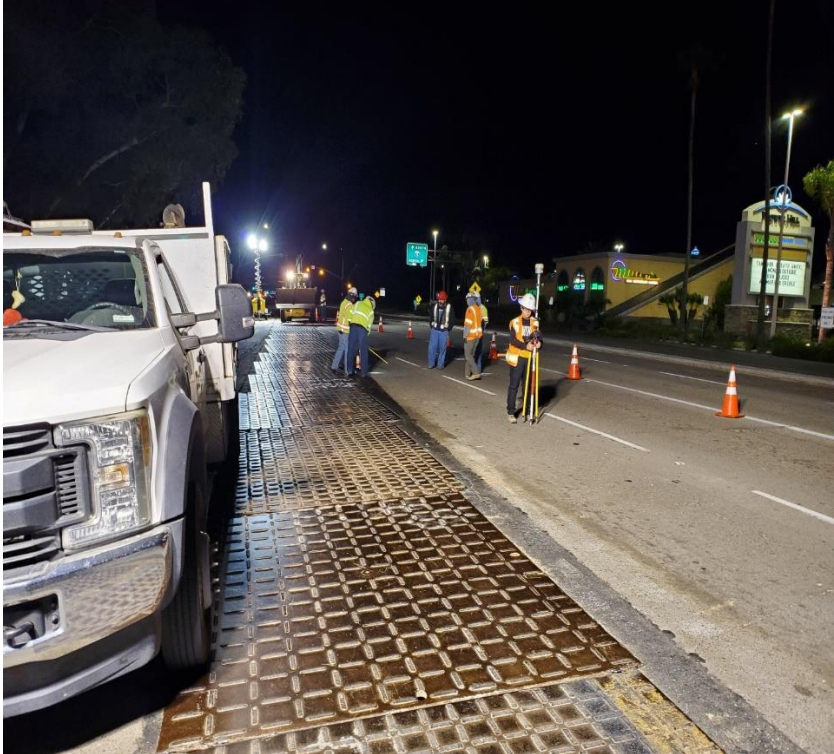
An NV5 crew was present onsite to perform surveying for the new trench location (Photo 4).

Photo 4 – NV5 crew surveying the area for the new trench. Photo facing west.
05/11/22	TL674A Reconfiguration – Via de la Valle

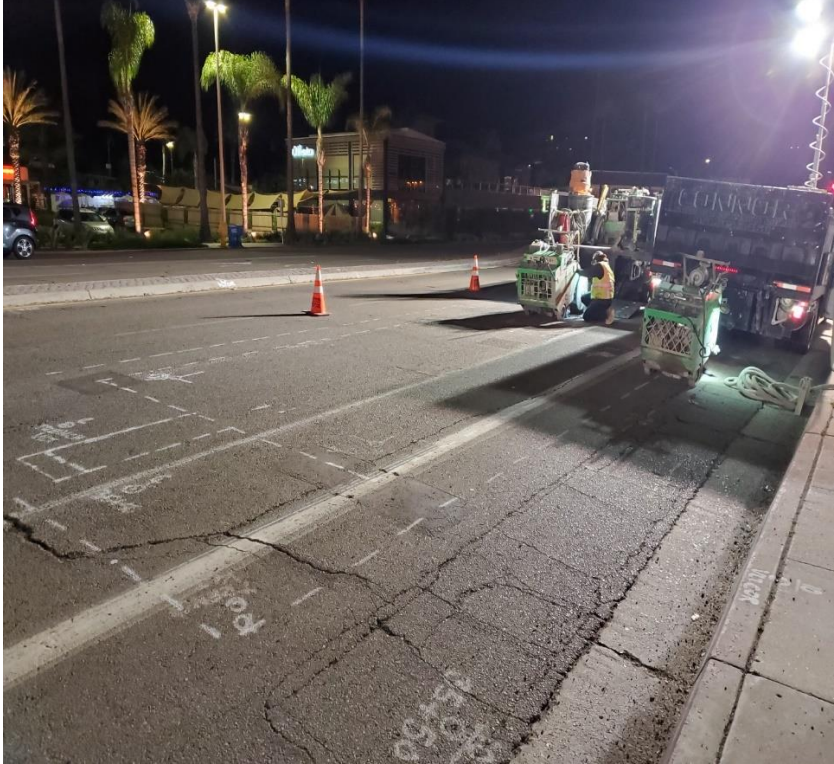
Connor Concrete was onsite and prepared to cut the asphalt for the new trench (Photo 5).

Photo 5 – A Connor Concrete cutting crew was preparing to cut asphalt for the new trench. Photo facing east.

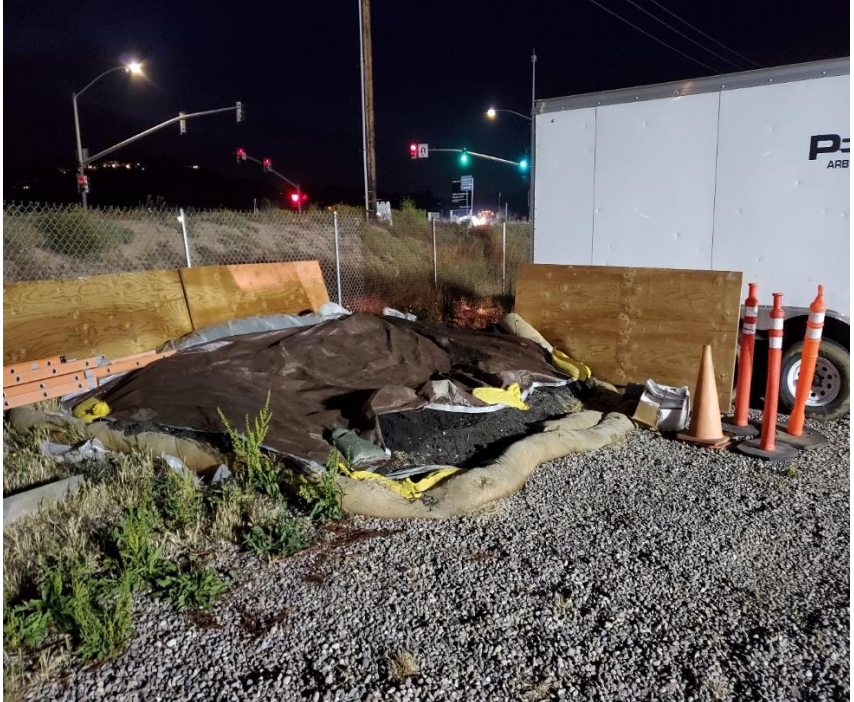
I arrived at the Pumpkin Patch Yard at 1600 and attended the safety tailboard meetings. I met with the San Diego Gas & Electric (SDG&E) Field Construction Advisor (FCA) and discussed the construction plans for the shift. I observed materials stored in the Pumpkin Patch Yard in compliance with Spill Prevention, Control, and Countermeasure (SPCC) and Storm Water Pollution Prevention Plan (SWPPP) (Photo 1).

Photo 1 – Cold patch material stored in the Pumpkin Patch Yard with BMPs in place to prevent stormwater runoff. Photo facing north.

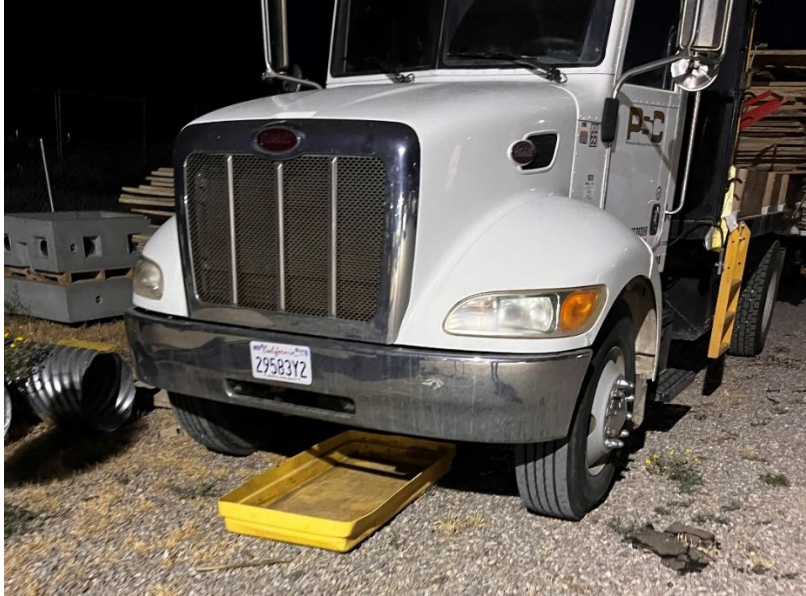
Photo 1 – Secondary containment placed underneath a parked truck in the Pumpkin Patch Yard.
05/31/22	TL674A Reconfiguration – Via de la Valle

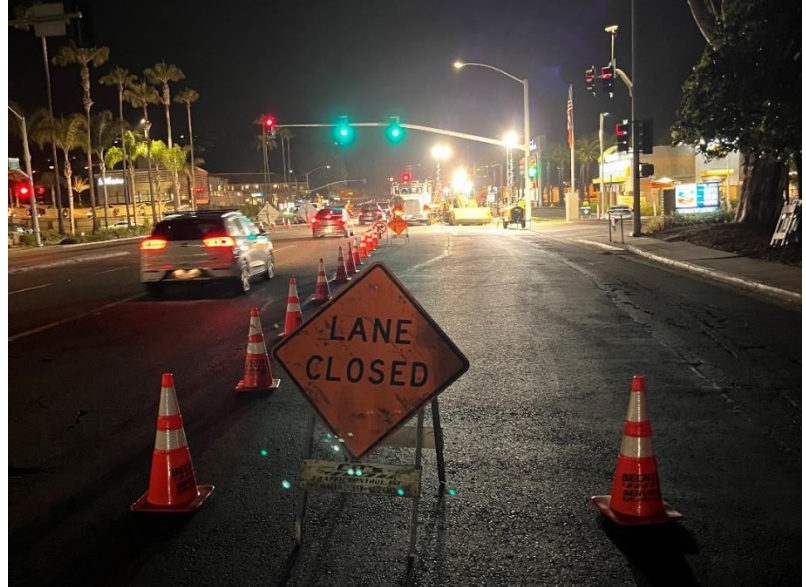
Photo 2 – Traffic Control along Via de la Valle.

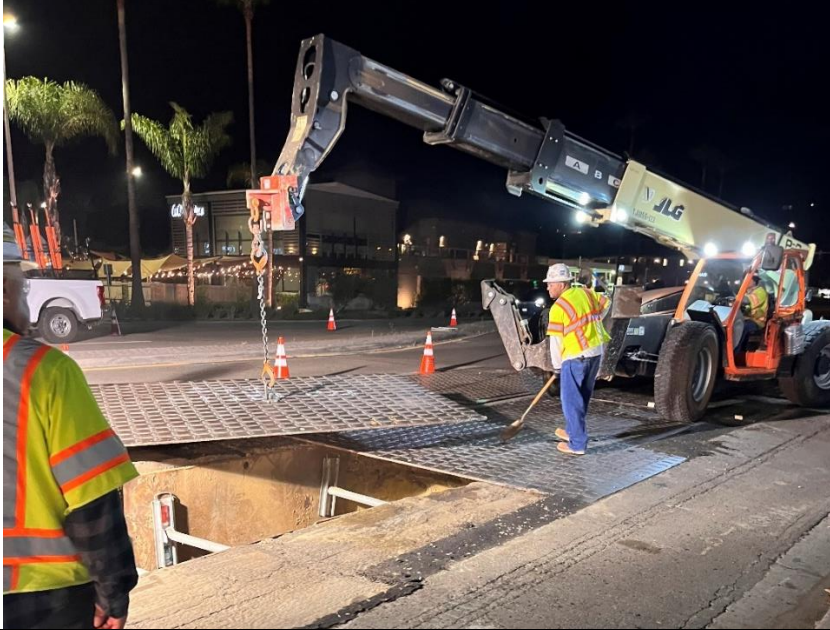
Photo 3 – Removal of steel plates along Via de la Valle.
05/31/22	TL674A Reconfiguration – Via de la Valle

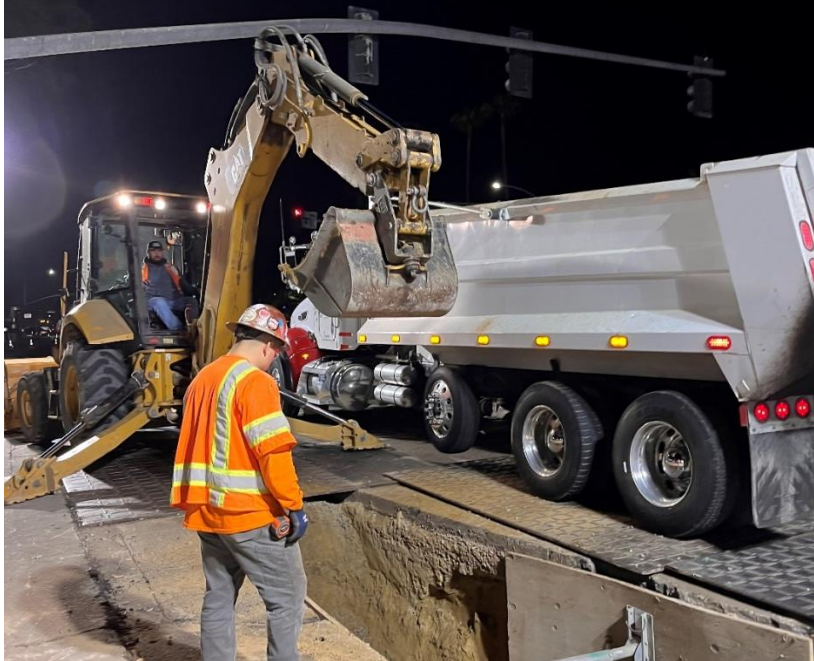
Photo 4 – Excavation of trenches along Via de la Valle.
