Re: Monthly Report Summary #6 for the Del Mar Reconfiguration (TL674A Reconfiguration and TL666D Removal) Project

CPUC Site Inspection Reports
June 7 and 16, 2022

Del Mar Reconfiguration Project CPUC Site Inspection Form

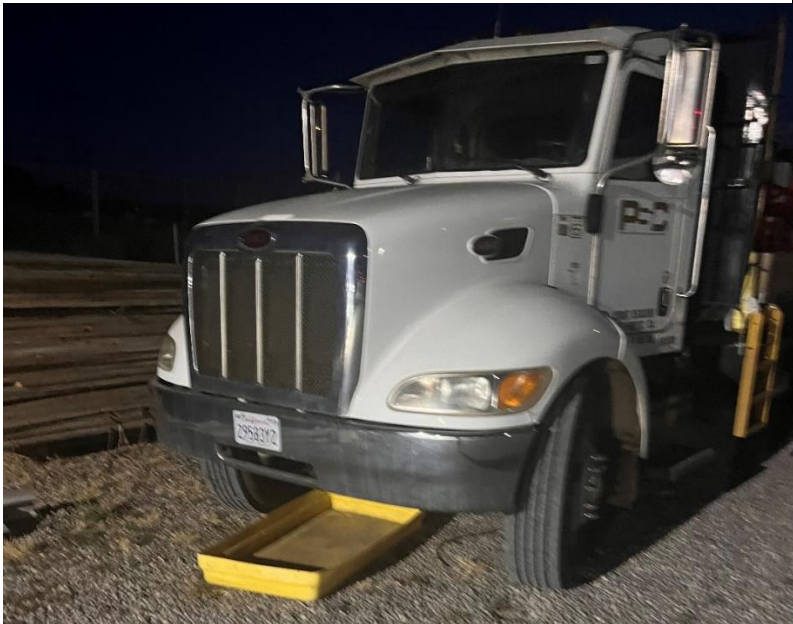
I arrived onsite at the Pumpkin Patch Yard at 1600. I attended the safety tailboard meetings and met with the San Diego Gas & Electric (SDG&E) Field Construction Advisor (FCA) where we discussed the construction plans for the shift. I observed drip pans placed underneath all parked equipment (Photo 1) and hazardous materials were stored with adequate secondary containment (Photo 2) stored in compliance with Spill Prevention, Control, and Countermeasure (SPCC) and Storm Water Pollution Prevention Plan (SWPPP).

Photo 1 – Drip pans placed underneath parked equipment in the Pumpkin Patch Yard.
06/07/22	Pumpkin Patch Yard

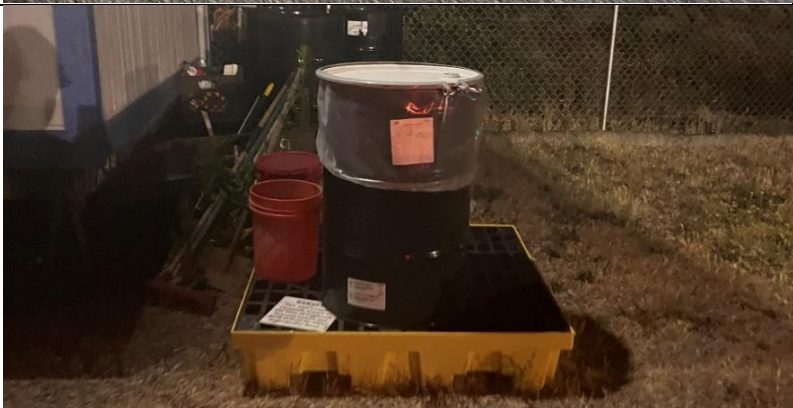
Photo 2 – Hazardous materials in secondary containment in the Pumpkin Patch Yard.

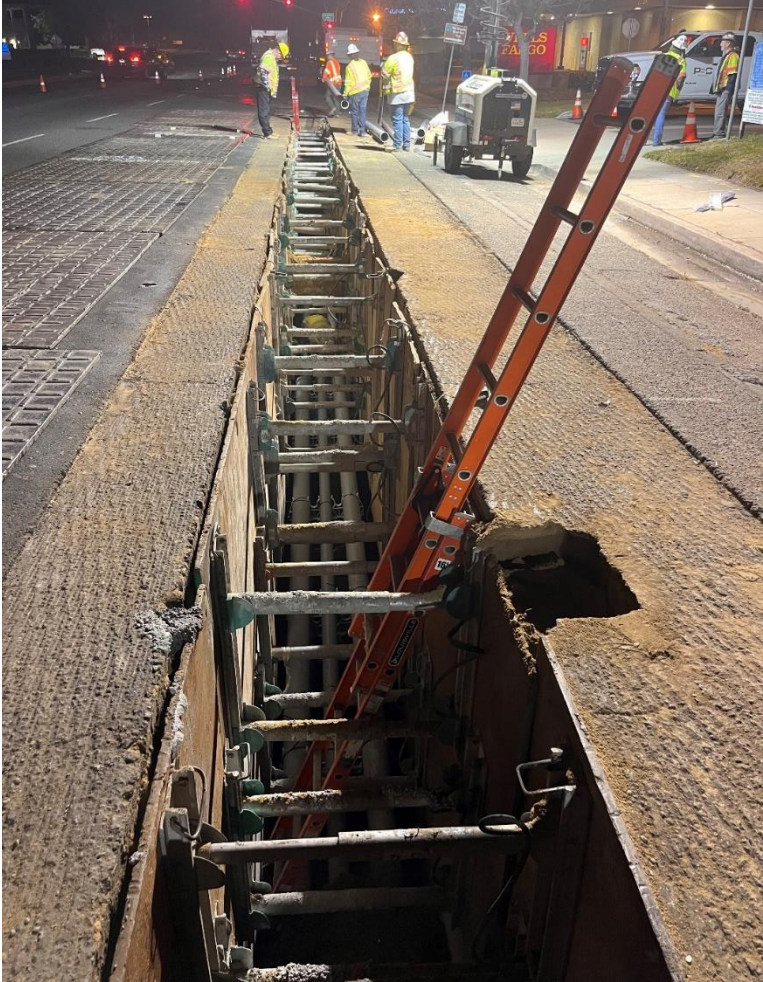
I drove to the Via de La Valle project area where crews were installing conduit in an open trench (Photo 3). Later in the shift, a concrete delivery arrived and was poured into the open trench (Photo 4).

Photo 3 – Conduit being placed in the open trench along Via de La Valle. Traffic control was in place along the road.
06/07/22	TL674A Reconfiguration – Via de la Valle

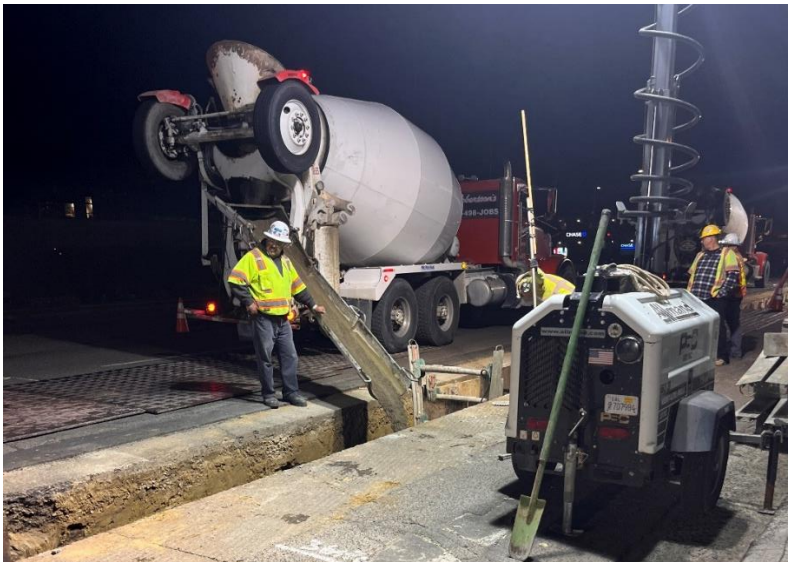
Photo 4 – Concrete slurry being poured into an open trench along Via de La Valle.

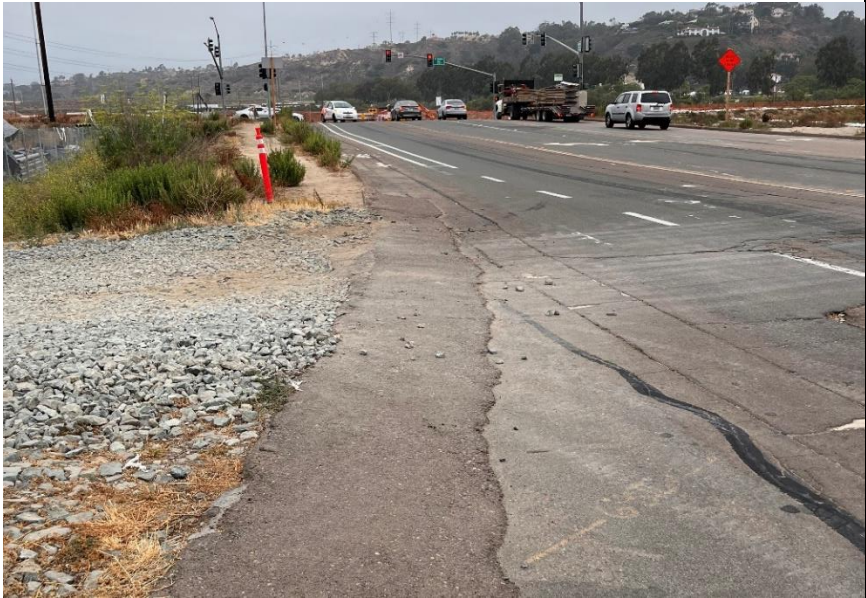
- Track out from crushed SWPPP rock was observed at the exit of the Pumpkin Patch Yard leading onto San Dieguito Road. Onsite compliance managers have recommended the track out be cleaned up; no action has been reported.

I arrived onsite to the Pumpkin Patch Yard at 0730. I met with the San Diego Gas & Electric (SDG&E) Field Construction Advisor (FCA) and we discussed the construction plans for the shift. I observed track out from equipment leaving the yard onto San Dieguito Road (Photo 1). A covered dumpster was onsite and in compliance with the Construction General Permit and Storm Water Pollution Prevention Plan (SWPPP) (Photo 2).

Photo 1 – Track out from the Pumpkin Patch Yard.
06/16/22	Pumpkin Patch Yard	 	Photo 2 – A covered dumpster in the staging yard in compliance with SWPPP.

Inspect the Pumpkin Patch Yard for track out to measure entrance improvement effectiveness.

Improve SWPPP at the project entrance area to prevent track out from Pumpkin Patch Yard.
