**Re: Monthly Report Summary #7 for the Del Mar Reconfiguration (TL674A Reconfiguration and TL666D Removal) Project**

CPUC Site Inspection Reports  
July 6, 11, 20 and 27, 2022

## Del Mar Reconfiguration Project CPUC Site Inspection Form

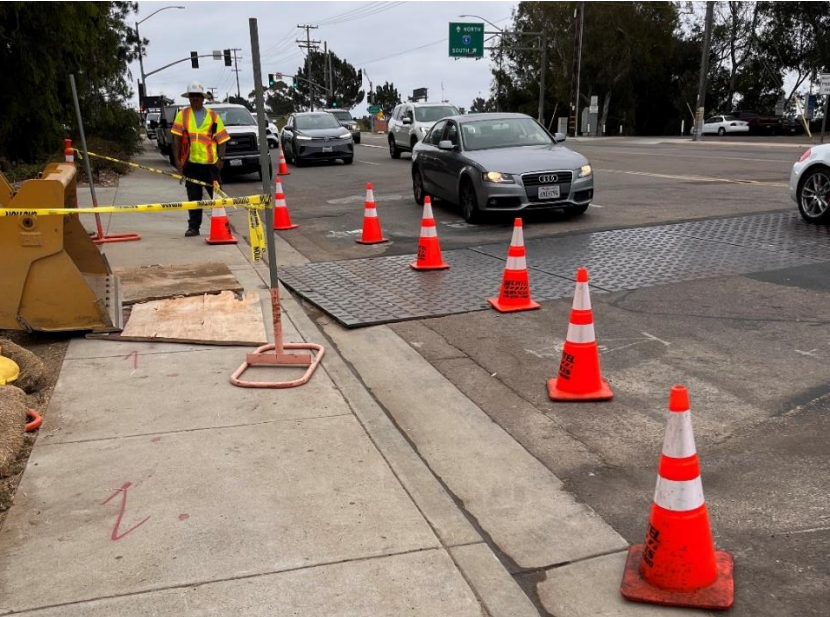
I arrived onsite at the TL6973 Underground Alignment substation location at 1600. I observed trenching activities in combination with watering to minimize dust (Photo 1). A loader was observed onsite grading moist fill (Photo 2). Trenching activities required an excavator to creep onto the sidewalk so crew implemented a walk-around protocol (Photo 3).

Photo 3 – Walking detour due to an excavator being parked on the sidewalk.
07/06/22	Pumpkin Patch Yard

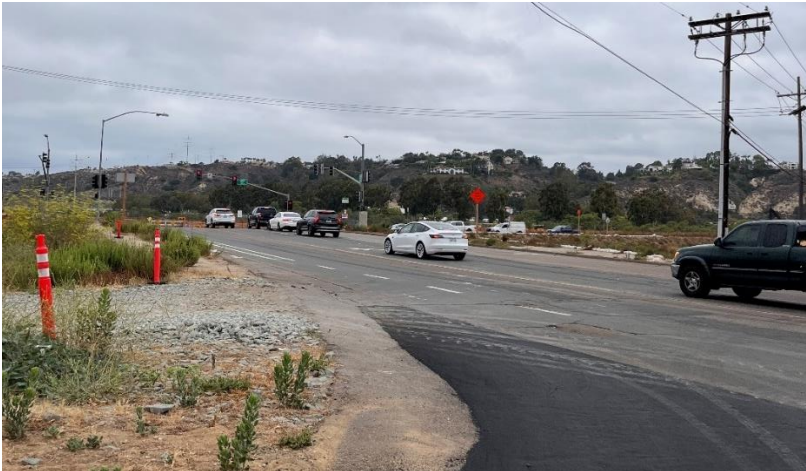
- Track out from crushed SWPPP rock was observed at the exit of the Pumpkin Patch Yard leading onto San Dieguito Road. Onsite compliance managers have recommended the track out be cleaned up; no action has been reported.

I drove to the Pumpkin Patch Yard where a covered roll-off bin was observed in accordance with the Storm Water Pollution Prevention Plan (SWPPP) (Photo 4). Track out was observed leaving the Pumpkin Patch Yard and resulted from the broken SWPPP rock at the entrance (Photo 5).

Photo 5 – Track out was observed from the Pumpkin Patch Yard.

Track out from the Pumpkin Patch Yard should be cleaned and the entrance requires maintenance to prevent continued compaction.

Improve SWPPP at the project entrance area to prevent track out from Pumpkin Patch Yard.

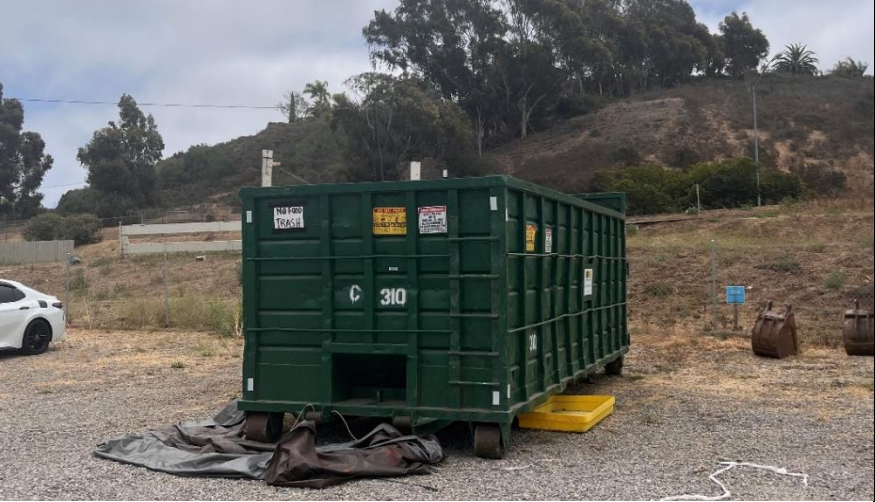
I arrived onsite at the Pumpkin Patch Yard at 1200. I observed drums on spill pallets contained in compliance with the Storm Water Pollution Prevention Plan (SWPPP) (Photo 1). The roll-off bin was uncovered during the inspection when not in use (Photo 2). Continued track out was observed from the Pumpkin Patch Yard that resulted from crushed SWPPP rock at the exit (Photo 3).

Photo 2 – Uncovered roll-off bin not in use.
07/11/22	Pumpkin Patch Yard

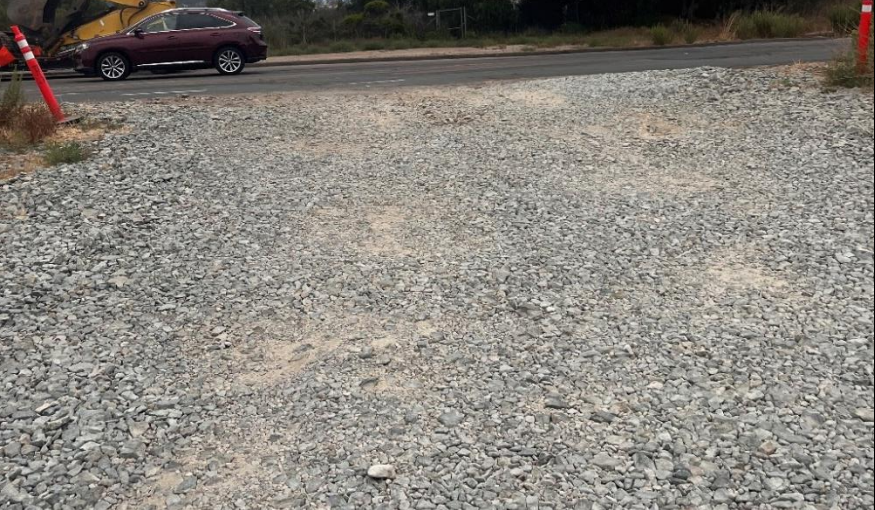
Photo 3 – Crushed SWPPP rock was the source of track out from the Pumpkin Patch Yard.

Track out from the Pumpkin Patch Yard should be cleaned and the entrance requires maintenance to prevent continued compaction.

Improve SWPPP at the project entrance area to prevent track out from Pumpkin Patch Yard.

Sweep the Pumpkin Patch Yard entrance prior to the next inspection.

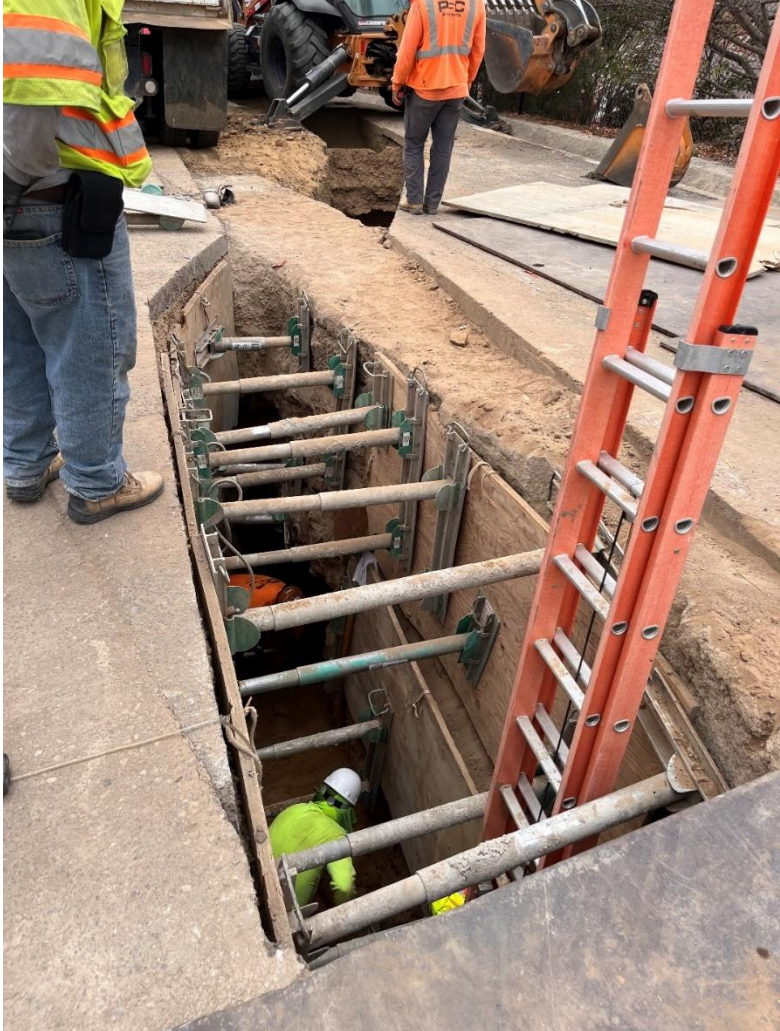
I drove to the TL6973 Underground Alignment substation location where trenching was observed beneath conduit. Three workers were manually excavating the trench to reach where the excavator could not (Photo 4). Continued grading was observed within the work area (Photo 5).

Photo 4 – Manual trenching beneath conduit.

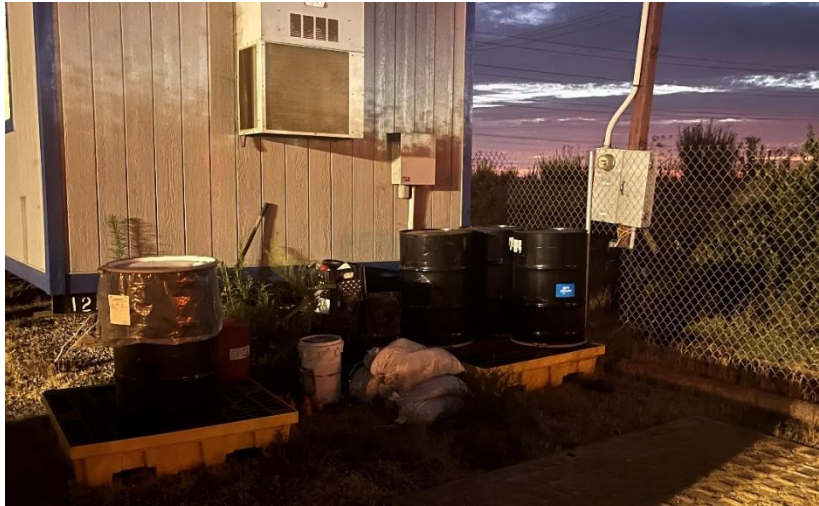
I arrived onsite at the Pumpkin Patch Yard at 1600 to attend the tailgate safety meeting. I observed drums on spill pallets contained in compliance with the Storm Water Pollution Prevention Plan (SWPPP) (Photo 1).

Photo 1 – Drums on spill pallets in compliance with SWPPP.
07/20/22	TL6973 Underground Alignment

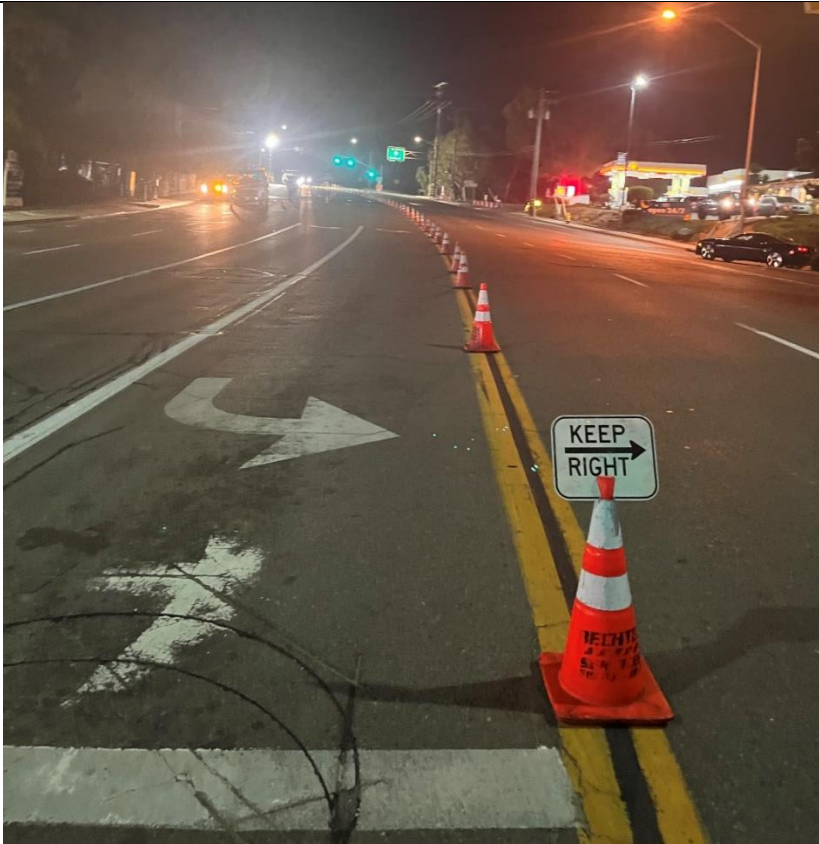
I drove to the TL6973 Underground Alignment substation location to observe traffic control in place (Photo 2). Continued grading was observed within the work area (Photo 3).

Photo 2 – Traffic control in place along Via de La Valle.

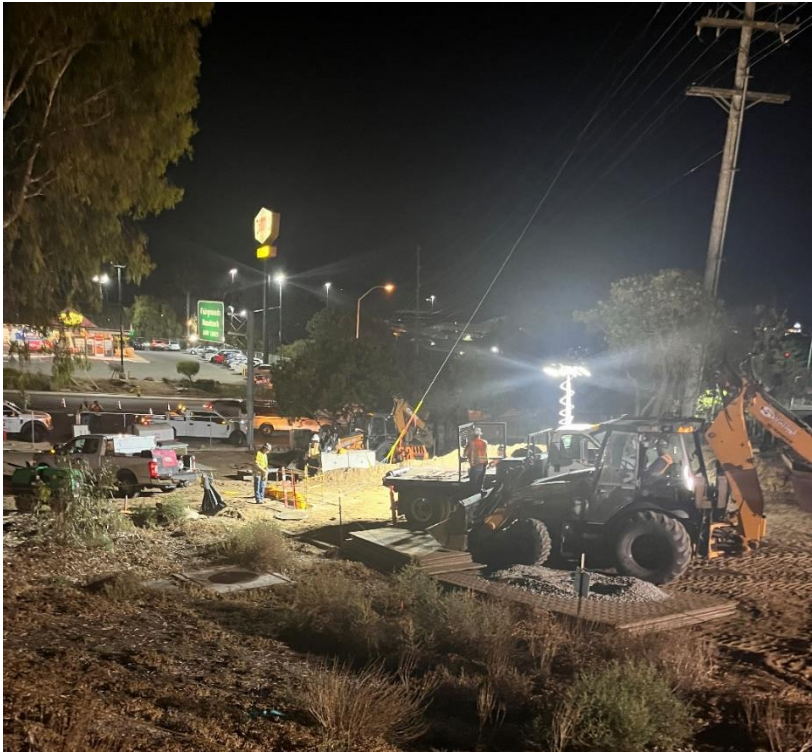
Photo 3 – Grading and vault cleaning activities were observed.

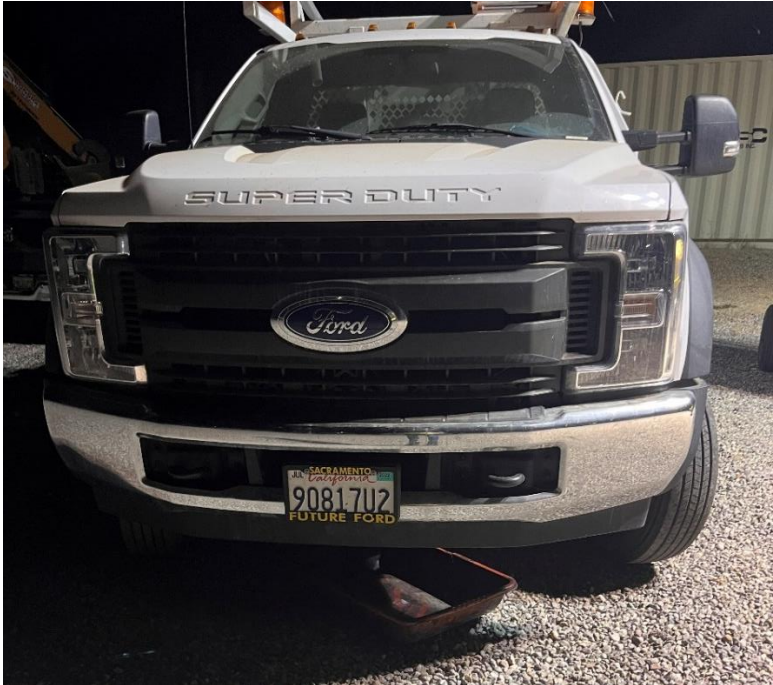
I arrived onsite at the Pumpkin Patch Yard at 1600 to attend the safety tailboard meeting. I observed a parked vehicle with secondary containment in place and a roll-off bin covered (Photos 1 and 2).

Photo 1 – A vehicle was parked over a drip pan in compliance with the SWPPP.
07/27/22	Pumpkin Patch Yard

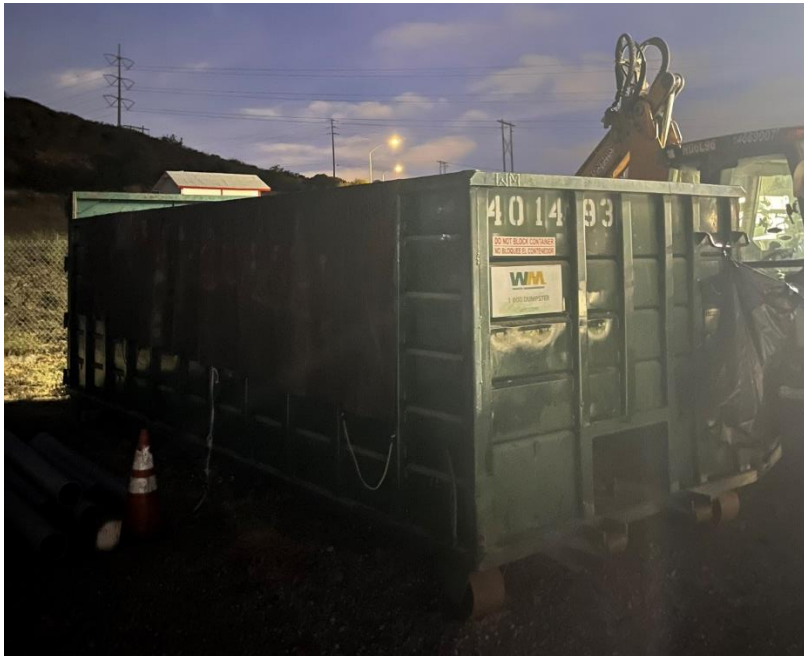
Photo 2 – A covered dumpster onsite.

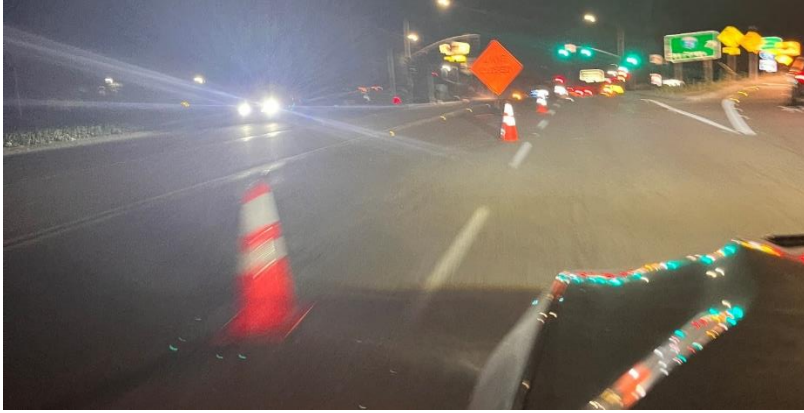
I drove to the TL674A Reconfiguration location on Via de la Valle to observe traffic control in place (Photo 3). Operations were normal.

Photo 3 – Traffic control along Via de La Valle.
