**Re: Monthly Report Summary #8 for the Del Mar Reconfiguration (TL674A Reconfiguration and TL666D Removal) Project**

CPUC Site Inspection Reports  
August 10, 15, 23 and 29, 2022

## Del Mar Reconfiguration Project CPUC Site Inspection Form

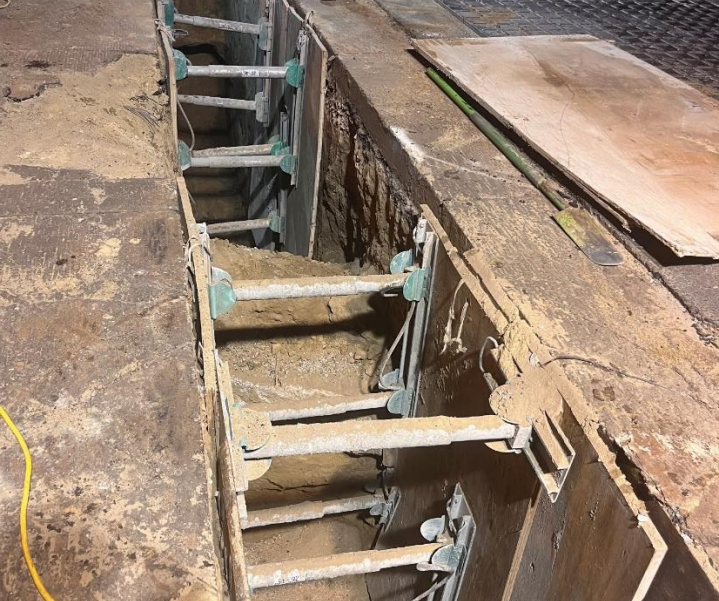
I drove to the TL6973 Reconfiguration – Via de la Valle location to observe traffic control in place (Photo 2). Active trenching and excavating (Photo 3) were occurring to install shoring and bracing (Photo 4).

Photo 4 – Shoring installed in the excavation trench.

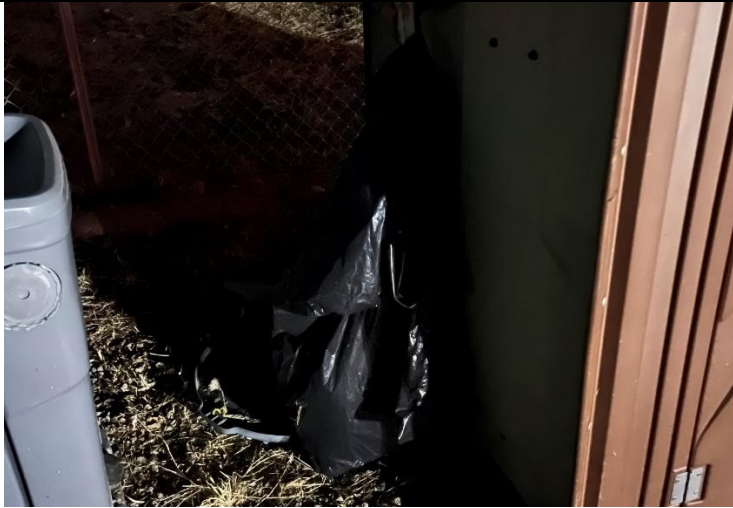
I arrived onsite at the project's Pumpkin Patch Yard at 2000 and met with the San Diego Gas and Electric (SDG&E) Environmental Inspector (EI). I attended the safety tailboard meetings and met with SDG&E Field Construction Advisor (FCA) and discussed the construction plans for the shift. I observed an uncovered trash collection area (Photo 1) and covered stockpiles (Photo 2).

Photo 1 – An uncovered trash collection area.
08/15/22	TL6973 Reconfiguration – Via de la Valle

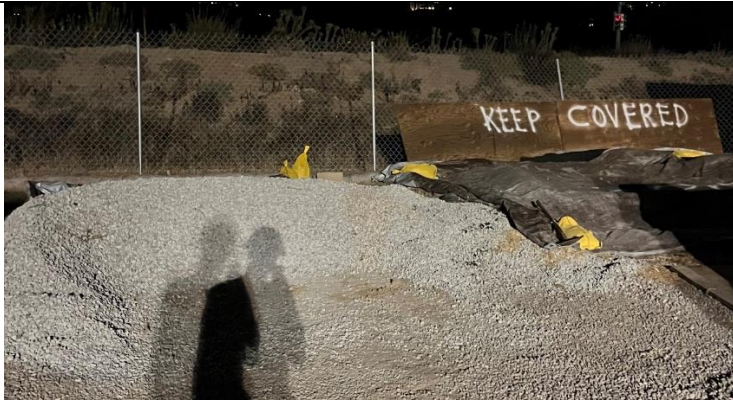
Photo 2 – Covered and uncovered stockpiles.
08/15/22	TL6973 Reconfiguration – Via de la Valle

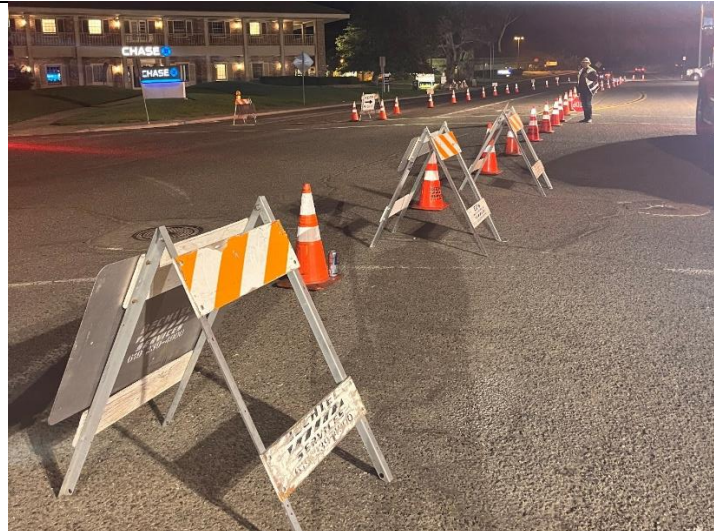
Photo 3 – Traffic control along Via de la Valle.

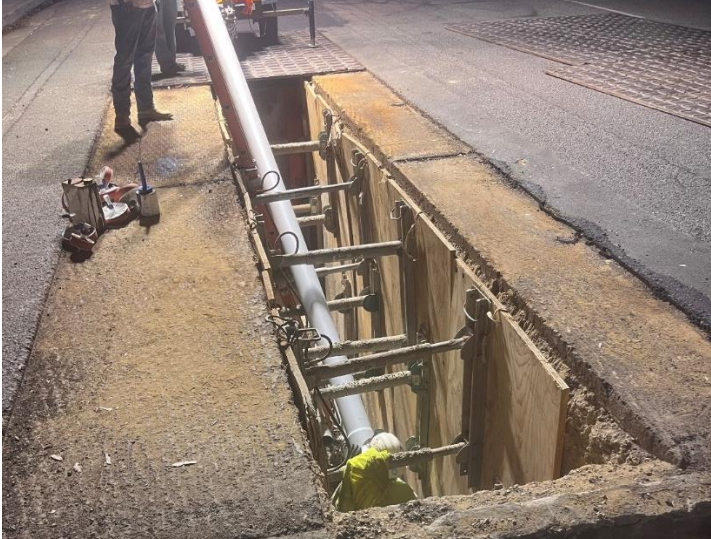
Photo 4 – Shoring installed in the excavation trench.
08/15/22	TL6973 Reconfiguration – Via de la Valle

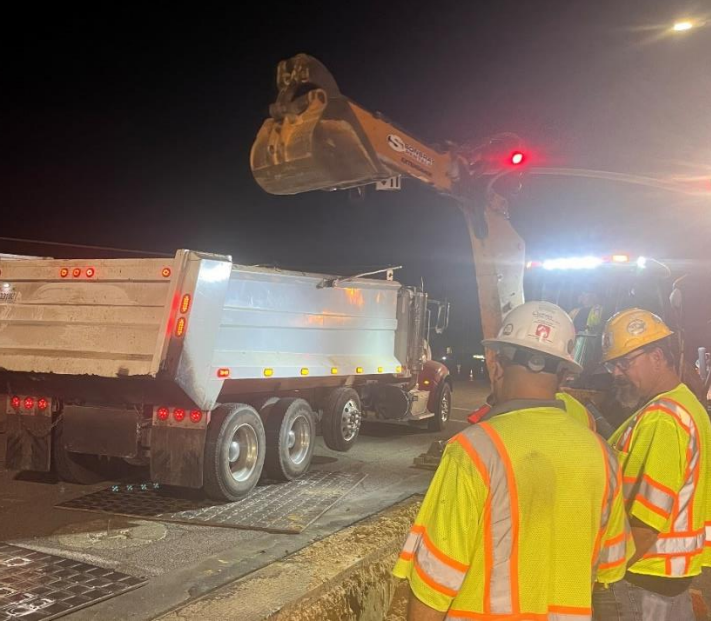
Photo 5 – Trenching along Via de la Valle.

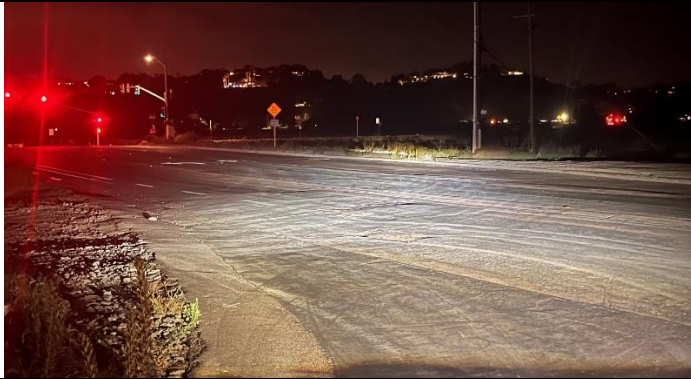
I arrived onsite at the project's Pumpkin Patch Yard at 2000 and met with the San Diego Gas and Electric (SDG&E) Environmental Inspector (EI). I attended the safety tailboard meetings and met with the SDG&E Field Construction Advisor (FCA) and discussed the construction plans for the shift. I observed trackout at the egress of the Pumpkin Patch Yard (Photo 1).

Photo 1 – Trackout observed at the entrance to the site.
08/23/22	TL6973 Reconfiguration – Via de la Valle

Clean up trackout and replace degraded rock near the entrance.

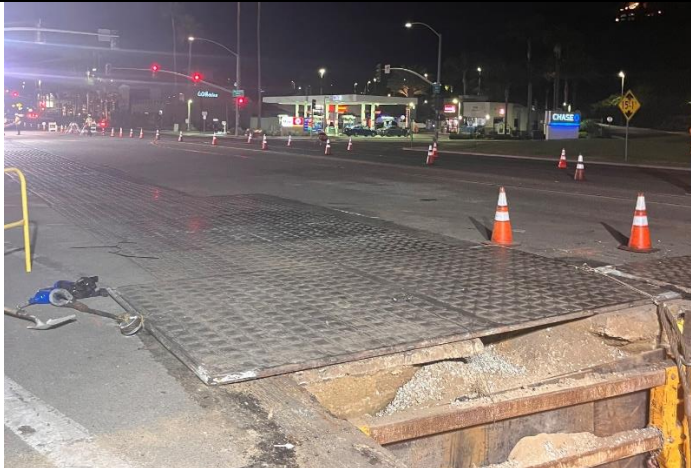
I drove along Via de la Valle near the intersection of Via de la Valle and Jimmy Durante Boulevard. Traffic control and necessary access for emergency responders was observed (Photo 2). Shoring was installed prior to vault installation that would occur later in the shift (Photo 3).

Photo 2 – Traffic control along Via de la Valle.
08/23/22	TL6973 Reconfiguration – Via de la Valle

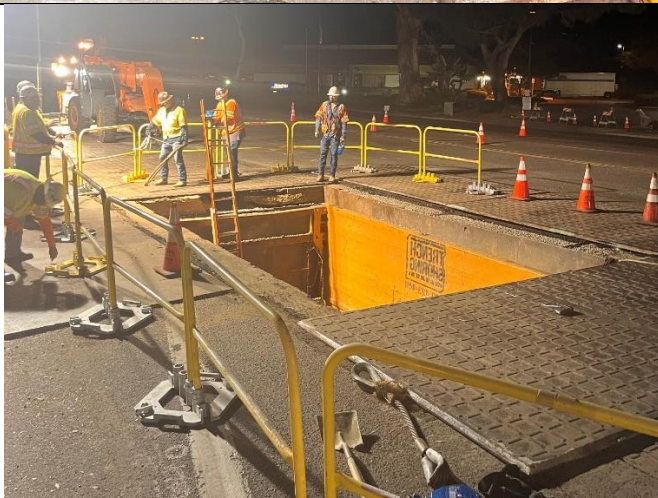
Photo 3 – Shoring ahead of vault installation.

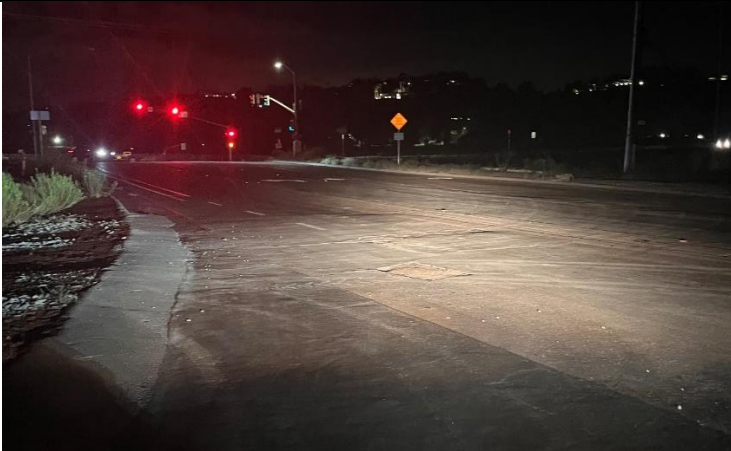
Trackout was still evident from the Pumpkin Patch Yard.

Photo 1 – Trackout at entrance to the Pumpkin Patch Yard.
08/29/22	Pumpkin Patch Yard

Clean up trackout and replace degraded rock near the project entrance.

Clean up trackout from the Pumpkin Patch Yard.

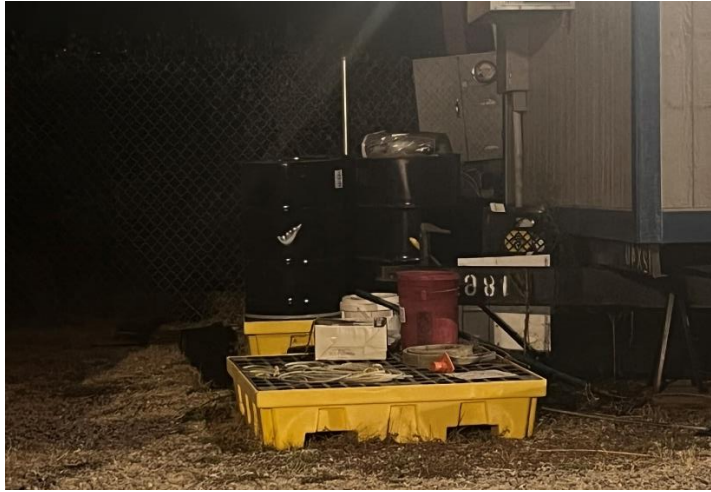
Photo 2 – Drums on spill pallets in compliance with the SWPPP.
08/29/22	TL6973 Reconfiguration – Via de la Valle

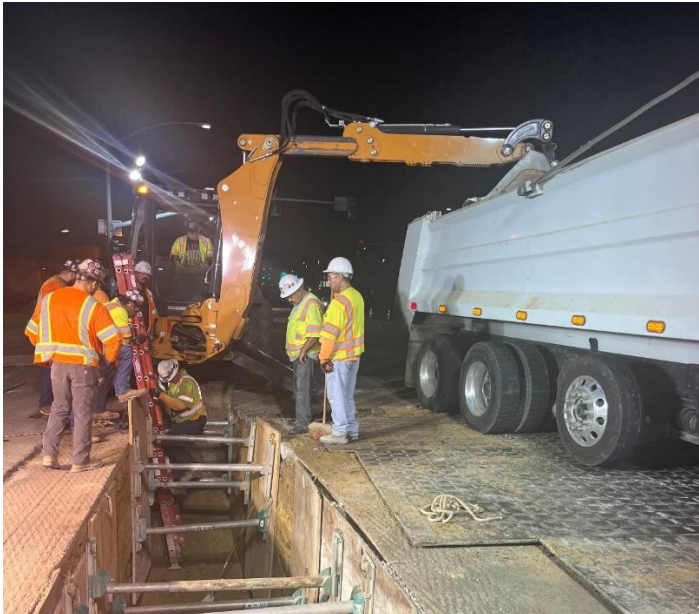
I drove along Via de la Valle near the intersection of Via de la Valle and Jimmy Durante Boulevard. Shoring was installed and excavation activities were occurring during the entirety of the shift (Photo 3).

Photo 3 – Excavation and installation of shoring to stabilize the trench.
