Re: Monthly Report Summary #14 for the Del Mar Reconfiguration (TL674A Reconfiguration and TL666D Removal) Project

CPUC Site Inspection Reports

Del Mar Reconfiguration Project CPUC Site Inspection Form

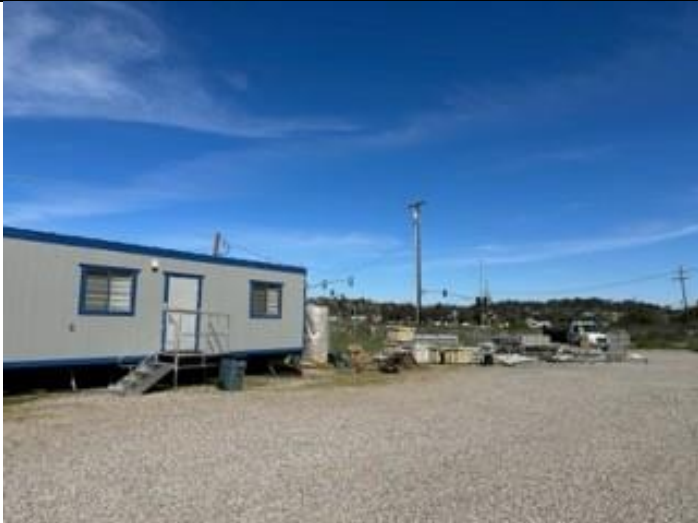
Pumpkin Patch Yard: WSP USA representatives (WSP) met onsite at the Pumpkin Patch Yard construction trailer (Photo 1) with the San Diego Gas and Electric (SDG&E) Environmental Compliance Lead (ECL), SDG&E Consultant Insignia Environmental (Insignia) Environmental Compliance Project Manager (ECPM) and Insignia Environmental Inspector (EI). After arrival onsite, WSP representatives received Worker Environmental Awareness Program Training (WEAP). Best management practices (BMPs) were in place along the yard’s perimeter fence and around some soil stockpiles (Photo 2). Waste dumpsters were covered and secured in accordance with mitigation measure (MM) HAZ-1 and the Project’s Hazardous Materials Waste Management Plan (Photo 3).

Photo 1: Construction trailer located at the Pumpkin Patch Yard and material stored throughout. Trash bins are securely covered. Photo facing northwest.
2/10/23	Pumpkin Patch Yard

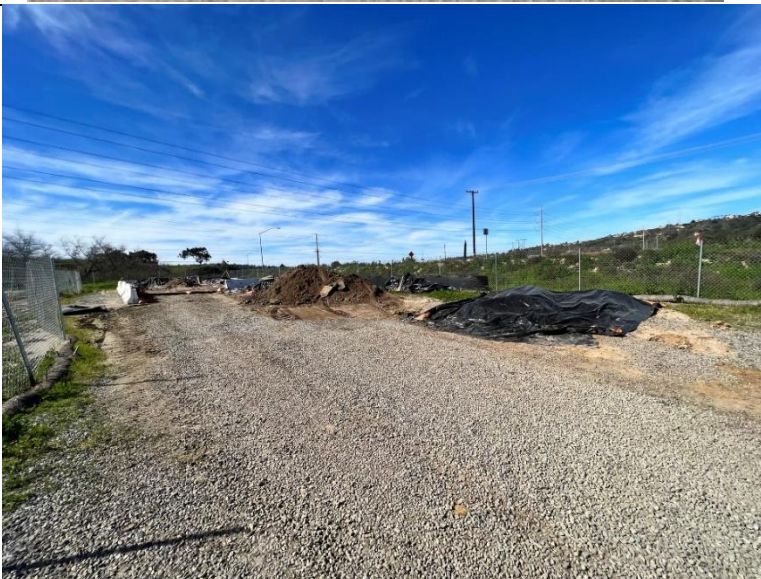
Photo 2: Soil stockpiling onsite. Some covered, some uncovered. Erosion and dust control are properly installed and functioning. Photo facing west.

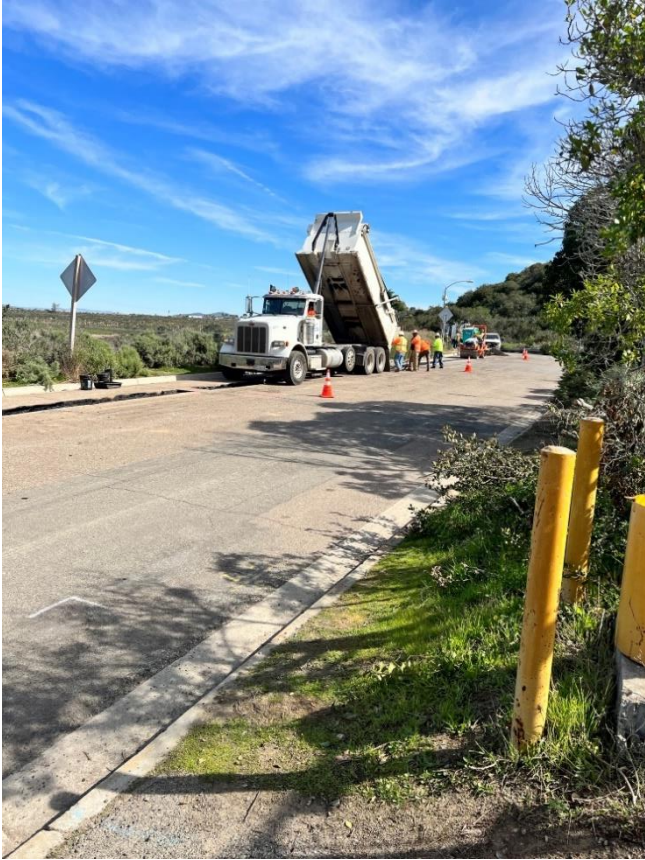
C510: WSP Representatives then drove to Racetrack View Drive near the San Dieguito Lagoon with the required fire tools (Photo 4) to observe trench backfill, concrete pouring, and road paving activities (Photos 5 and 6) for the undergrounding of C510. Environmentally Sensitive Areas (ESA) signage was installed throughout the construction work areas (Photo 7). Traffic control measures were placed throughout the work areas, and traffic control flagger personnel were stationed at both ends of the work areas to guide oncoming vehicular traffic (Photo 8). Additionally, construction crews installed a handhole box and temporarily covered trenched areas with steel plates which are anticipated to be backfilled and paved next week (Photo 9).

Photo 5: All workers in proper PPE and are backfilling trench and completing paving activities along the ROW. Photo facing south.

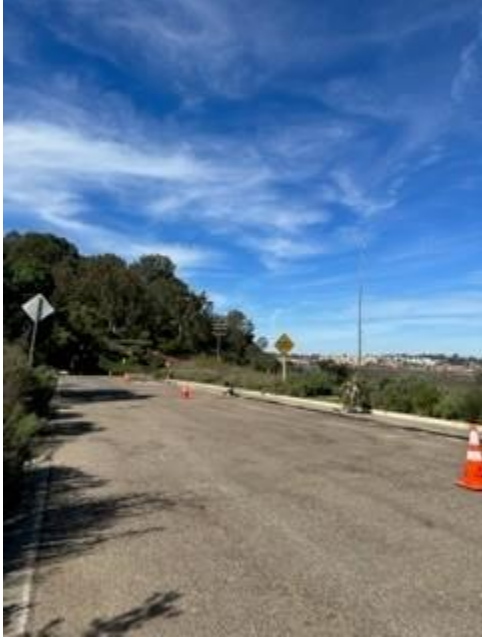
Photo 8: Traffic control measures are in place during lane closure. A traffic control flagger stationed at each end of the work area. Photo facing north.
2/10/23	C510 – Racetrack View Drive

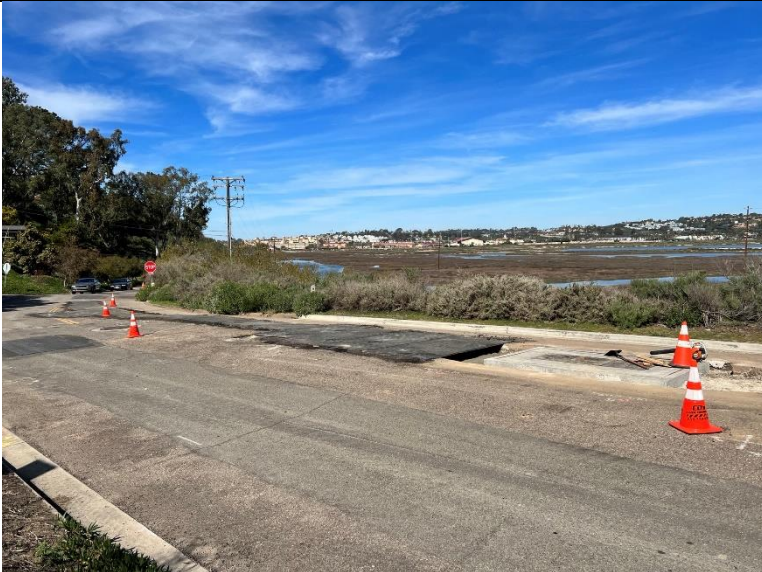
Photo 9: Hand hole box leveling and installation complete. Steel plates are temporarily covering the trench. Traffic control flaggers are located at both ends of the work areas. Photo facing north.

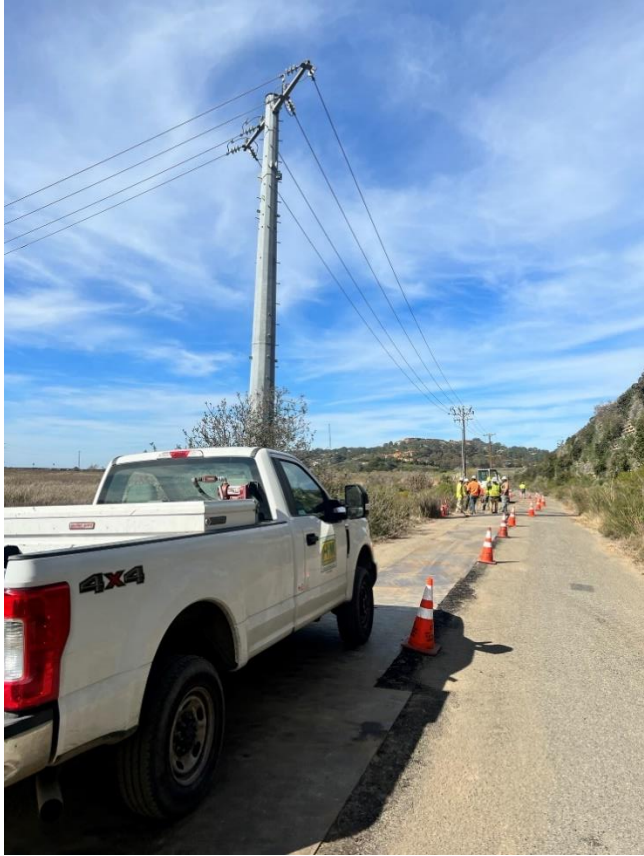
C1448: Afterward, WSP representatives drove to Sorrento Valley Road and observed final paving activities and manual sweeping as crews cleaned up for the day (Photo 10). Traffic control flaggers were also stationed at both ends of the work areas, alerting crews of oncoming bicyclists and pedestrian hikers/joggers using the trail.

<p>Photo 10: Dust control measures being implemented. Excavations and trenches are temporarily covered with steel plates. Biological monitor is present on-site and sensitive biological resources are flagged with posted signage. Photo facing northwest.</p>
