**Re: Monthly Report Summary #15 for the Del Mar Reconfiguration (TL674A Reconfiguration and TL666D Removal) Project**

CPUC Site Inspection Reports  
March 3, 13, and 31, 2023

## Del Mar Reconfiguration Project CPUC Site Inspection Form

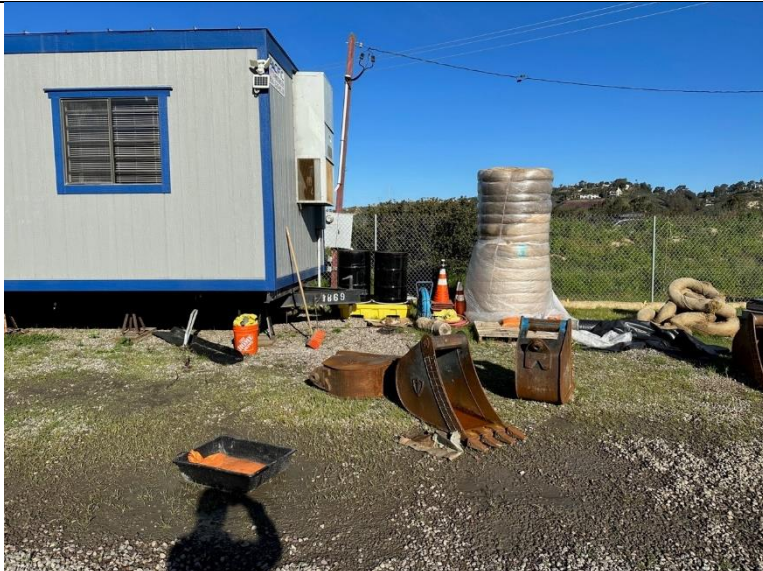
Photo 1: Construction trailer at the Pumpkin Patch Yard and material stored throughout. Hazardous waste containers are securely covered. Photo facing northwest.

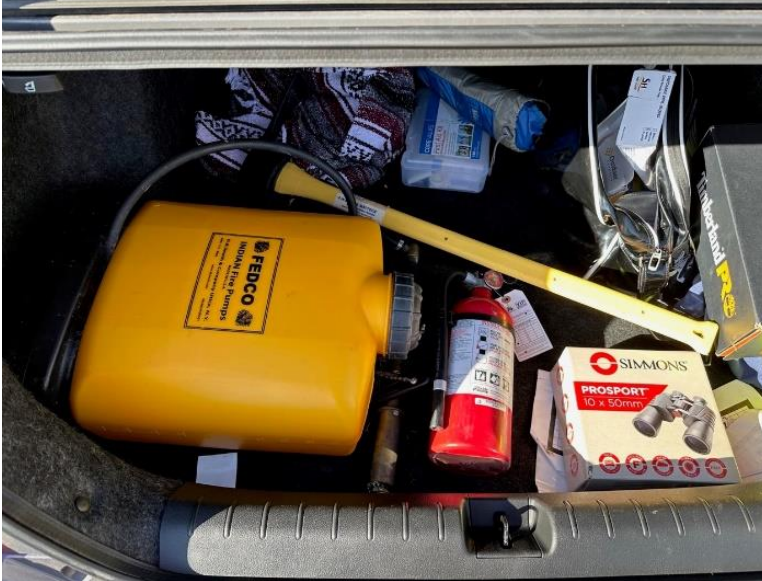
Photo 4: Fire prevention and control measures taken with WSP Monitors while onsite.
3/03/23	C510 – Racetrack View Drive

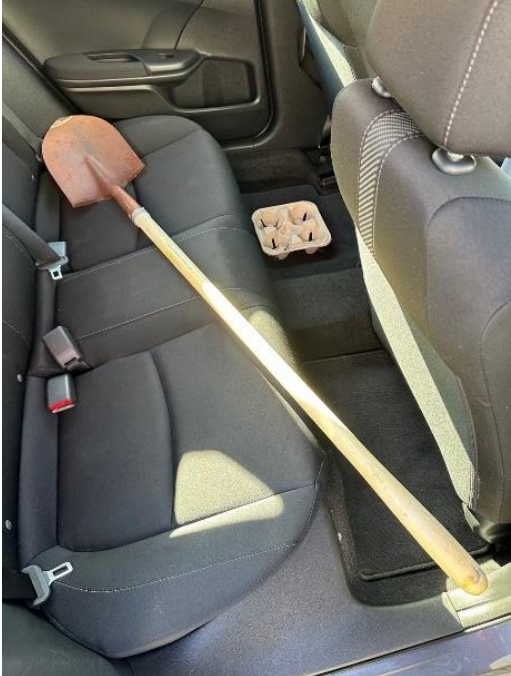
Photo 5: Fire prevention and control measures taken with WSP Monitors while onsite.

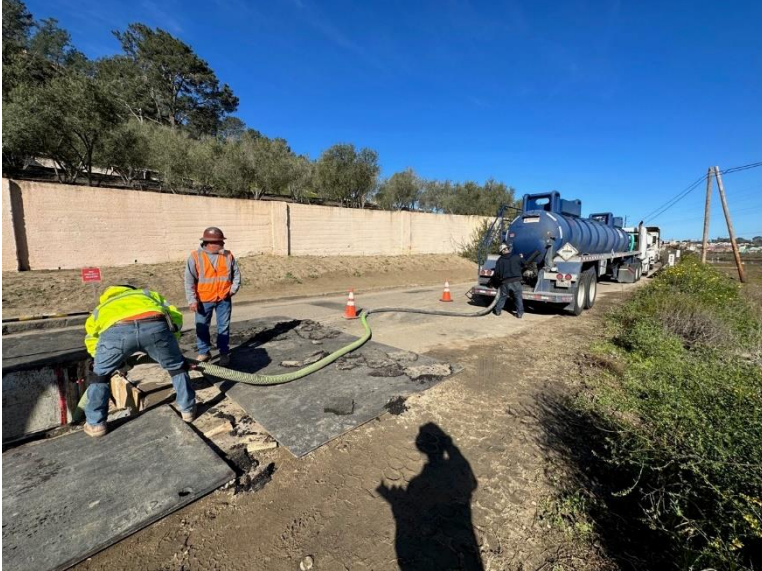
- An H&M water tank truck drove outside of the access road boundaries delineated within the C510 workspace along San Dieguito Drive. This caused rutting and track-out. Twenty-five minutes later an H&M dump truck also drove outside of the access road boundaries. The environmental inspector contacted Insignia and SDG&E to report the issue.

Photo 6: Dewatering activities. Tire rutting cleanup after self-reported non-compliance incident. Additional signage installed.
3/03/23	C510 – Racetrack View Drive

The impacted areas were primarily bare ground where no rare plants were observed. The ruts were raked out at three locations and equipment was moved in order to widen the traffic lane within the workspace. The Environmental Inspector spoke with the truck drivers about the importance of remaining within the paved road.

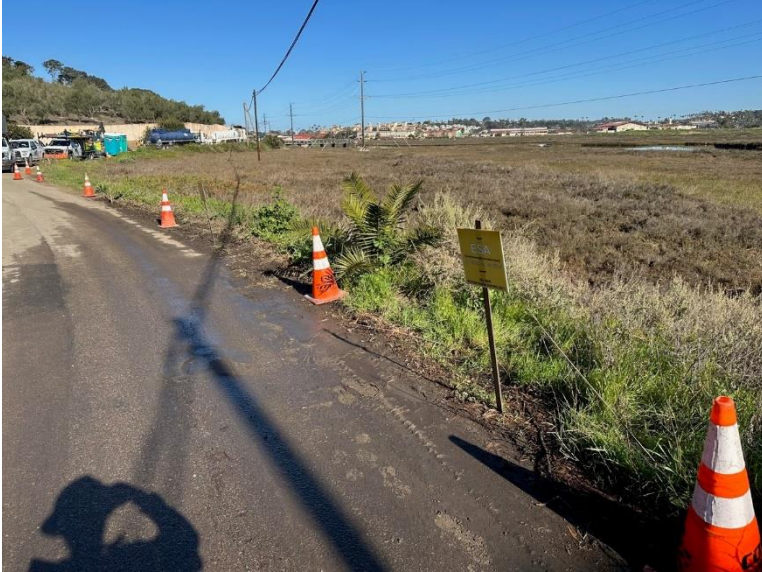
Photo 7: Tire rutting cleanup after self-reported non-compliance incident. ESA signage in place and construction cones marking sensitive habitat along ROW.

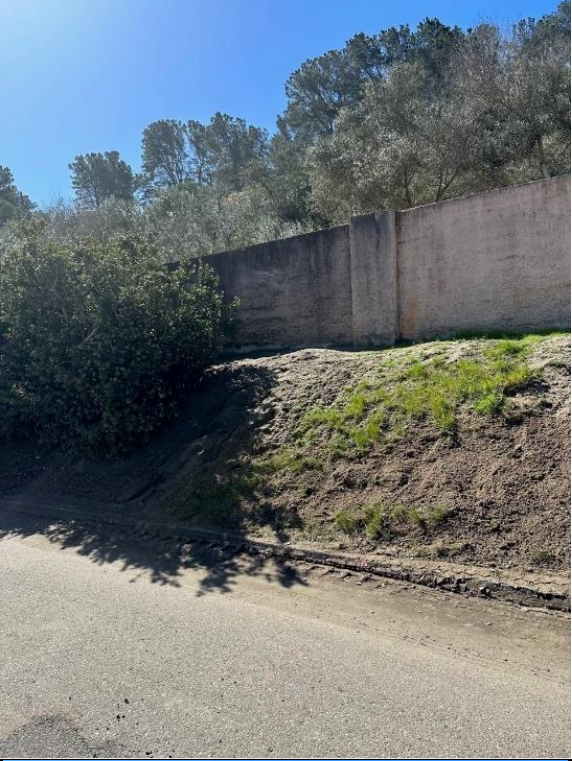
Photo 8: Tire rutting cleanup after self-reported non-compliance incident.
3/03/23	C510 – Racetrack View Drive

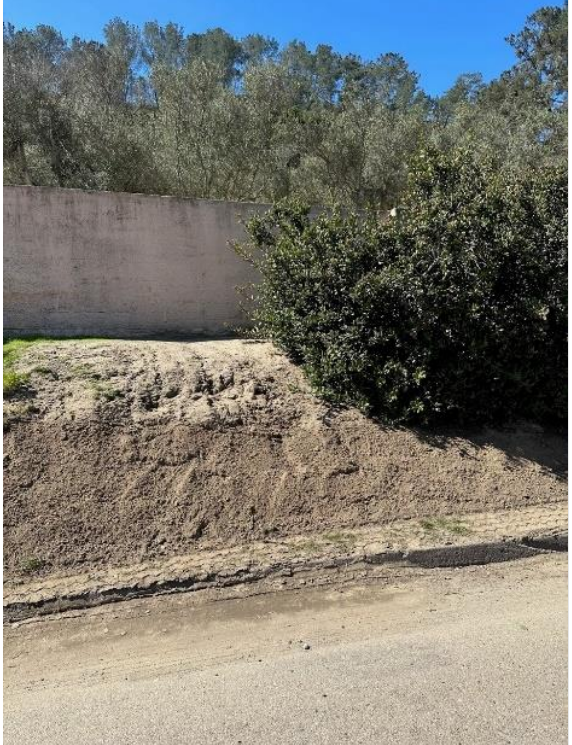
Photo 9: Tire rutting following cleanup after self-reported non-compliance incident.

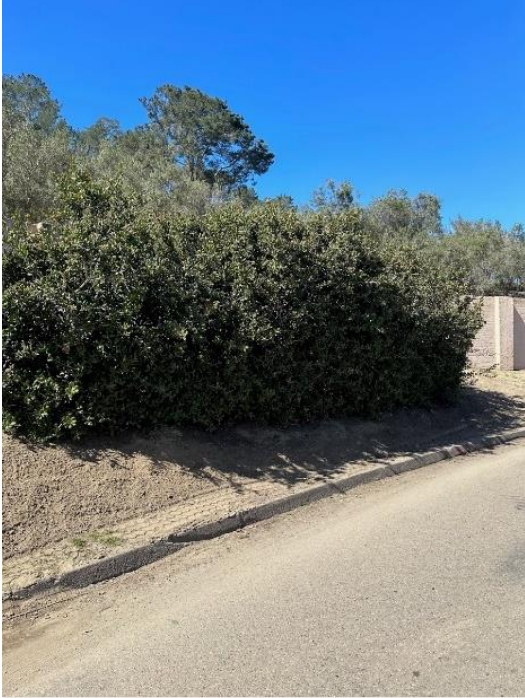
Photo 10: Tire rutting following cleanup after self-reported non-compliance incident.
3/03/23	C510 – Racetrack View Drive

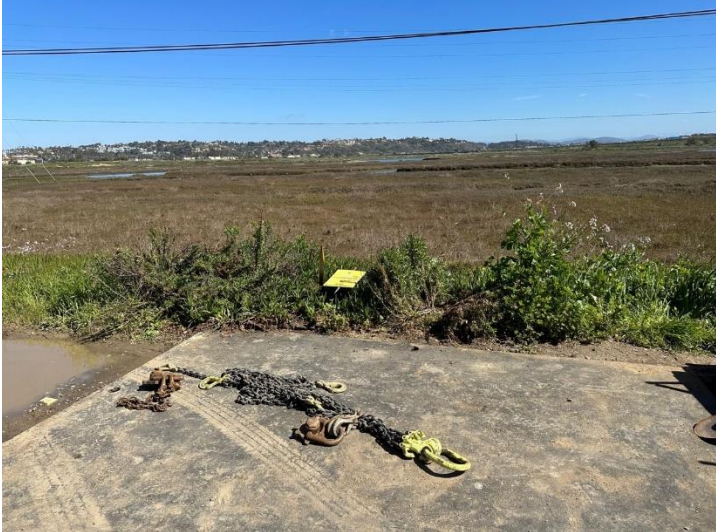
Photo 11: ESA Signage broken, was fixed and reposted.

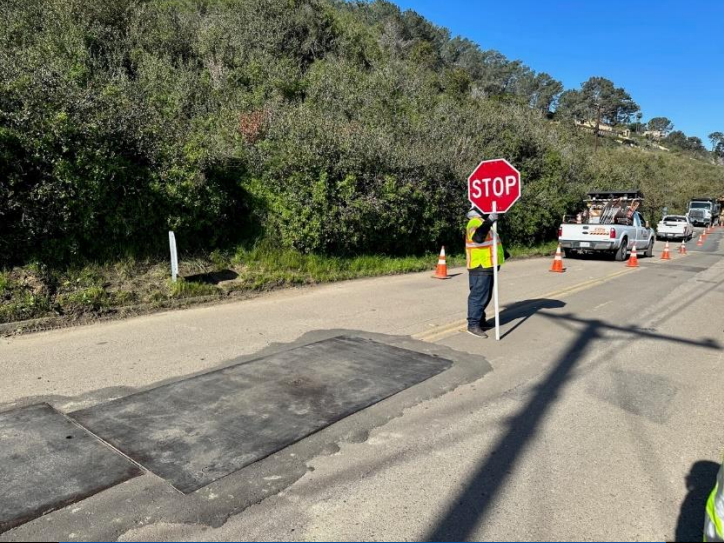
Photo 12: Steel plates temporarily covering the trench when not in use. Traffic control measures were in place during lane closure. Photo facing northwest.
3/03/23	C510 – Racetrack View Drive

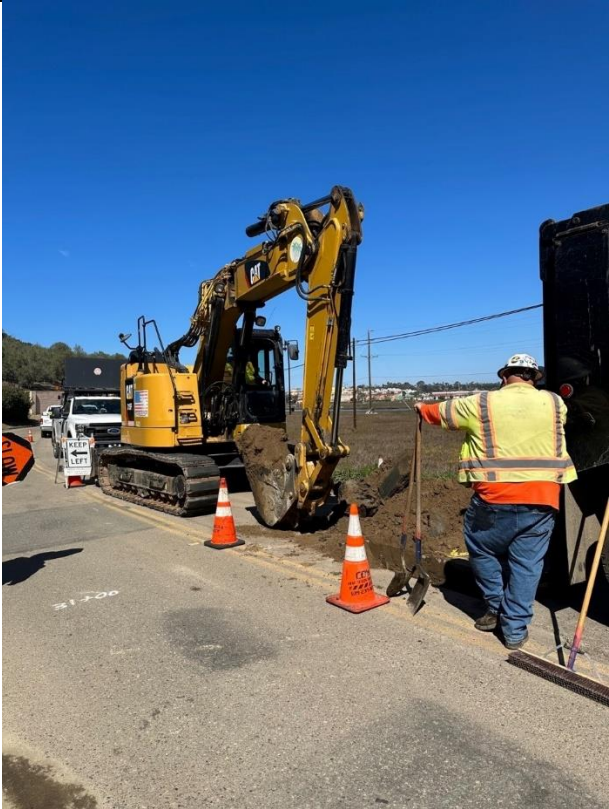
Photo 13: All workers in proper PPE and were trenching and excavating along the ROW. Traffic control present. Paleo monitor present. Photo facing north.

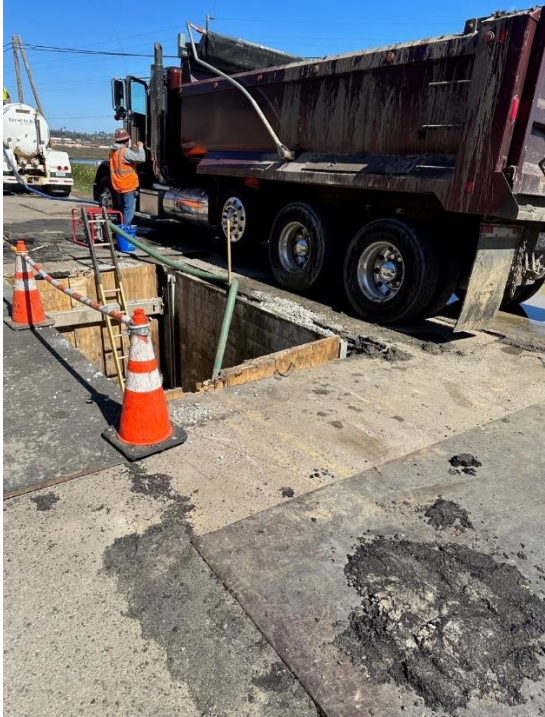
Photo 14: Vehicle was off when not in use and traffic cones marked trench. Traffic control measures were in place. Photo facing northeast.
3/03/23	C510 – Racetrack View Drive

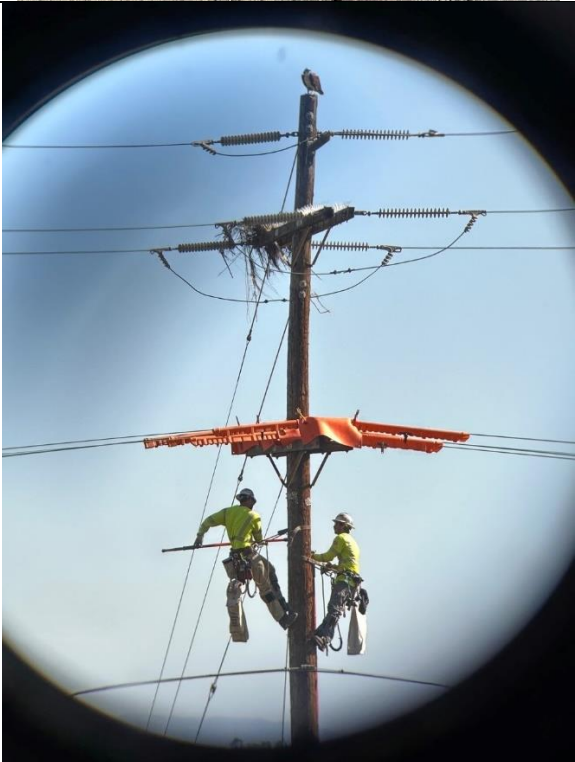
Photo 15: Workers conducting WDFW approved osprey material removal on pole at Location 32. Osprey present on top of pole.

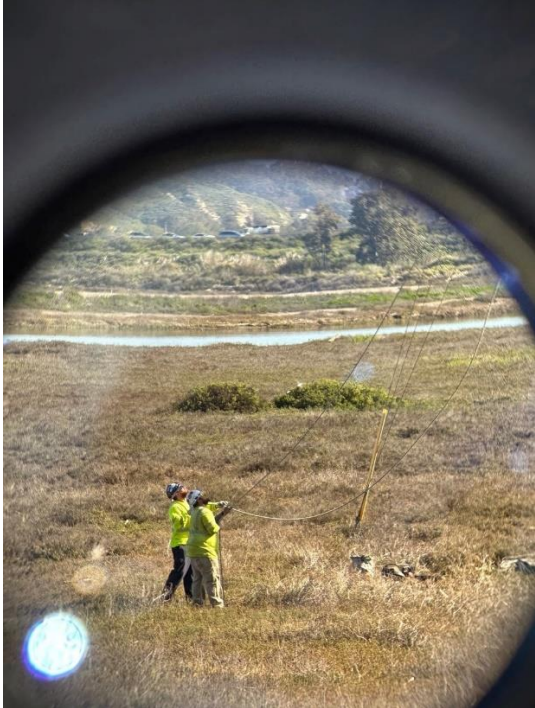
Photo 16: Workers conducting WDFW approved osprey material removal on pole at Location 32. Workers on ground providing support for workers on pole conducting removal.
3/03/23	C510 – Racetrack View Drive

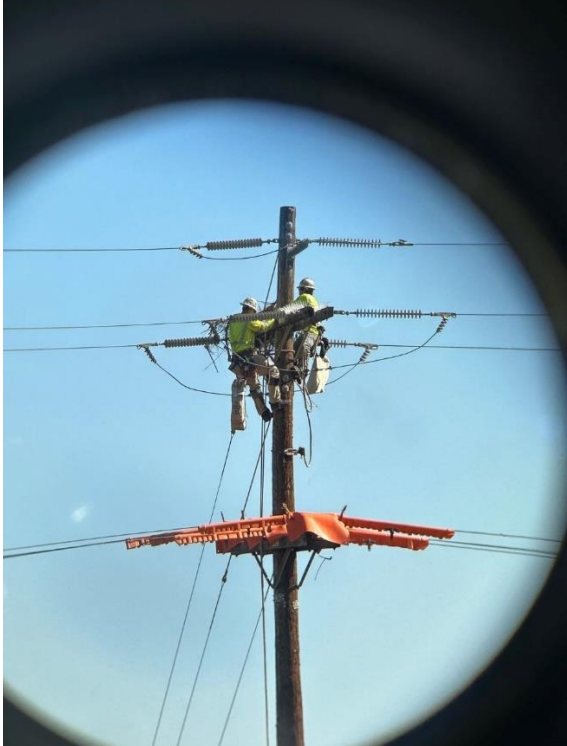
Photo 17: Workers conducting WDFW approved osprey material removal on pole at Location 32.

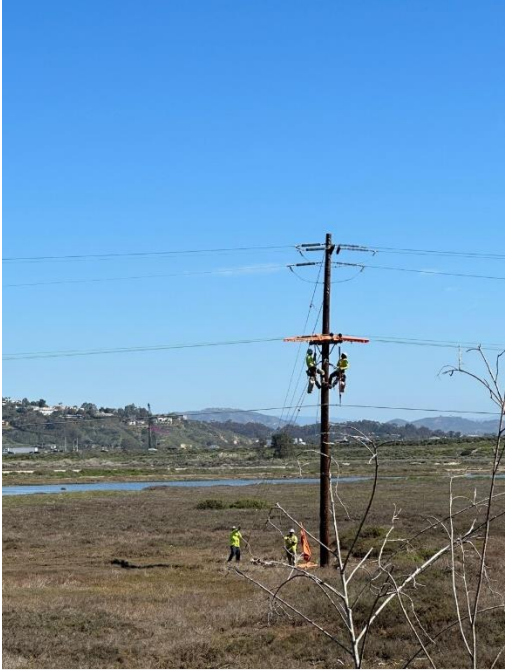
Photo 18: Workers completing WDFW approved osprey material removal.
3/03/23	C510 – Racetrack View Drive

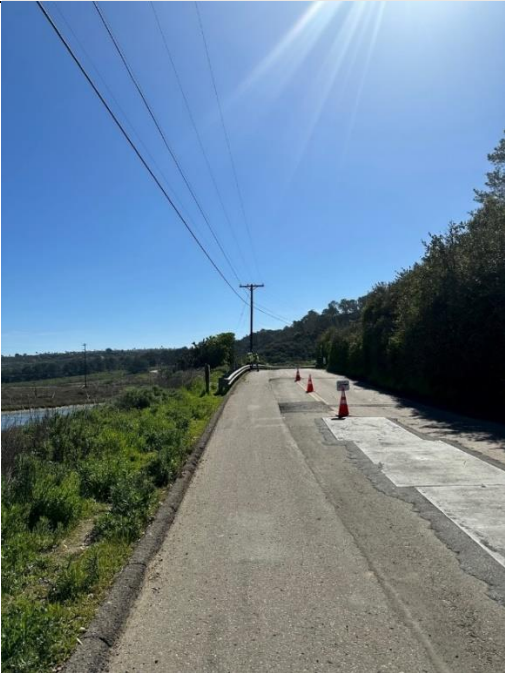
Photo 19: Completed paving plus steel plates temporarily covering the trench when not in use.

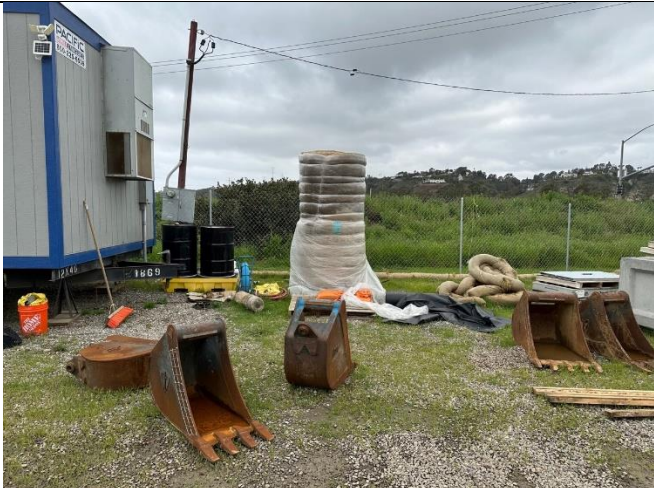
Photo 1: Construction trailer located at the Pumpkin Patch Yard and material stored throughout. Photo facing northwest.
3/13/23	Pumpkin Patch Yard

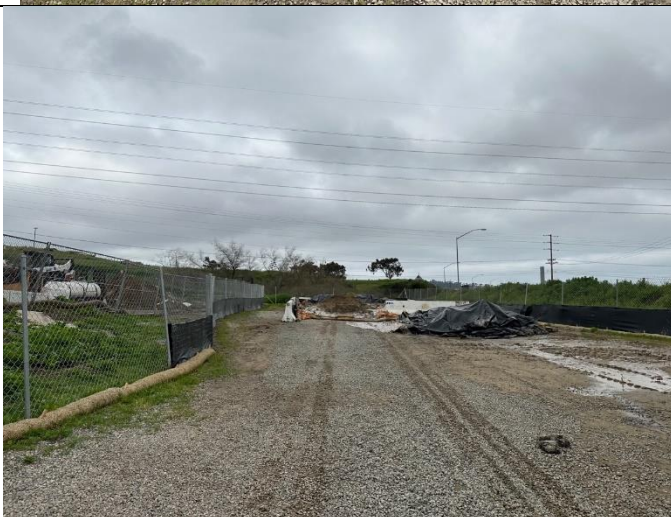
Photo 2: Soil stockpiling on-site. BMPs such as straw wattle and gravel were properly installed and functioning. Photo facing west.

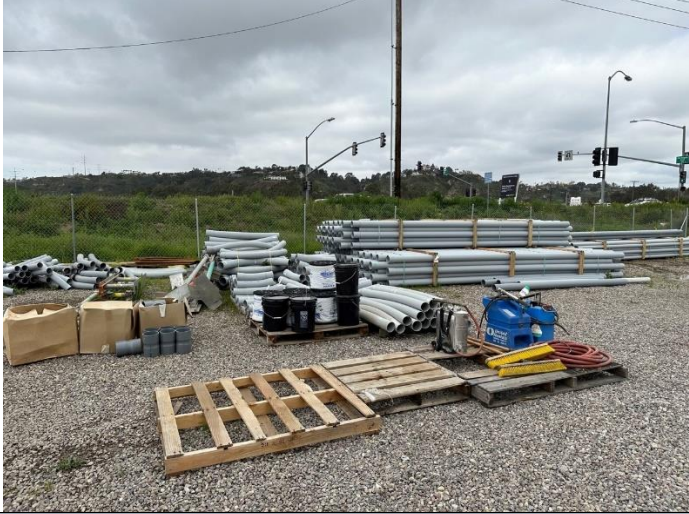
Photo 3: Material storage on-site. BMPs such as straw wattle and gravel were properly installed and functioning. Photo facing west.
3/13/23	Pumpkin Patch Yard

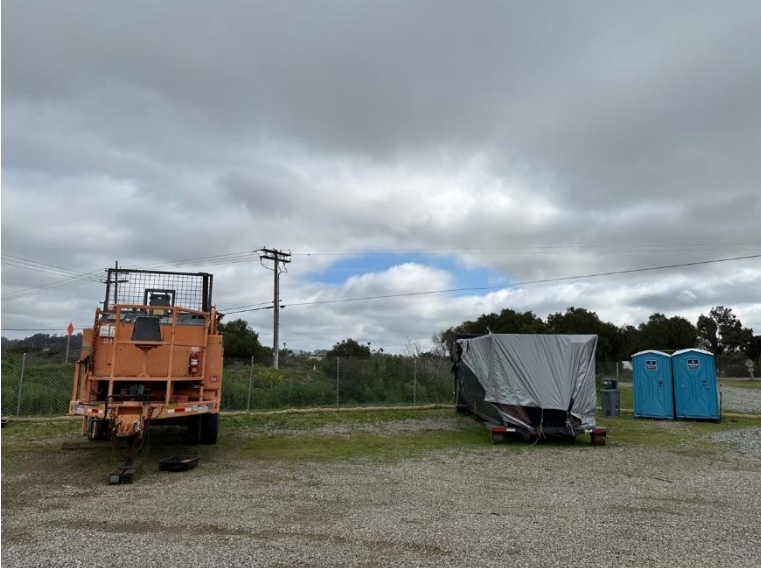
Photo 4: Waste dumpsters were properly covered and secured. Photo facing northeast.

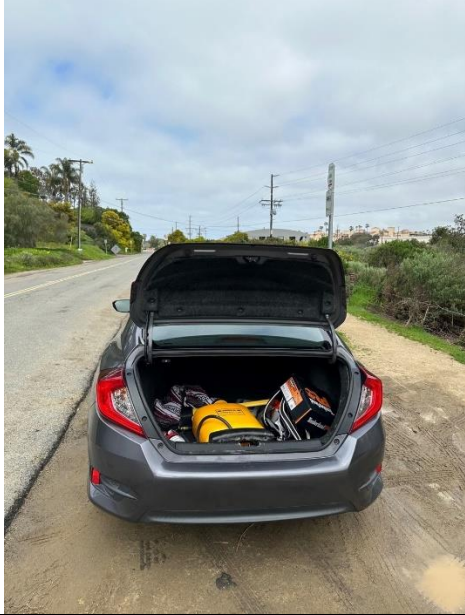
Photo 5: Fire prevention and control measures taken with WSP Monitor to be present on-site. Photo facing north.
3/13/23	Pumpkin Patch Yard

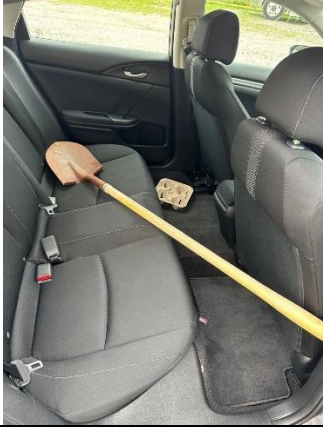
Photo 6: Fire prevention and control measures taken with WSP Monitor to be present on-site. Photo facing west.

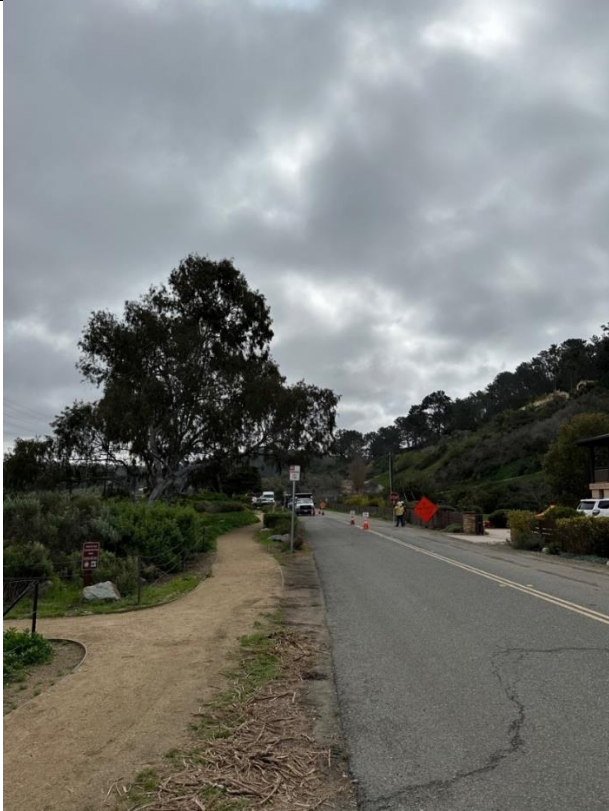
Photo 7: Traffic control measures were in place during lane closure. Photo facing south.
3/13/23	C510 – Racetrack View Drive

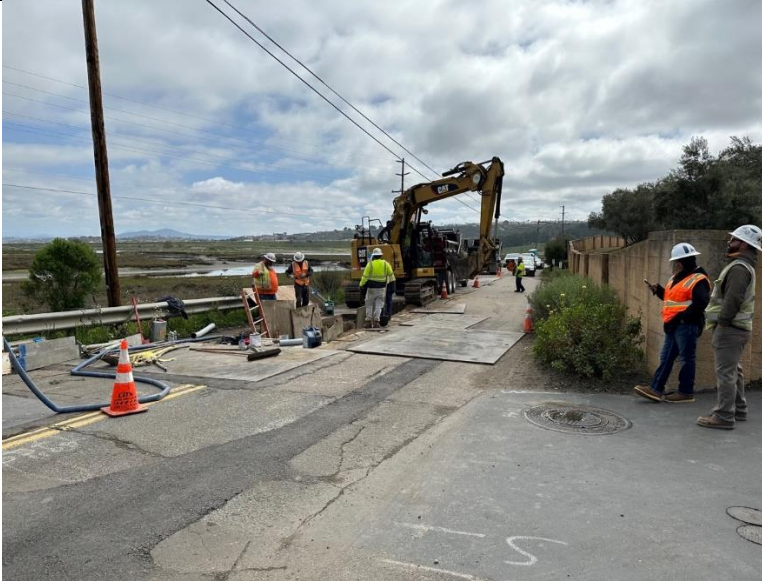
Photo 8: Steel plates were present to cover excavations temporarily. Paleo and cultural monitors were present. Photo facing southeast.

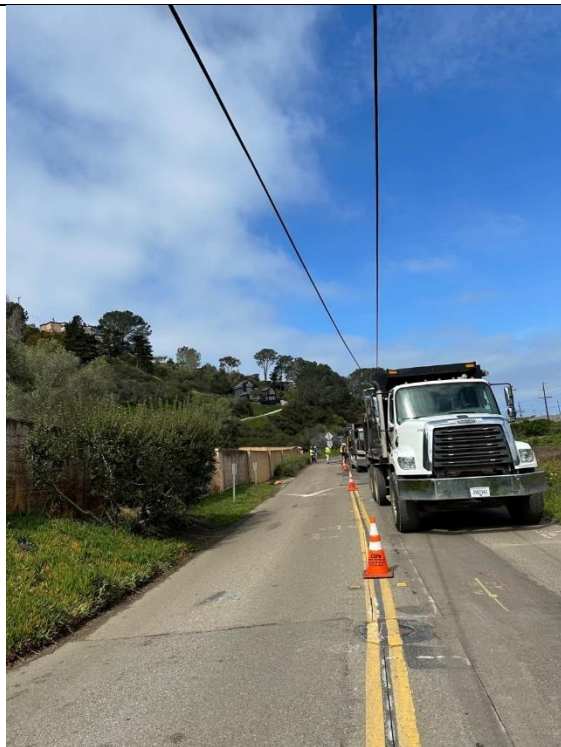
Photo 9: Equipment stopped when not in use. Work was contained to the right of way, not encroaching on nearby habitat. Photo facing north.
3/13/23	C510 – Racetrack View Drive

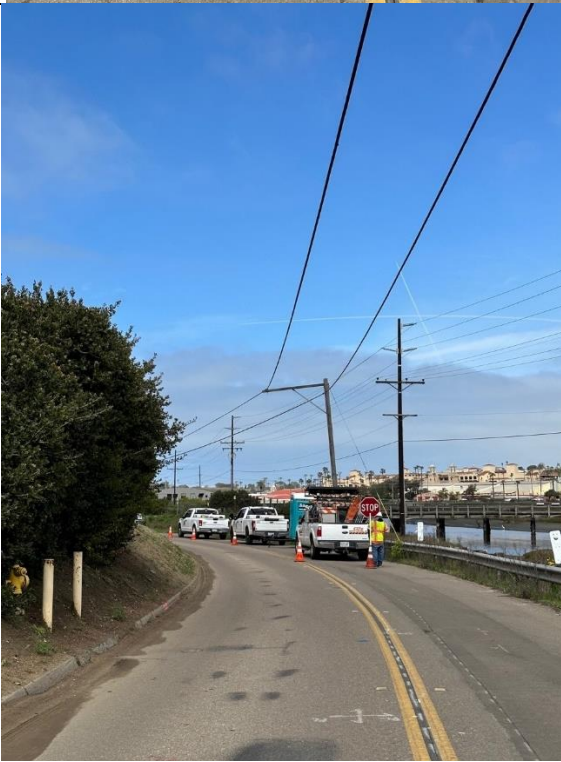
Photo 10: Traffic control measures were in place during lane closure. Photo facing north.

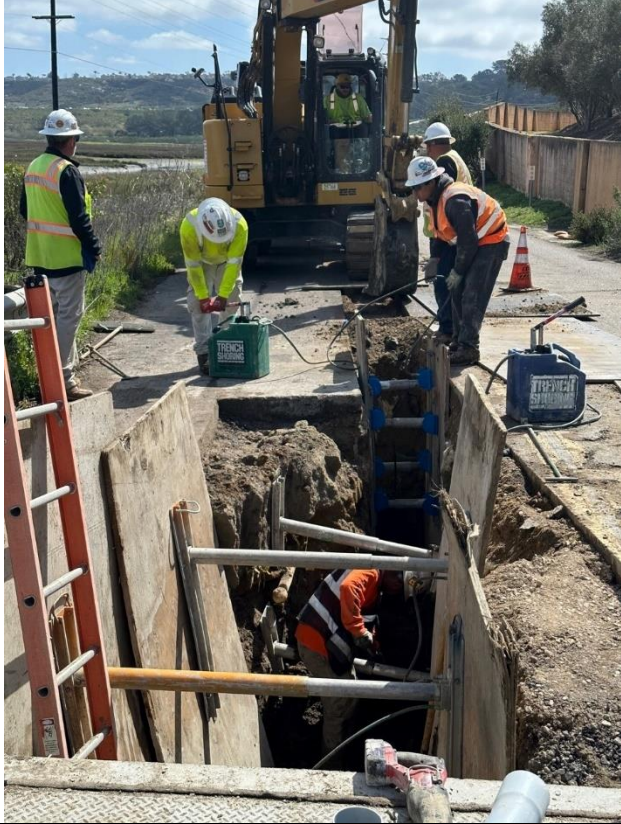
Dewatering activities were ongoing as necessary due to saturated soils encountered during trenching, likely due to underground sewage lines. Manual digging activities are employed as necessary, including on 3/13/2023 to tunnel around gas lines and other underground infrastructure within the trenching area.

Photo 11: Shoring and excavating along the ROW. Photo facing south.
3/13/23	C510 – Racetrack View Drive

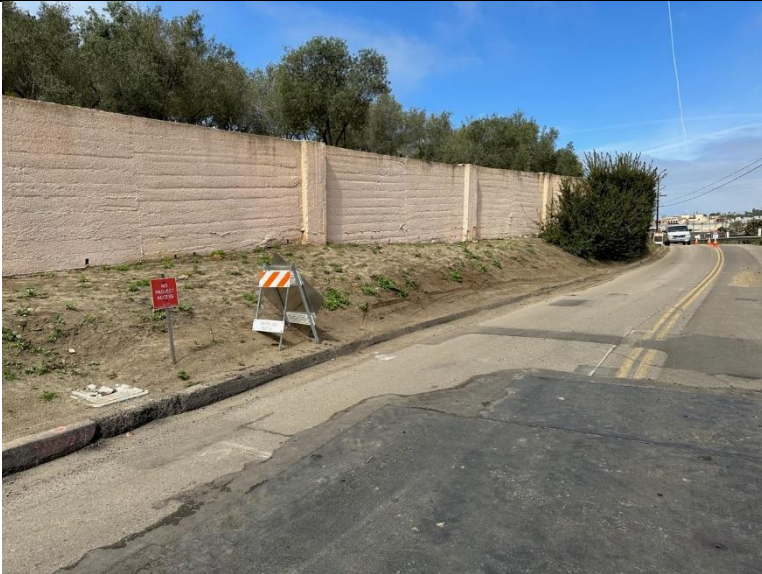
WSP representative followed up previously on Non-Compliance Level 1 incident from MM BR-2 observed by Lead Environmental Inspector (LEI) on 3/2/2023. WSP representative confirmed that workers continued to remain within work limits. WSP representative confirmed ongoing presence of actions taken including prior widening of the traffic lane, raking out of ruts, installation of additional signage and construction cones to delineate work area at SN 29+40, SN 31+40, and SN 29+60 (Photos 12 and 13).

Photo 12: No Project Access sign and traffic sign marking area of previous tire rutting and cleanup after self-reported non-compliance incident.

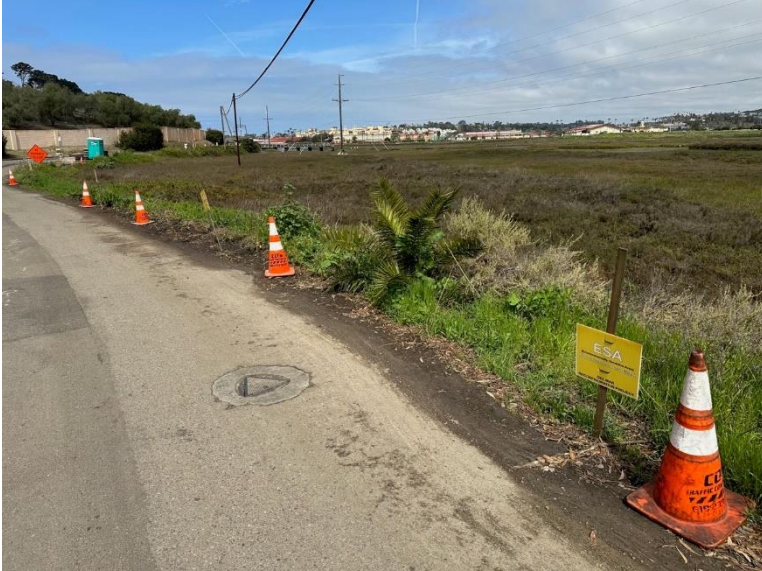
Photo 13: ESA signage present and traffic cones mark boundary of sensitive habitat along ROW.
3/13/23	C510 – Racetrack View Drive

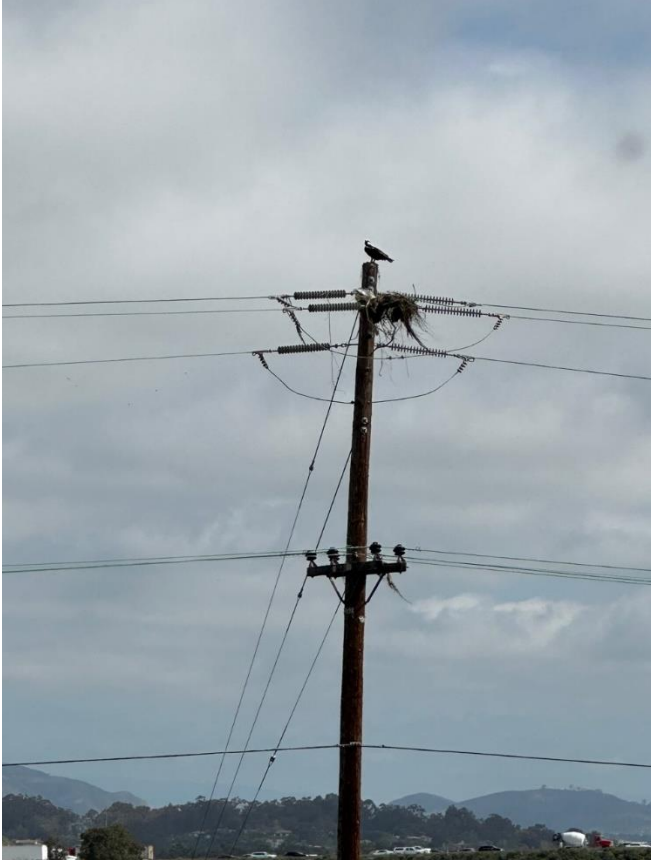
Photo 14: Nesting material present on pole at Location 32. Photo facing east.

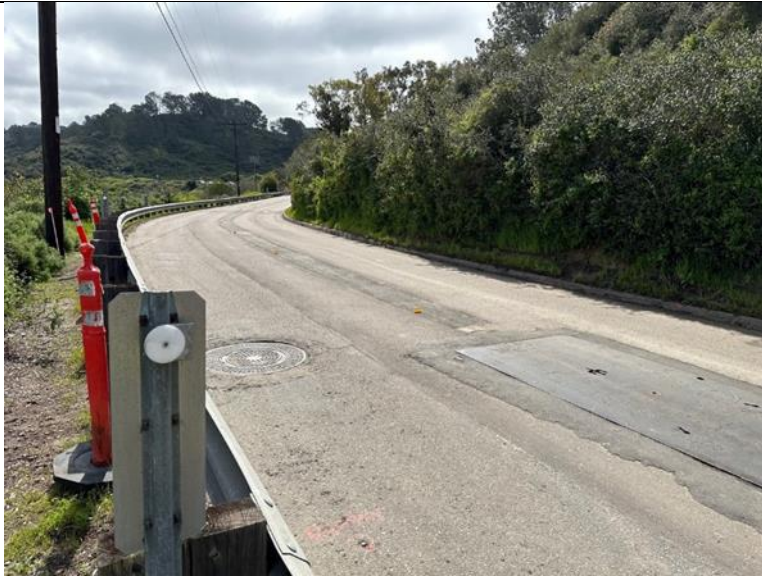
EIs were adhering to applicable avian protection measures during nesting bird season. WSP representative previously observed CDFW approved osprey nesting material removal on 3/3/2023. New osprey nesting material placed by the same osprey couple have been observed on the same active pole near Location 32 (Photo 14). California Fish and Wildlife Service was informed, and discussions are ongoing as to whether nesting material removal may be removed again due to fire risk dependent on nesting behavior from the ospreys. Construction activities are being adjusted accordingly due to working limitations based on nesting buffer of osprey nesting material near Location 32; excavated areas are covered with steel plates to be backfilled once the situation is resolved (Photo 15).

Photo 15: Completed paving and steel plate covering excavated area until work can be completed. Photo facing southwest.
3/13/23	C510 – Racetrack View Drive

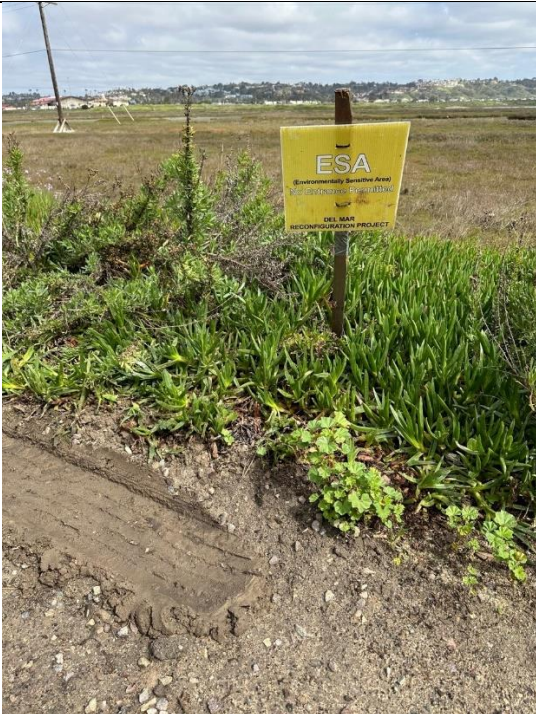
Following up from 3/3/2023, previously broken ESA signage was fixed and reposted (Photo 16).

Photo 16: Previously broken ESA signage was repaired and reposted.

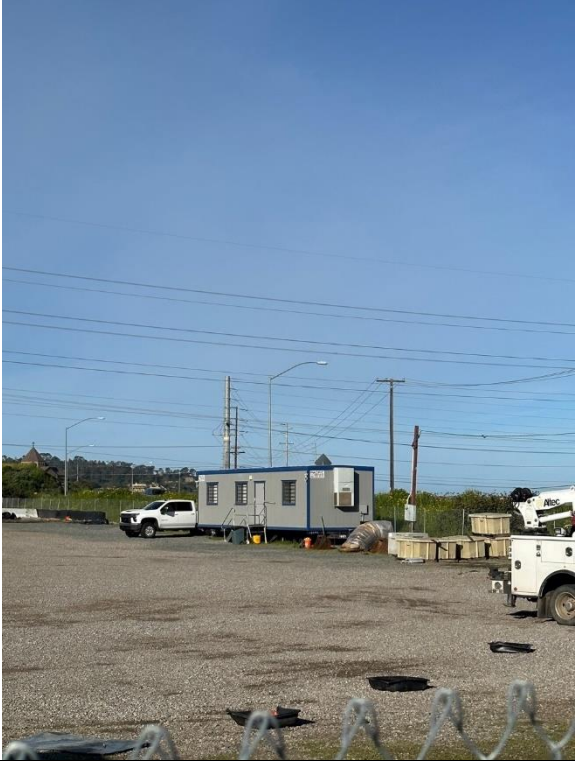
**Pumpkin Patch Yard:** WSP USA representative (WSP) arrived onsite with required fire safety tools. Best management practices (BMPs) and hazardous materials were observed stored in the Pumpkin Patch Yard (Photo 1 and 2). Waste dumpsters were stored properly and covered (Photo 3).

Photo 1: Construction trailer located at the Pumpkin Patch Yard and material stored throughout. Trash bins are securely covered. Photo facing northwest.
3/31/23	Pumpkin Patch Yard

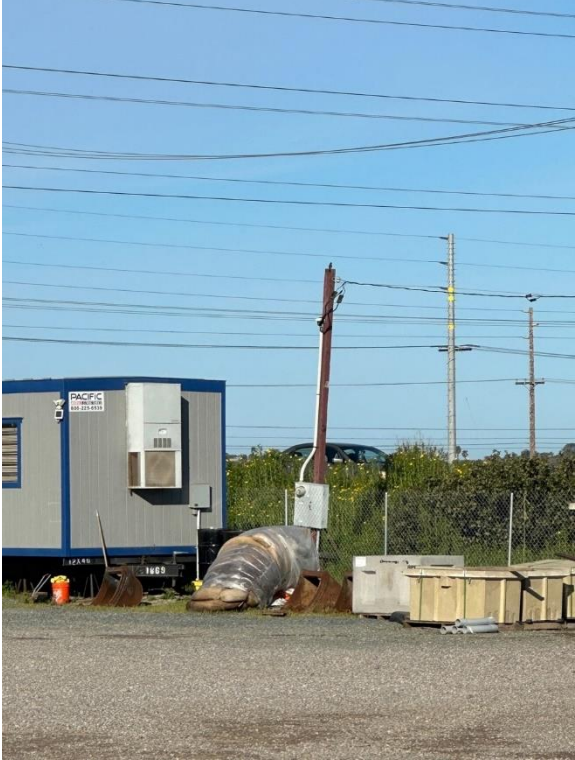
Photo 2: Material storage on-site. BMPs such as straw wattle and gravel were properly installed and functioning. Photo facing northwest.

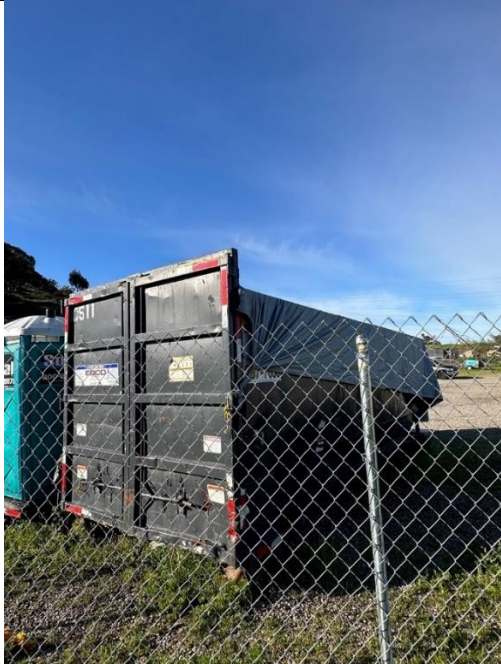
Photo 3: Waste dumpsters are properly covered and secured. Photo facing southwest.
3/31/23	C510 – Racetrack View Dr.

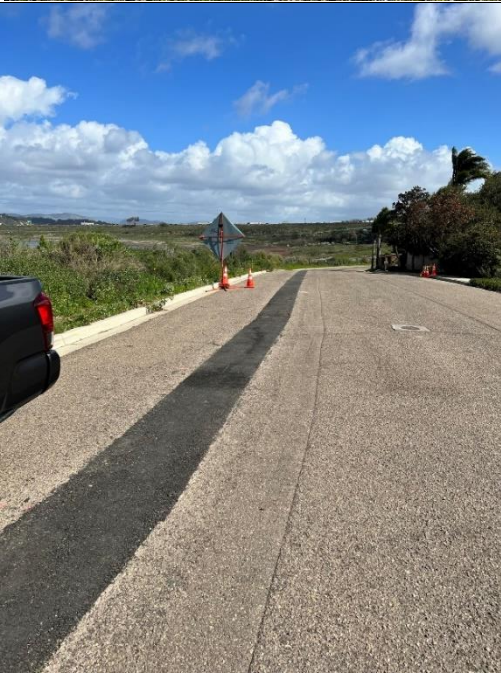
**C510:** WSP Representative then drove to Racetrack View Dr. near the San Dieguito Lagoon with the required fire tools to observe the completed paving and traffic control measures along the ROW (Photo 4).

Photo 4: Completed paving and traffic control measures along the ROW. Photo facing southeast.
