Re: Monthly Report Summary #6 for the Valley-Ivyglen 115-kV Substation (VIG) Project

Valley – Ivyglen Subtransmission Project CPUC Site Inspection Form

Project:	Valley – Ivyglen Project	Date:	December 1, 2020
Project Proponent:	SCE	Report #:	VS011
Lead Agency:	California Public Utilities Commission	Monitor(s):	Vincent Semonsen
CPUC PM:	Patricia Kelly, Energy Division	AM/PM Weather:	Sunny, warm with a slight breeze
CPUC-CM (WSP):	Chuck Cleeves	Start/End time:	1345 hrs – 1615 hrs
Project NTP(s):	NTP-1.

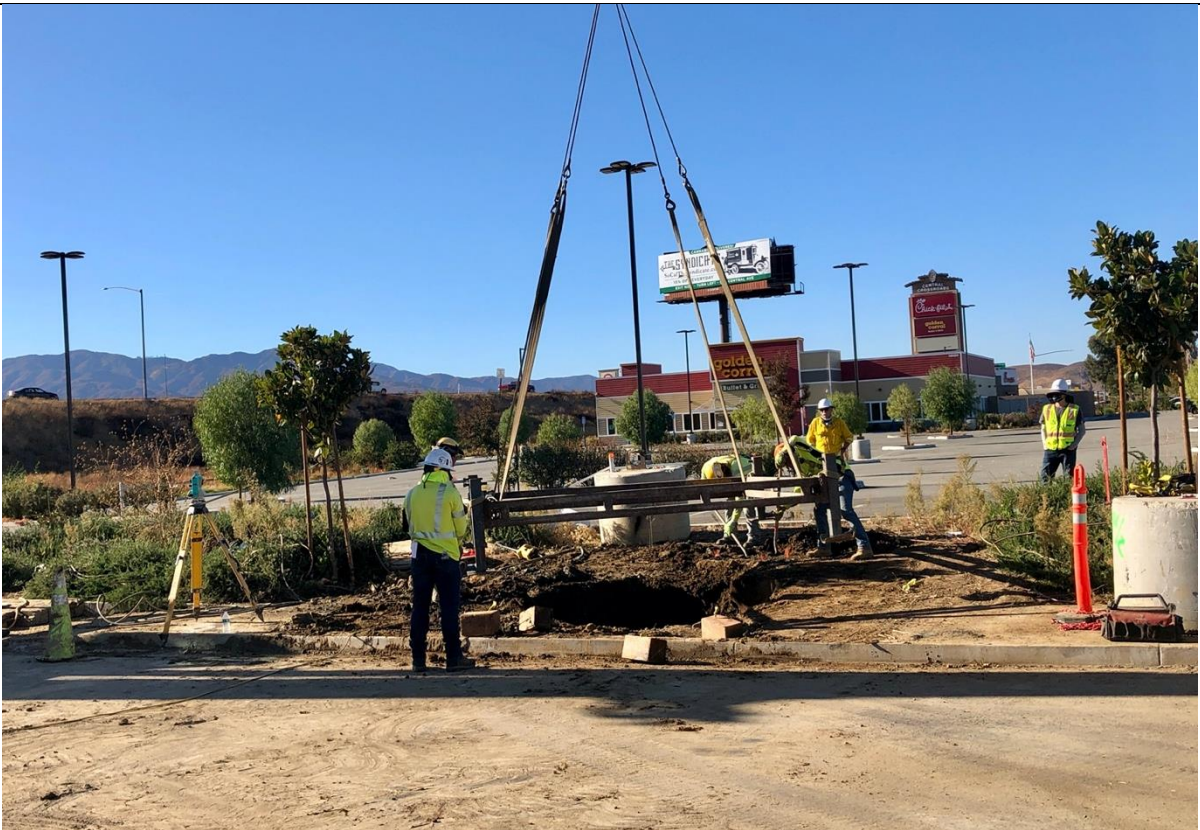
Photo 2 – Installation and pouring of the foundation for TSP 331. Photo facing northwest

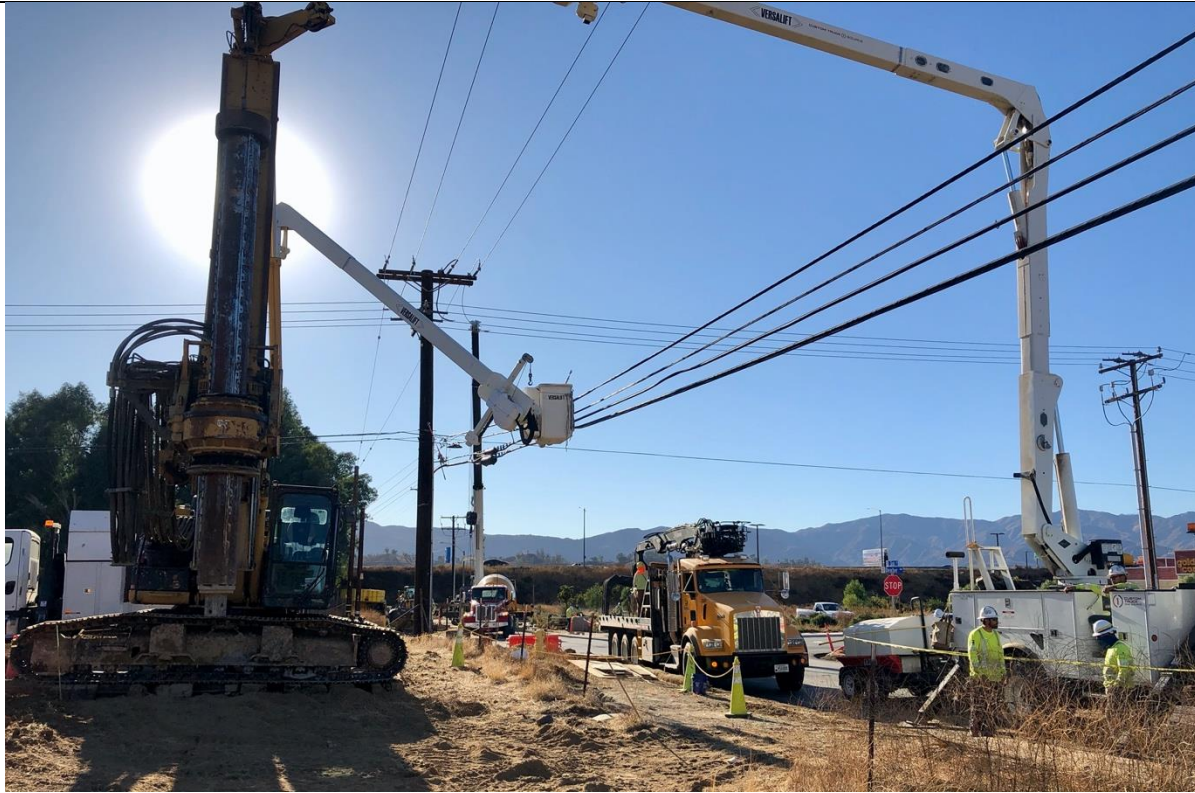
Photo 4 – Crews preparing to drill the foundation hole at TSP 330. Photo facing west

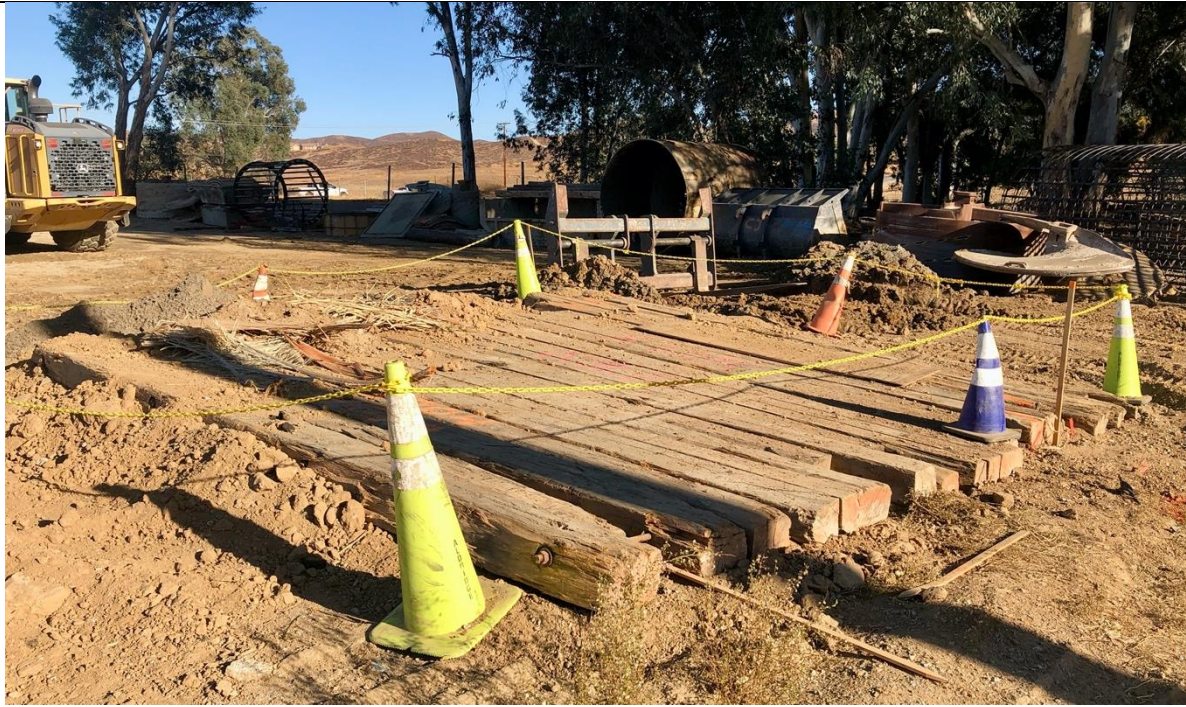
Photo 5 – Wooden mats covering the partially drilled foundation hole for TSP 333. Photo facing south

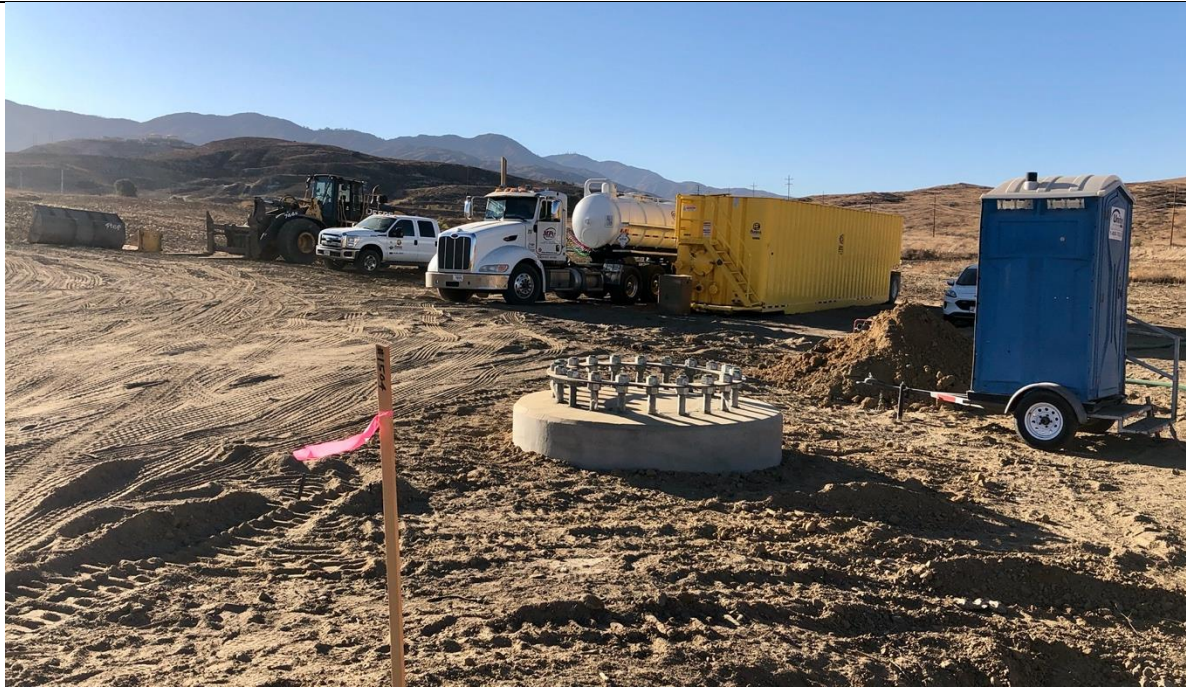
Photo 6 – Staging area and pulling station near the newly poured TSP 408. Photo facing northwest

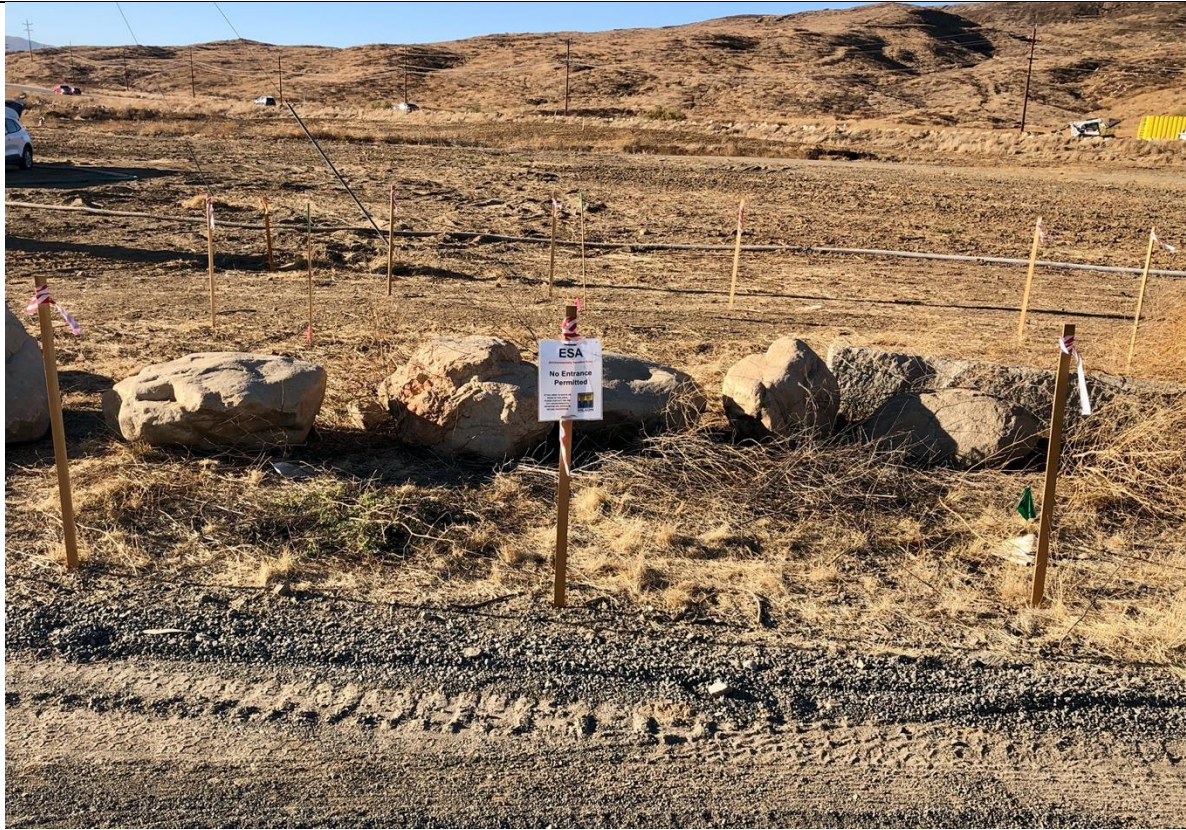
Photo 7 – A staked off area of botanical sensitivity between TSPs 408 and 409. Photo facing northeast

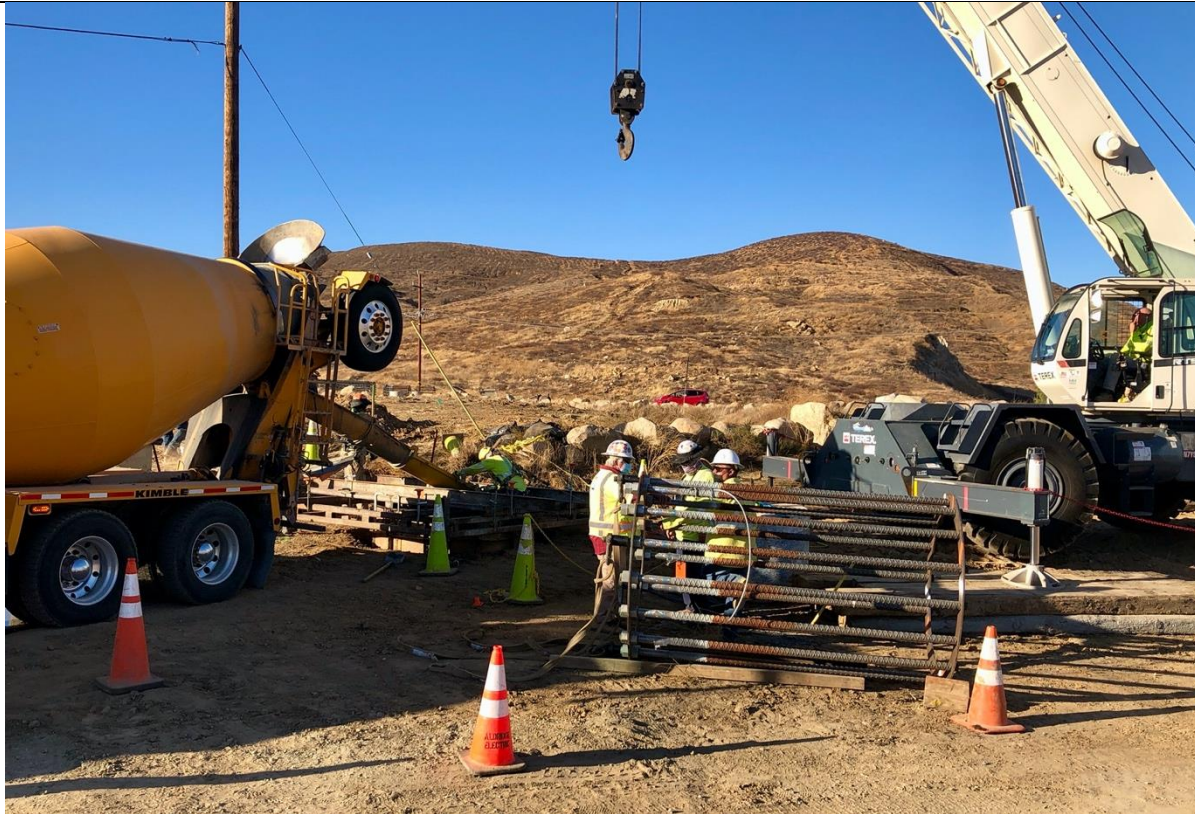
Photo 8 –
Installation of the
anchor bolt cage at
TSP 409. Photo
facing northeast

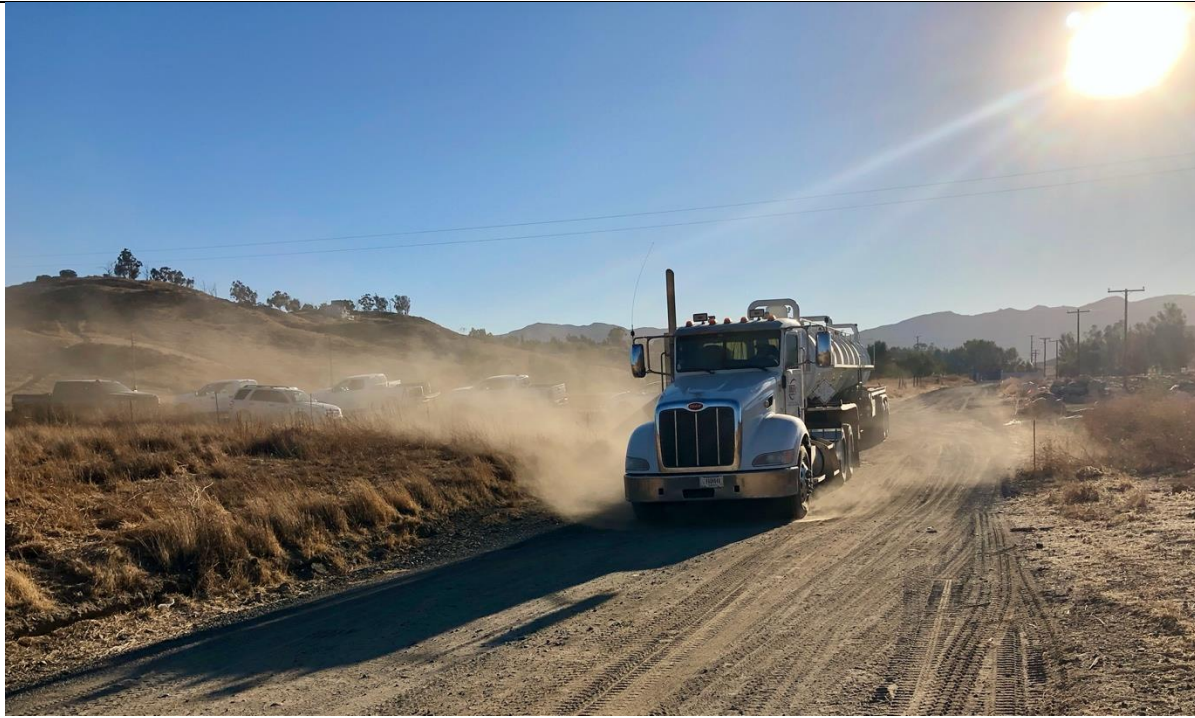
Photo 9 – Dusty
conditions around
TSPs 408 and 409.
Photo facing west

<p>MITIGATION MEASURES VERIFIED (Refer to MMCRP Report only on MMs pertinent to your observations today)</p> <p>All of the project personnel appeared to be WEAP trained.</p>
<p>RECOMMENDED FOLLOW-UP (i.e., items to check on next visit, minor issues to resolve)</p> <p>Dust control should be done several times a day.</p>
<p>COMPLIANCE SUGGESTIONS OR ADDITIONAL OBSERVATIONS (i.e., suggestions to improve compliance on-site, environmental observations of note)</p>
<p>COMPLIANCE SUMMARY</p> <p>Check all applicable boxes below to indicate new conditions or issues that have occurred since your last visit. Note this information on the monitoring datasheet and document with photographs.</p> <p><input type="checkbox"/> New biological or cultural discovery requiring compliance with mitigation measures, permit conditions, etc.</p> <p><input type="checkbox"/> Potential compliance incident(s) observed. Document incident(s) and potential for environmental resources to be impacted.</p> <p><input type="checkbox"/> New non-compliance issues reported by SCE monitors since your last visit. Describe issues and resolution under "compliance suggestions or additional observations" (above) and include SCE report identification number.</p>

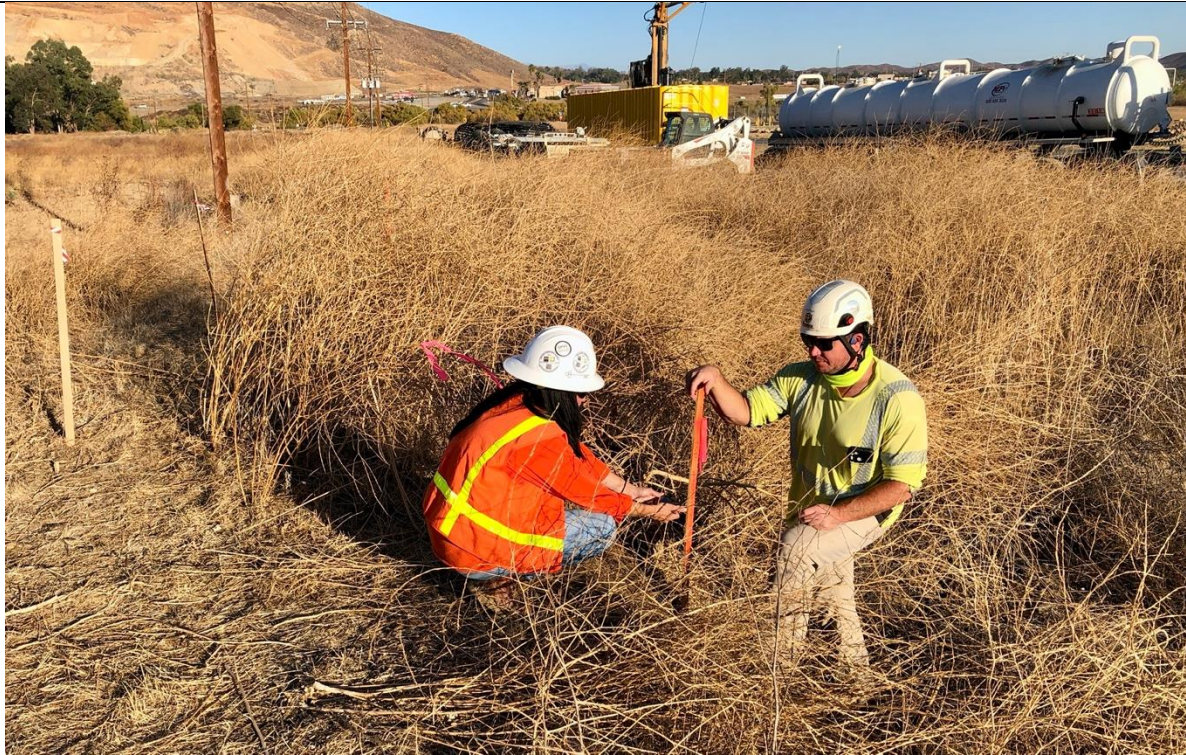
Photo 10 – The LEI and a drilling foreman discussing the impacts from work to be done at TSP 412E. Photo facing southeast

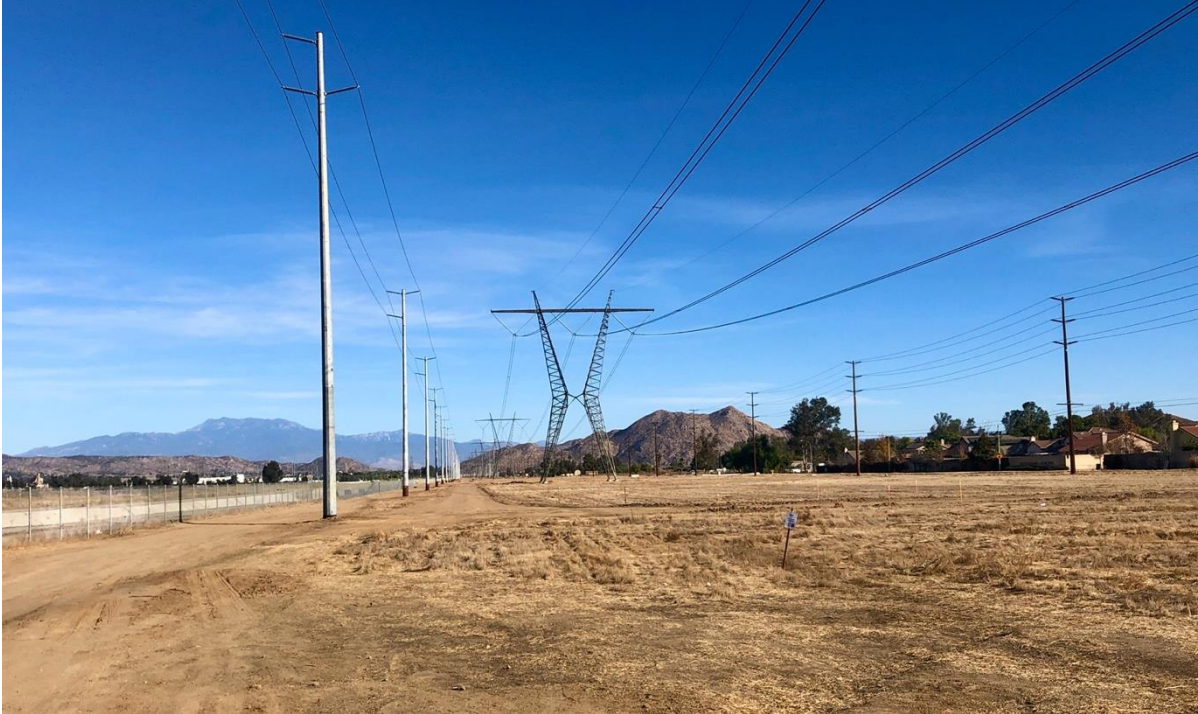
I met with the lead environmental inspector (LEI) at 1400 hours near tower 045E, which was at the Hwy 74 crossing. SCE had strung the wire from tower sites 007E to 073E and across Hwy 74 (Photo 1). Best management practices (BMPs) were installed around this tower site (Photo 2).

Photo 1 – Looking east from TSP 045E, wire has been strung on the newly installed TSPs. Photo facing east

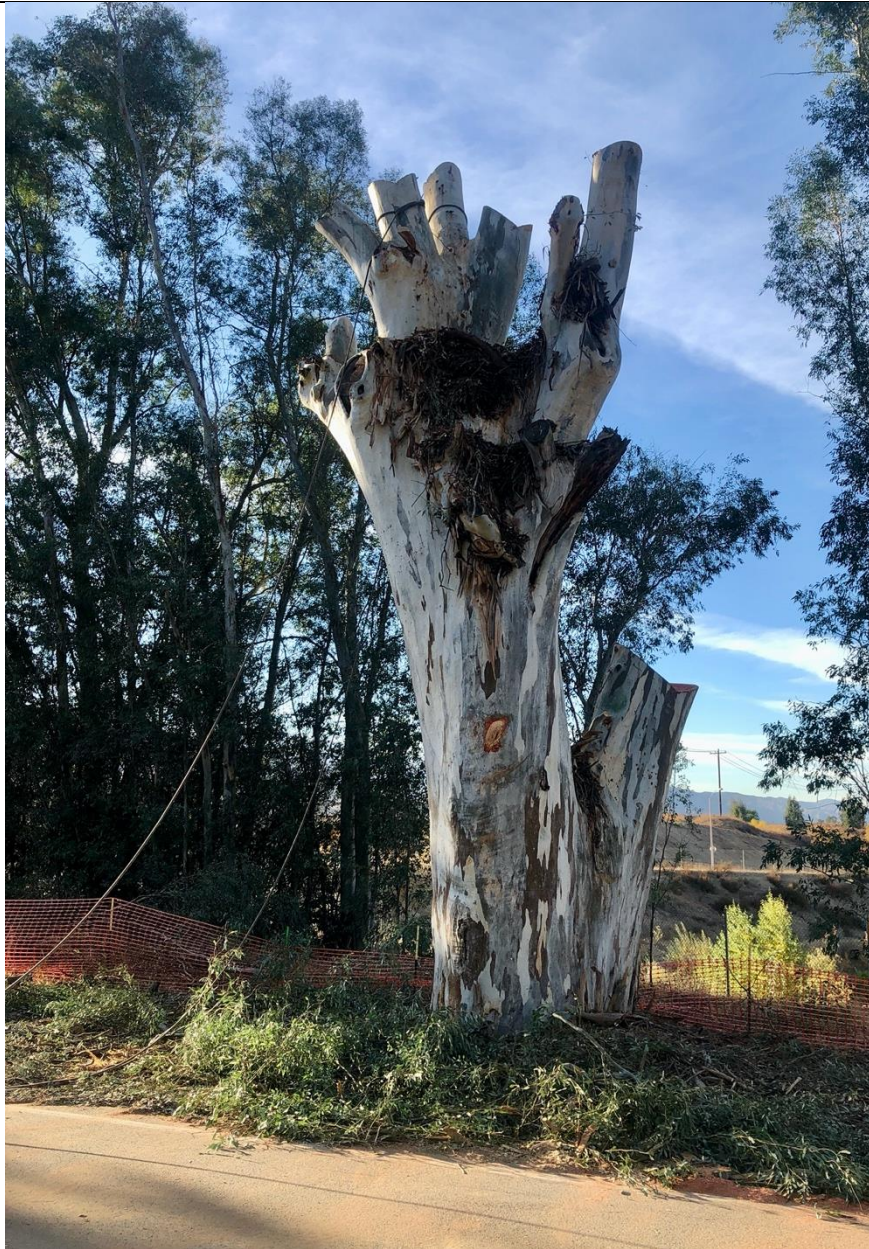
We drove north to a small section of Segment VIG5, where a lot of construction occurred. An onsite tree crew was removing large Eucalyptus trees within the transmission corridor (Photo 4). Another crew was pouring the foundation for TSP 449 (Photo 5). The concrete trucks were washing out in the designated concrete washout location (Photo 6). The foundation hole hit groundwater, so they were pumping out the water while the concrete pour was being performed. A drill rig was set up at TSP 450 and drilled a small portion of that foundation hole (Photo 7). The drill rig was idling, and I asked the LEI if it needed to be running; she was going to check with the crew about it.

Photo 4 –
Eucalyptus trees
being trimmed and
removed along
Segment 5 near
TSPs 449 and 450.
Photo facing
northwest

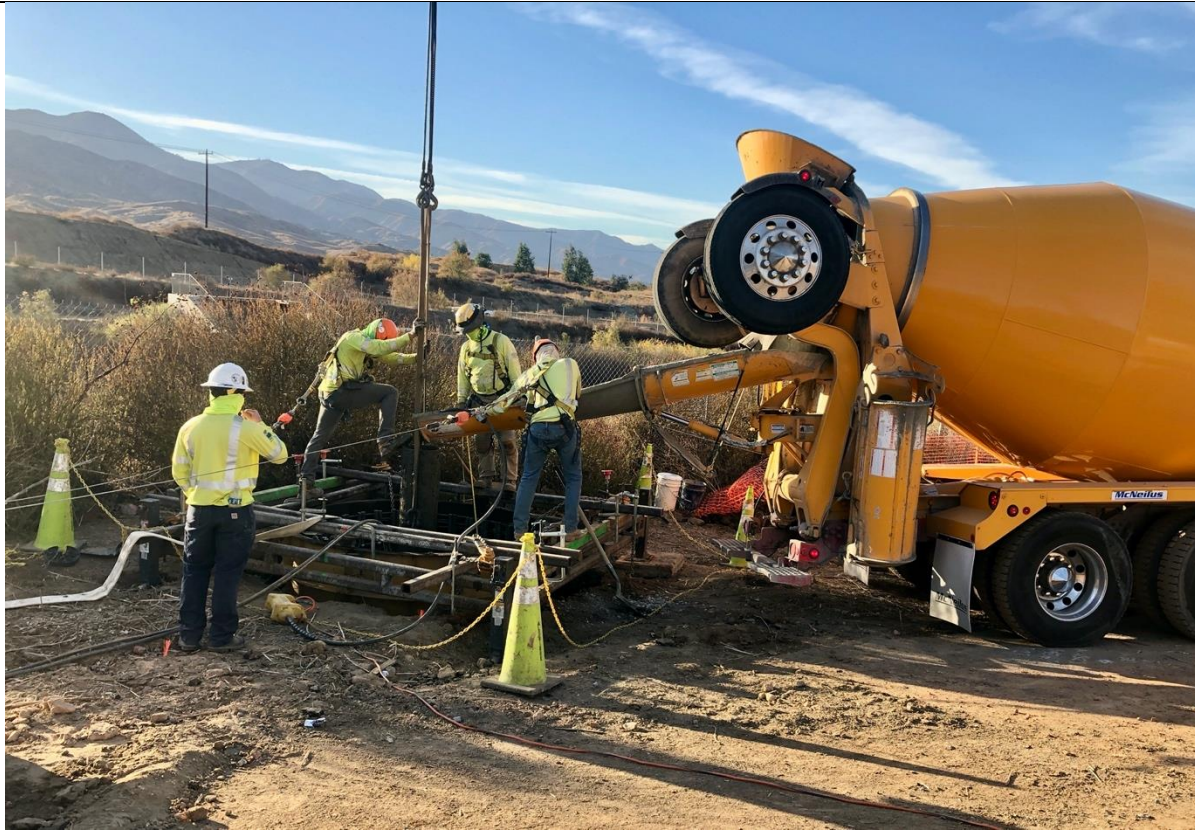
Photo 5 – Concrete
pour of TSP 449.
Photo facing
northwest

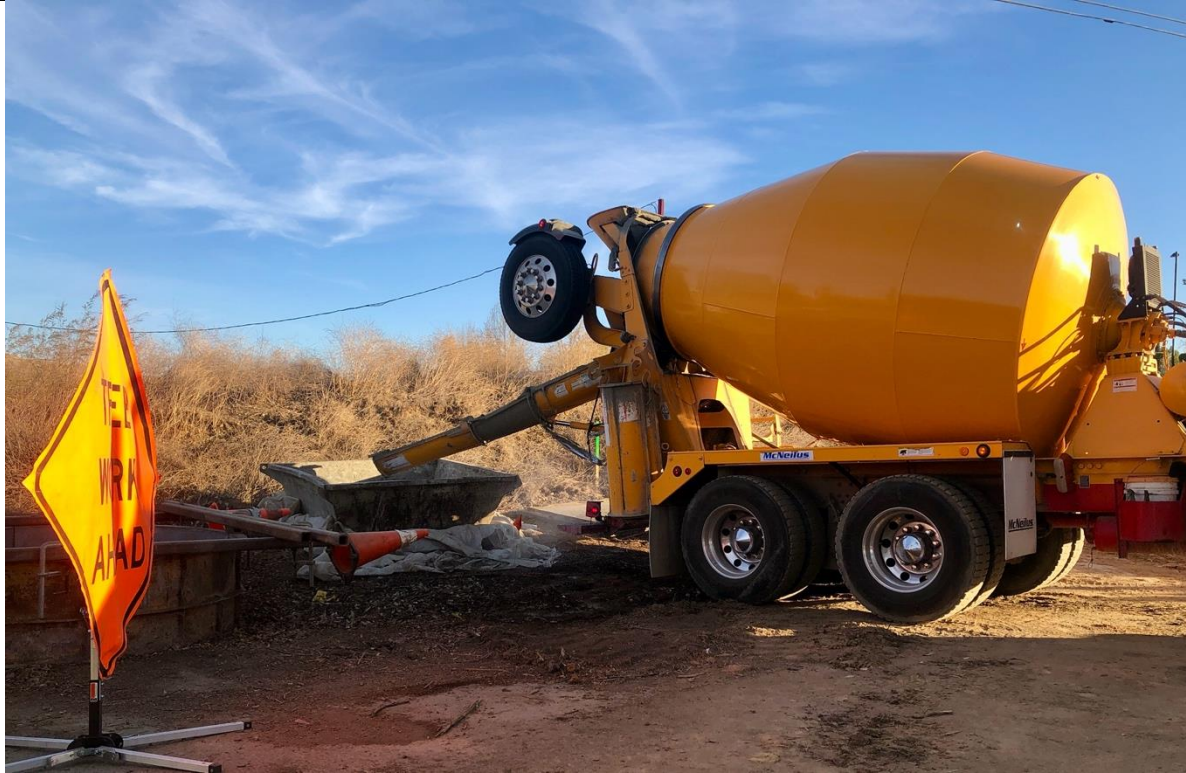
Photo 6 – Concrete washout station for the work at TSPs 449 and 450. Photo facing southwest

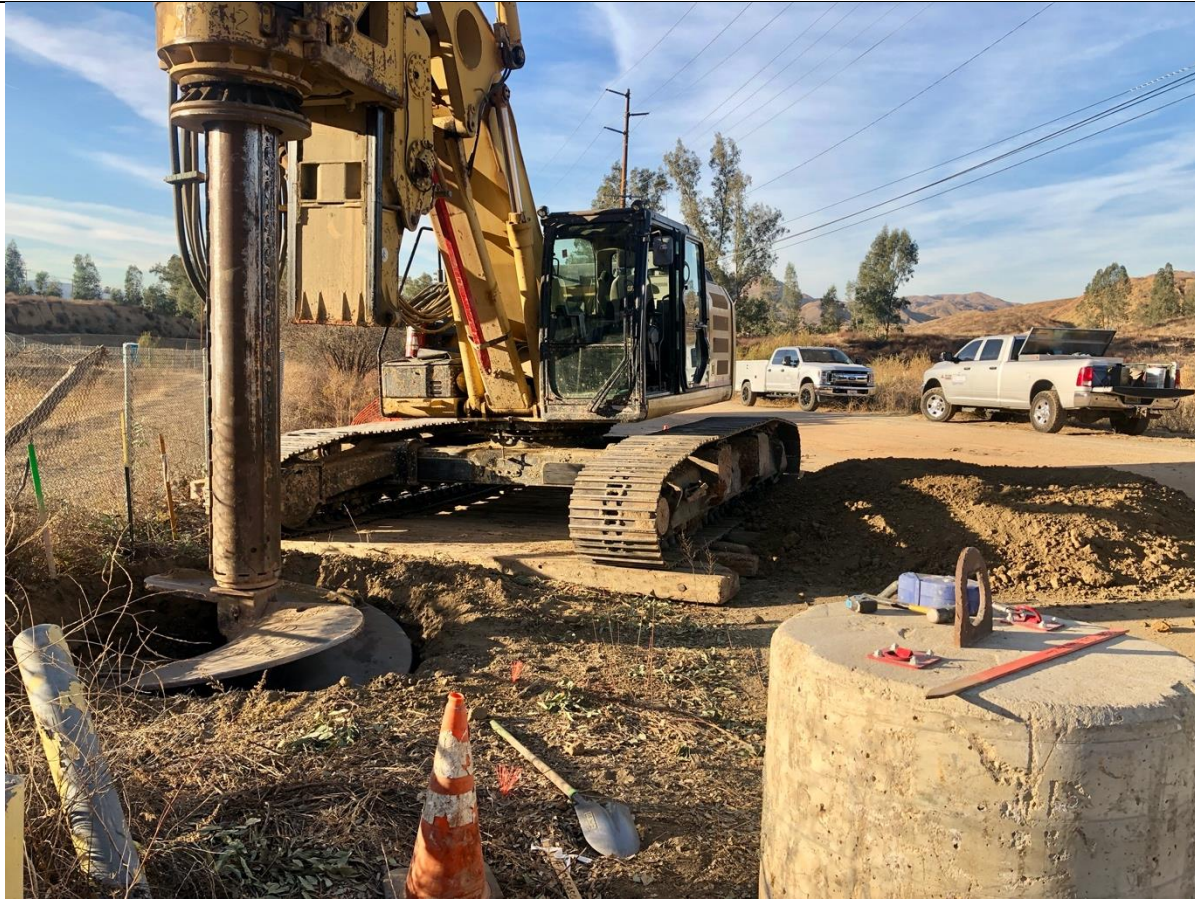
Photo 7 – Partial
drilling operation at
TSP 450. Photo
facing north

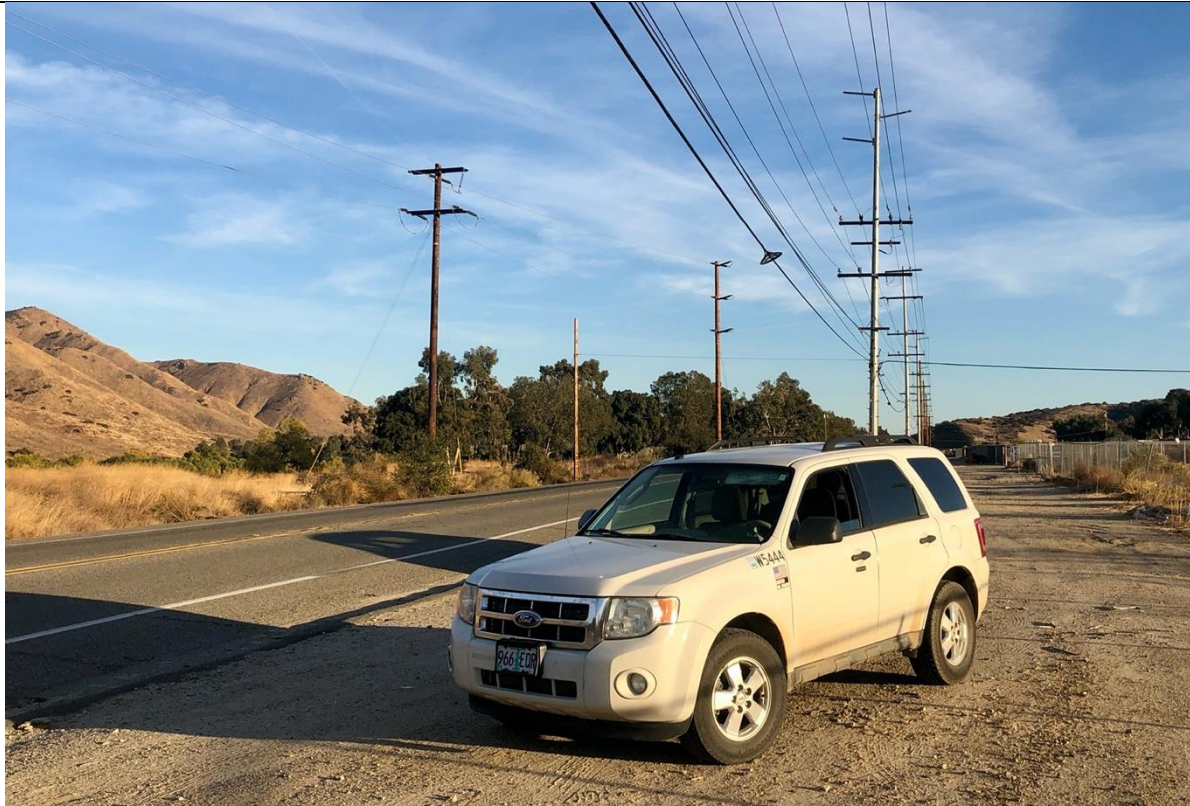
At Segment VIG7, the shoofly poles installed along the east side of the roadway were energized so crews could begin work on the new/permanent TSPs on the west side of the road (Photo 8).

Photo 8 – Shoofly towers at Segment 7. Photo facing south

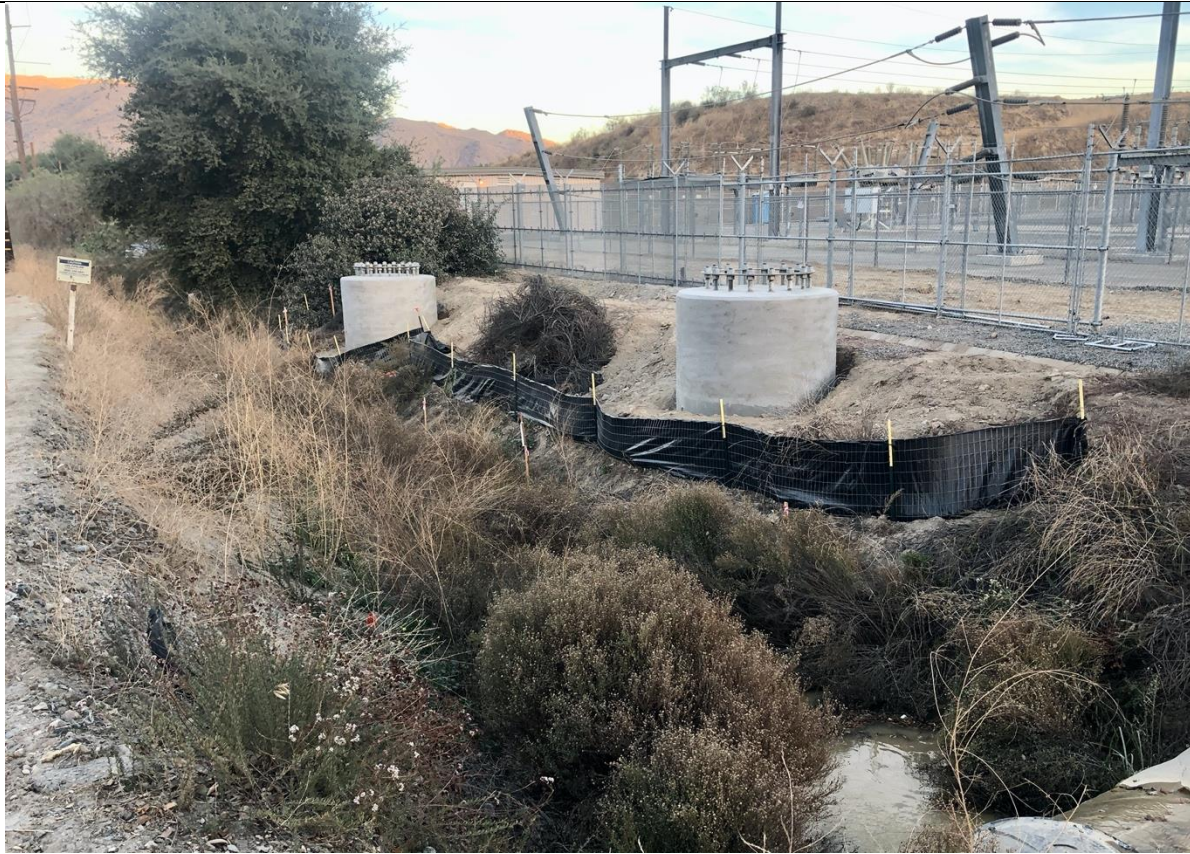
Our last stop was at the Ivyglen Substation, where SCE had installed several TSP foundations in the creek bank adjacent to the substation (Photo 9). The LEI said the drilling and pouring of the foundations went well, with no dirt or concrete spilling into the creek. There was flowing water in this small drainage; the runoff appeared to come from a mining operation upstream of the substation. The wire-backed silt fencing looks to have caught the small amounts of dirt sloughing down the creek bank.

Photo 9 – New TSP foundations adjacent to the IvyGlen substation. Photo facing south

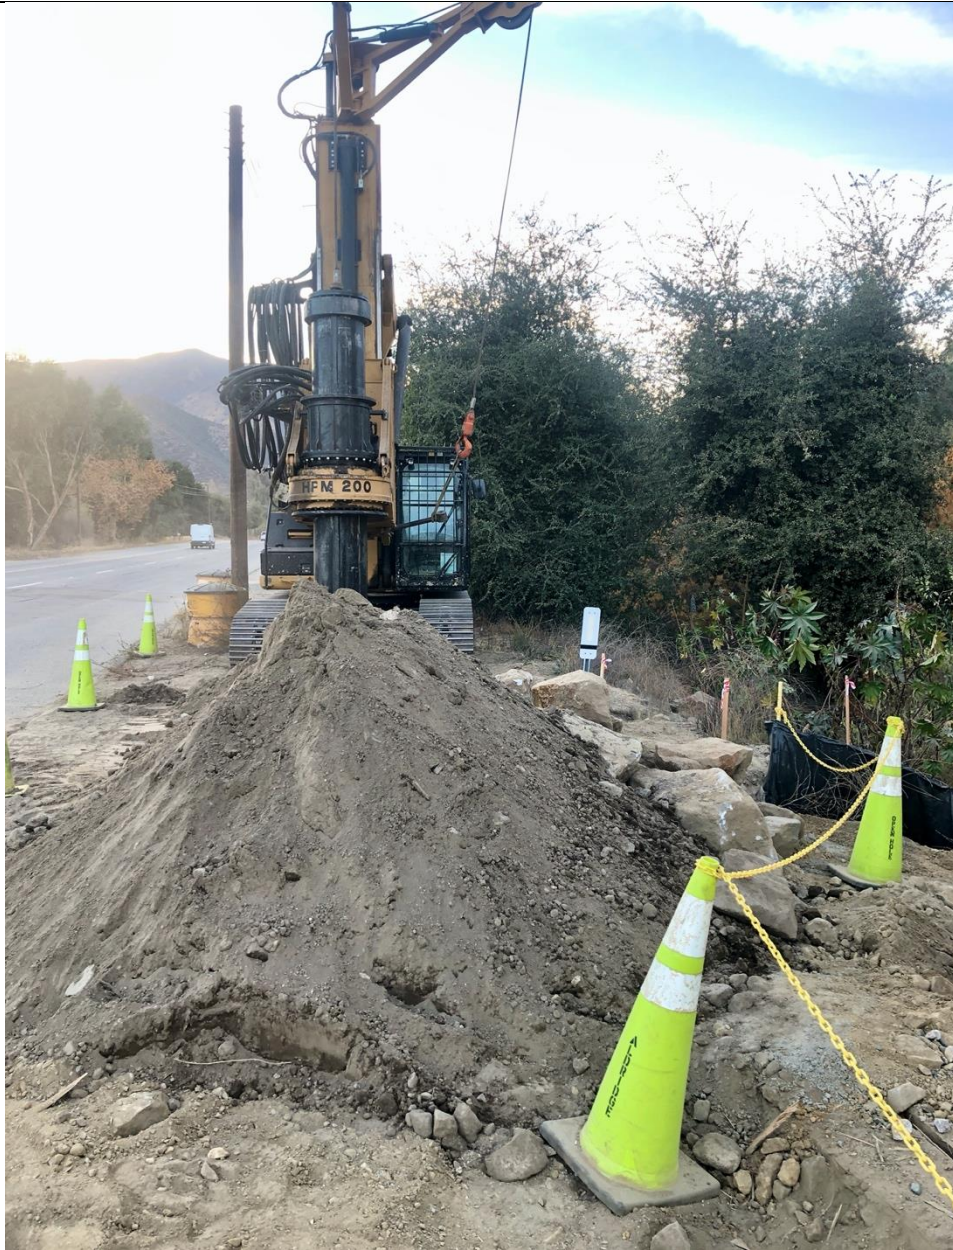
Photo 10 – Drilling operation across the street from the IvyGlen substation. Photo facing northwest

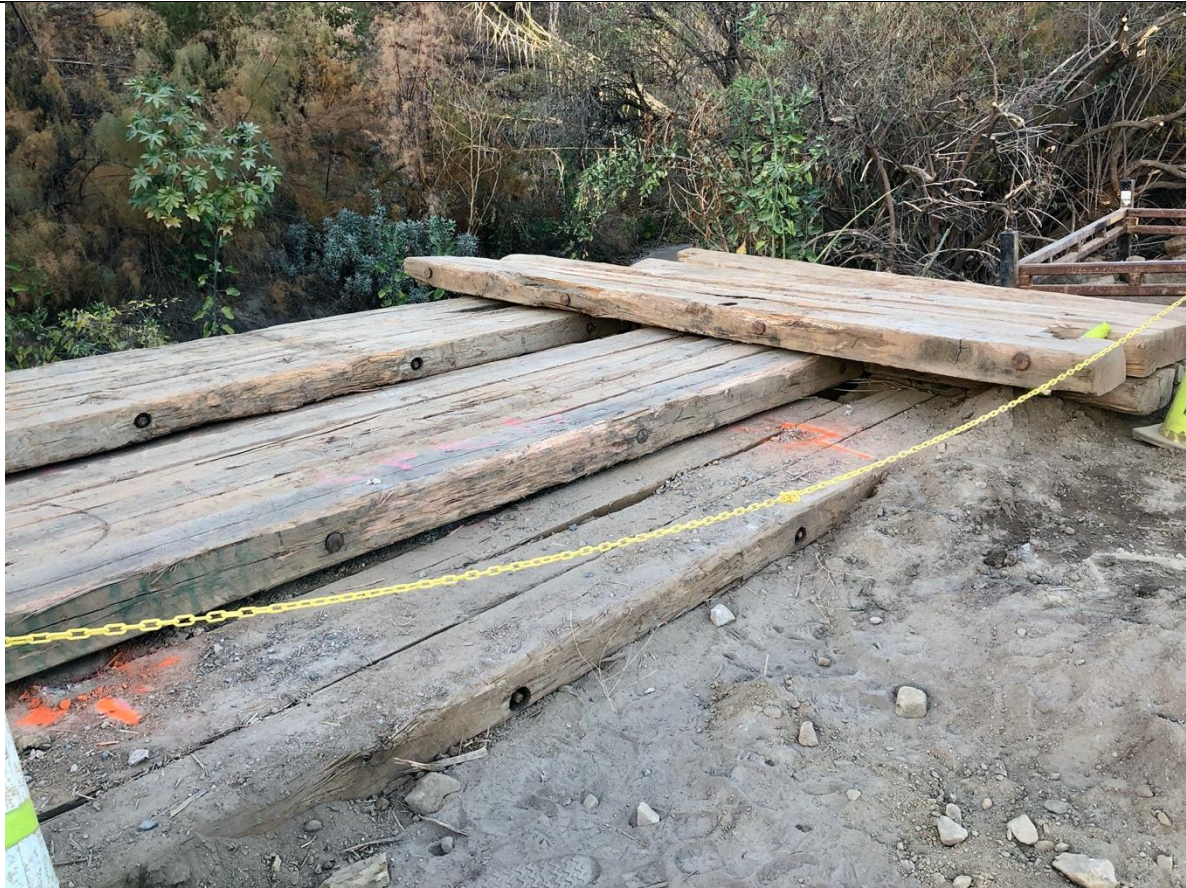
A drill rig was parked across the street from the substation (Photo 10). Another foundation hole had been partially drilled at this location, with tailings stockpiled onsite and wooden mats covering the hole (Photo 11). The wooden mats worked well to keep people from accessing the excavation, but there were many openings where small animals could enter and fall into the hole. The LEI called about getting this hole covered with plastic. We also noted that most of the parked equipment had secondary containment under it (Photo 12); however, one piece of equipment did not have any secondary containment and the LEI called in about that too.

Photo 11 – Wooden matting covering the partially drilled foundation hole.

Dust control should be done several times a day.
Any excavations should be sealed so that small animals cannot enter them.

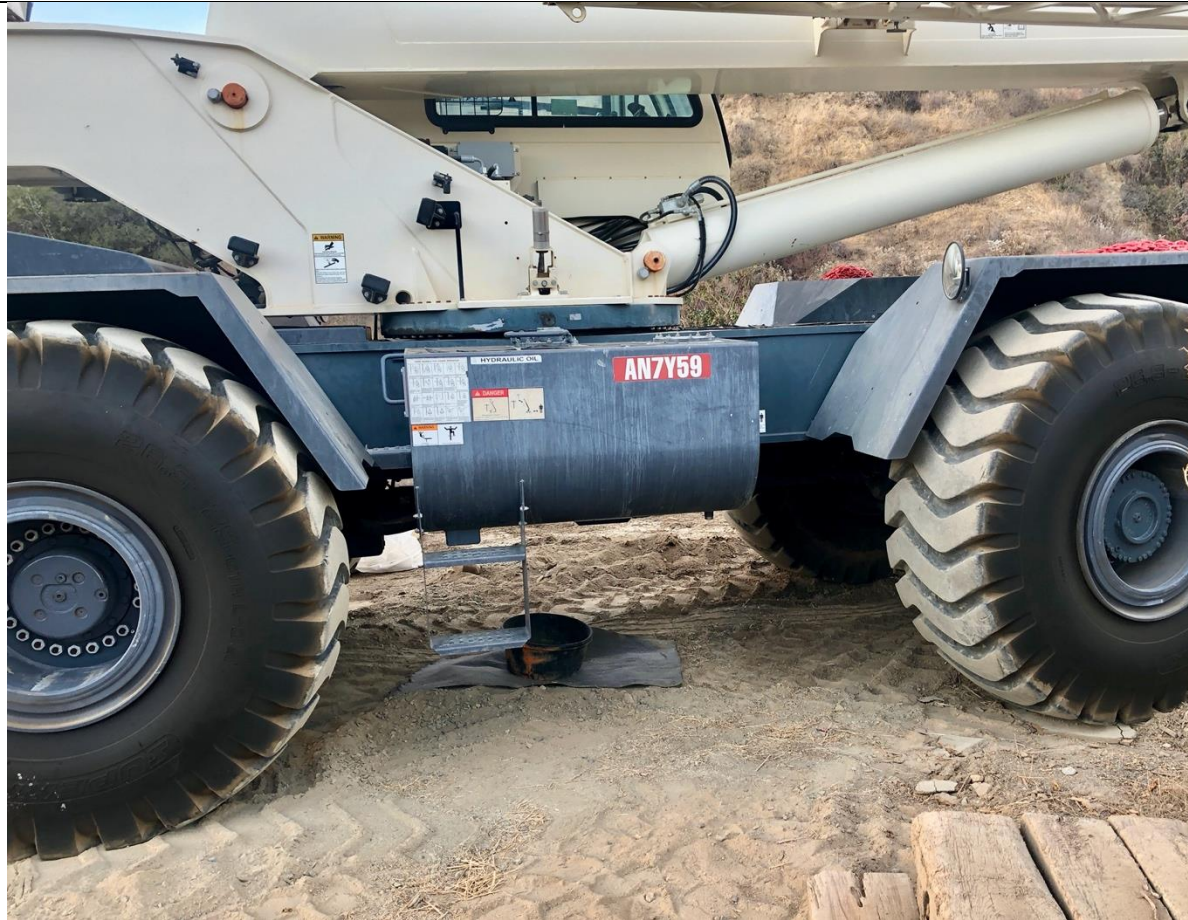
Photo 12 –
Secondary
containment under
parked equipment.
