Re: Monthly Report Summary #7 for the Valley-Ivyglen 115-kV Substation (VIG) Project

Valley – Ivyglen Subtransmission Project CPUC Site Inspection Form

Project:	Valley – Ivyglen Project	Date:	January 6, 2021
Project Proponent:	SCE	Report #:	VS013
Lead Agency:	California Public Utilities Commission	Monitor(s):	Vincent Semonsen
CPUC PM:	Patricia Kelly, Energy Division	AM/PM Weather:	Partly cloudy, mild temps and breezy
CPUC-CM (WSP):	Chuck Cleeves	Start/End time:	1300 hrs – 1530 hrs
Project NTP(s):	NTP-1.

Project:	Valley – Ivyglen Project	Date:	January 20, 2021
Project Proponent:	SCE	Report #:	VS014
Lead Agency:	California Public Utilities Commission	Monitor(s):	Vincent Semonsen
CPUC PM:	Patricia Kelly, Energy Division	AM/PM Weather:	Partly cloudy, mild temps and breezy
CPUC-CM (WSP):	Chuck Cleeves	Start/End time:	1345 hrs – 1600 hrs
Project NTP(s):	NTP-1.

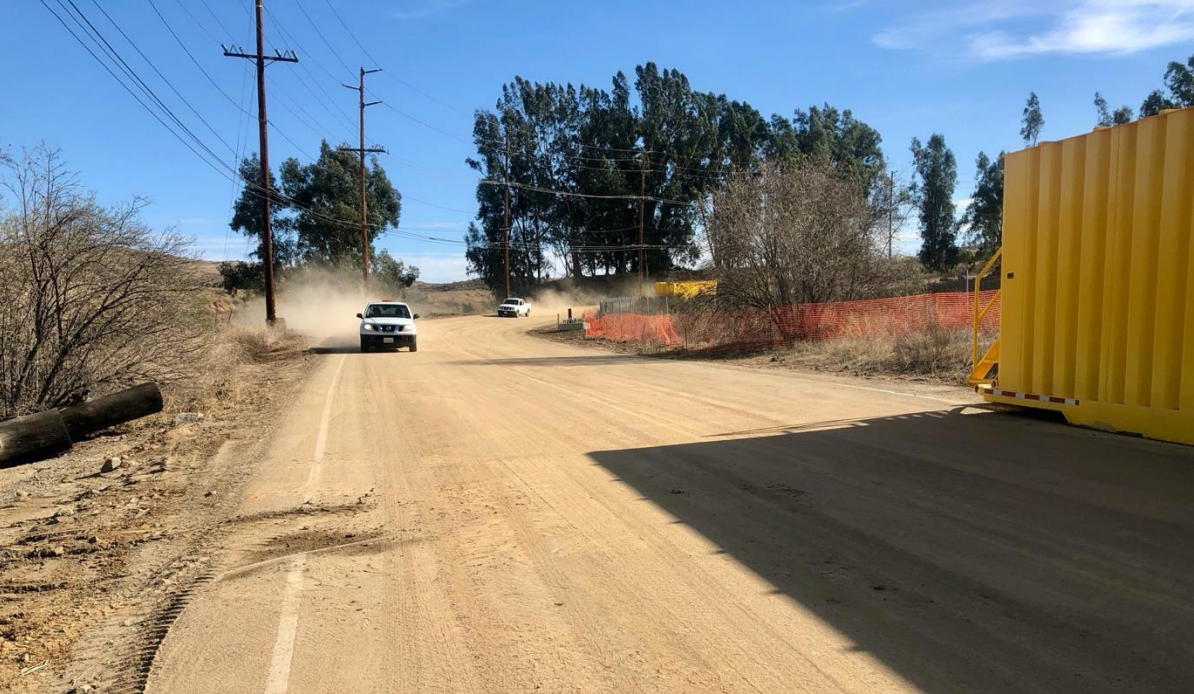
We drove to tubular steel pole (TSP) 452, which had been drilled and poured (Photo 1). Crews were still working on removing eucalyptus trees along this stretch and the baker tanks were still in place. SCE installed Environmental Sensitive Area (ESA) signage as wetlands were on both sides of the road (Photo 2). The road was extremely dusty, and I spoke with the LEI about sweeping this small section (Photo 3). She said other projects nearby were using the road and could be contributing to the dust problem.

Photo 3 – A very dusty access road along the transmission corridor. Photo facing south

Dust control should be done several times a day.
Any excavations should be sealed so that small animals cannot enter them.

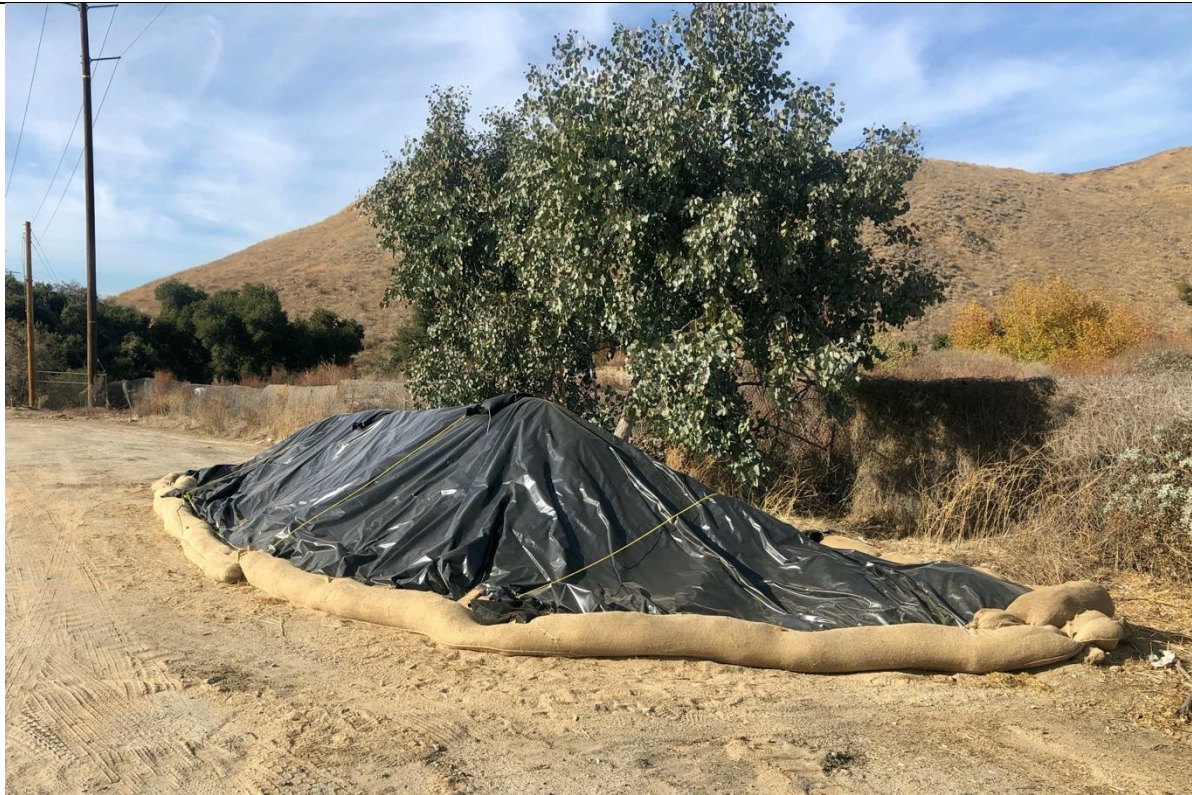
We drove out to Segment VIG7, where we met with an Environmental Inspector. The LEI had a phone meeting, so the environmental inspector was now my escort. A nearby pile of dirt from the pole installation had been covered in plastic and ringed with straw wattles (Photo 4). At TSP site 574 crews had done some site prep work prior to the foundation work, building a temporary access road with some of the spoils and putting in silt fencing (Photo 5).

Photo 4 – BMPs
over and around a
spoil pile. Photo
facing northeast

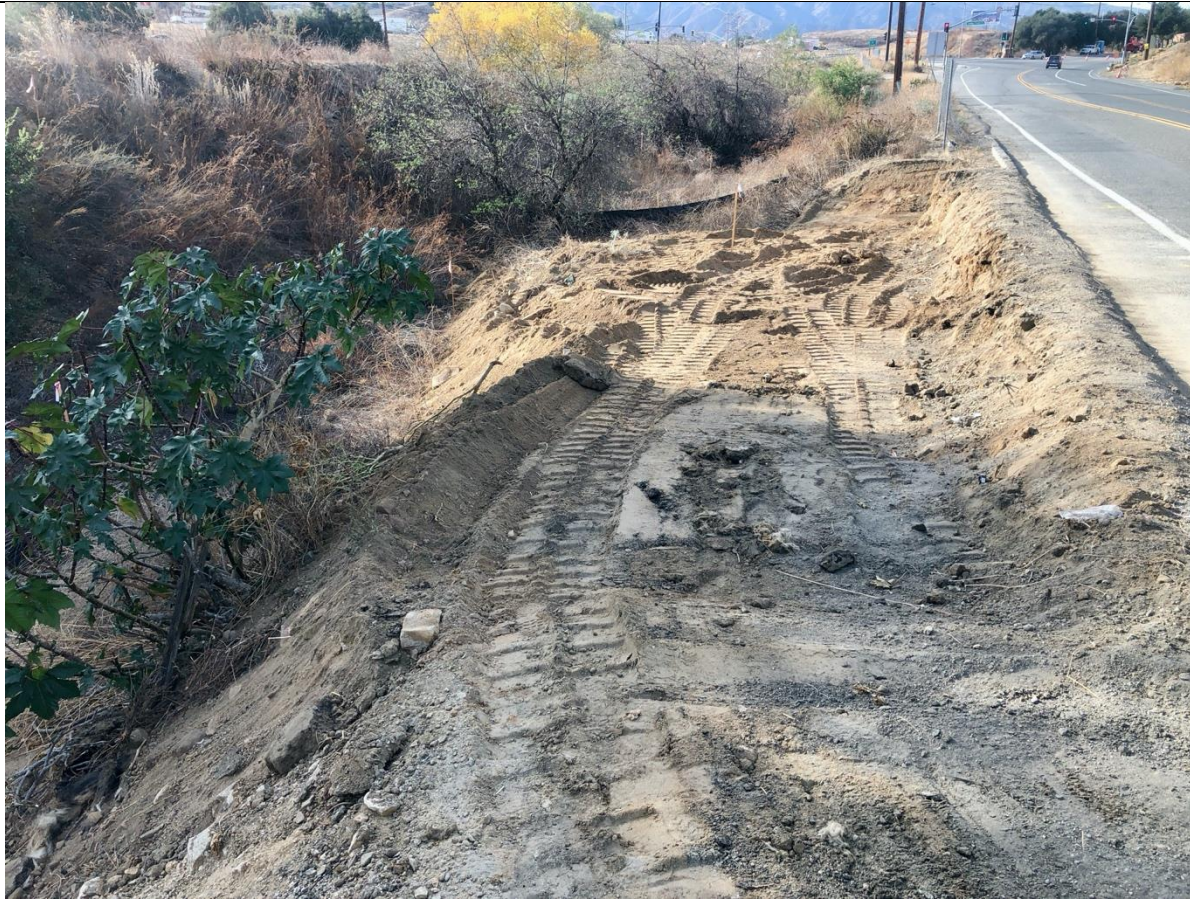
Photo 5 – Site preparation before foundation drilling at TSP 574. Photo facing northwest

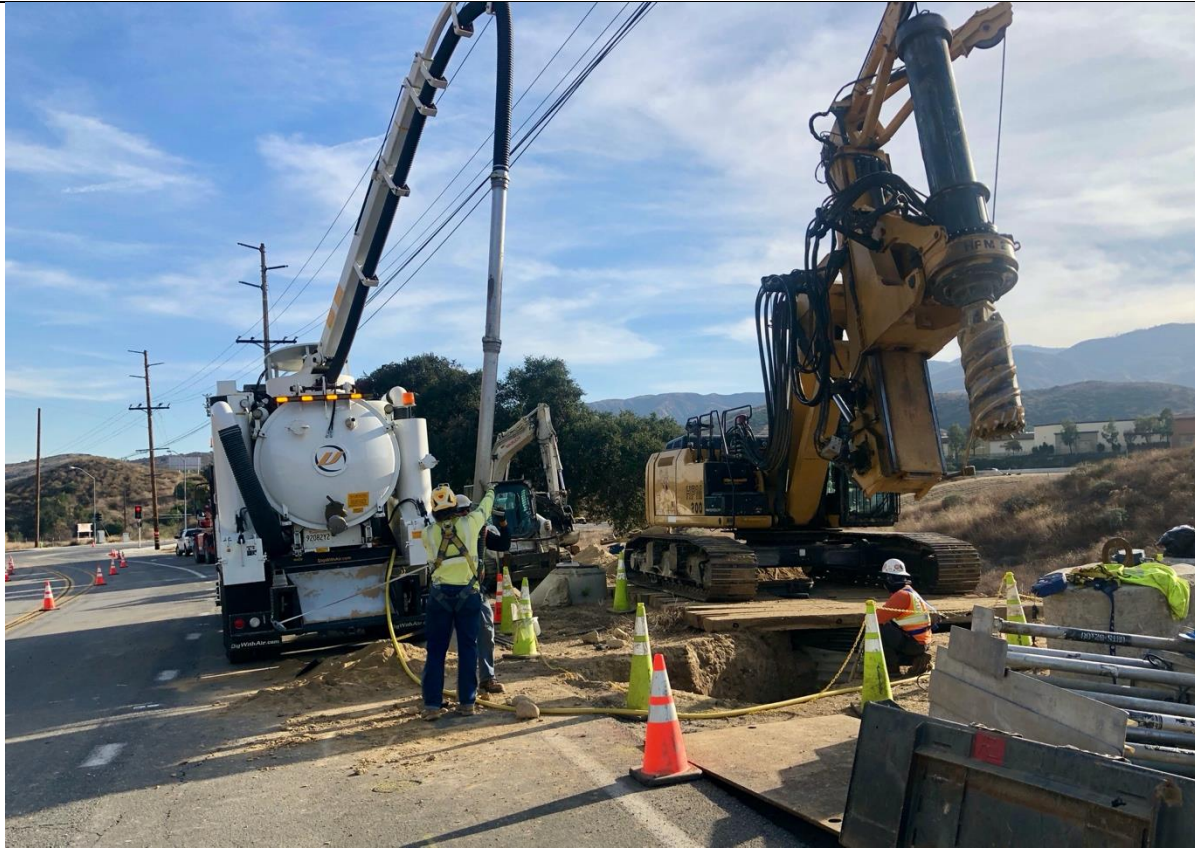
A drilling crew was working on the foundation hole in five TSP locations to the north at TSP 579 (Photo 6). They were currently excavating with a hydrovac truck, and a paleontological monitor was nearby spot-checking the spoils.

Photo 6 –
Foundation
excavation at TSP
579. Photo facing
southwest

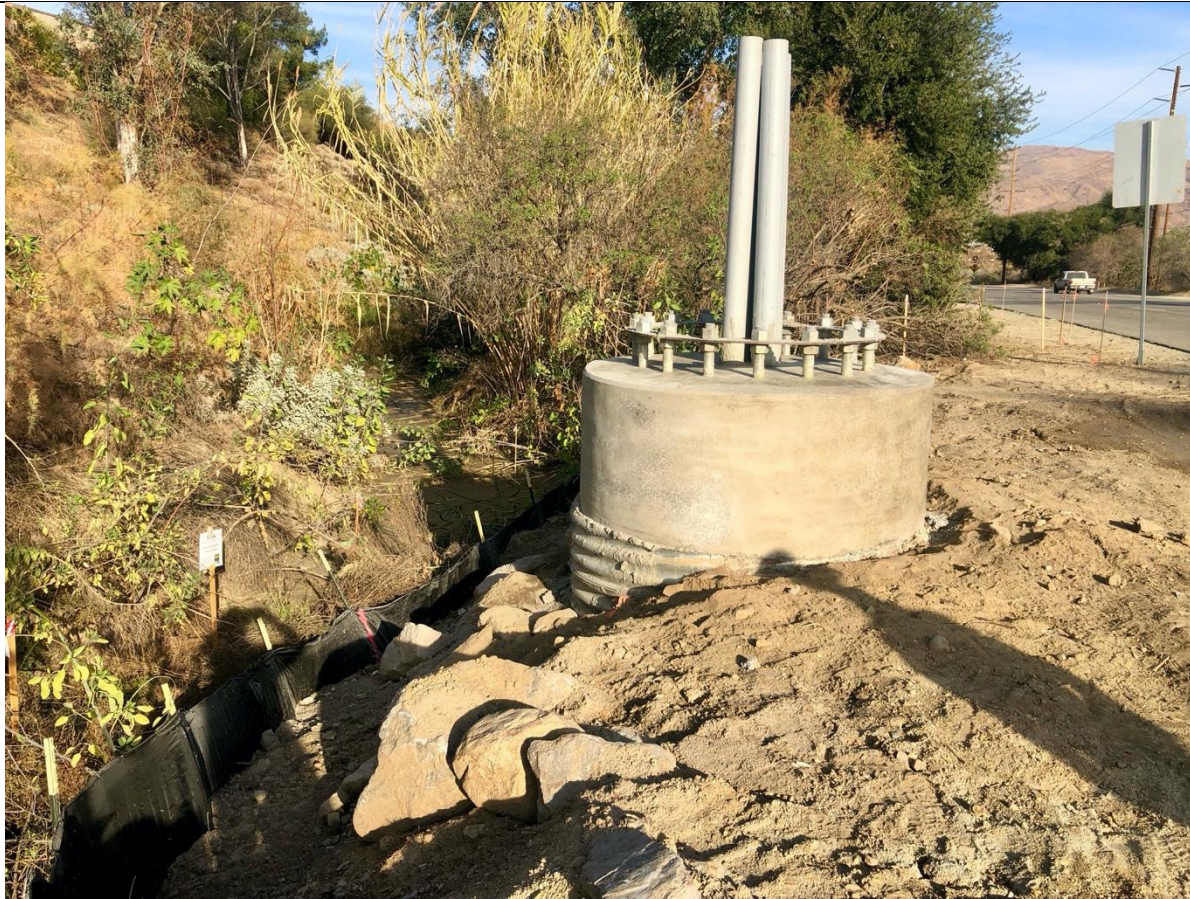
From there we went to the Ivyglen Substation to look at the TSP foundation work. The roadway's TSP foundation on the north side was complete, including the conduit installation (Photo 7). However, the silt fencing below the foundation and along the small creek held up well, catching the bit of dirt sloughing down from the hole. The Environmental Inspector said they would clean up the area and pull the dirt from along the silt fence.

Photo 7 – Newly
poured foundation
near the IvyGlen
substation. Photo
facing east

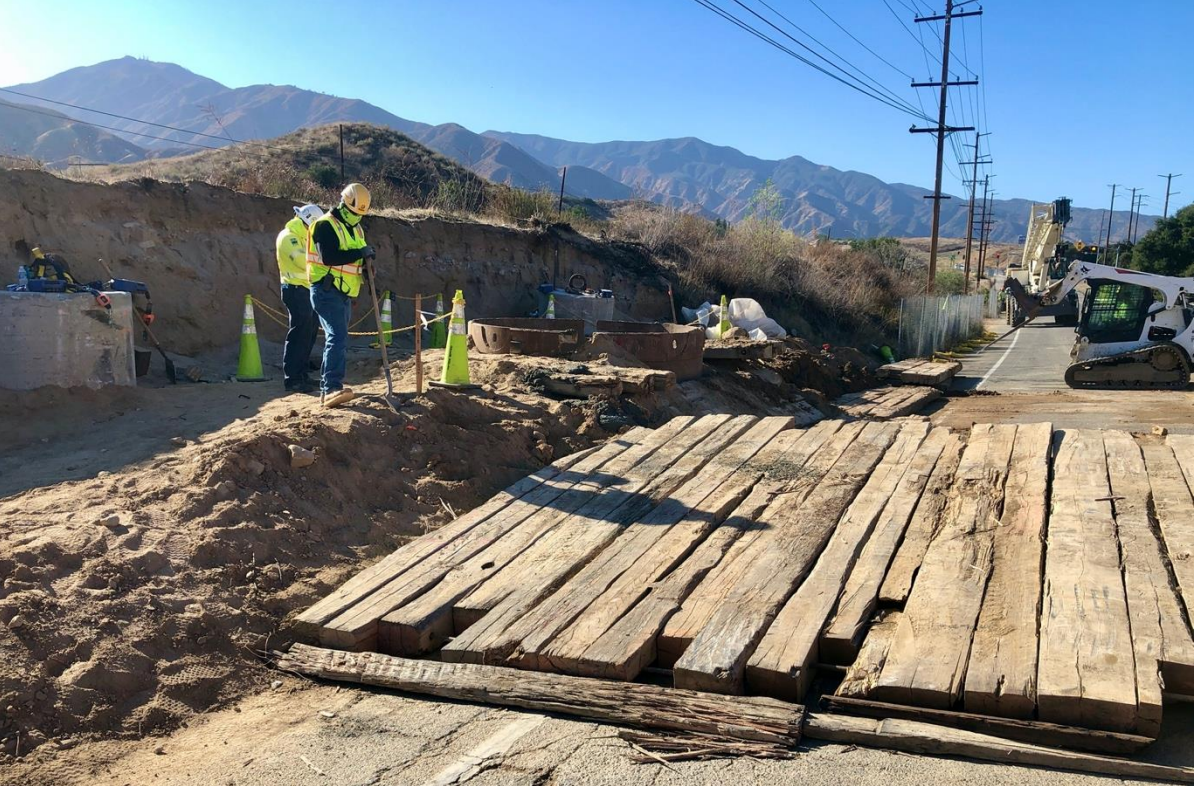
Photo 1 – Drilling work underway at TSP 573. Photo facing northwest

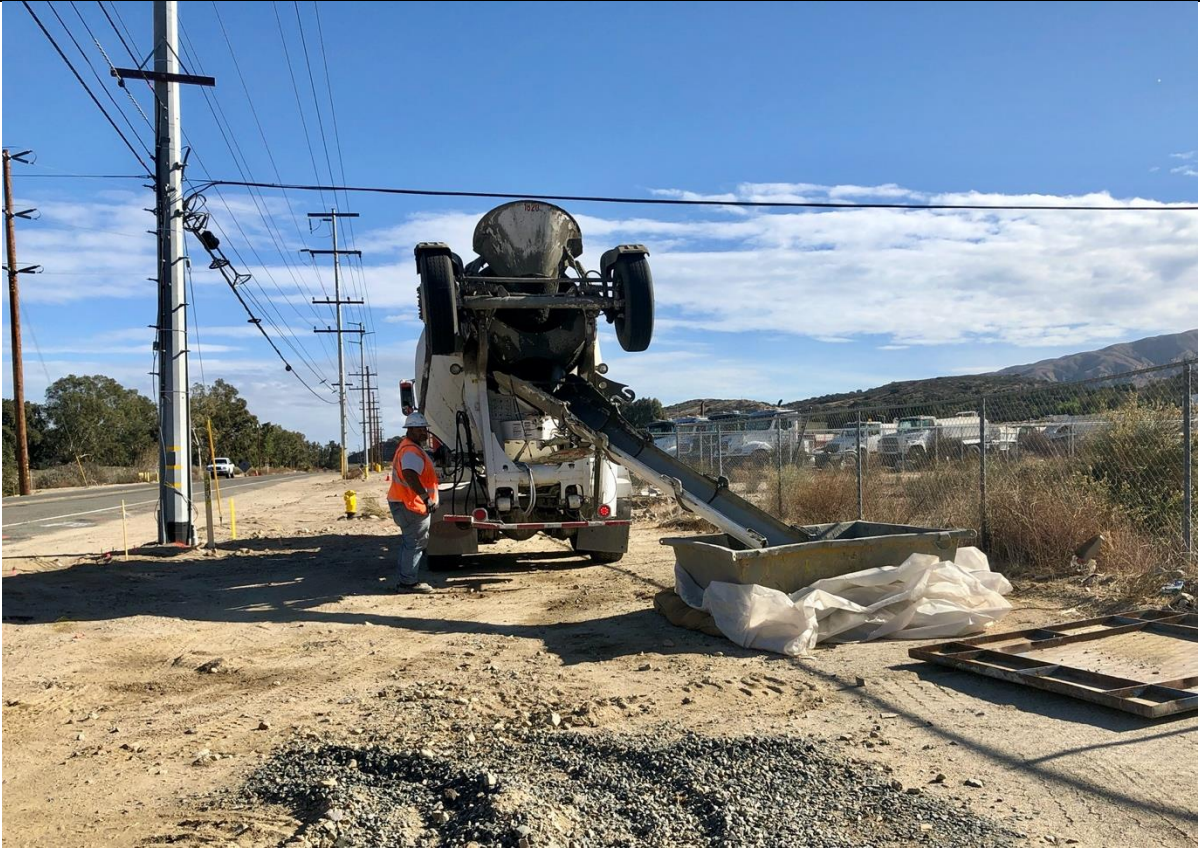
Photo 2 – Proper concrete washout work after pouring slurry. Photo facing south

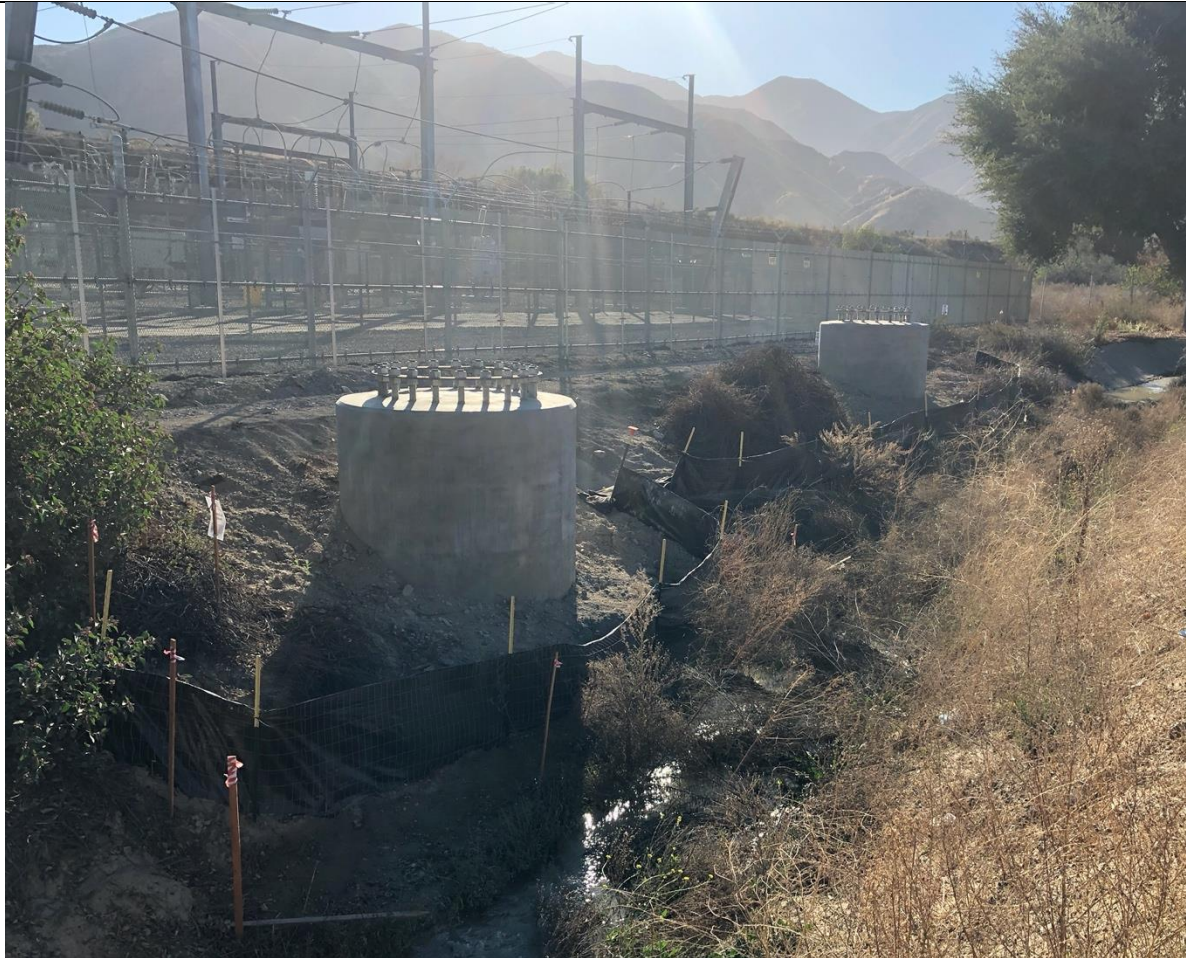
Photo 4 – Newly installed TSSs near the IvyGlen substation. BMPs look good. Photo facing west

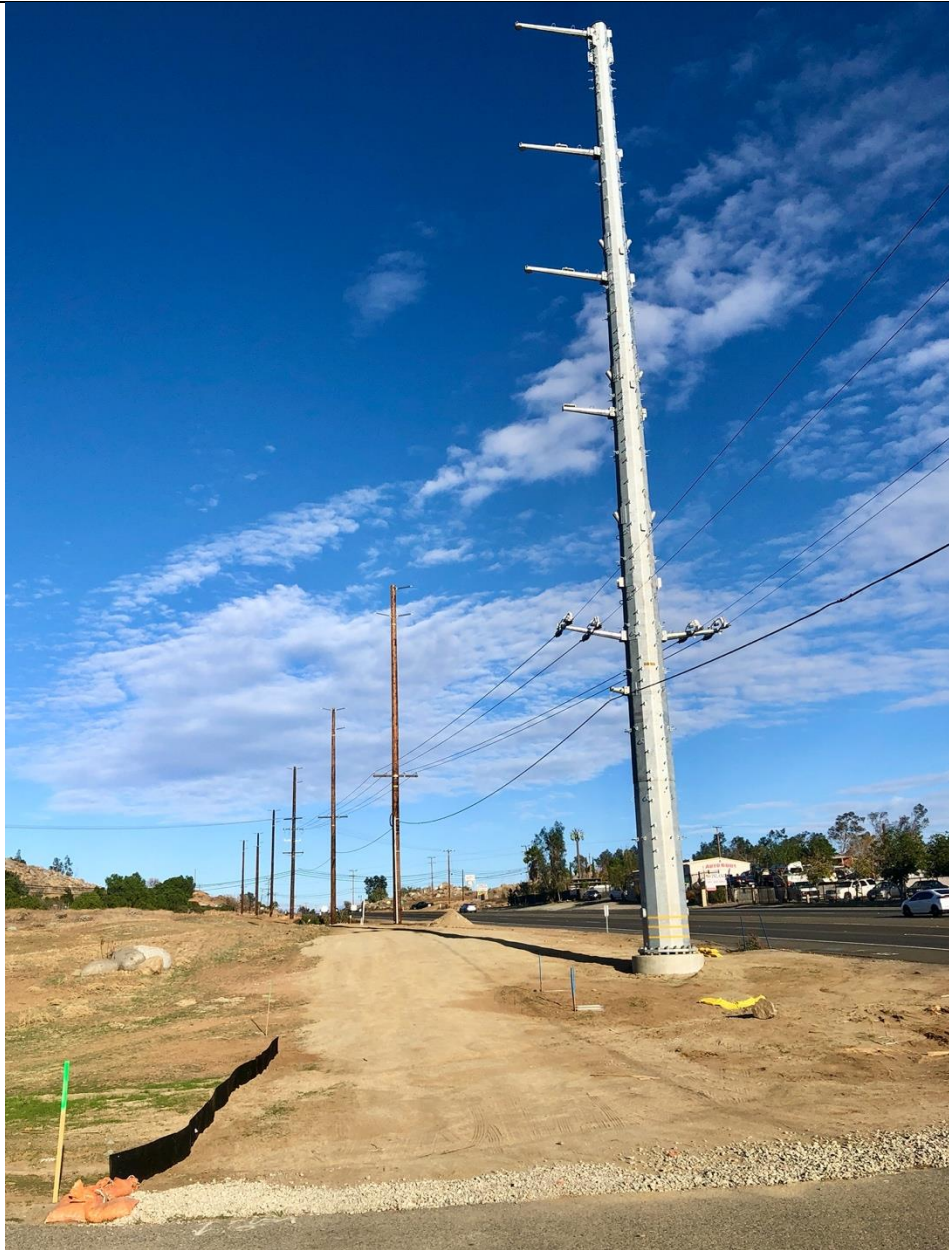
Photo 5 – Newly
installed TSP 245
with BMPs in place.
Photo facing east

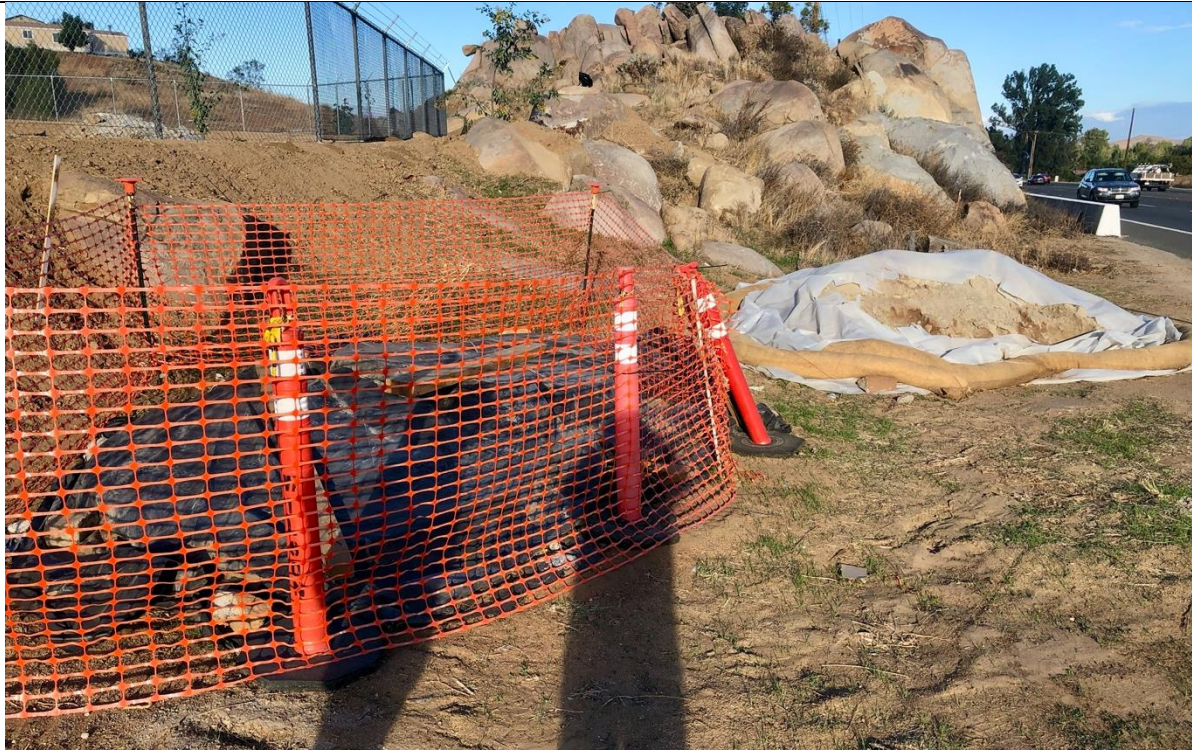
Photo 6 –
Foundation hole
excavation in
progress. Photo
facing east

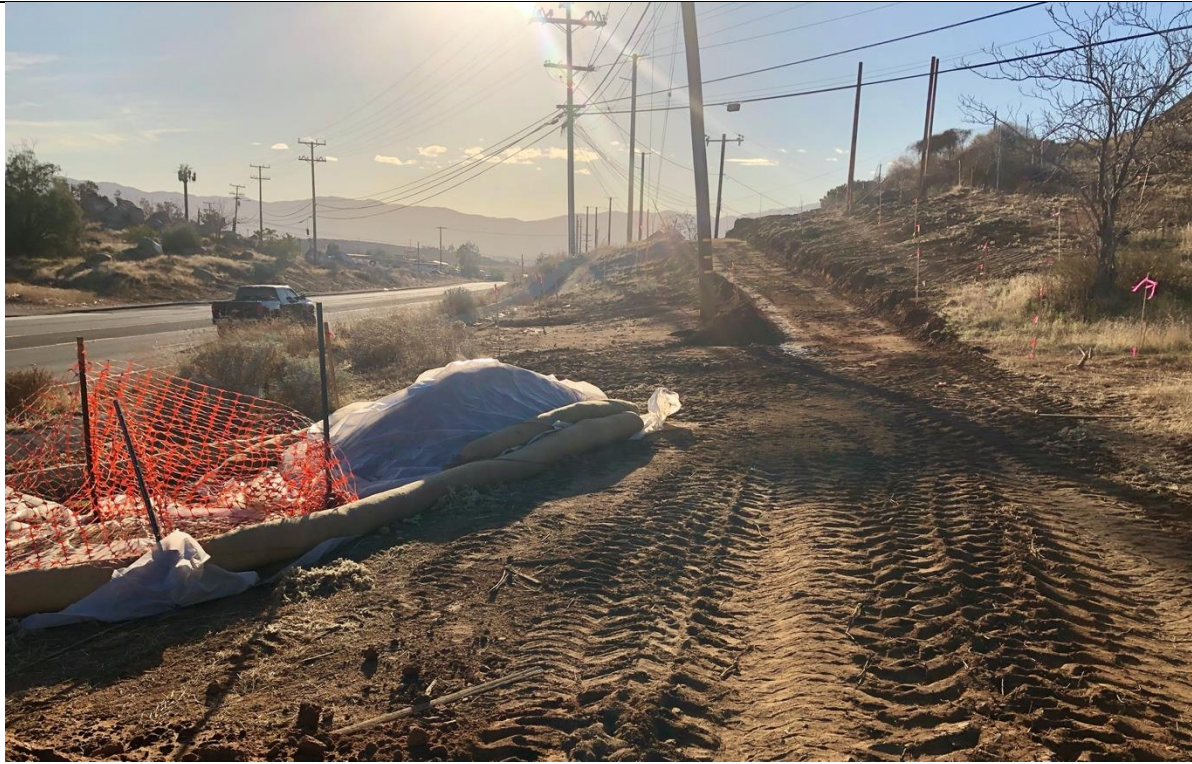
Photo 7 – Road
work under the new
transmission towers
near pole #236.
Photo facing west
