**Re: Monthly Report Summary #9 for the Valley-Ivyglen 115-kV Substation (VIG) Project**

CPUC Site Inspection Reports

## Valley – Ivyglen Subtransmission Project CPUC Site Inspection Form

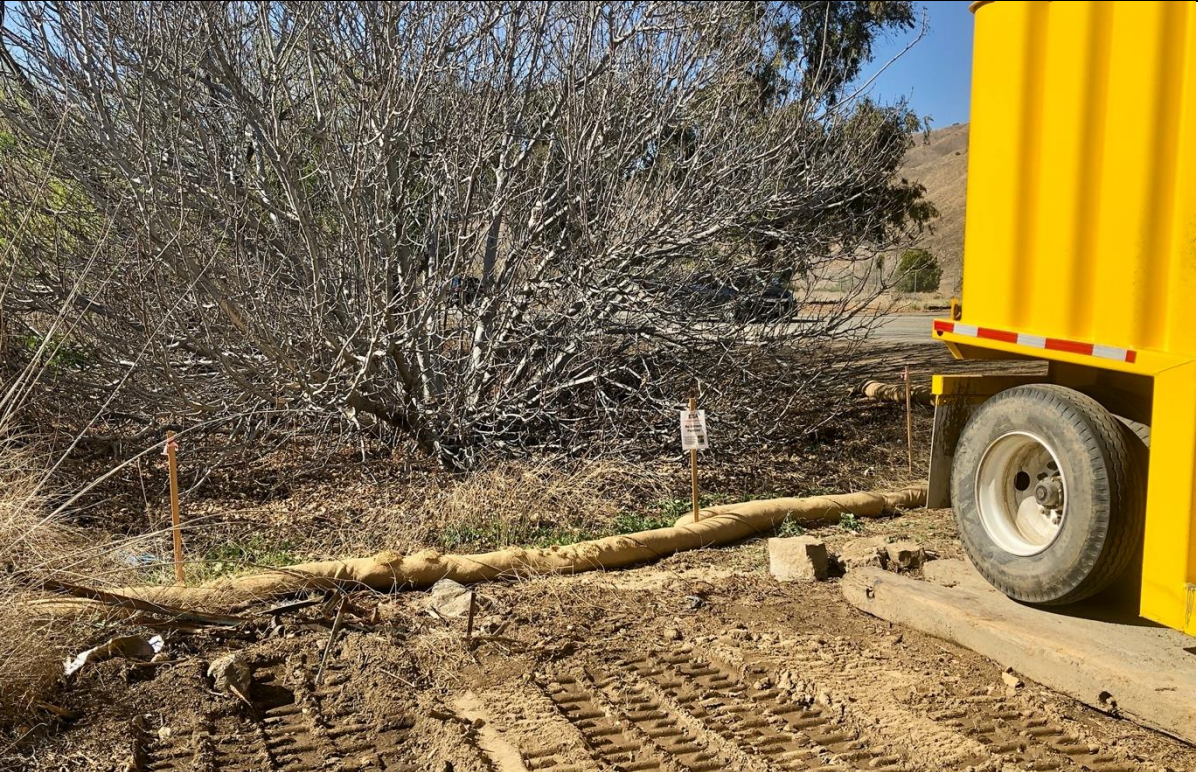
A photograph of a construction site. On the right, the rear portion of a yellow dump truck is visible, including its rear wheel and a concrete curb. A silt fence, made of a long, thick, tan fabric strip, runs across the middle ground. Behind the silt fence, there is a wooden sign on a post. The background consists of a dense thicket of bare, greyish-brown trees and shrubs under a clear blue sky. The ground in the foreground is dirt with visible tire tracks.	Photo 3 – BMPs and ESA signage is in place at Tower site 496 2196E. Photo facing northwest

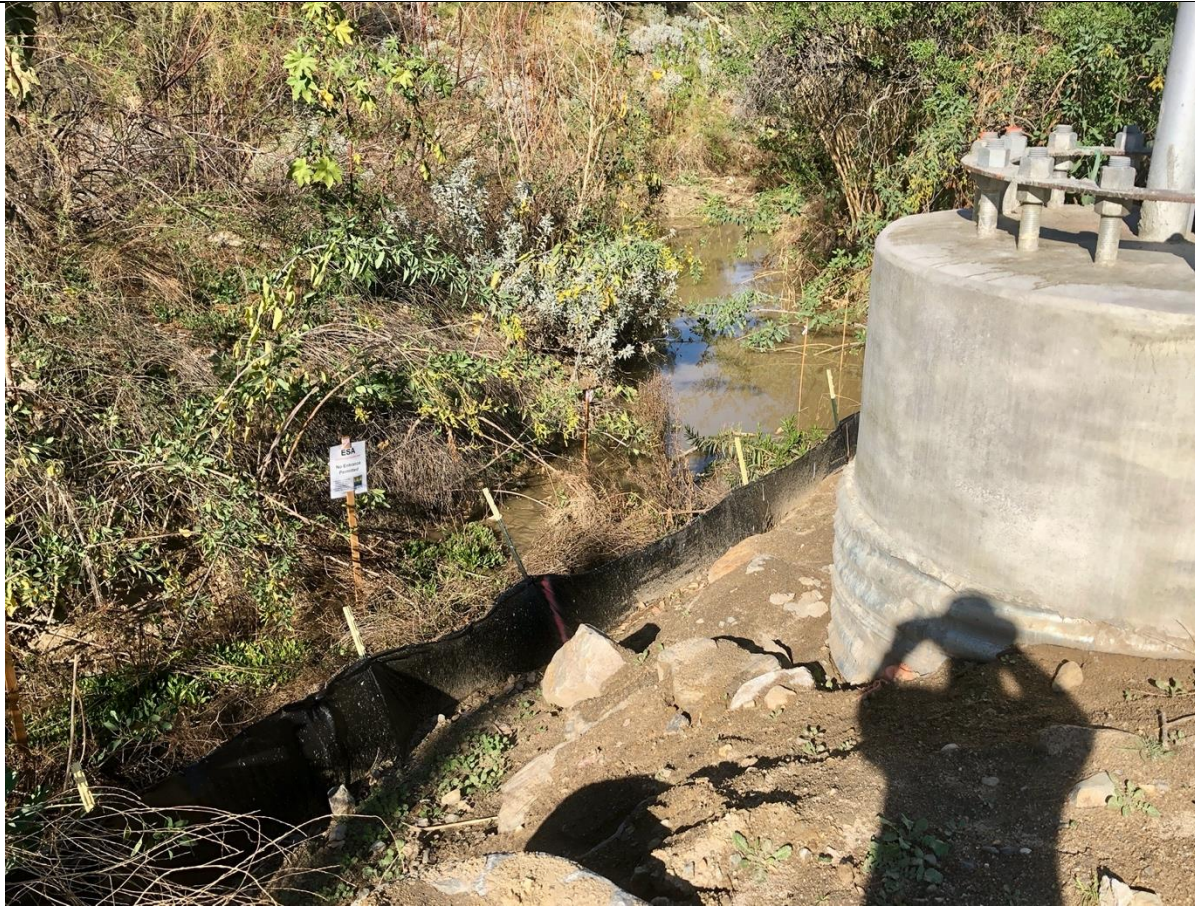
Photo 5 – Tower foundation across the street from the IvyGlenn substation.

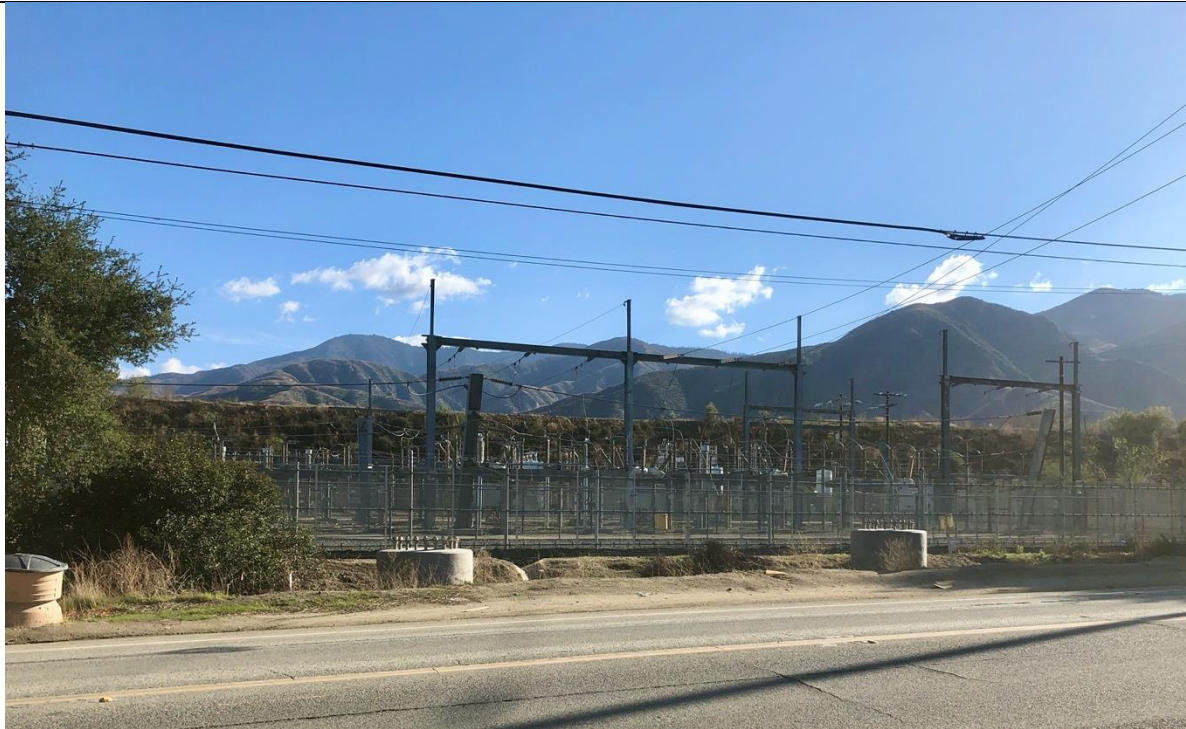
Photo 6 – Tower foundations next to the IvyGlenn substation. Photo facing south

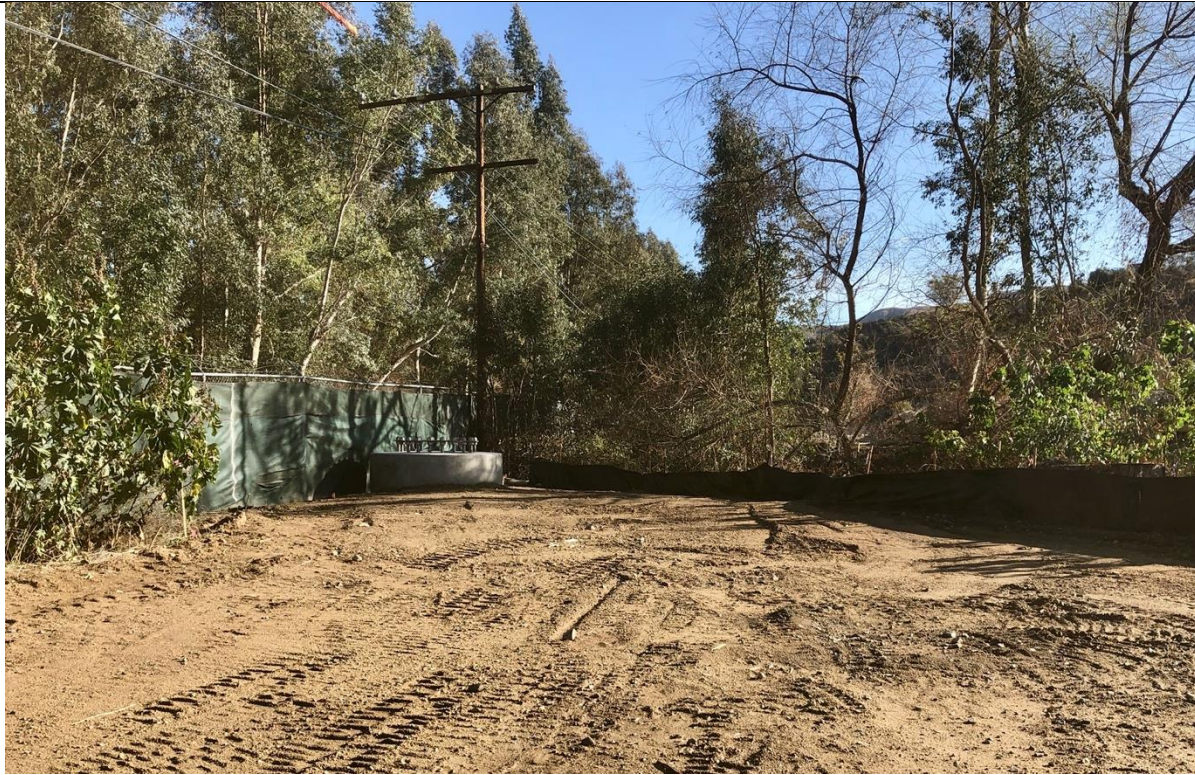
Photo 7 – The foundation for TSP 522 now drilled and poured. Photo facing south

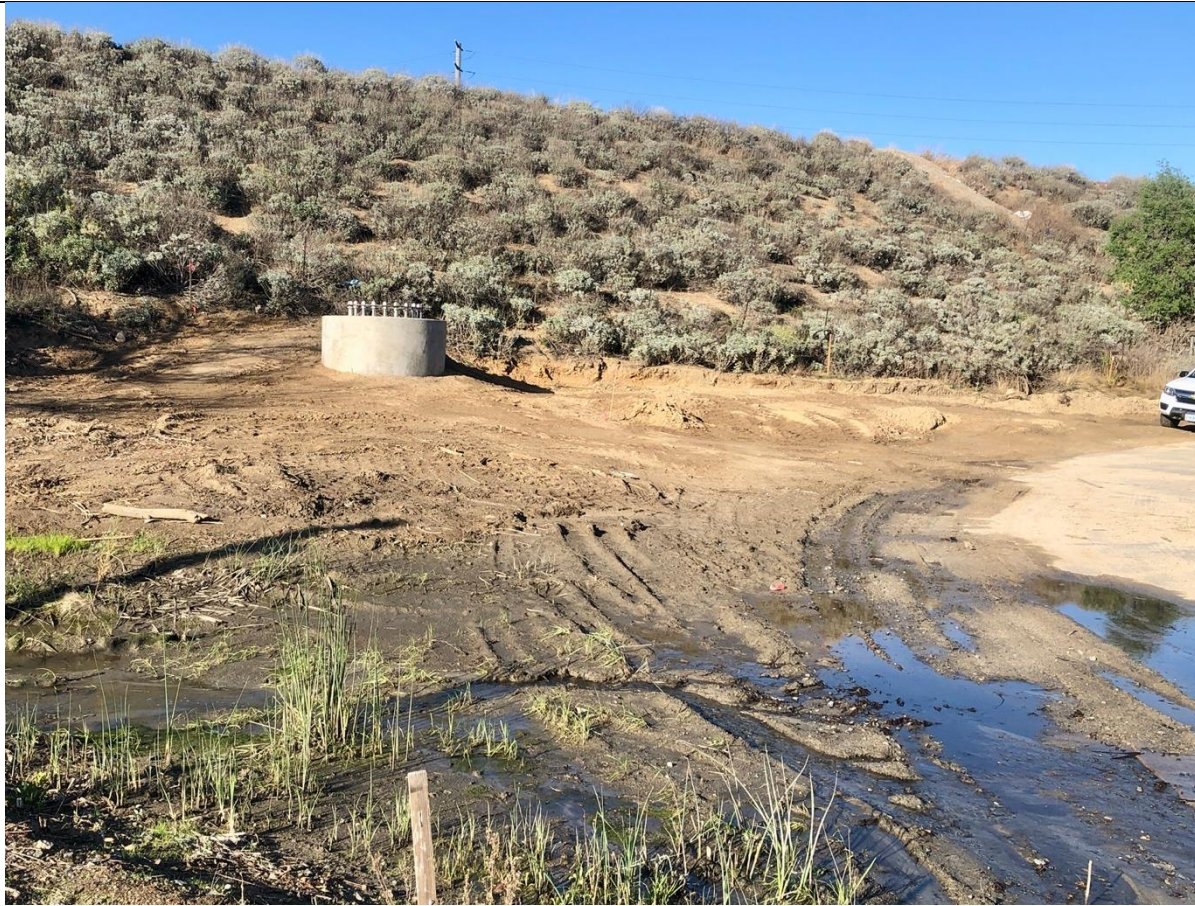
Photo 8 – The area  
around TSP 520  
remains wet from an  
upstream spring.  
Photo facing east

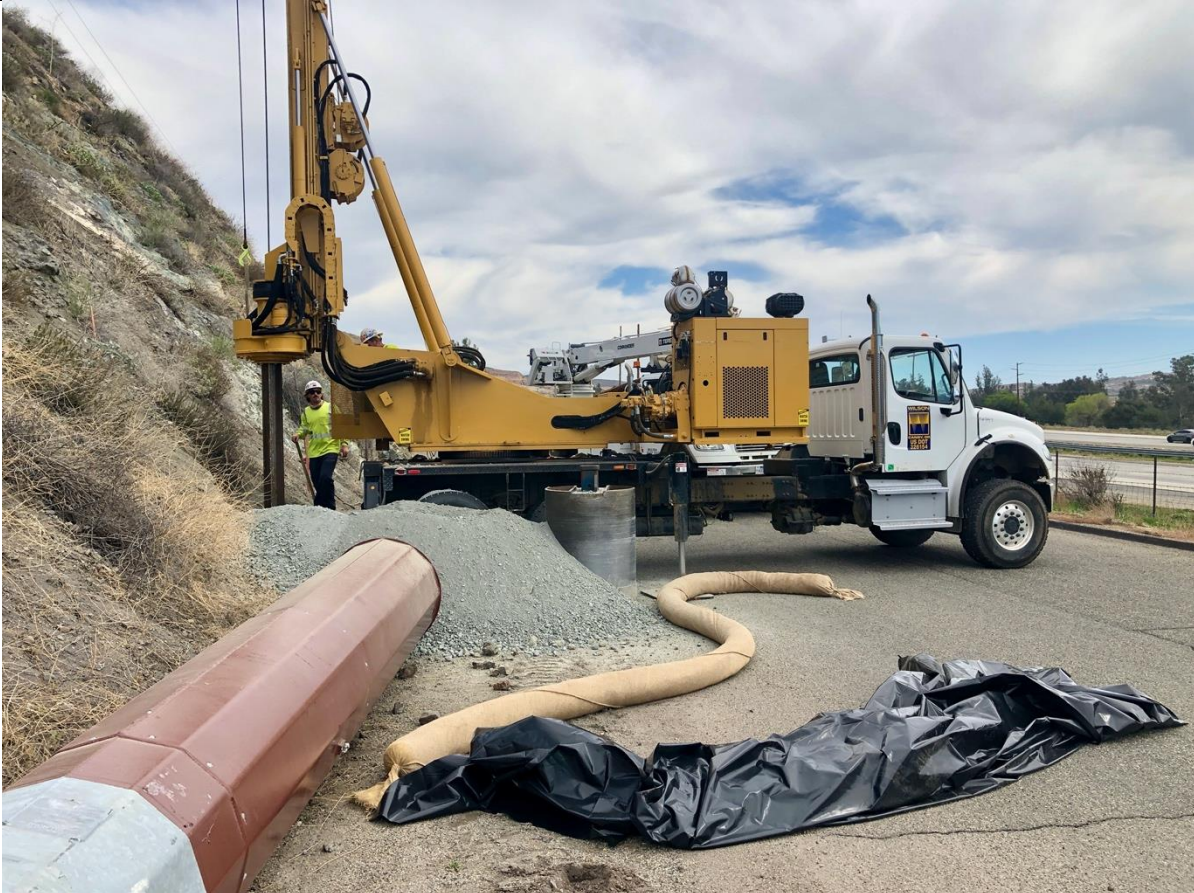
Photo 2 – Drilling work at TSP 496-2178. The drilling is mostly in rock and does not need a Paleo monitor. Photo facing south

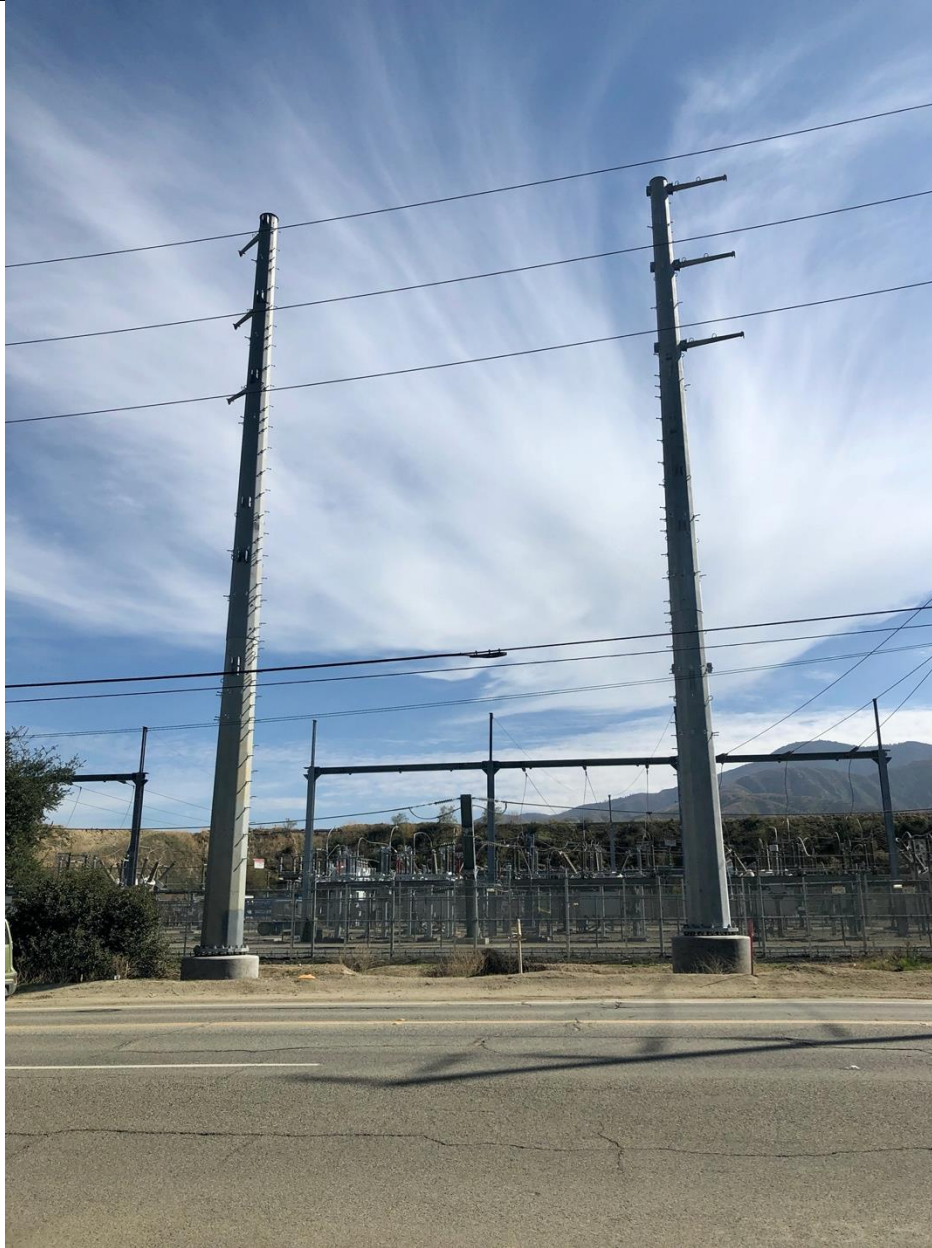
Photo 4 – TSP are up at the IvyGlen substation. Photo facing southwest

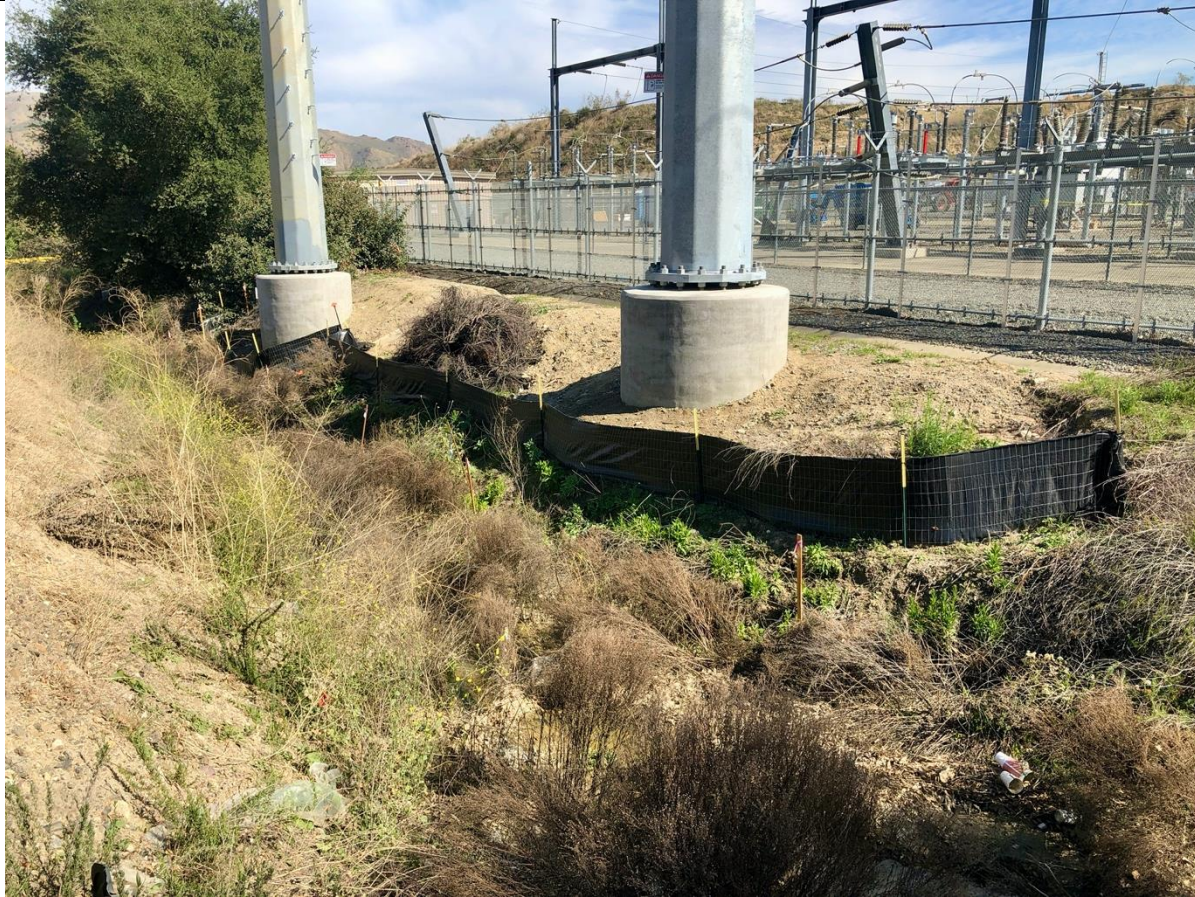
Photo 5 – BMPs remain in place around the TSP foundations in the drainage. Photo facing southeast

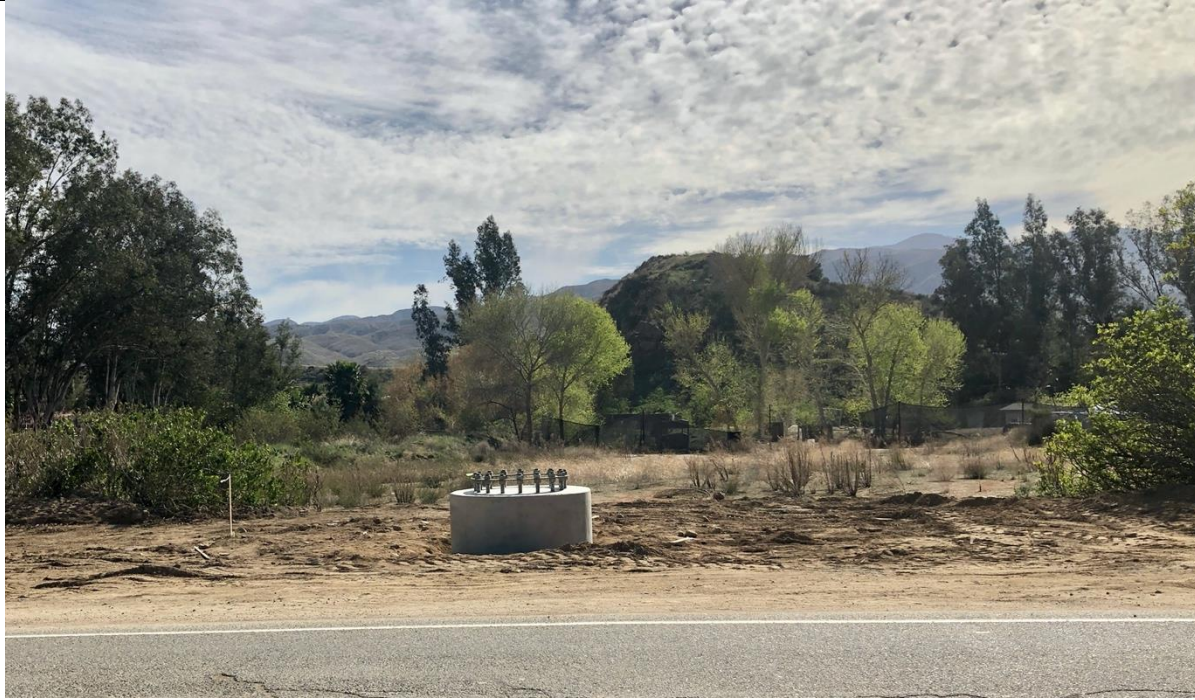
Photo 6 – New TSP  
foundation along  
Temescal Canyon  
road. Photo facing  
west

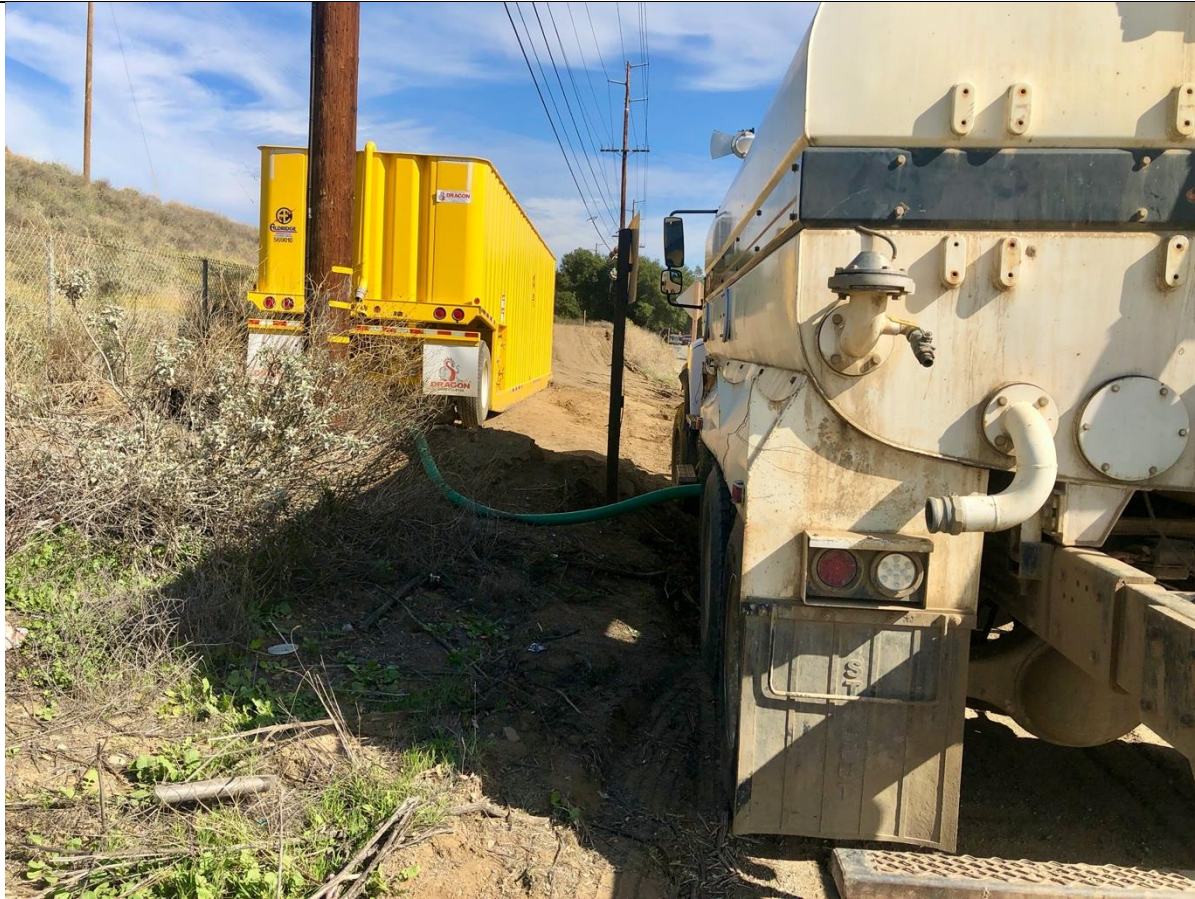
Photo 7 – Baker tanks are in place due to the high water table. Photo facing south

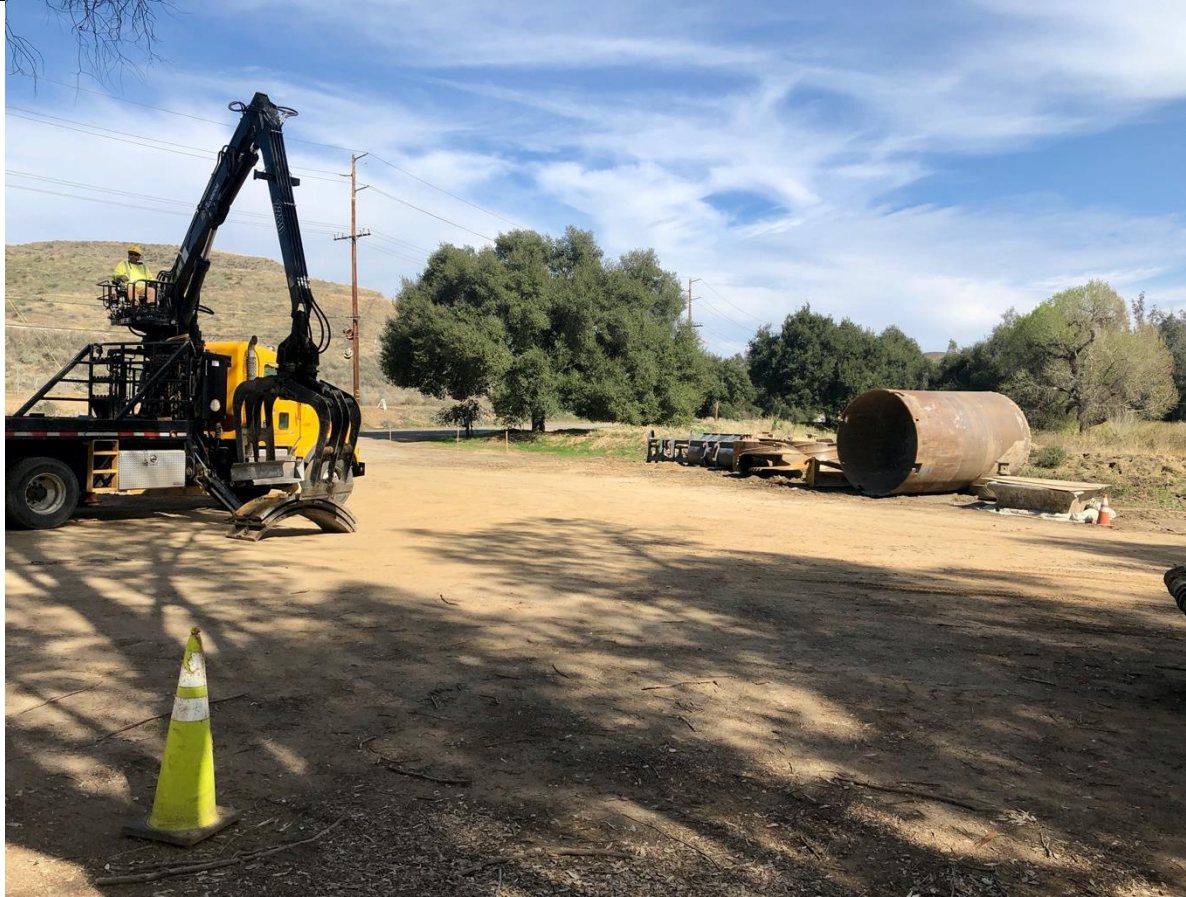
Photo 8 – A staging area along Temescal Canyon road. Photo facing southeast

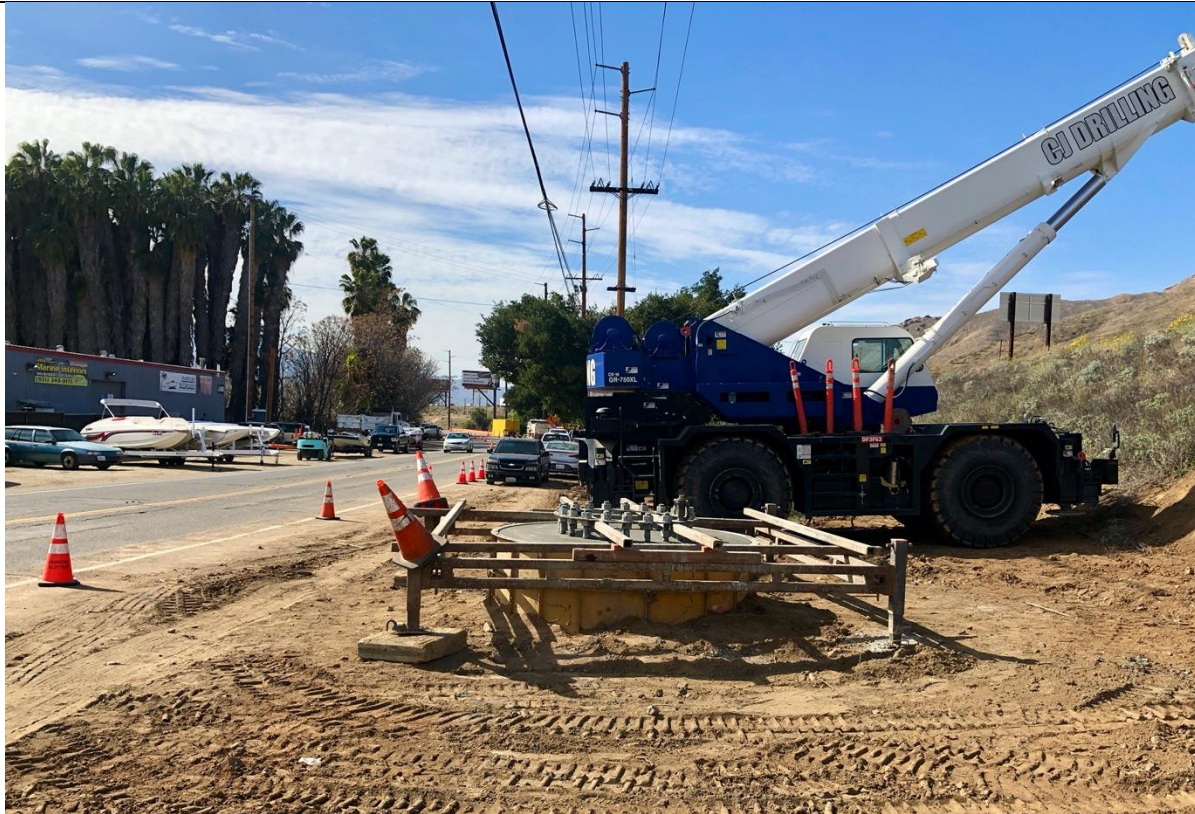
Photo 9 – Newly poured TSP along Temescal Canyon Road. Photo facing northwest

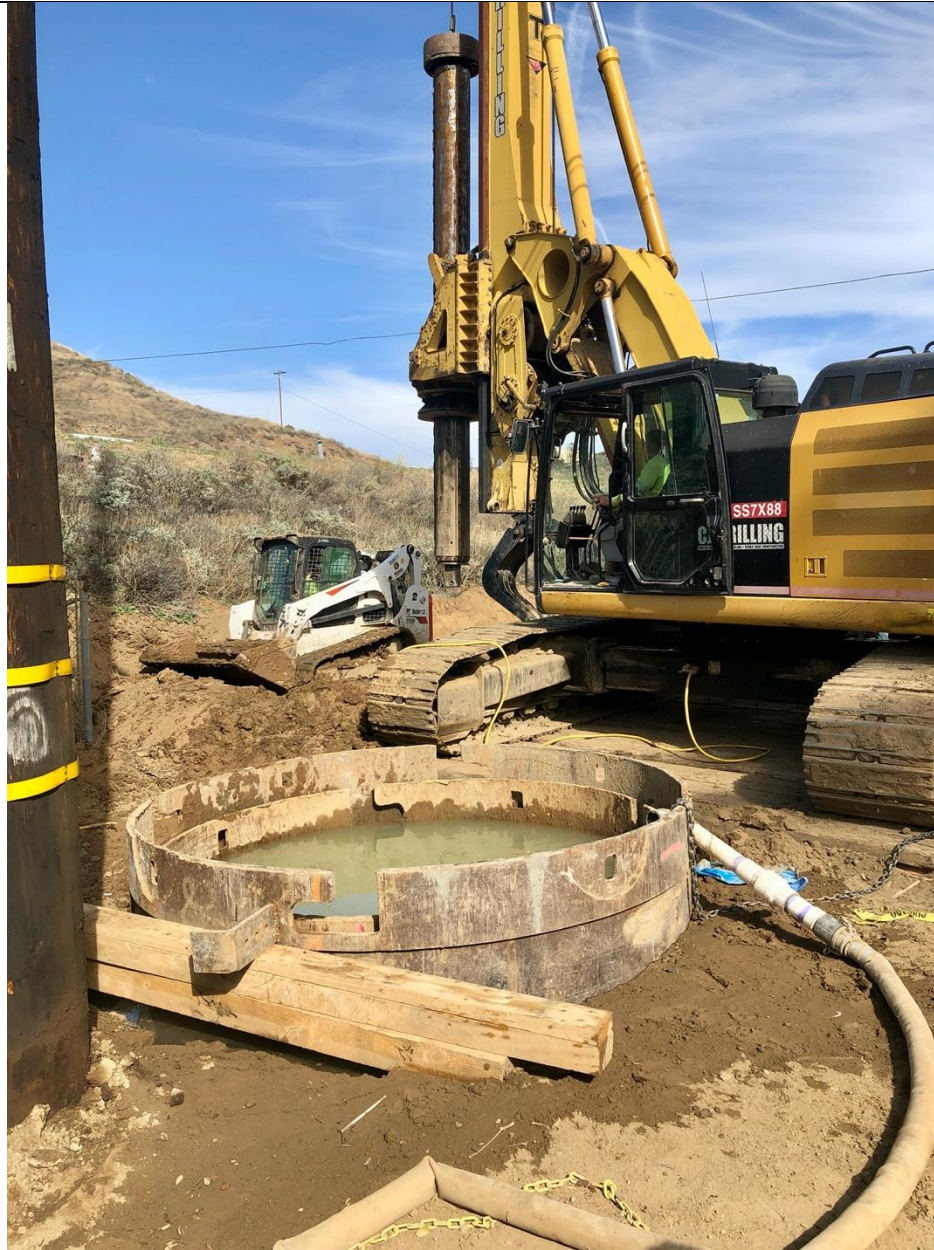
Photo 10 – TSP 501 foundation hole being drilled – groundwater is high and they add water to the hole to keep the sidewalls from collapsing. Photo facing east

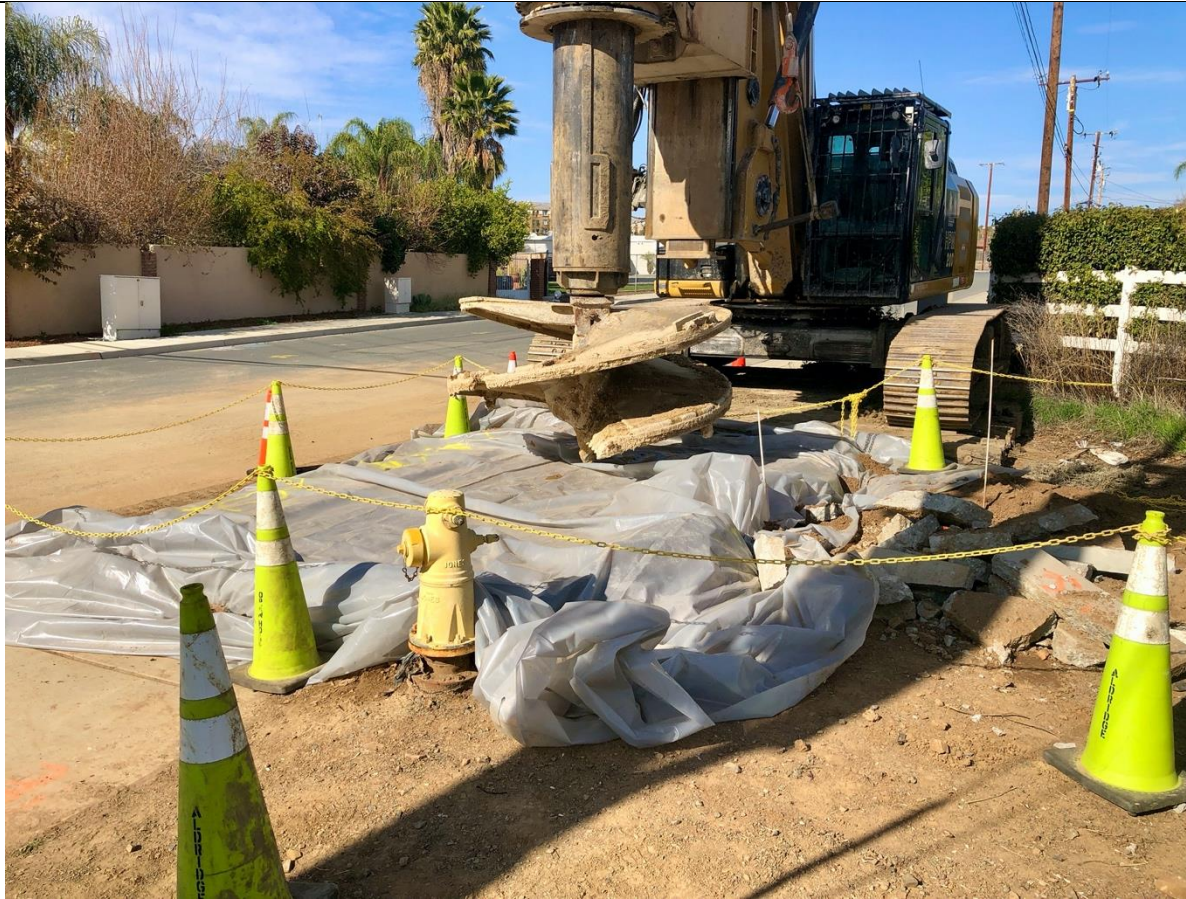
Photo 11 – TSP 313 off of Conrad Rd near HWY 74 has been partially drilled. Crews have shut down for the day and covered the hole. Photo facing east

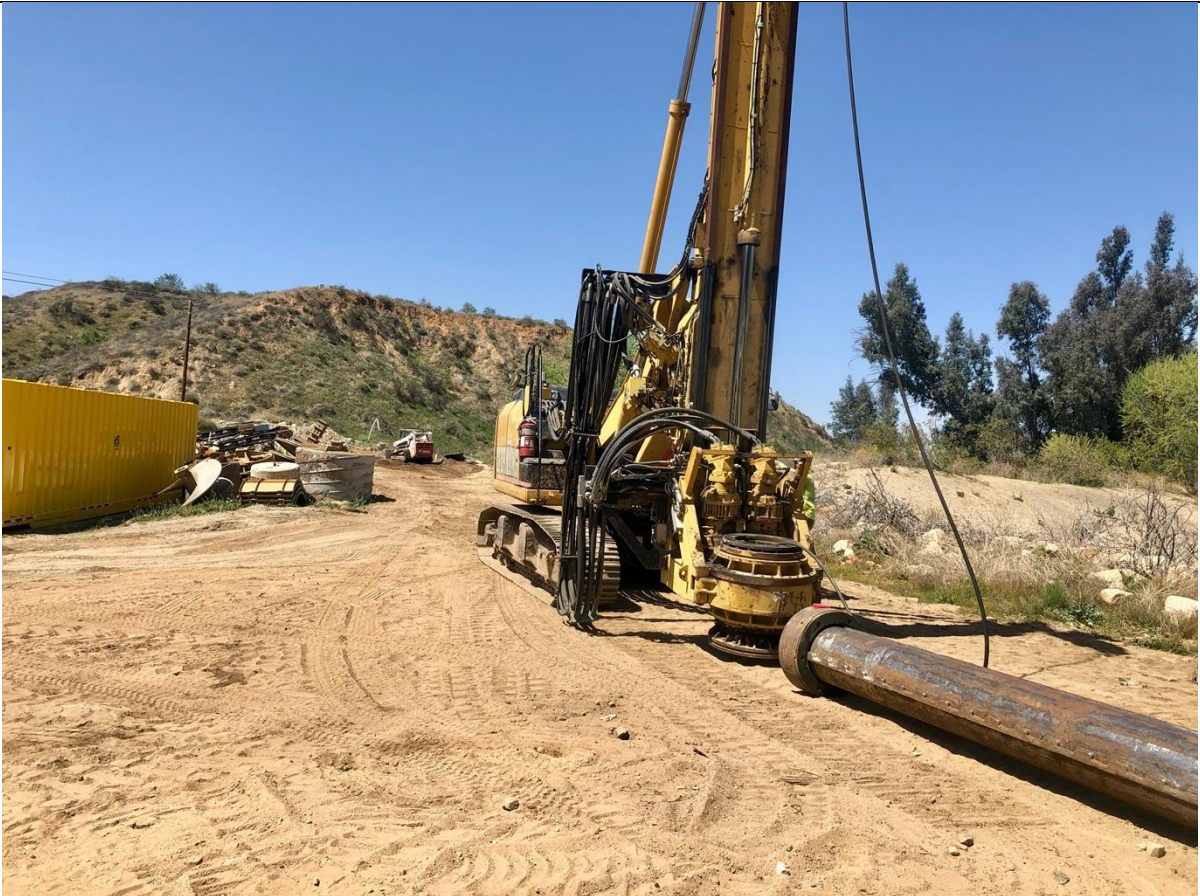
Photo 1 – Drilling equipment parked near TSP 525E. Photo facing northwest

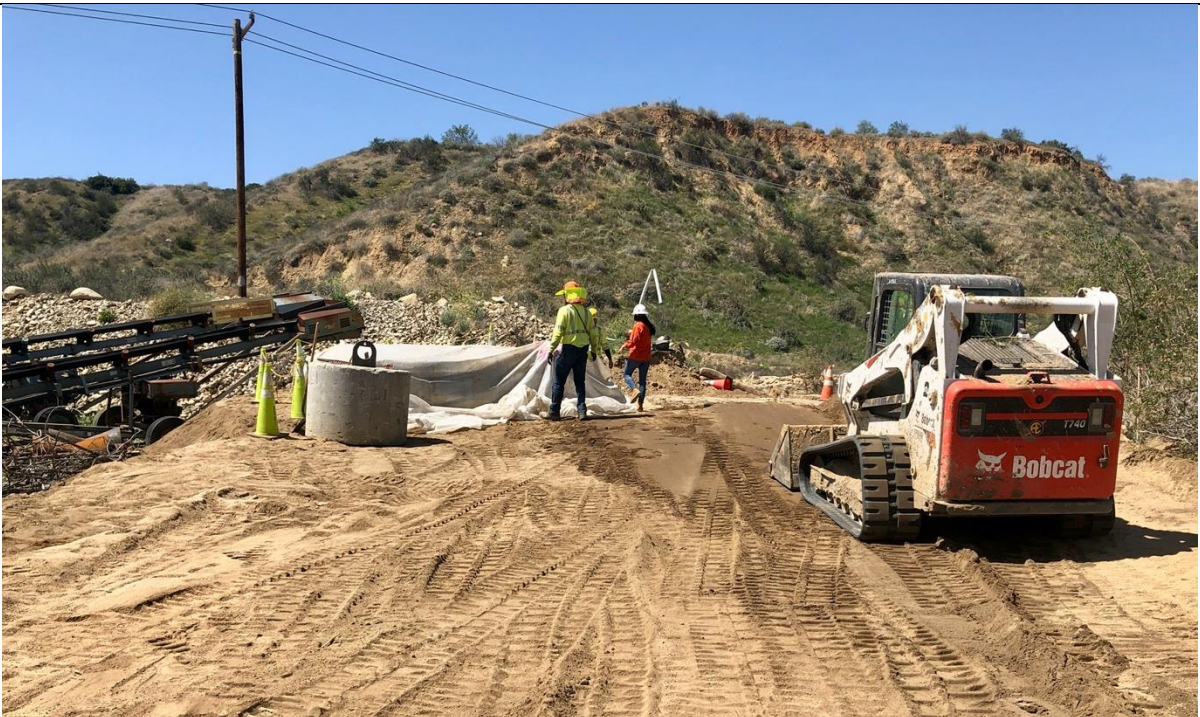
Photo 2 – Covering the foundation hole at TSP 525E. Photo facing northwest

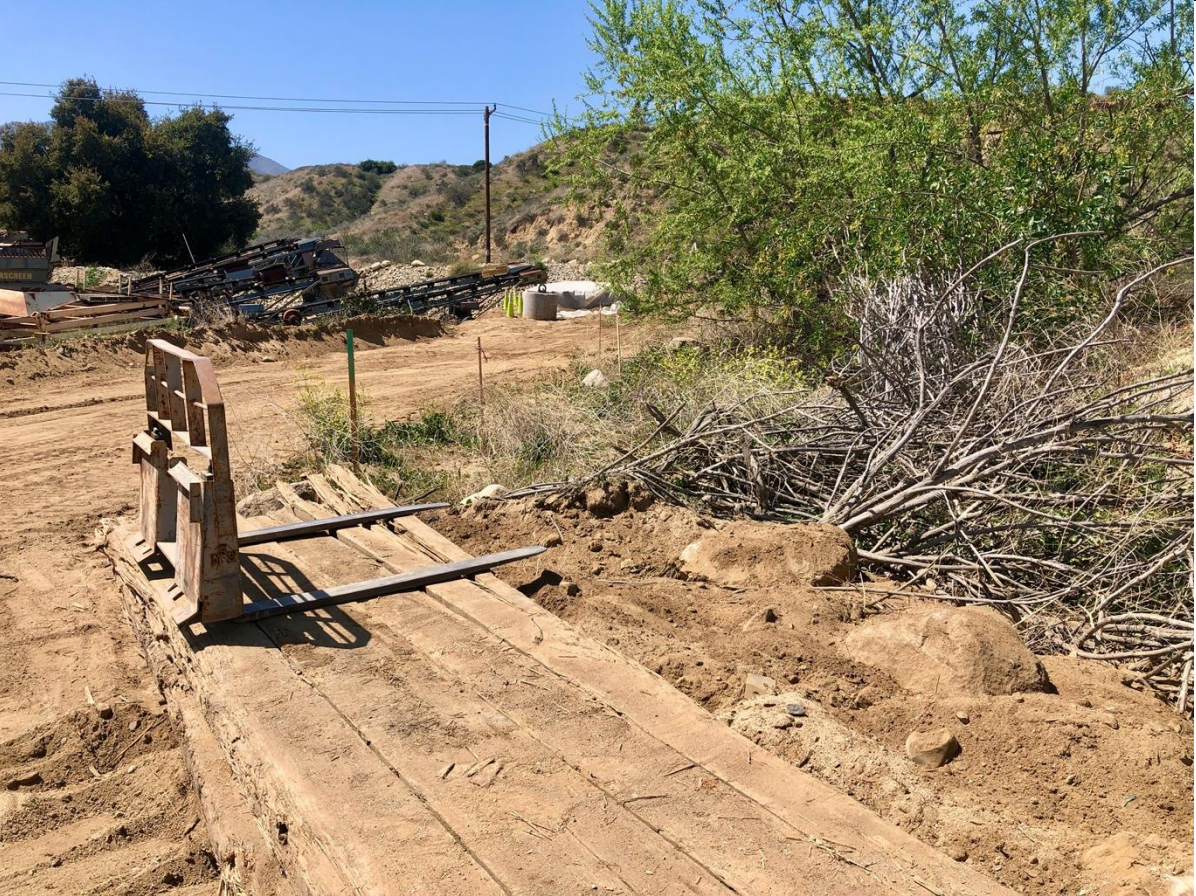
Photo 3 – Staking installed at the edge of the workspace and around the sensitive habitat near TSP 525E. Photo facing west

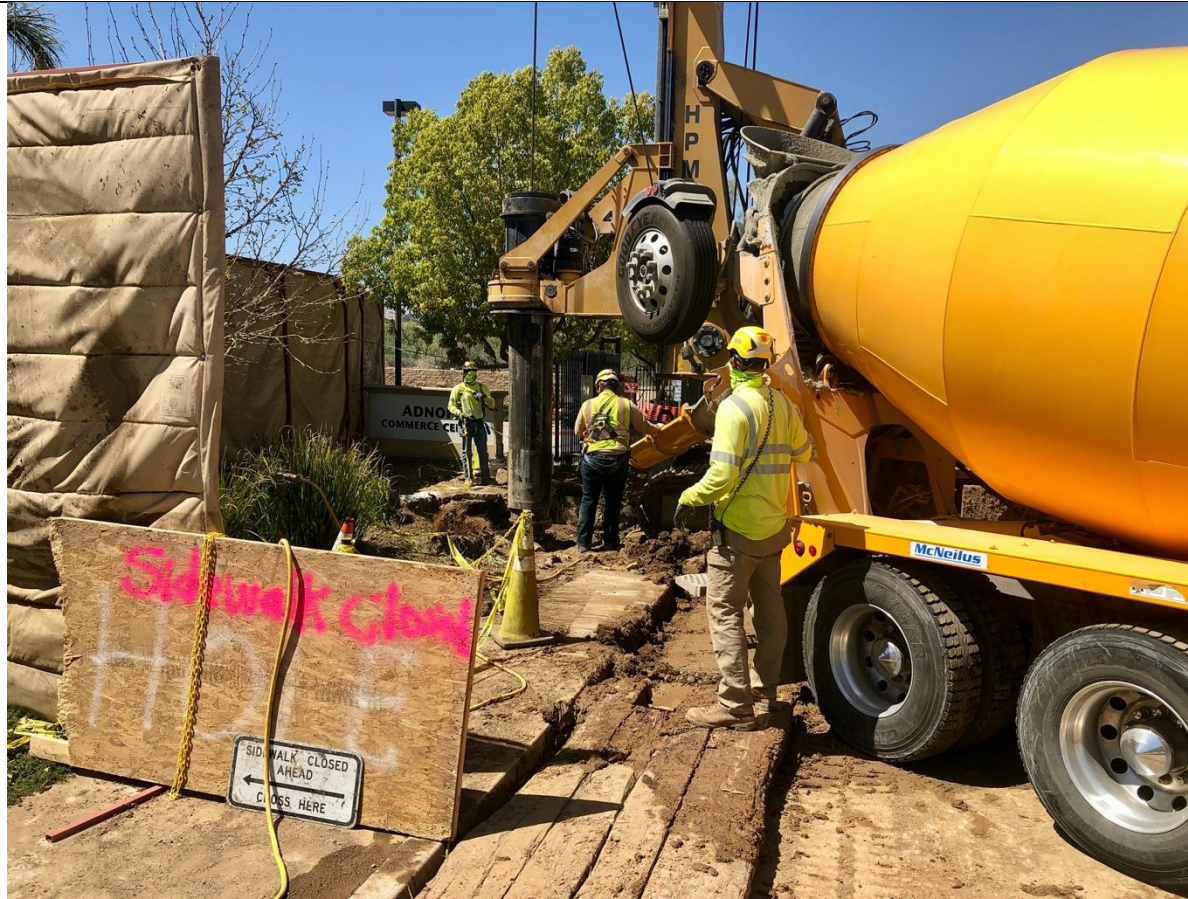
Photo 4 – Pouring  
slurry in the  
foundation hole at  
TSP 358E. Photo  
facing north

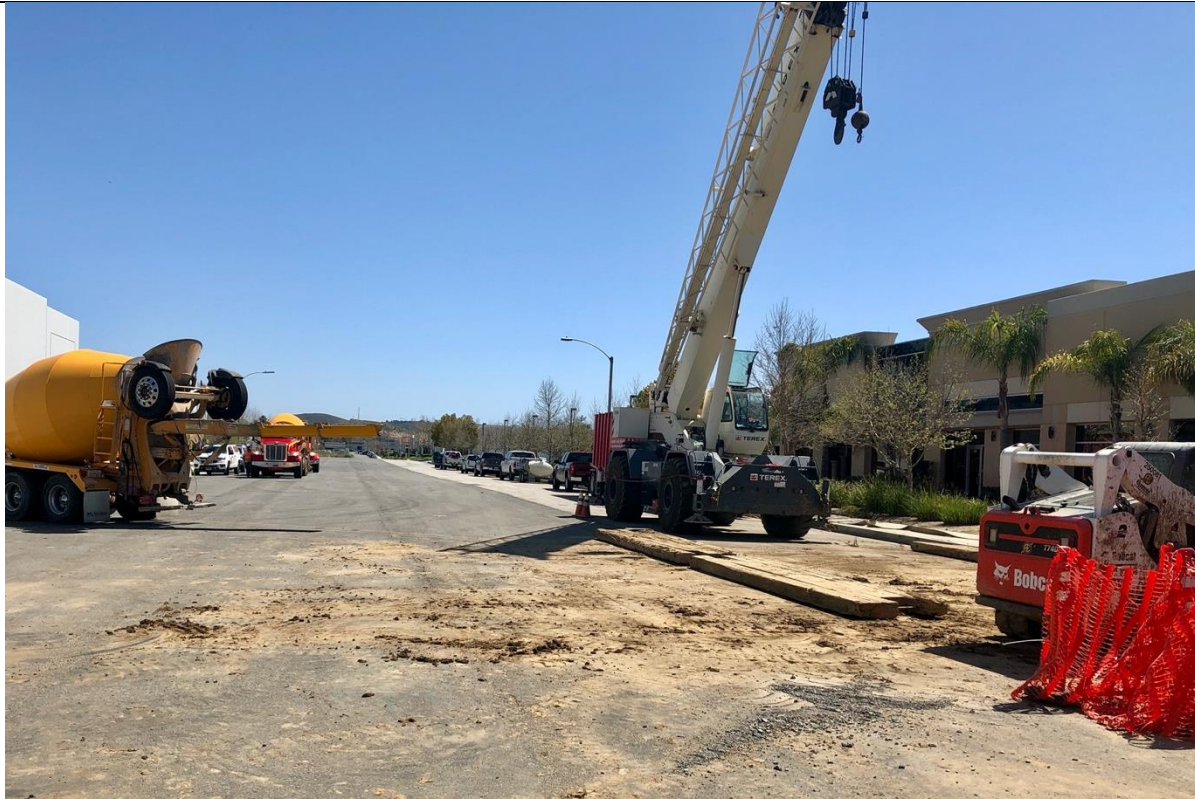
Photo 5 – Work area  
around TSP 358E.  
Photo facing south

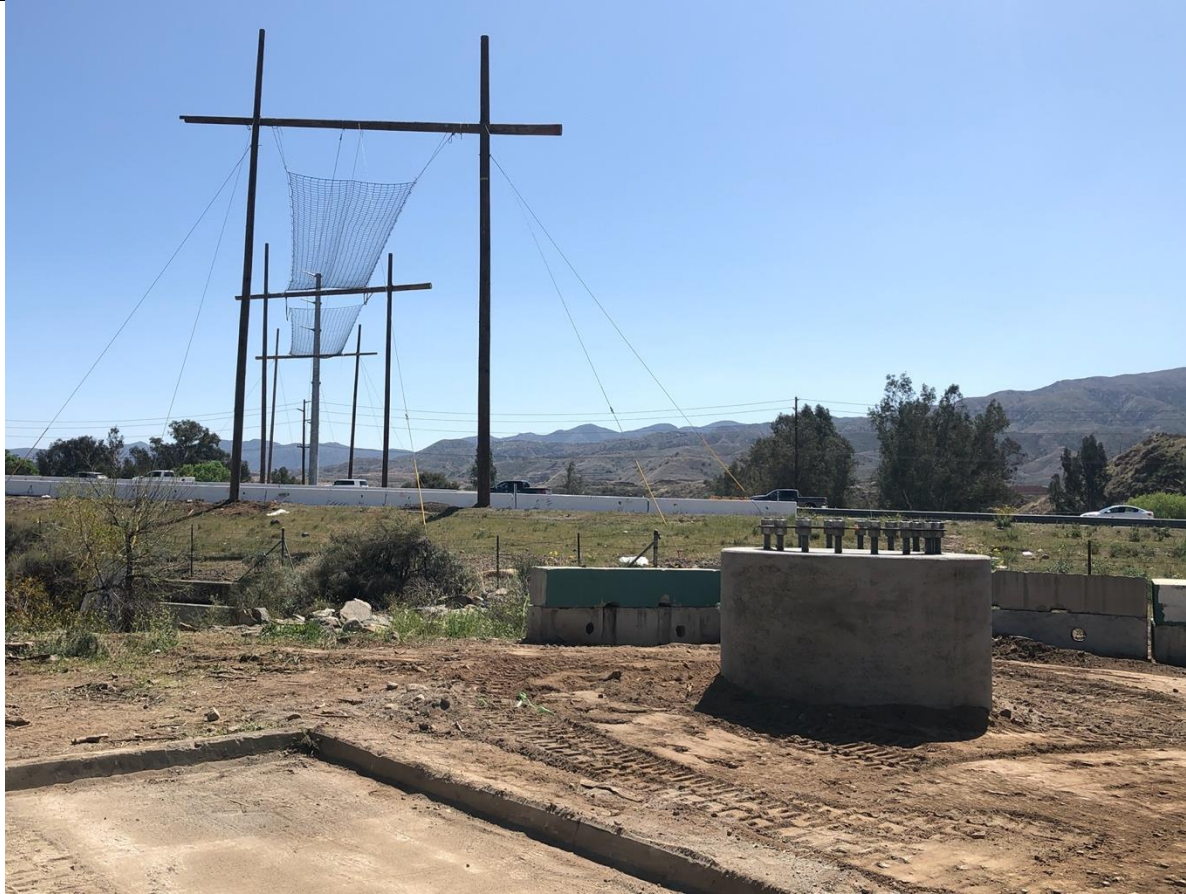
Photo 6 – New foundation at TSP 496-2177E – note the netting for stringing wire over Hwy 15. Photo facing south

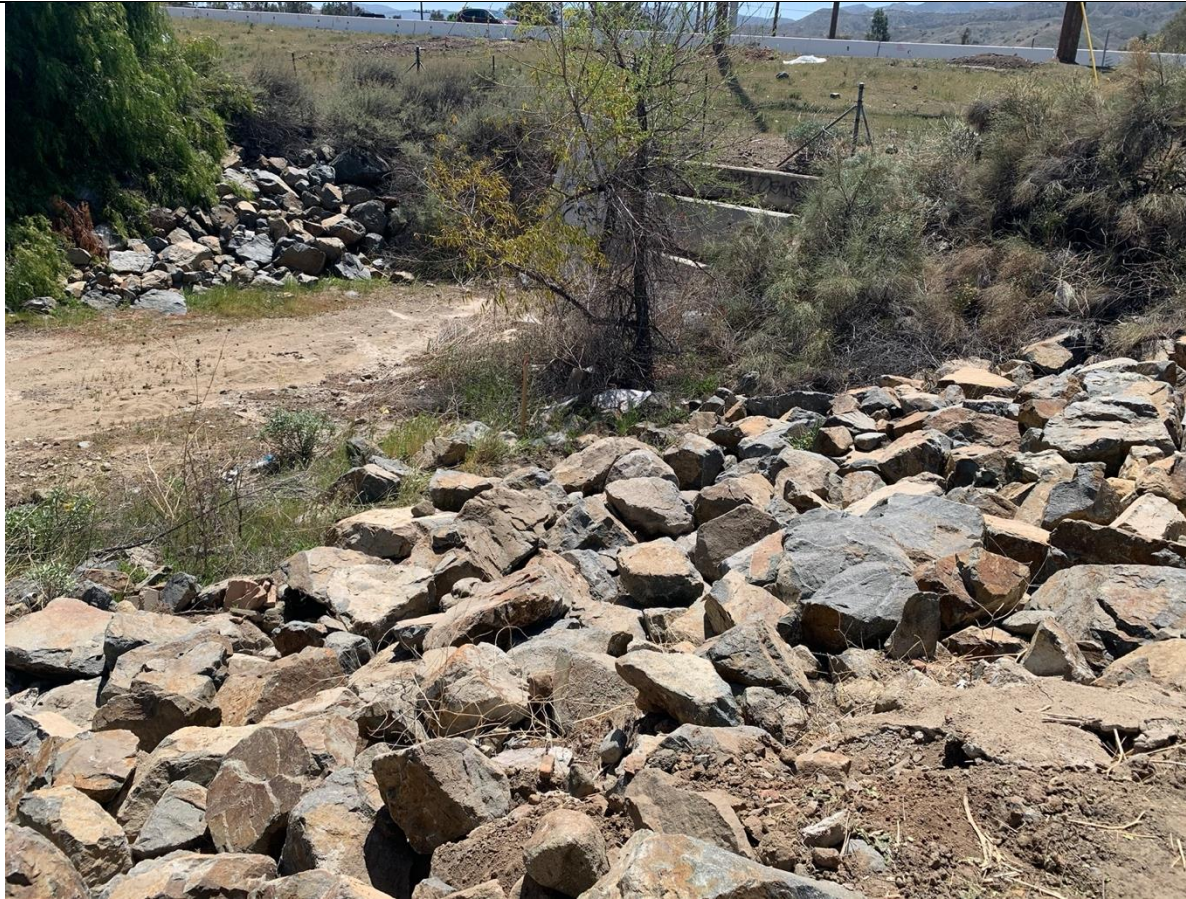
Photo 7 – Riprap next to TSP 496-2177E where concrete spilled out from the foundation pour – it had been cleaned up. Photo taken by the project Environmental inspector
