**Re: Monthly Report Summary #9 for the Valley-Ivyglen 115-kV Substation (VIG) Project**

CPUC Site Inspection Reports

## Valley – Ivyglen Subtransmission Project CPUC Site Inspection Form

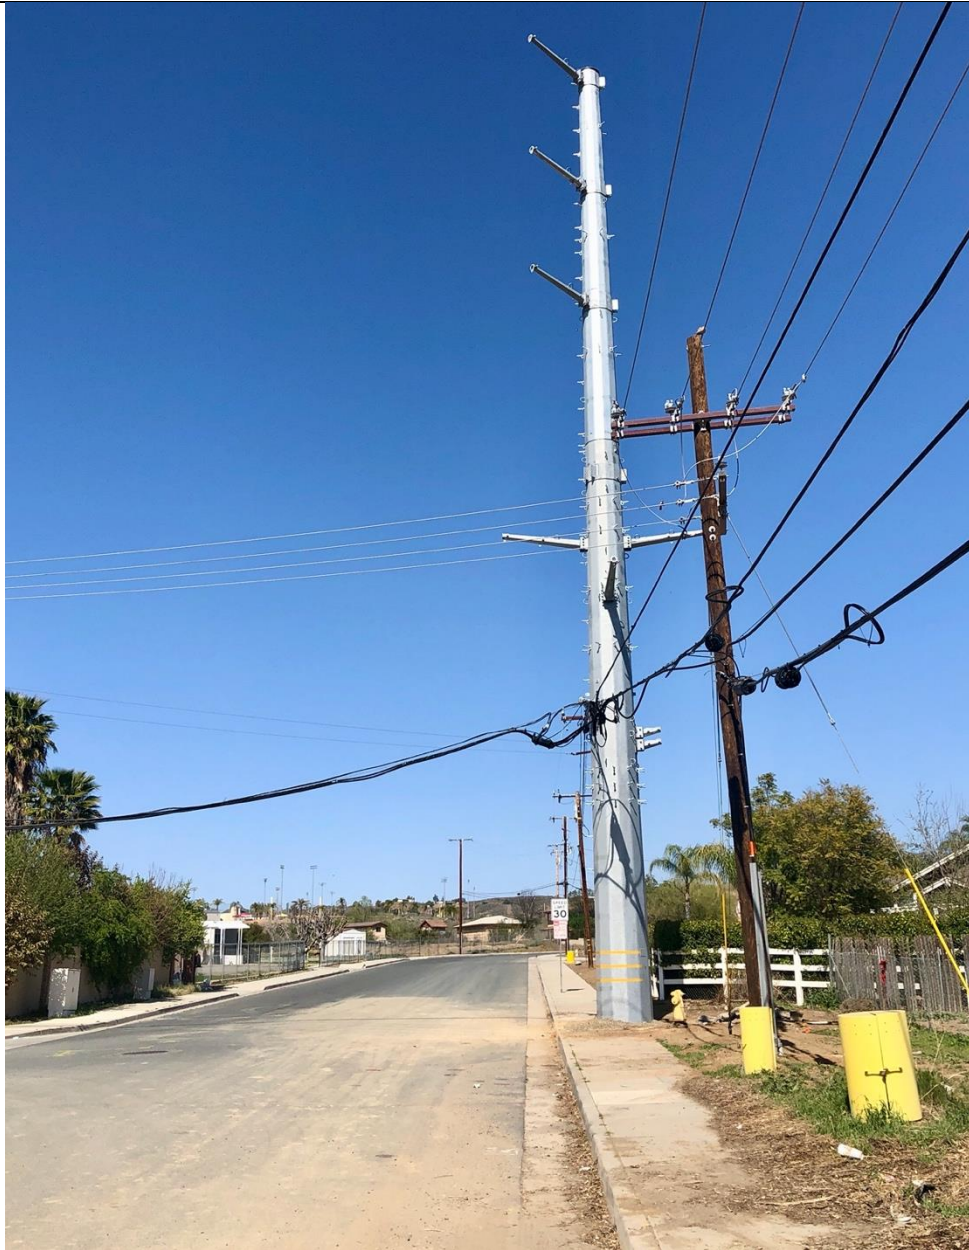
Photo 8 – TSP 313  
has been erected at  
the south end of  
Conrad road. Photo  
facing east
